Status Report

April, 2005

Milwaukee City Hall Historic Building Restoration

Department of Public Works
Operations Division
Buildings and Fleet Services

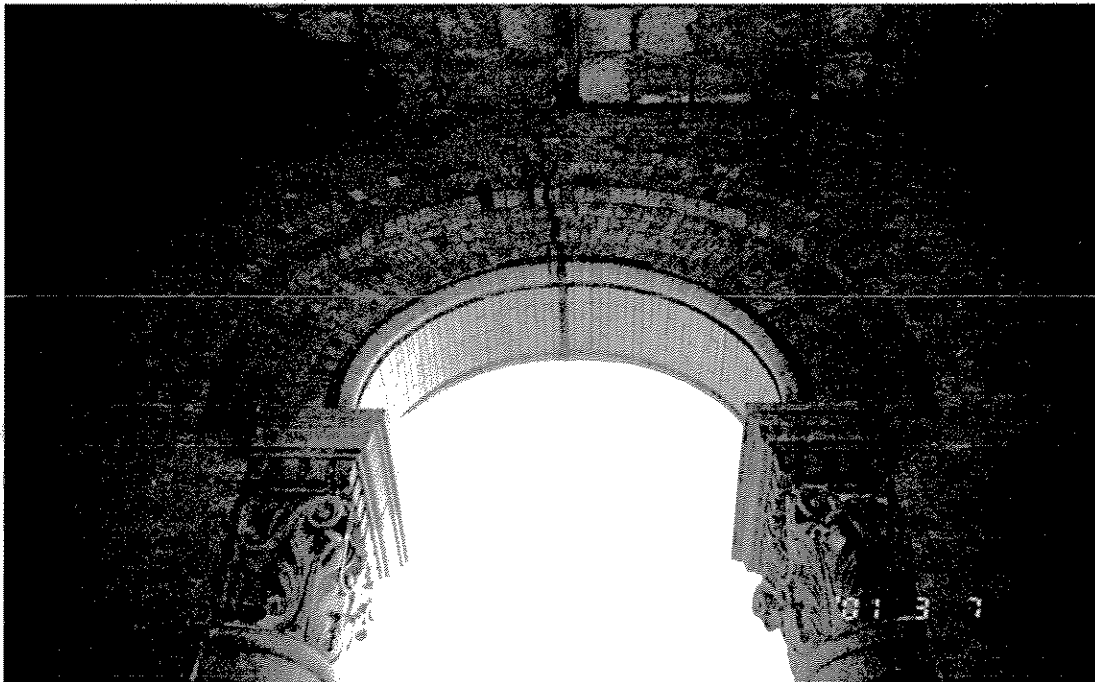
Structural analysis and monitoring of the south tower have determined that the weight of the masonry, in combination with expansion and contraction with temperature changes, have caused cracks to form at the masonry arches over openings and extend deep into these masonry walls. In some cases, these cracks extend over a full story in height, passing from the arches on one level through the massive walls to the level above. These cracks occur through the full thickness of the masonry walls, which are, in some instances, over four feet thick. In many places, members of the interior steel construction have corroded and expanded causing cracks and loosening of the terra-cotta elements and brick masonry.

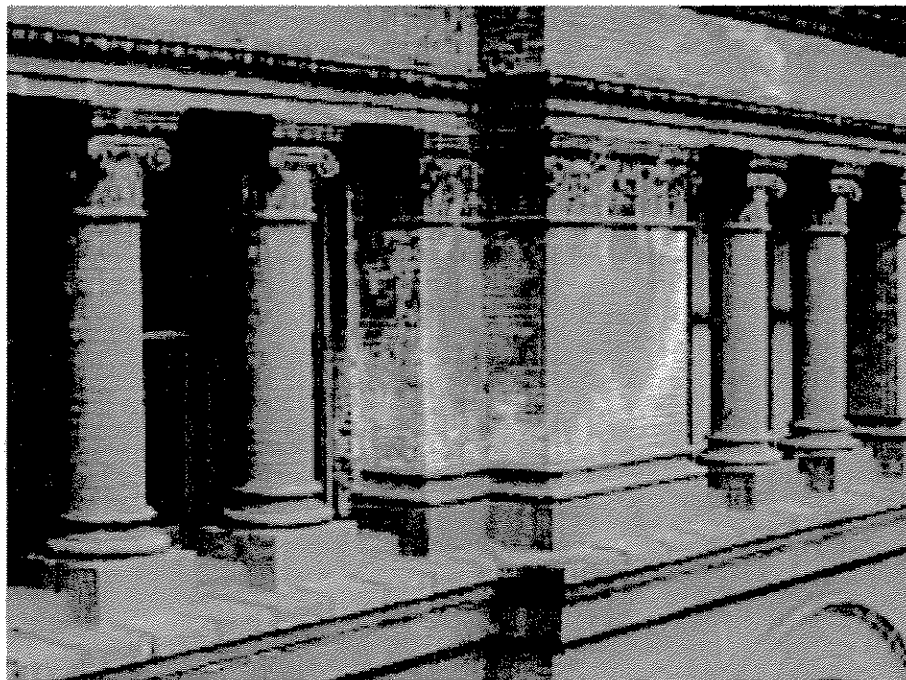
The main building's gutter line/cornice, located at the base of the eighth floor dormers, leak and allow water to penetrate the exterior walls of the assistant city attorneys' offices. This moisture is continuously saturating these masonry walls causing the interior plaster to deteriorate. Temporary drywall repairs have been made in these areas; however, rebuilding of the gutter line/cornice is imperative. Unless this work is done, moisture will continue to saturate the building's masonry walls and steel members. Embedded steel floor beams will continue to corrode and compromise their structural integrity. The upper portions of the dormers need to be repaired as well. Steel members embedded in the masonry walls have corroded and caused the dormers to crack and lean outward towards the street. To correct these problems, the gutter line / cornice and portions of each dormer must be rebuilt.

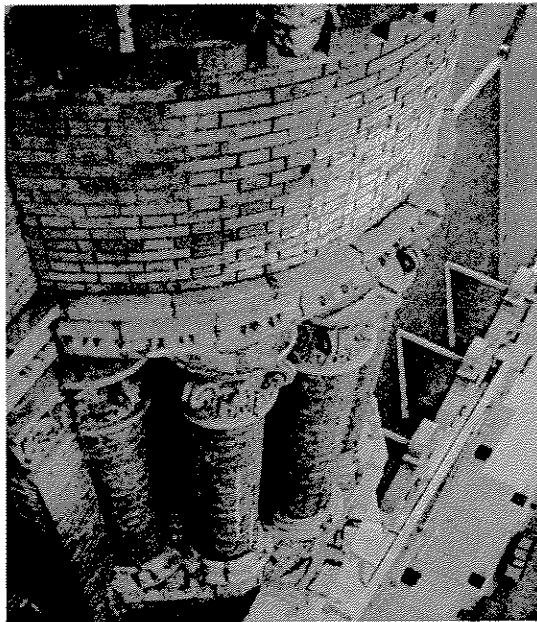
SGH inspected the South Tower in March 2001, October 2003, and January 2004 as a part of continuing inspections of City Hall. Their inspections show that the masonry walls and ornamental terra cotta elements have significant and numerous cracks. While some identified distress is local in nature and does not relate to the overall structural behavior of the tower, many cracks associated with structural deficiencies extend over the height of more than one level in the tower, having grown substantially in length and width.

The twelfth floor flat arches are cracked and deflected downward. The twelfth floor masonry columns, which support portions of the thirteenth floor and the roof, have advanced deterioration and exhibit very severe vertical cracks.

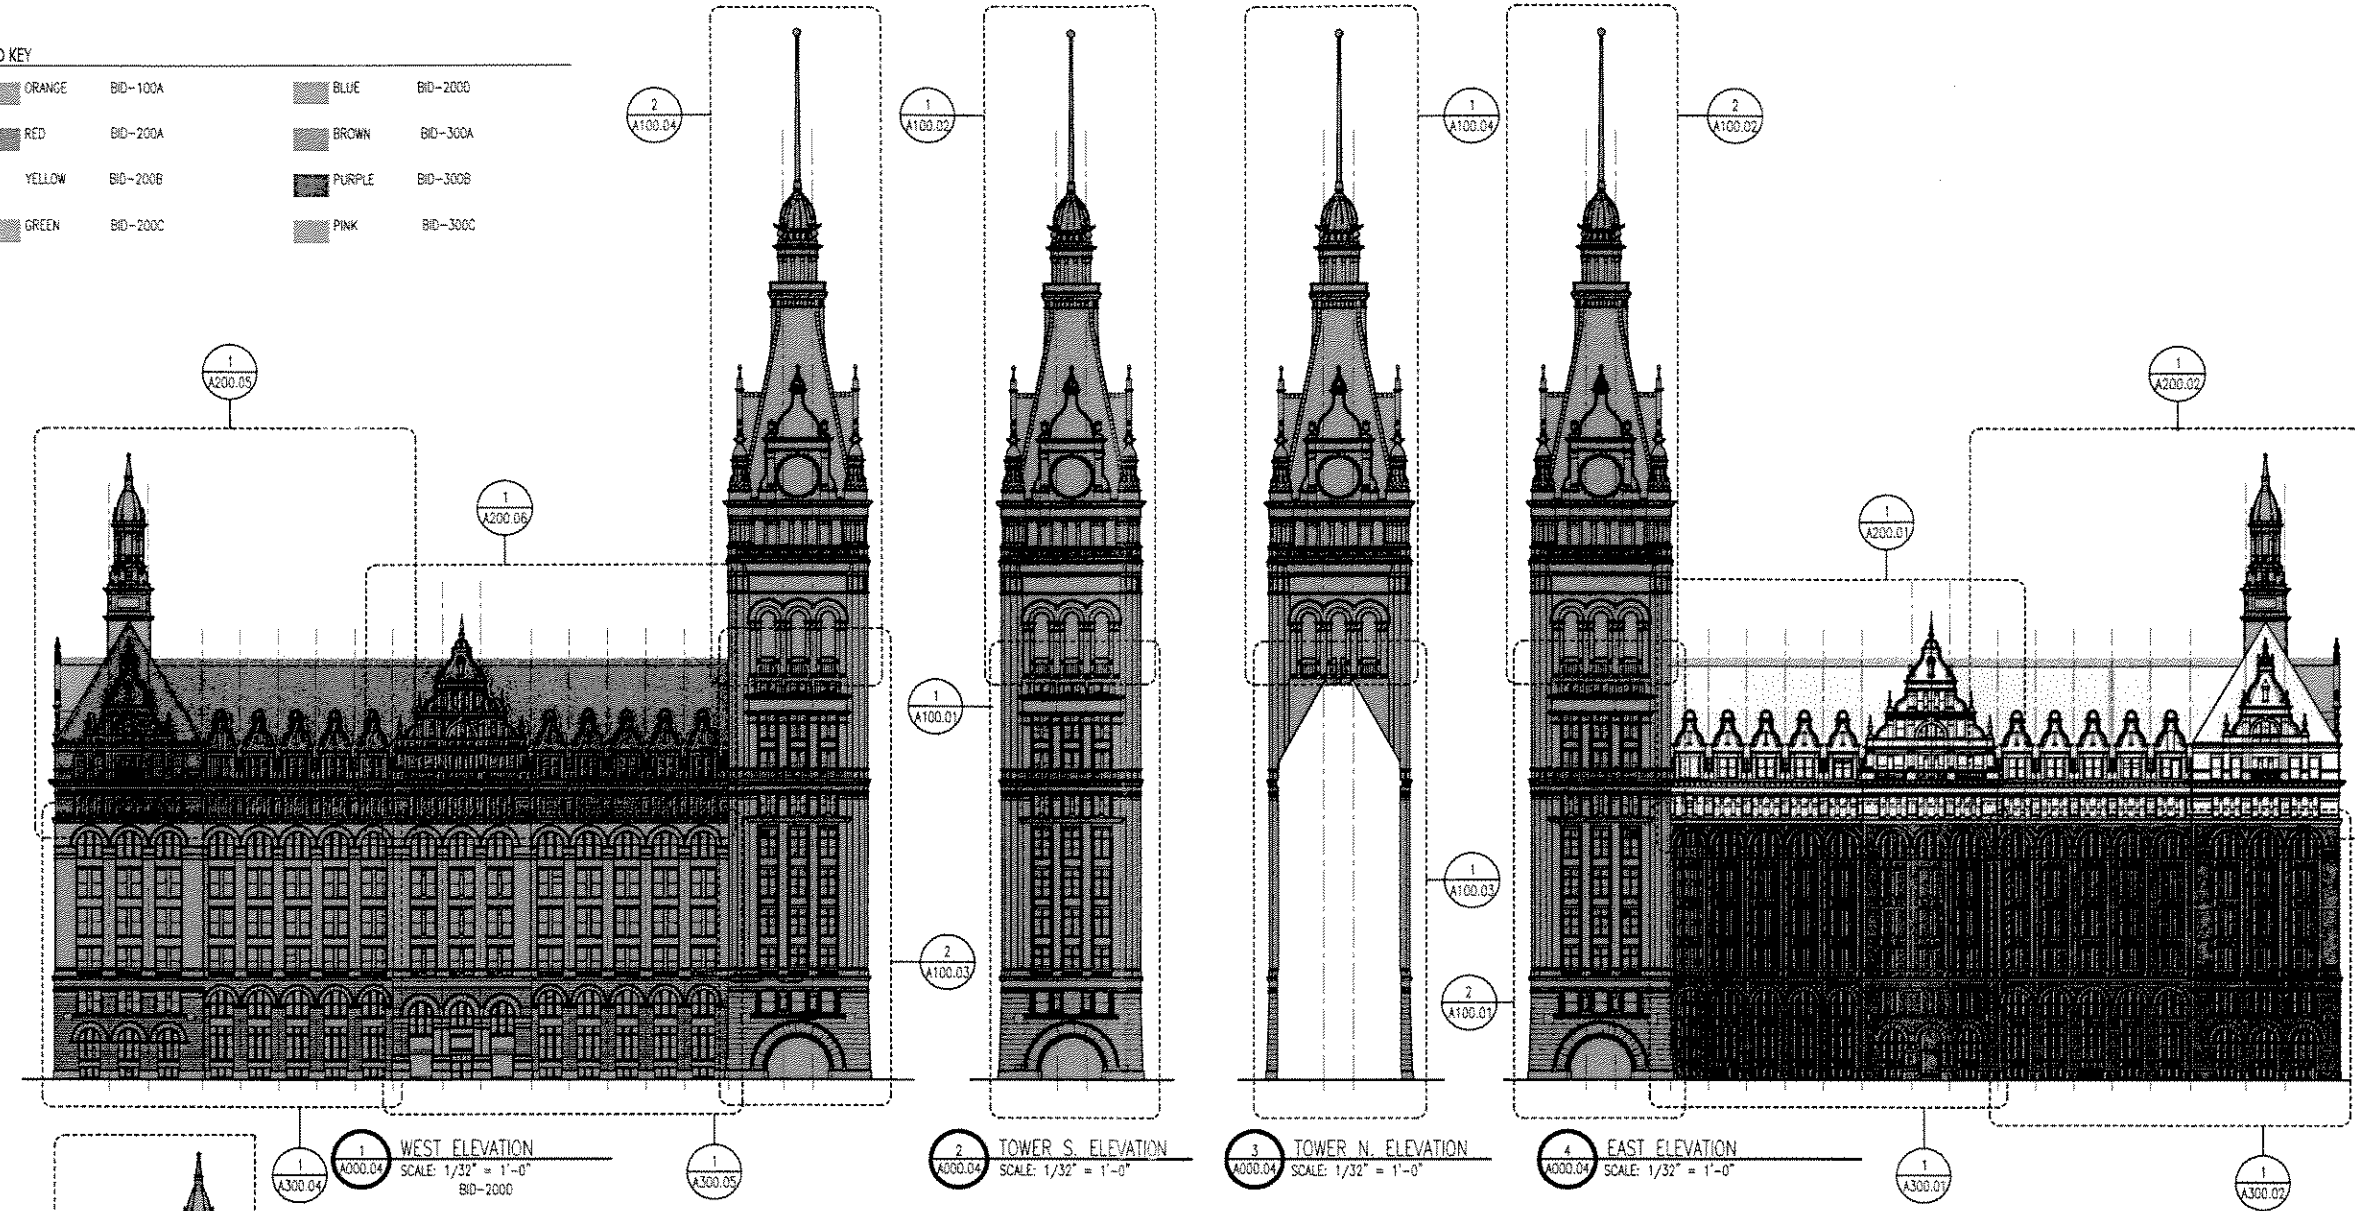
WEST ELEVATION
SCALE: 1/32" = 1'-0"
BID-200D

BID KEY

ORANGE	BID-100A	BLUE	BID-200D
RED	BID-200A	BROWN	BID-300A
YELLOW	BID-200B	PURPLE	BID-300B
GREEN	BID-200C	PINK	BID-300C

(A bid series location plan can be found in the appendix.)
