Turner Hall
1034 N Vel R Phillips Ave
Milwaukee, WI 53203

FEMA Grant Safety and Security Project
Certificate of Appropriateness Application
Drawing and Photo Exhibits

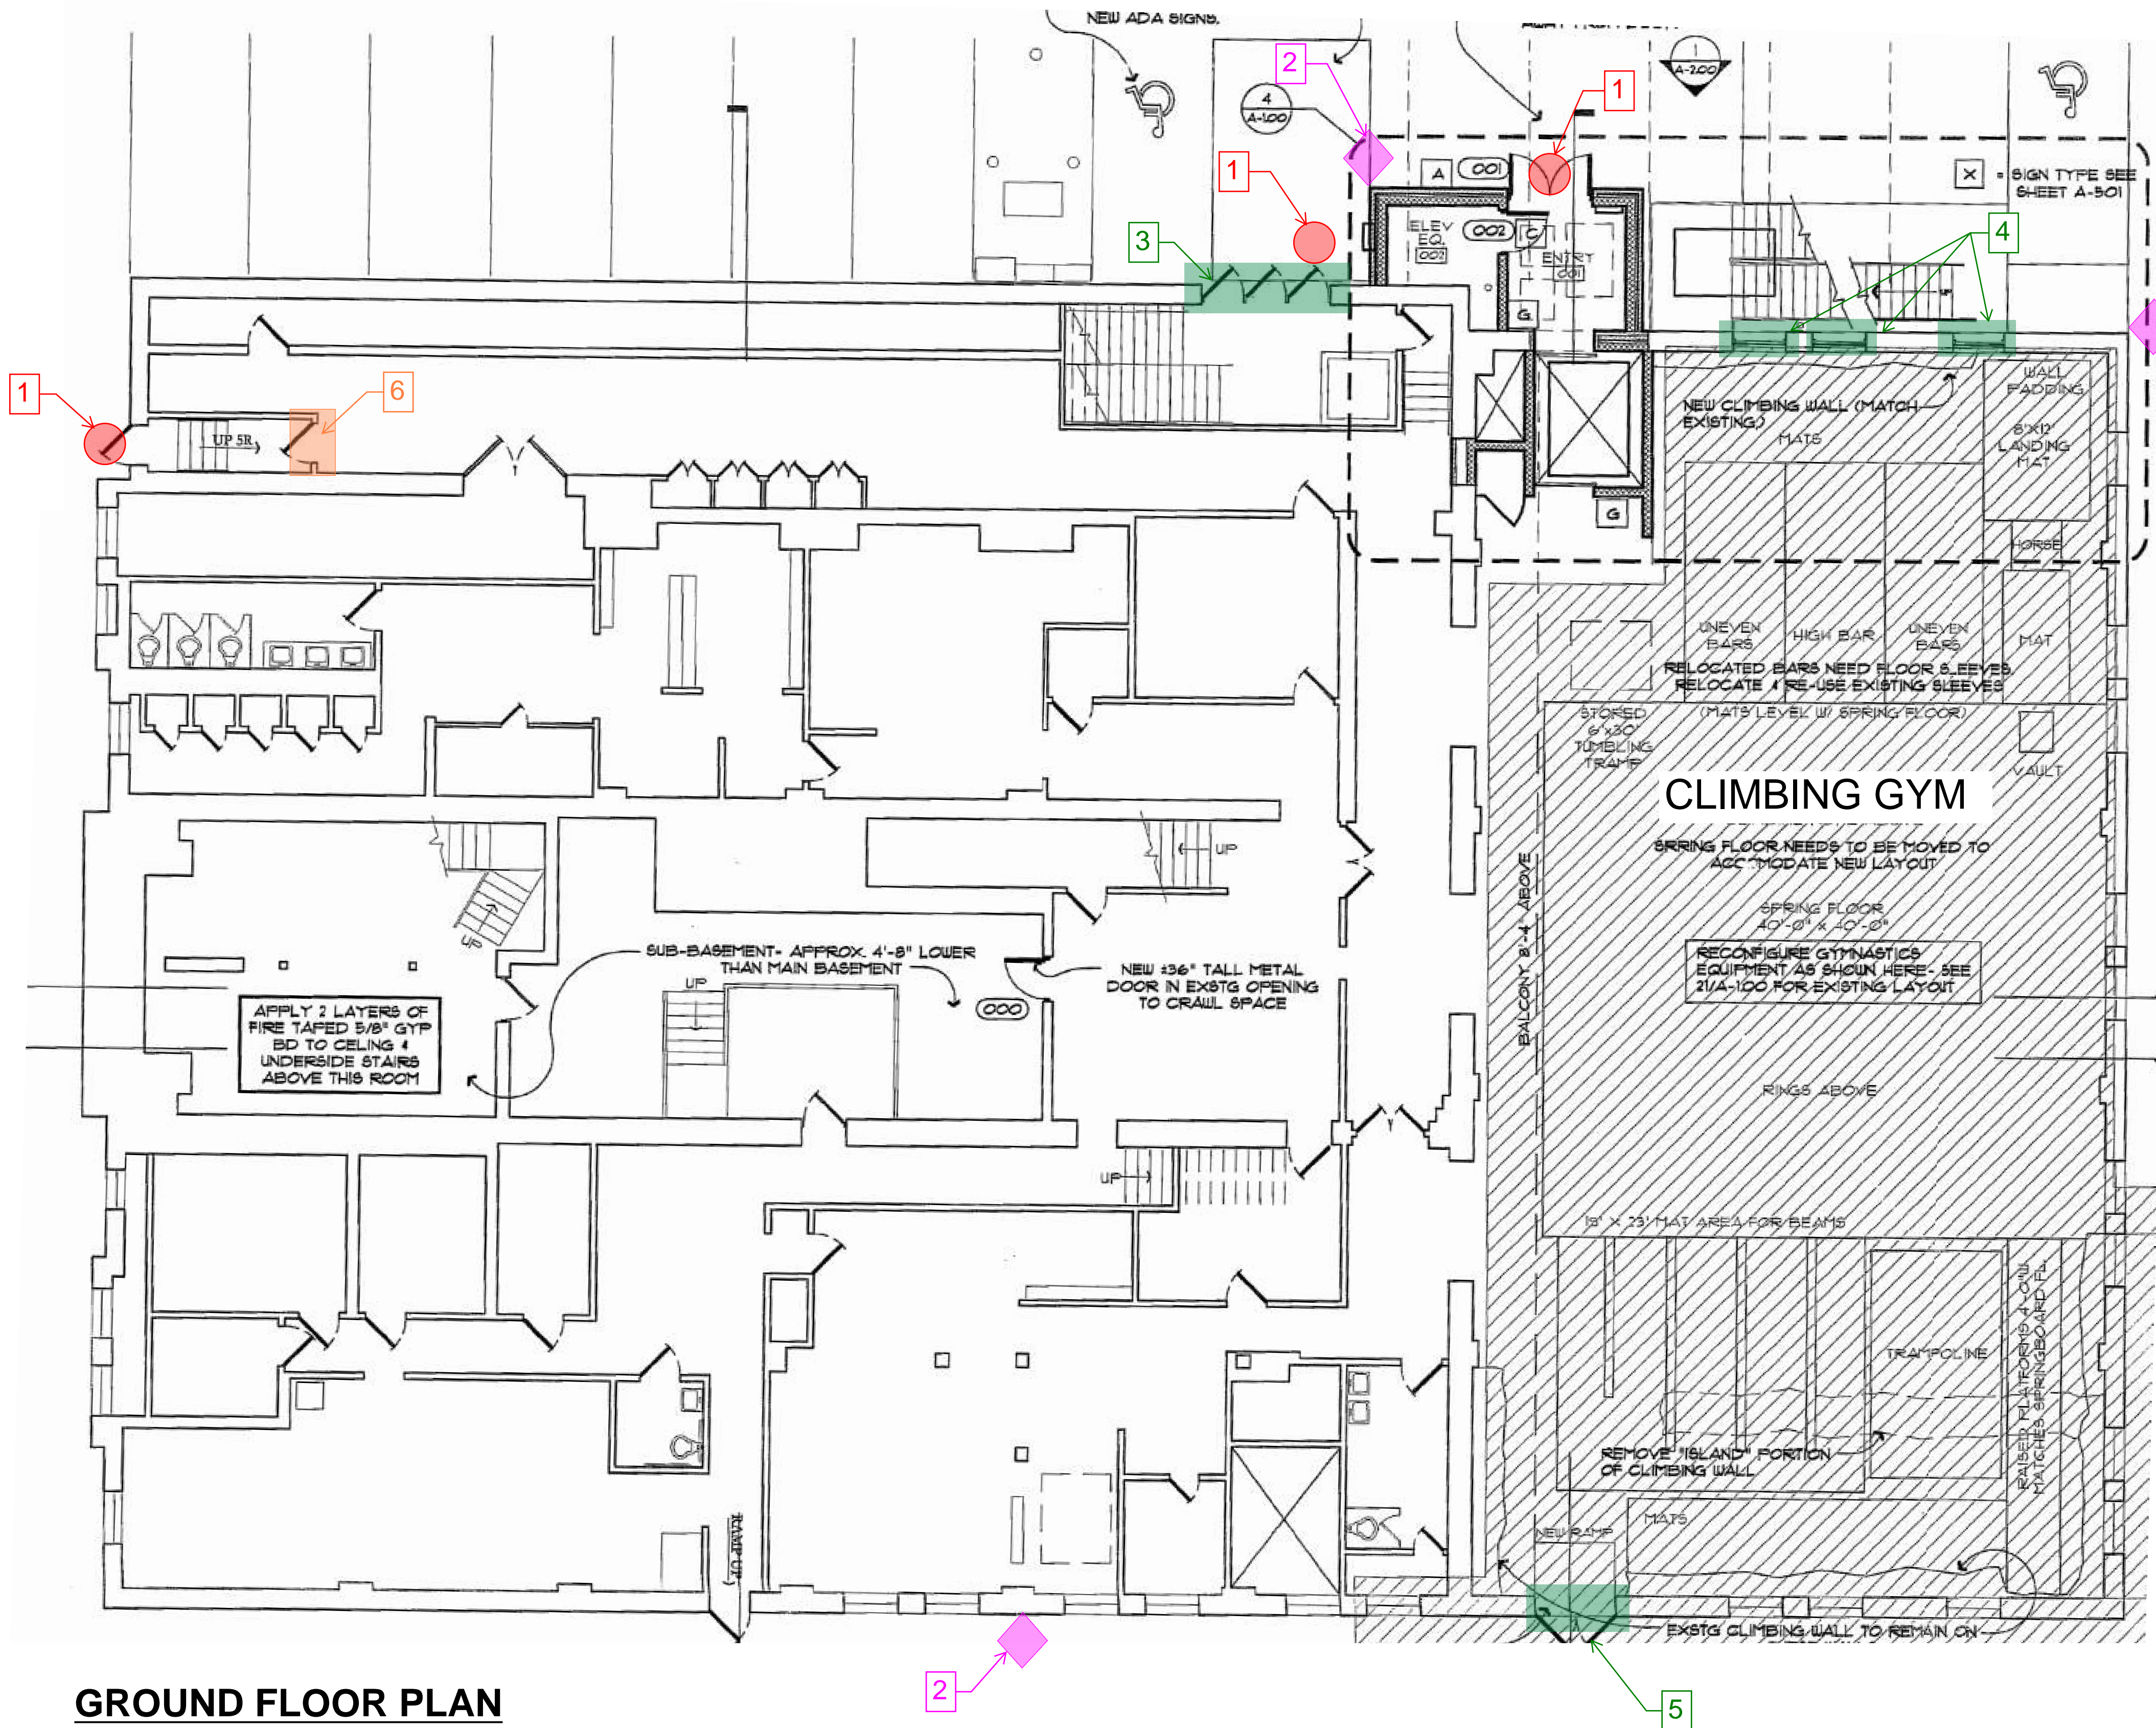
GROUND FLOOR PLAN

- 1 INSTALL NETWORKED ACCESS CONTROL SYSTEM TO DOOR. SEE ATTACHED PRODUCT SPECIFICATIONS.
- 2 INSTALL VIDEO SURVEILLANCE CAMERA, SEE ATTACHED PRODUCT SPECIFICATIONS.
- 3 REPLACE EXISTING NON-ORIGINAL HOLLOW METAL DOORS WITH NEW SIMILAR METAL DOORS. PAINT DOORS CREAM COLOR TO MATCH ADJACENT BRICK.
- 4 NEW GLAZING IN EXISTING WOOD SASHES. NEW GLAZING TO BE APPLIED WITH 8 MIL LLUMAR CLEAR SAFETY AND SECURITY WINDOW FILM. SEE ATTACHED PRODUCT SPECIFICATION.
- 5 REPLACE EXISTING NON-ORIGINAL HOLLOW METAL DOORS WITH NEW SIMILAR METAL DOORS.
- 6 NEW ALUMINUM DOOR WITH GLAZING INSTALLED AT EXISTING NON-HISTORIC OPENING, LOCATED IN THE ANNEX ADDITION

2005 - Phase II & III Building Restoration Floor Plans

Representative of building As-Built condition

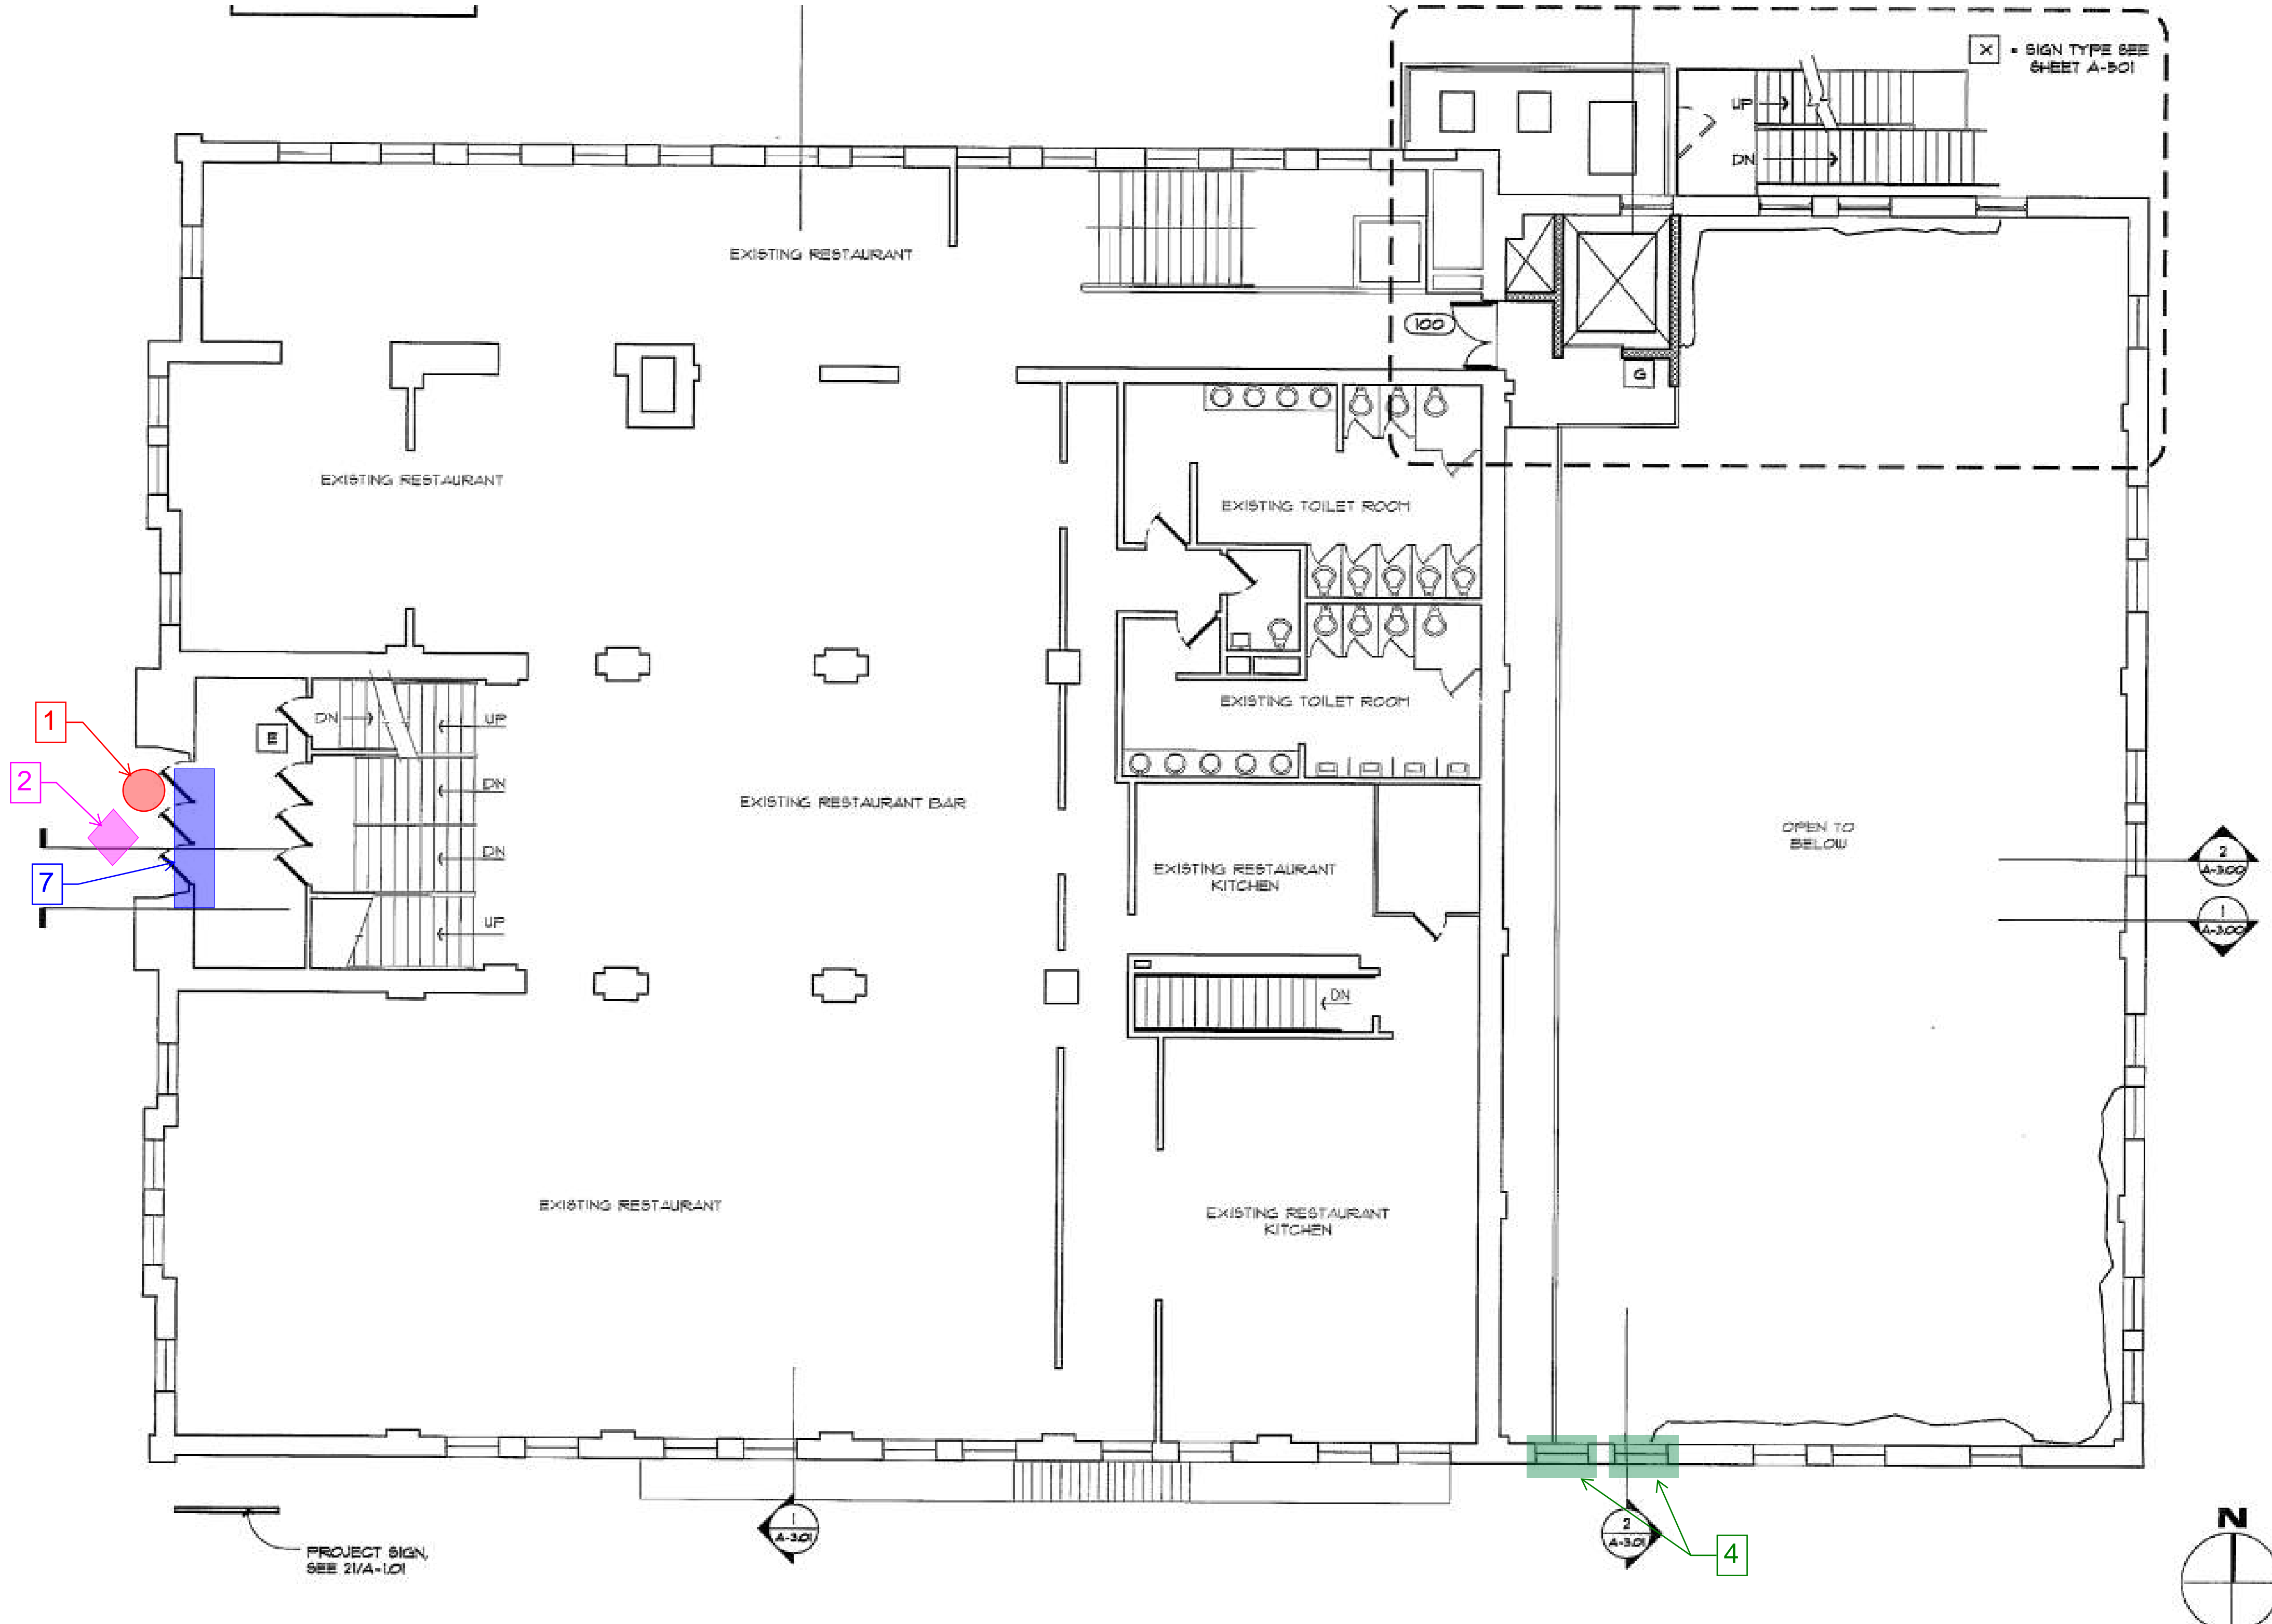
FIRST FLOOR PLAN

- 1 INSTALL NETWORKED ACCESS CONTROL SYSTEM TO DOOR. SEE ATTACHED PRODUCT SPECIFICATIONS.
- 2 INSTALL VIDEO SURVEILLANCE CAMERA, SEE ATTACHED PRODUCT SPECIFICATIONS.
- 4 NEW GLAZING IN EXISTING WOOD SASHES. NEW GLAZING TO BE APPLIED WITH 8 MIL LLUMAR CLEAR SAFETY AND SECURITY WINDOW FILM. SEE ATTACHED PRODUCT SPECIFICATION.
- 7 INSTALL 8 MIL LLUMAR CLEAR SAFETY AND SECURITY WINDOW FILM AT EXISTING GLAZING. SEE ATTACHED PRODUCT SPECIFICATION.

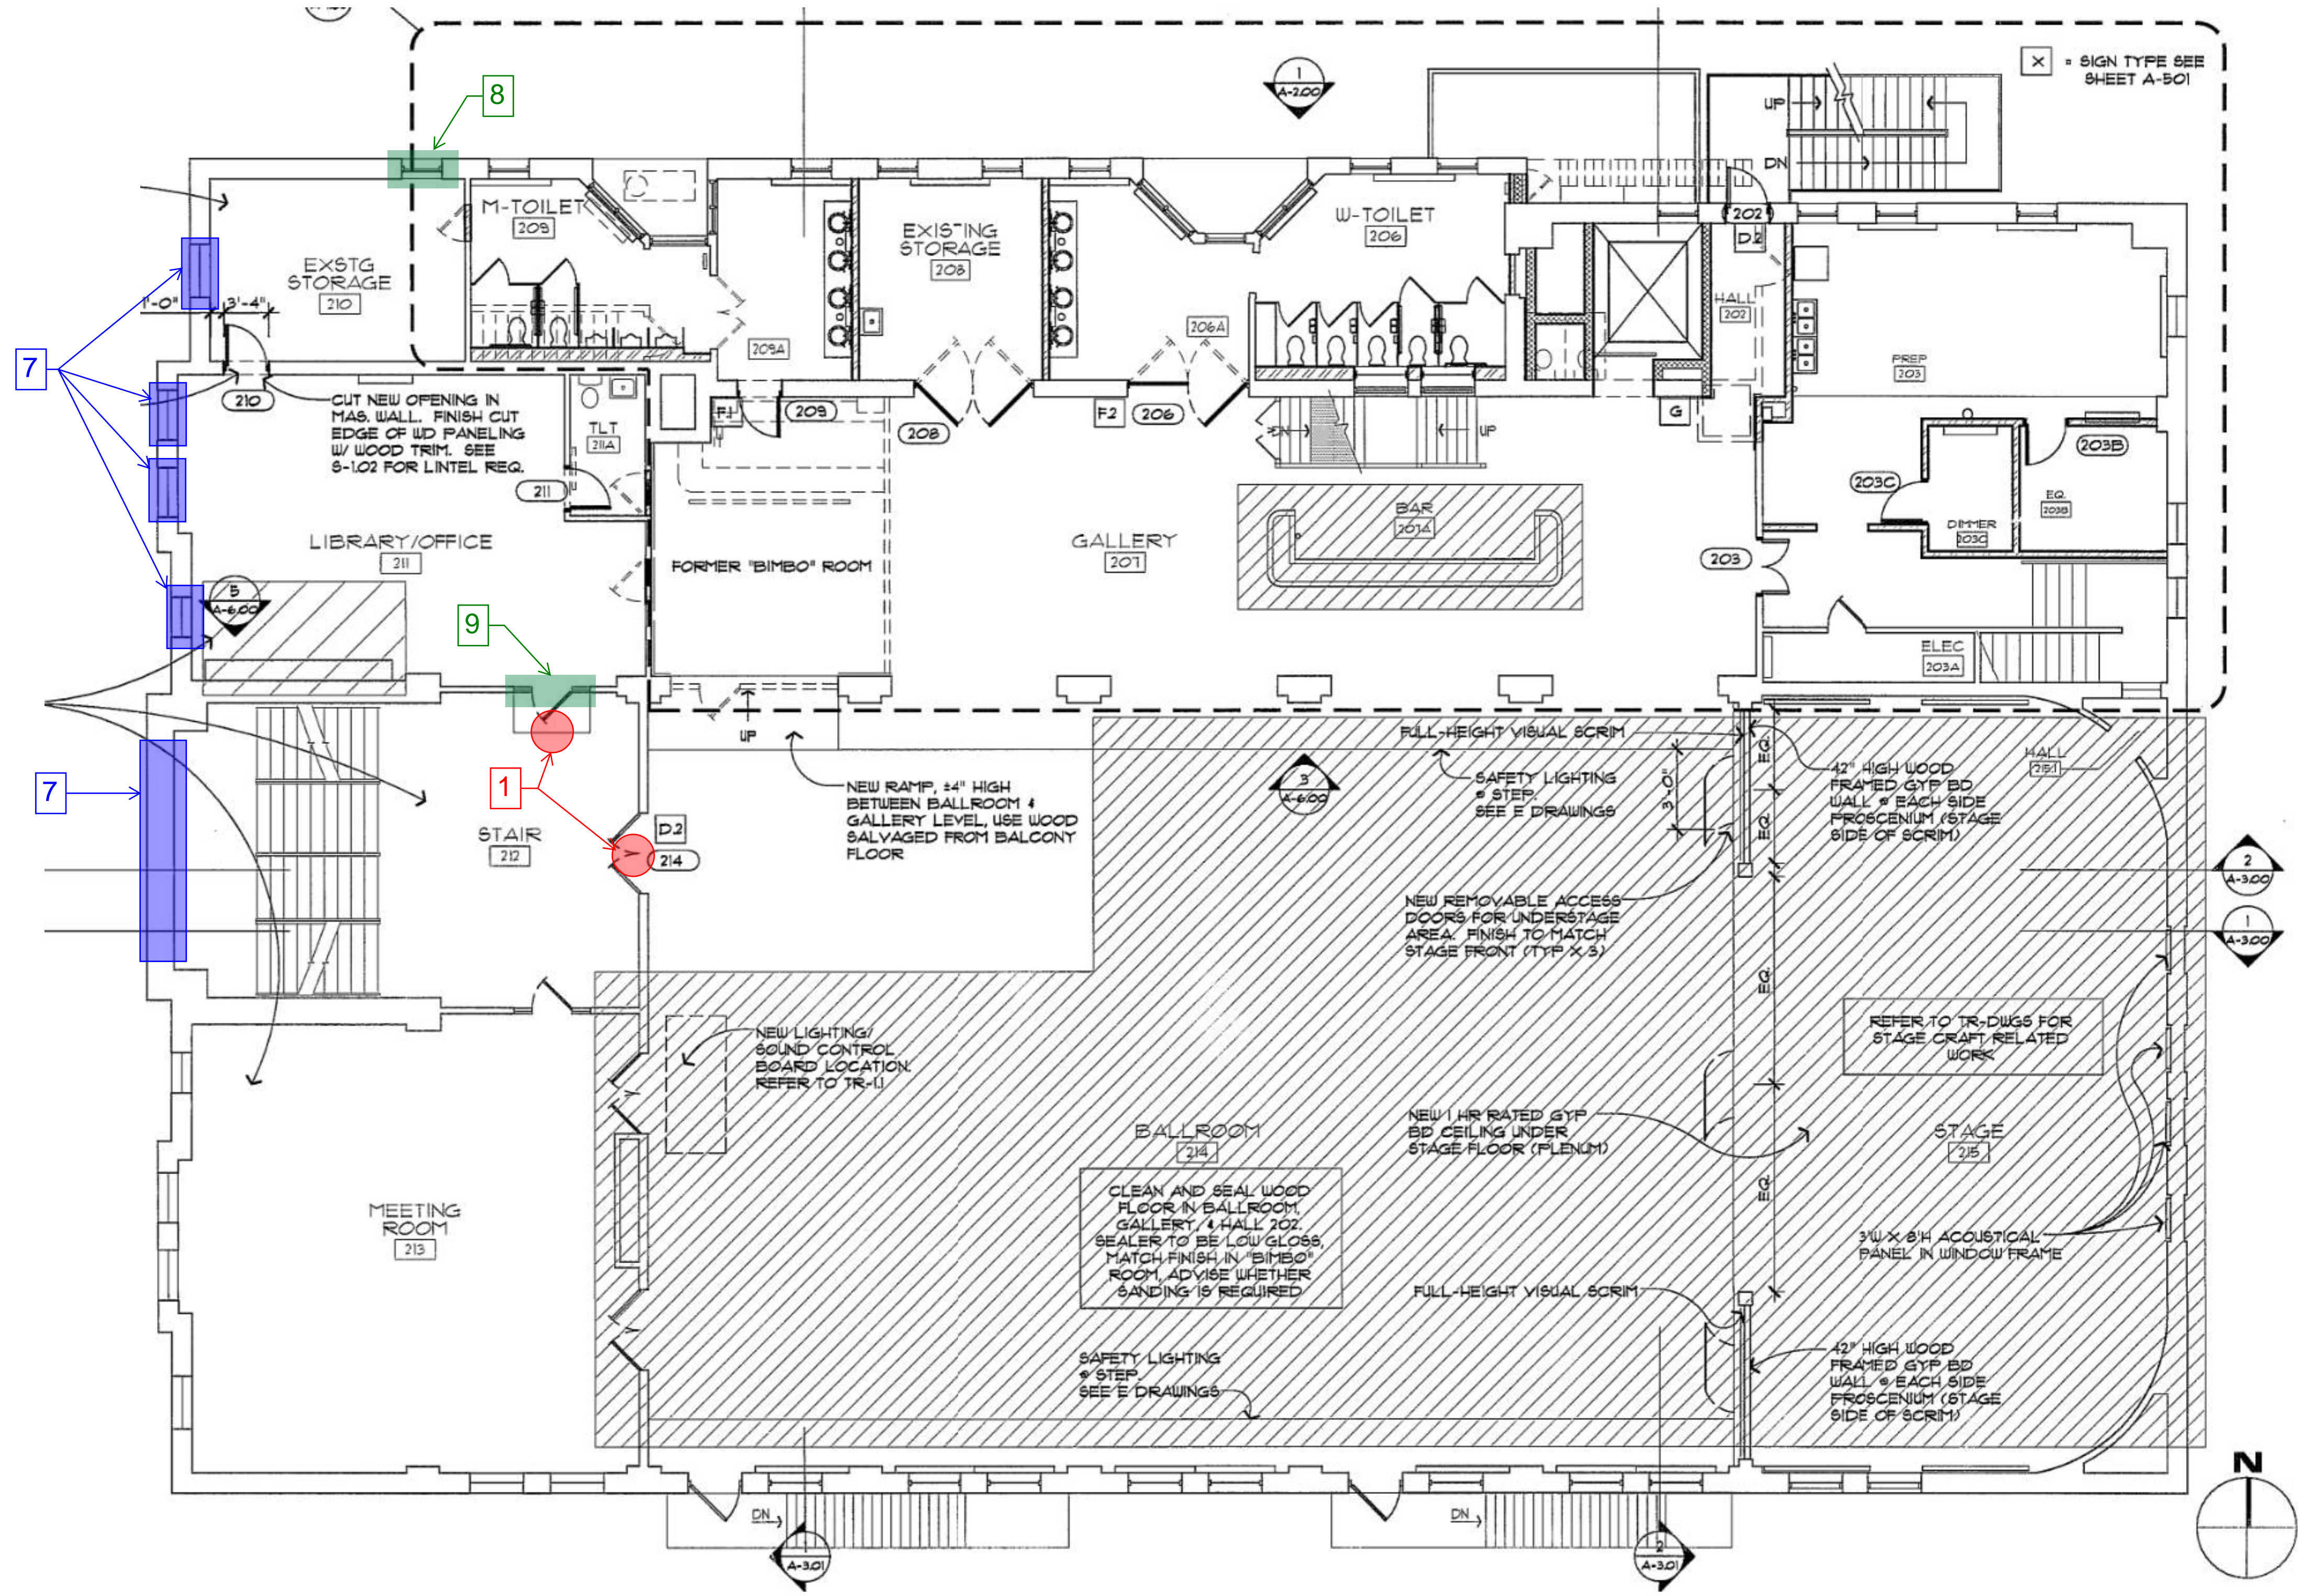
SECOND FLOOR PLAN

- 1 INSTALL NETWORKED ACCESS CONTROL SYSTEM TO DOOR. SEE ATTACHED PRODUCT SPECIFICATIONS.
- 2 INSTALL VIDEO SURVEILLANCE CAMERA, SEE ATTACHED PRODUCT SPECIFICATIONS.
- 7 INSTALL 8 MIL LLUMAR CLEAR SAFETY AND SECURITY WINDOW FILM AT EXISTING GLAZING. SEE ATTACHED PRODUCT SPECIFICATION.
- 8 NEW WOOD WINDOW TO MATCH EXISTING. NEW GLAZING TO BE LAMINATED SAFETY GLASS.
- 9 NEW WOOD DOOR, SIDELIGHTS AND TRANSOM TO MATCH EXISTING. EXISTING DOOR AND LIGHTS ARE NOT ORIGINAL, AND HAVE BEEN ALTERED OVER THE YEARS. NEW GLAZING TO BE LAMINATED SAFETY GLASS.

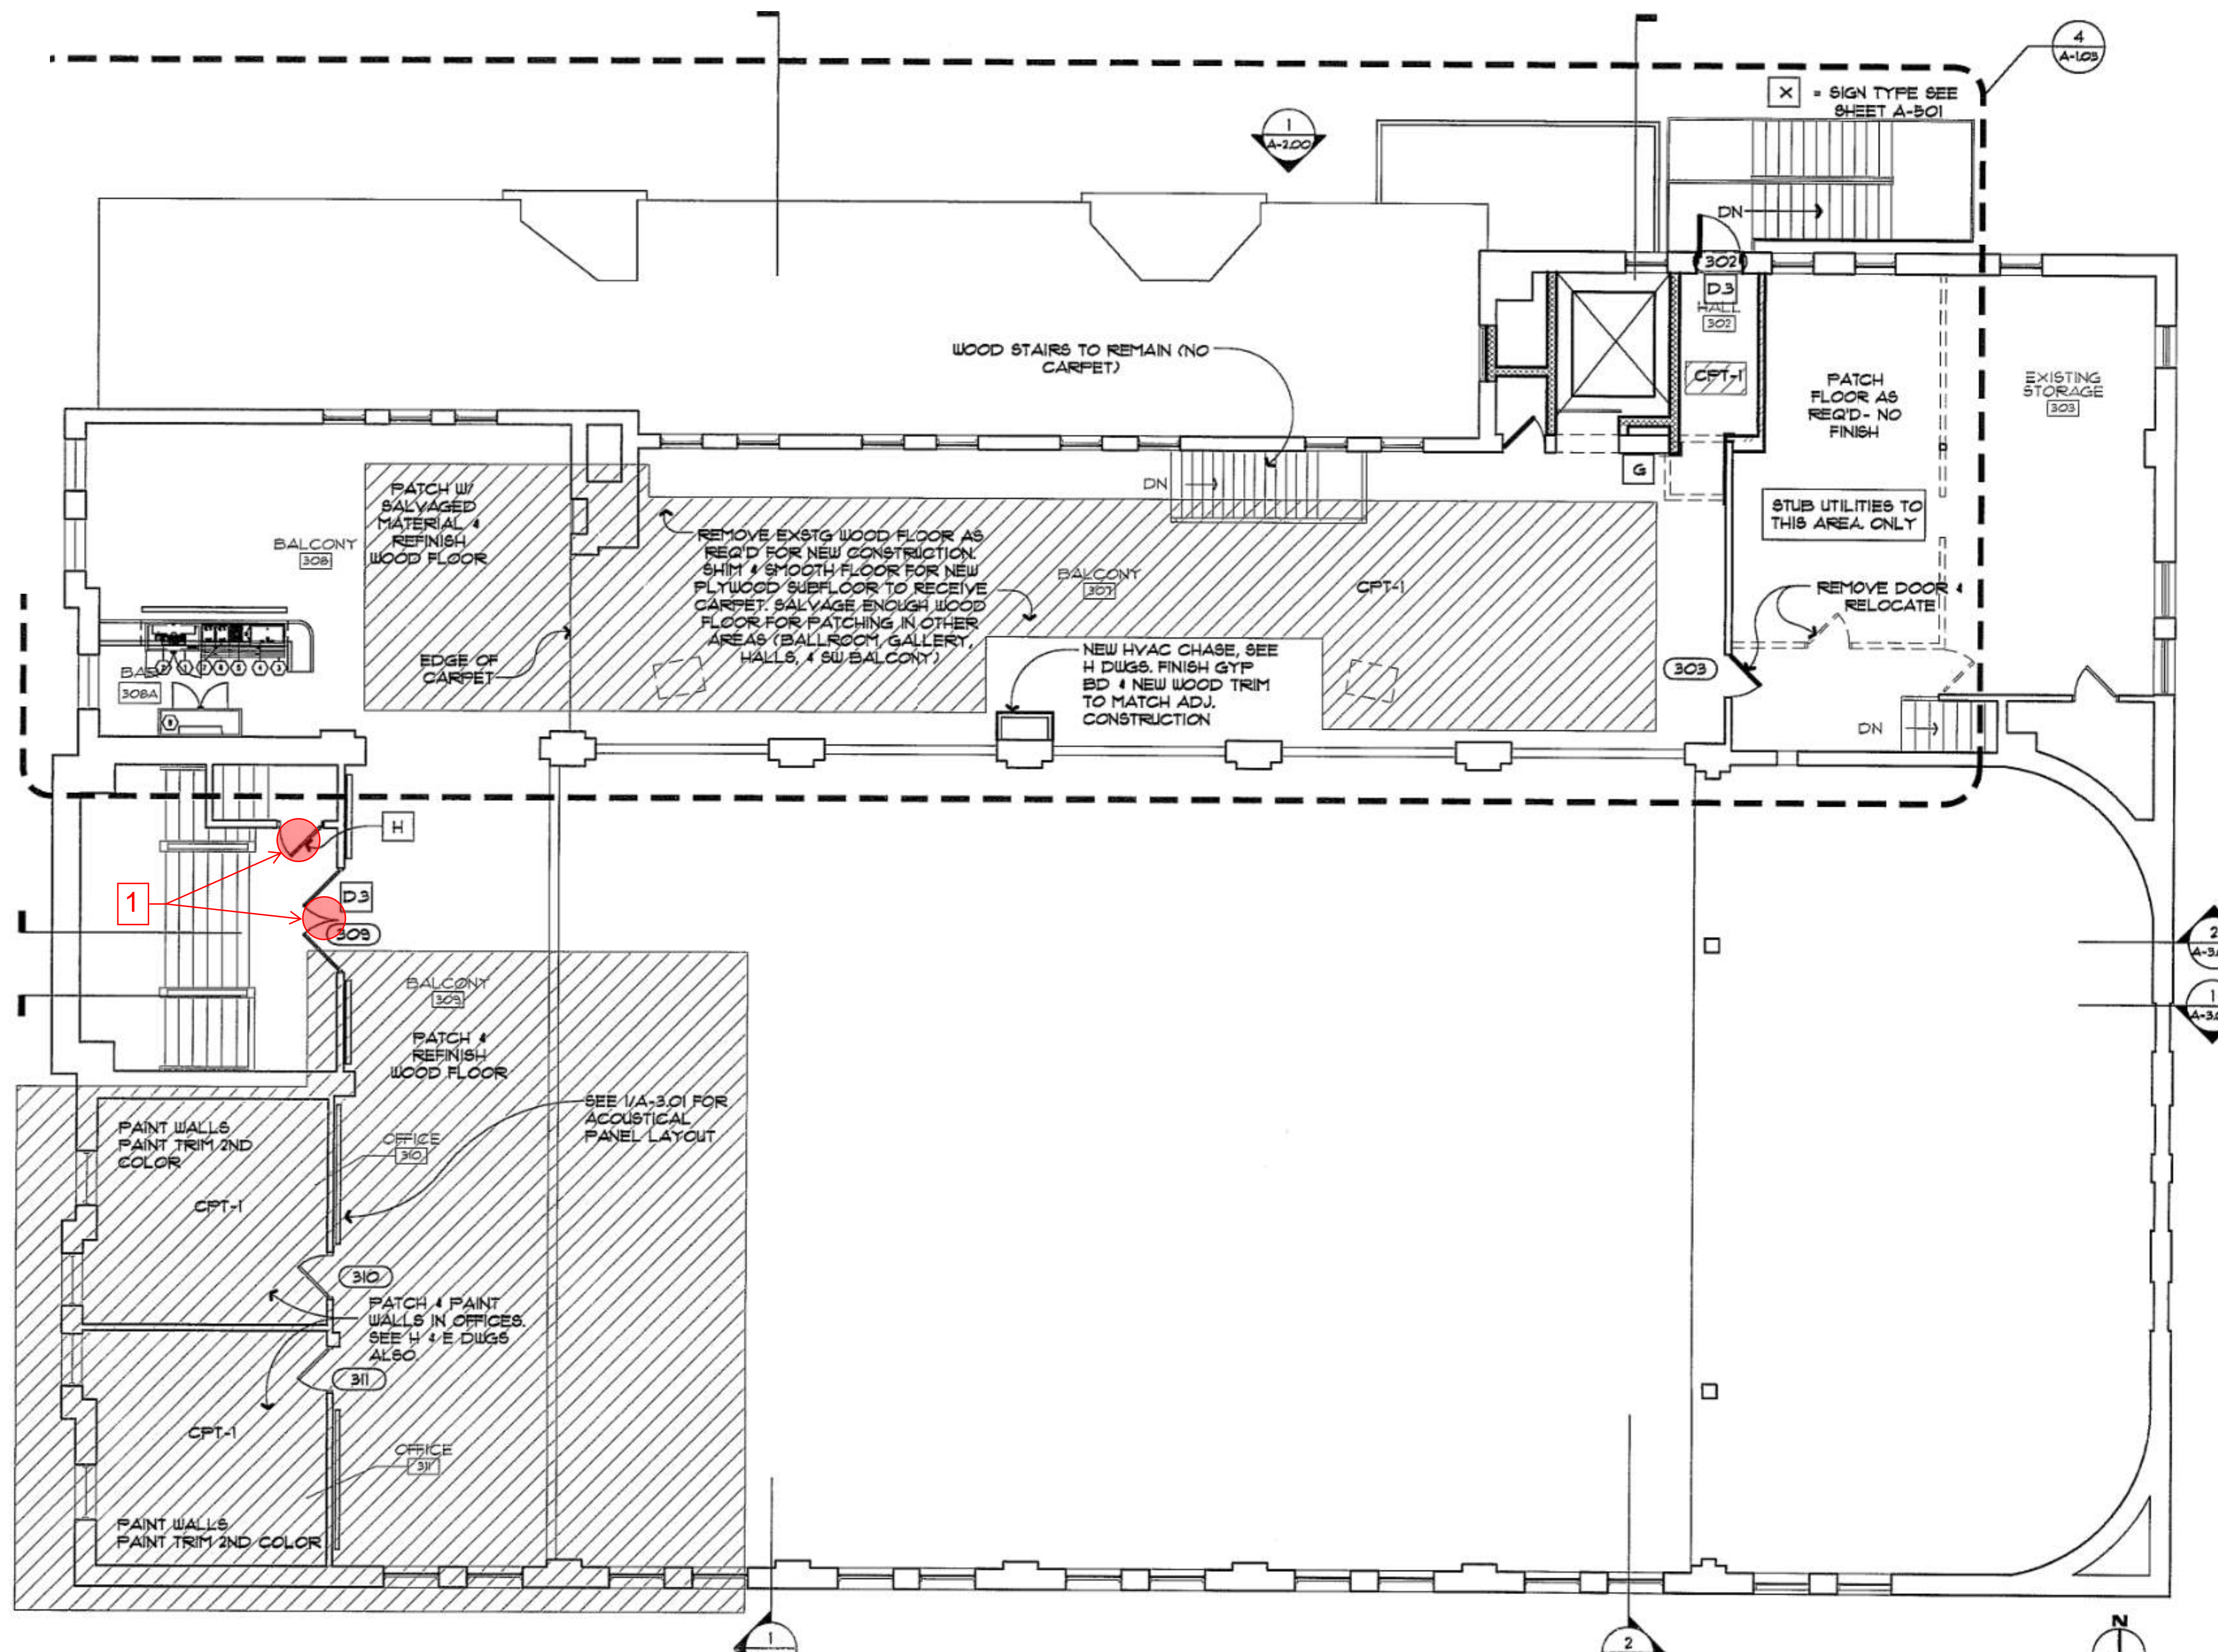
THIRD FLOOR PLAN

- 1** INSTALL NETWORKED ACCESS CONTROL SYSTEM TO DOOR. SEE ATTACHED PRODUCT SPECIFICATIONS.

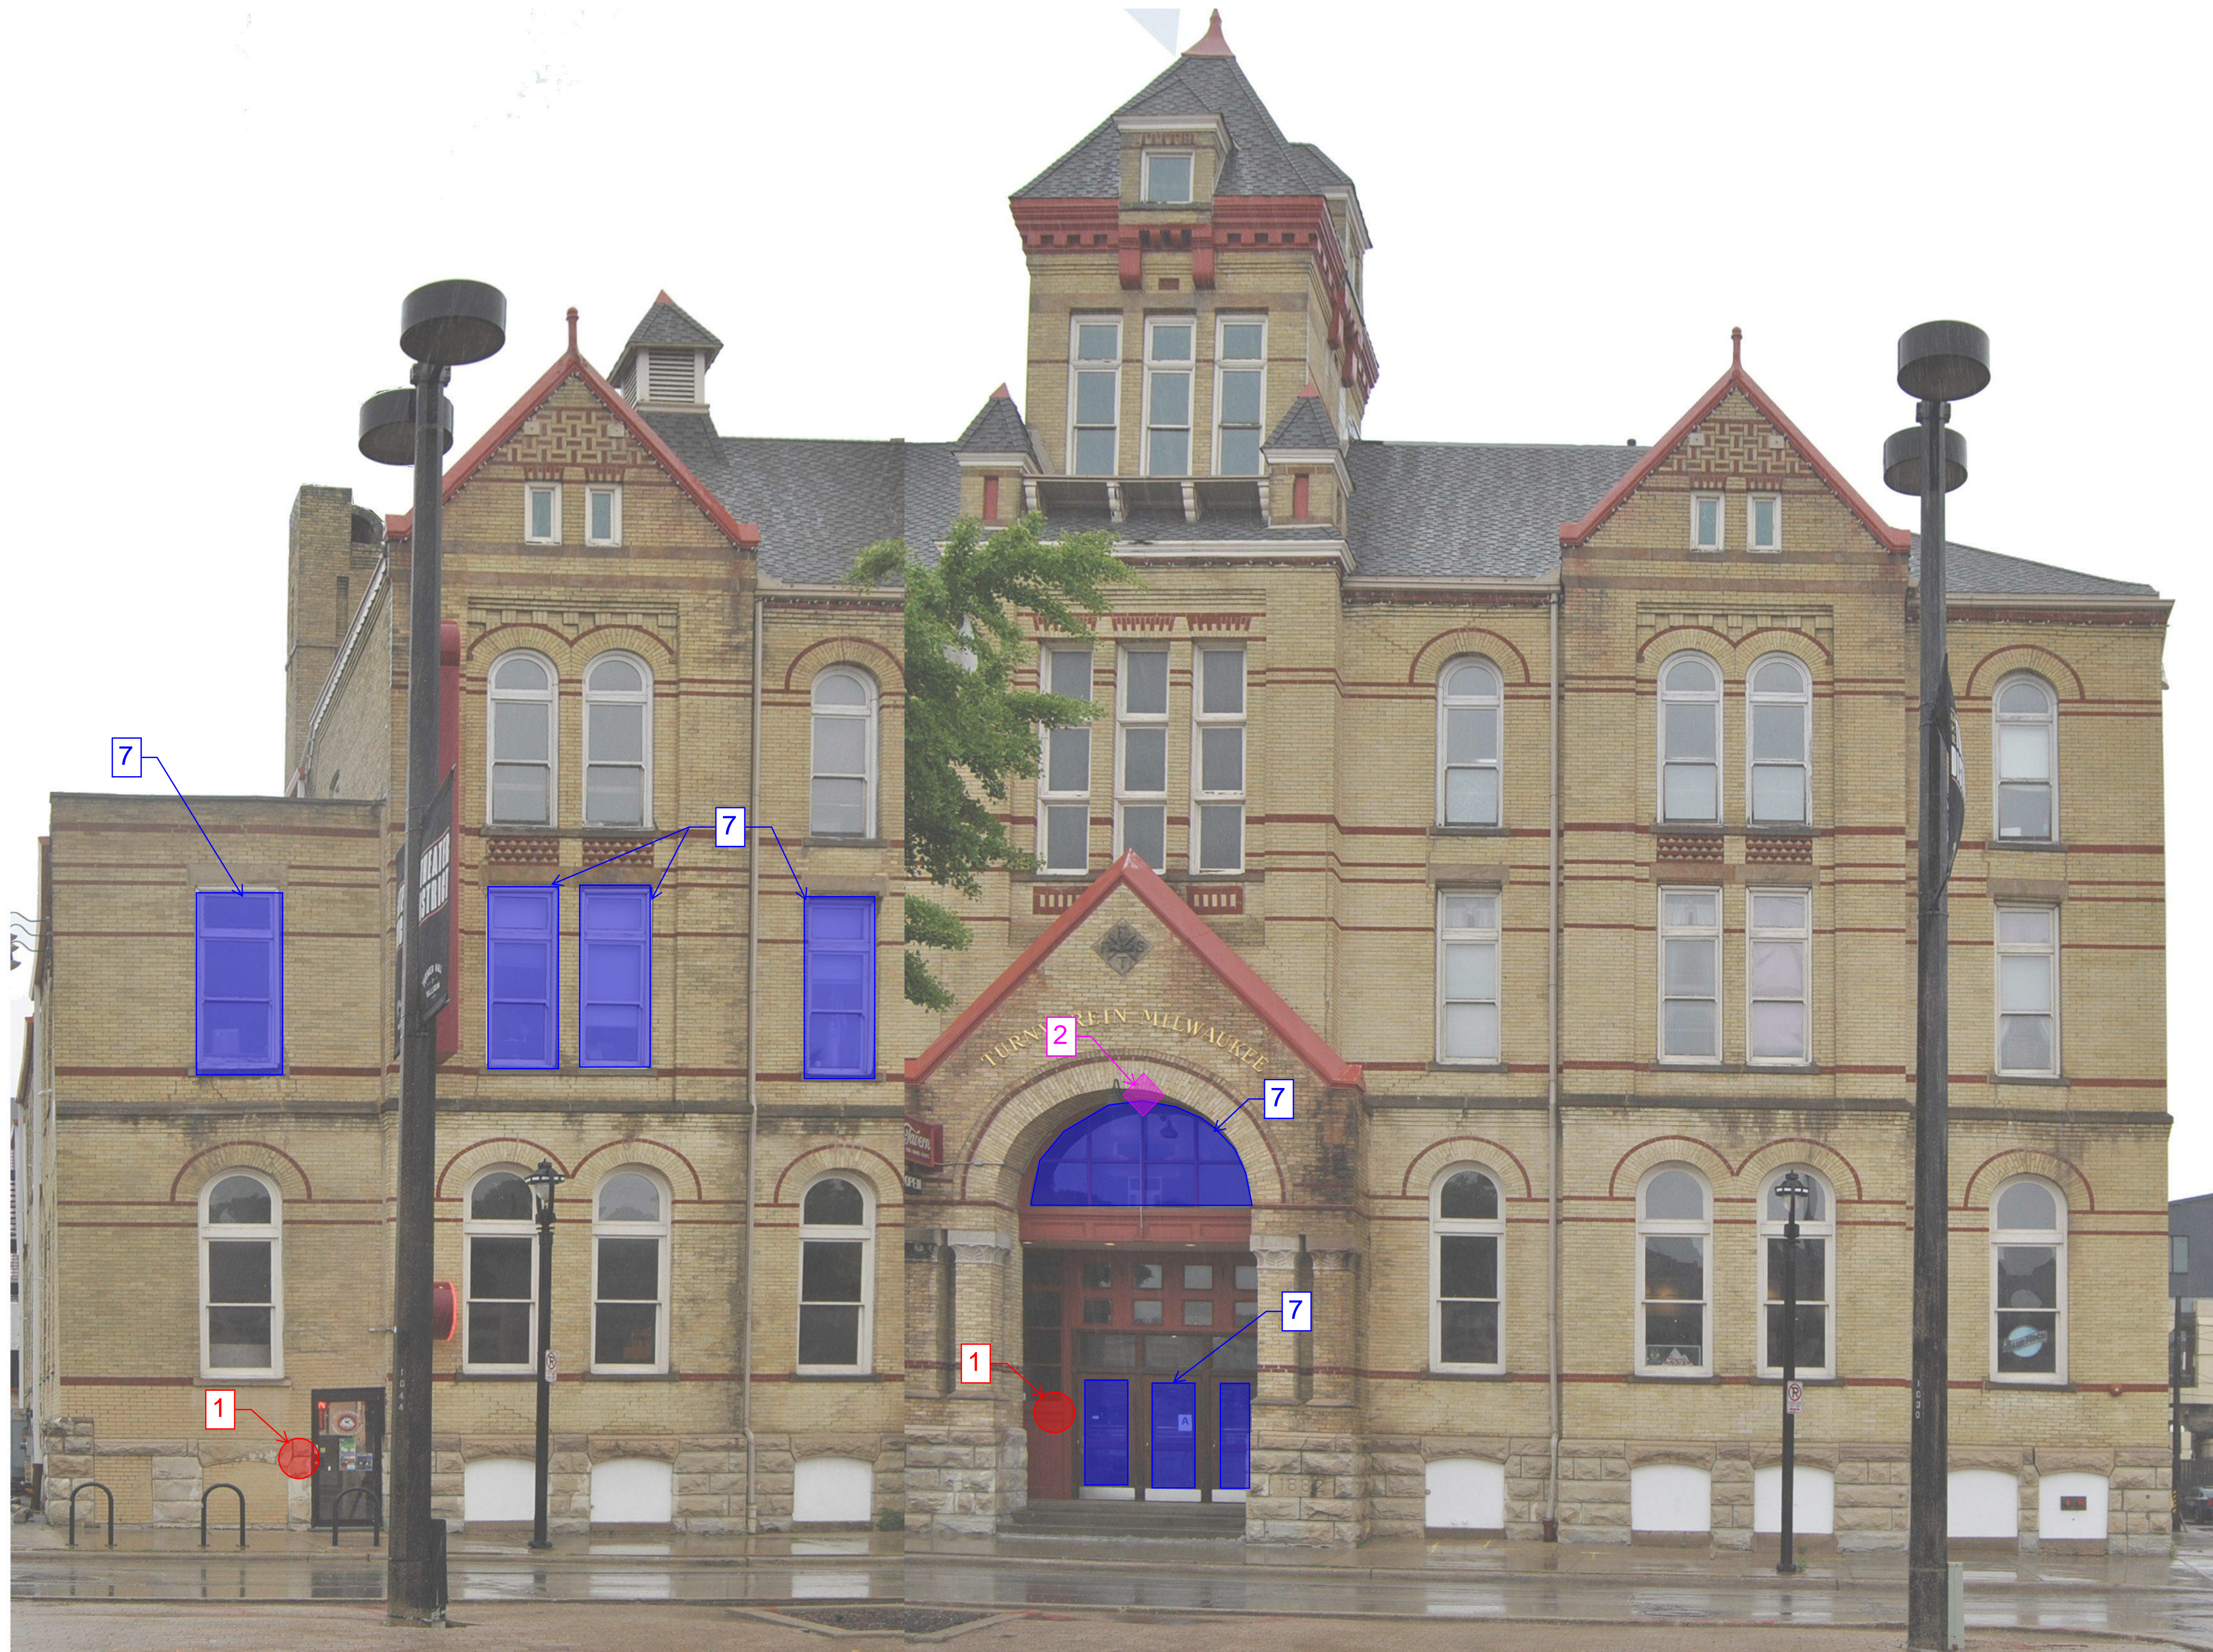
West Elevation - Existing Condition

- 1** INSTALL NETWORKED ACCESS CONTROL SYSTEM TO DOOR. SEE ATTACHED PRODUCT SPECIFICATIONS.
- 2** INSTALL VIDEO SURVEILLANCE CAMERA, SEE ATTACHED PRODUCT SPECIFICATIONS.
- 3** REPLACE EXISTING NON-ORIGINAL HOLLOW METAL DOORS WITH NEW SIMILAR METAL DOORS. PAINT DOORS CREAM COLOR TO MATCH ADJACENT BRICK.
- 4** NEW GLAZING IN EXISTING WOOD SASHES. NEW GLAZING TO BE APPLIED WITH 8 MIL LLUMAR CLEAR SAFETY AND SECURITY WINDOW FILM. SEE ATTACHED PRODUCT SPECIFICATION.
- 8** NEW WOOD WINDOW TO MATCH EXISTING. NEW GLAZING TO BE LAMINATED SAFETY GLASS.

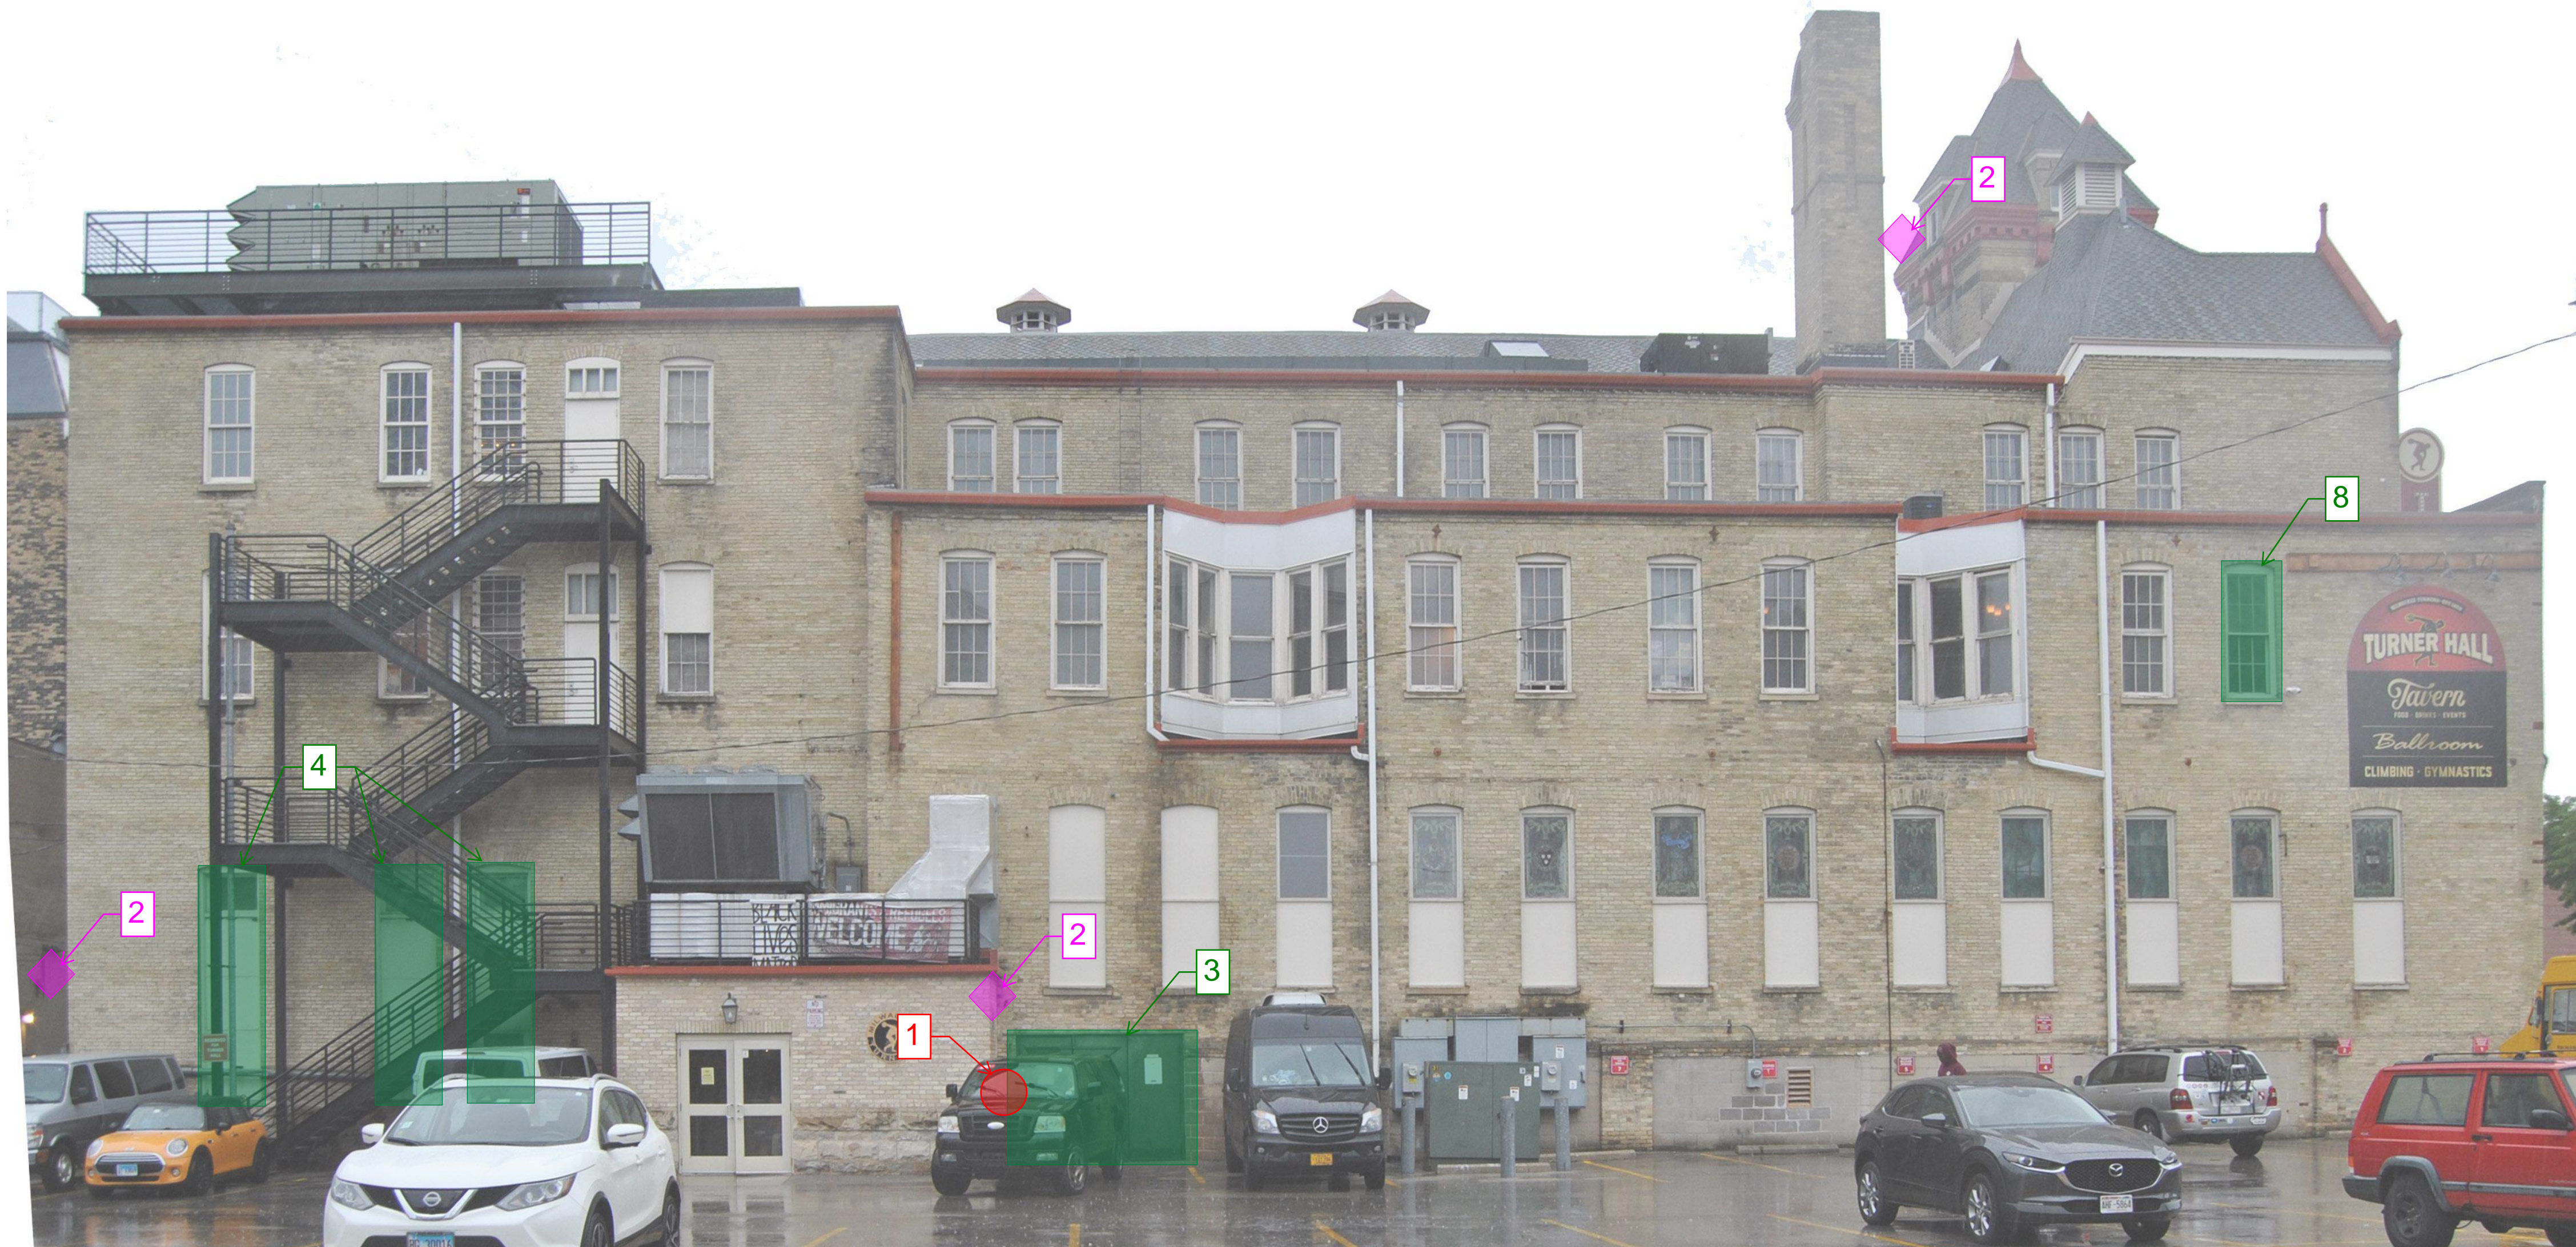
North Elevation - Existing Condition

- 1 INSTALL NETWORKED ACCESS CONTROL SYSTEM TO DOOR. SEE ATTACHED PRODUCT SPECIFICATIONS.
- 2 INSTALL VIDEO SURVEILLANCE CAMERA, SEE ATTACHED PRODUCT SPECIFICATIONS.
- 4 NEW GLAZING IN EXISTING WOOD SASHES. NEW GLAZING TO BE APPLIED WITH 8 MIL LLUMAR CLEAR SAFETY AND SECURITY WINDOW FILM. SEE ATTACHED PRODUCT SPECIFICATION.
- 5 REPLACE EXISTING NON-ORIGINAL HOLLOW METAL DOORS WITH NEW SIMILAR METAL DOORS.
