Turner Hall
1034 N Vel R Phillips Ave
Milwaukee, WI 53203

FEMA Grant Safety and Security Project
Certificate of Appropriateness Application
Drawing and Photo Exhibits

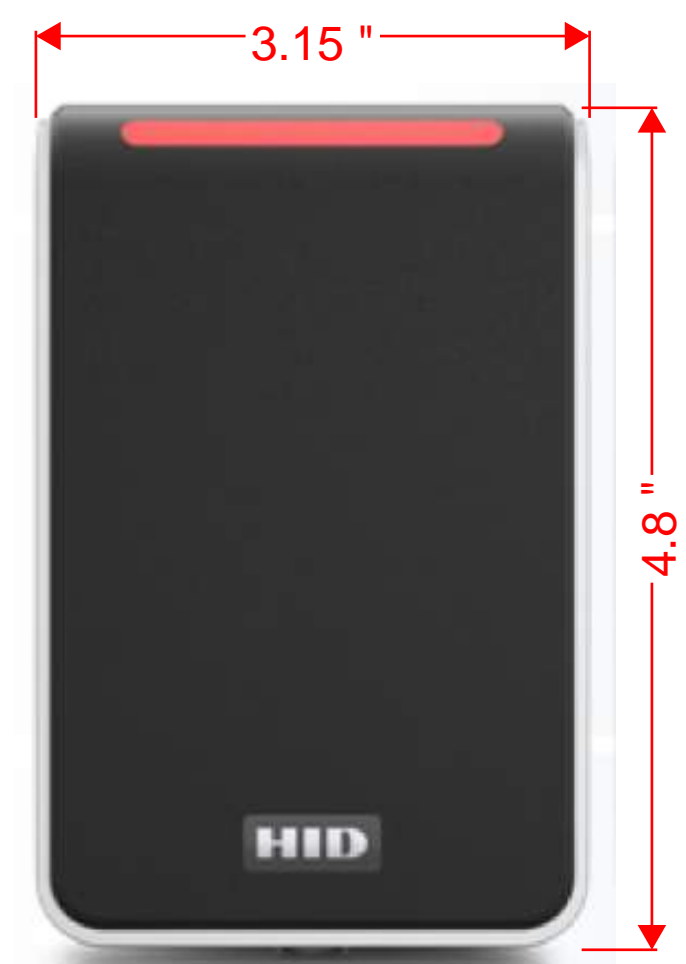
ACCESS CONTROL READER

1 Install Networked Access Control System Interior Doors

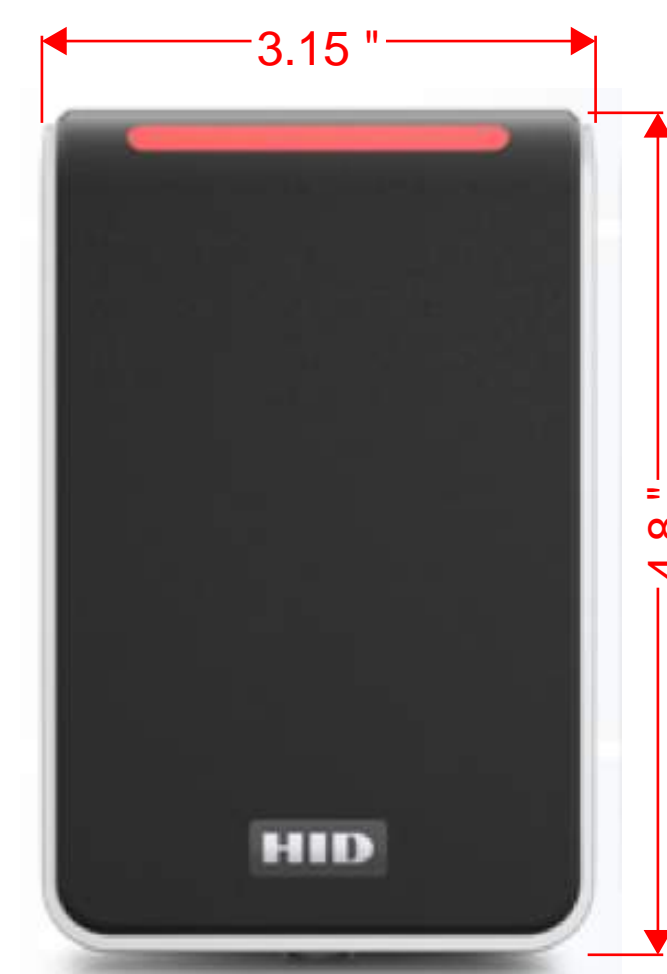
ACCESS CONTROL READER

1 Install Networked Access Control System Exterior Doors

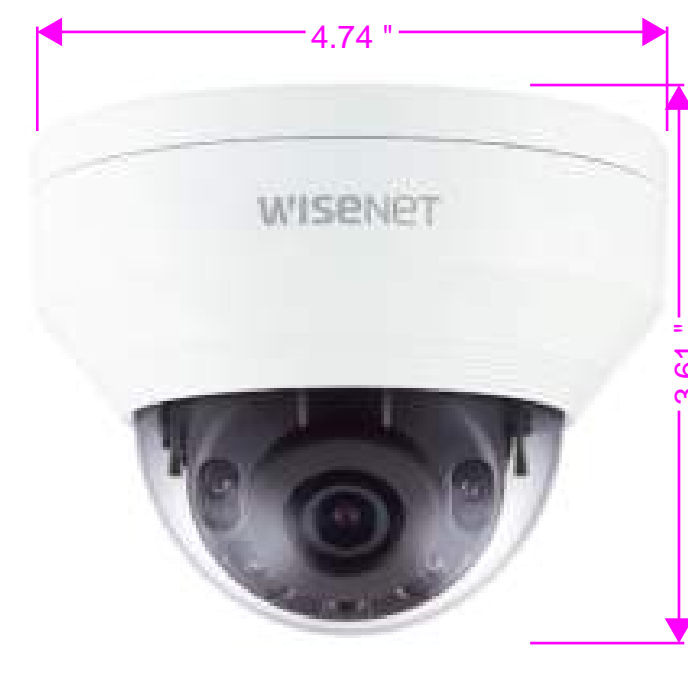
Surface Mounted Dome Camera. Paint white enclosure to match cream city brick color

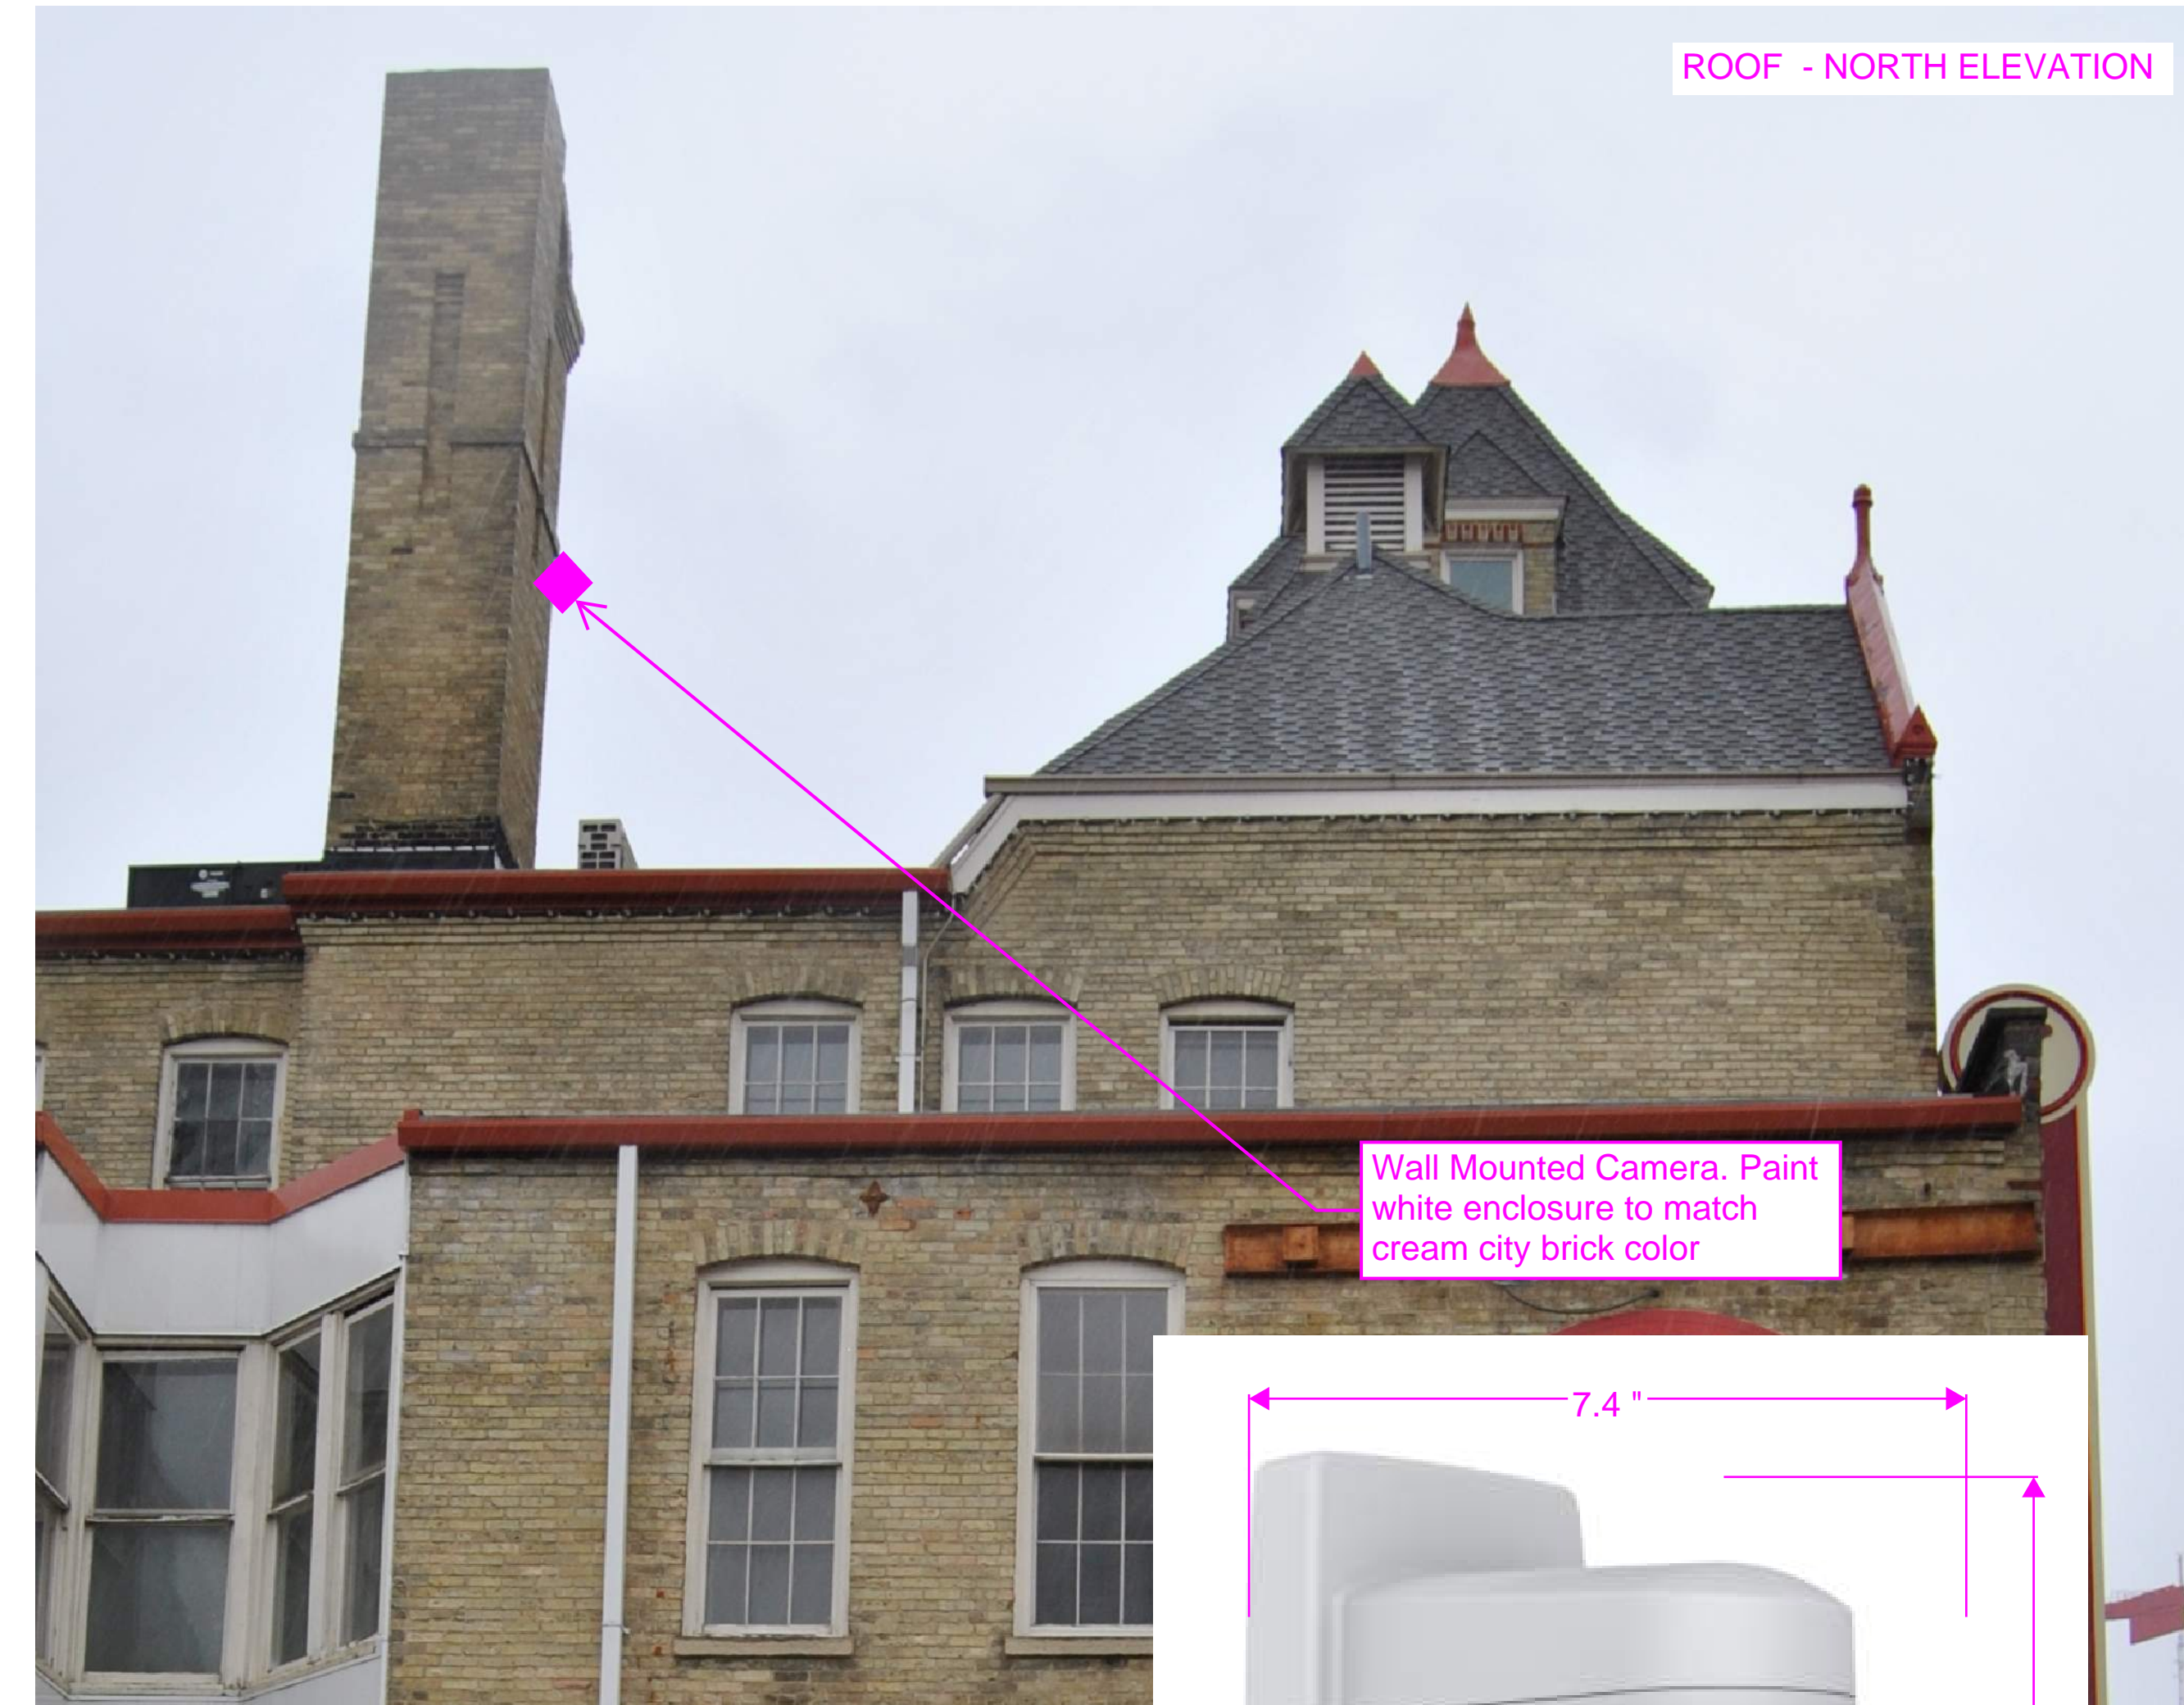
ROOF - NORTH ELEVATION

Wall Mounted Camera. Paint white enclosure to match cream city brick color

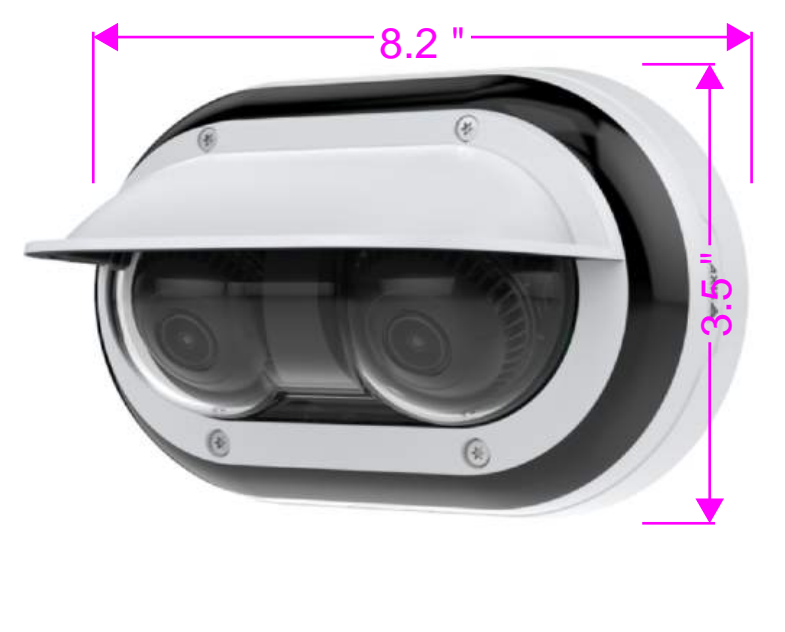
Surface Mounted Dual-sensor Dome Camera. Paint white enclosure to match cream city brick color

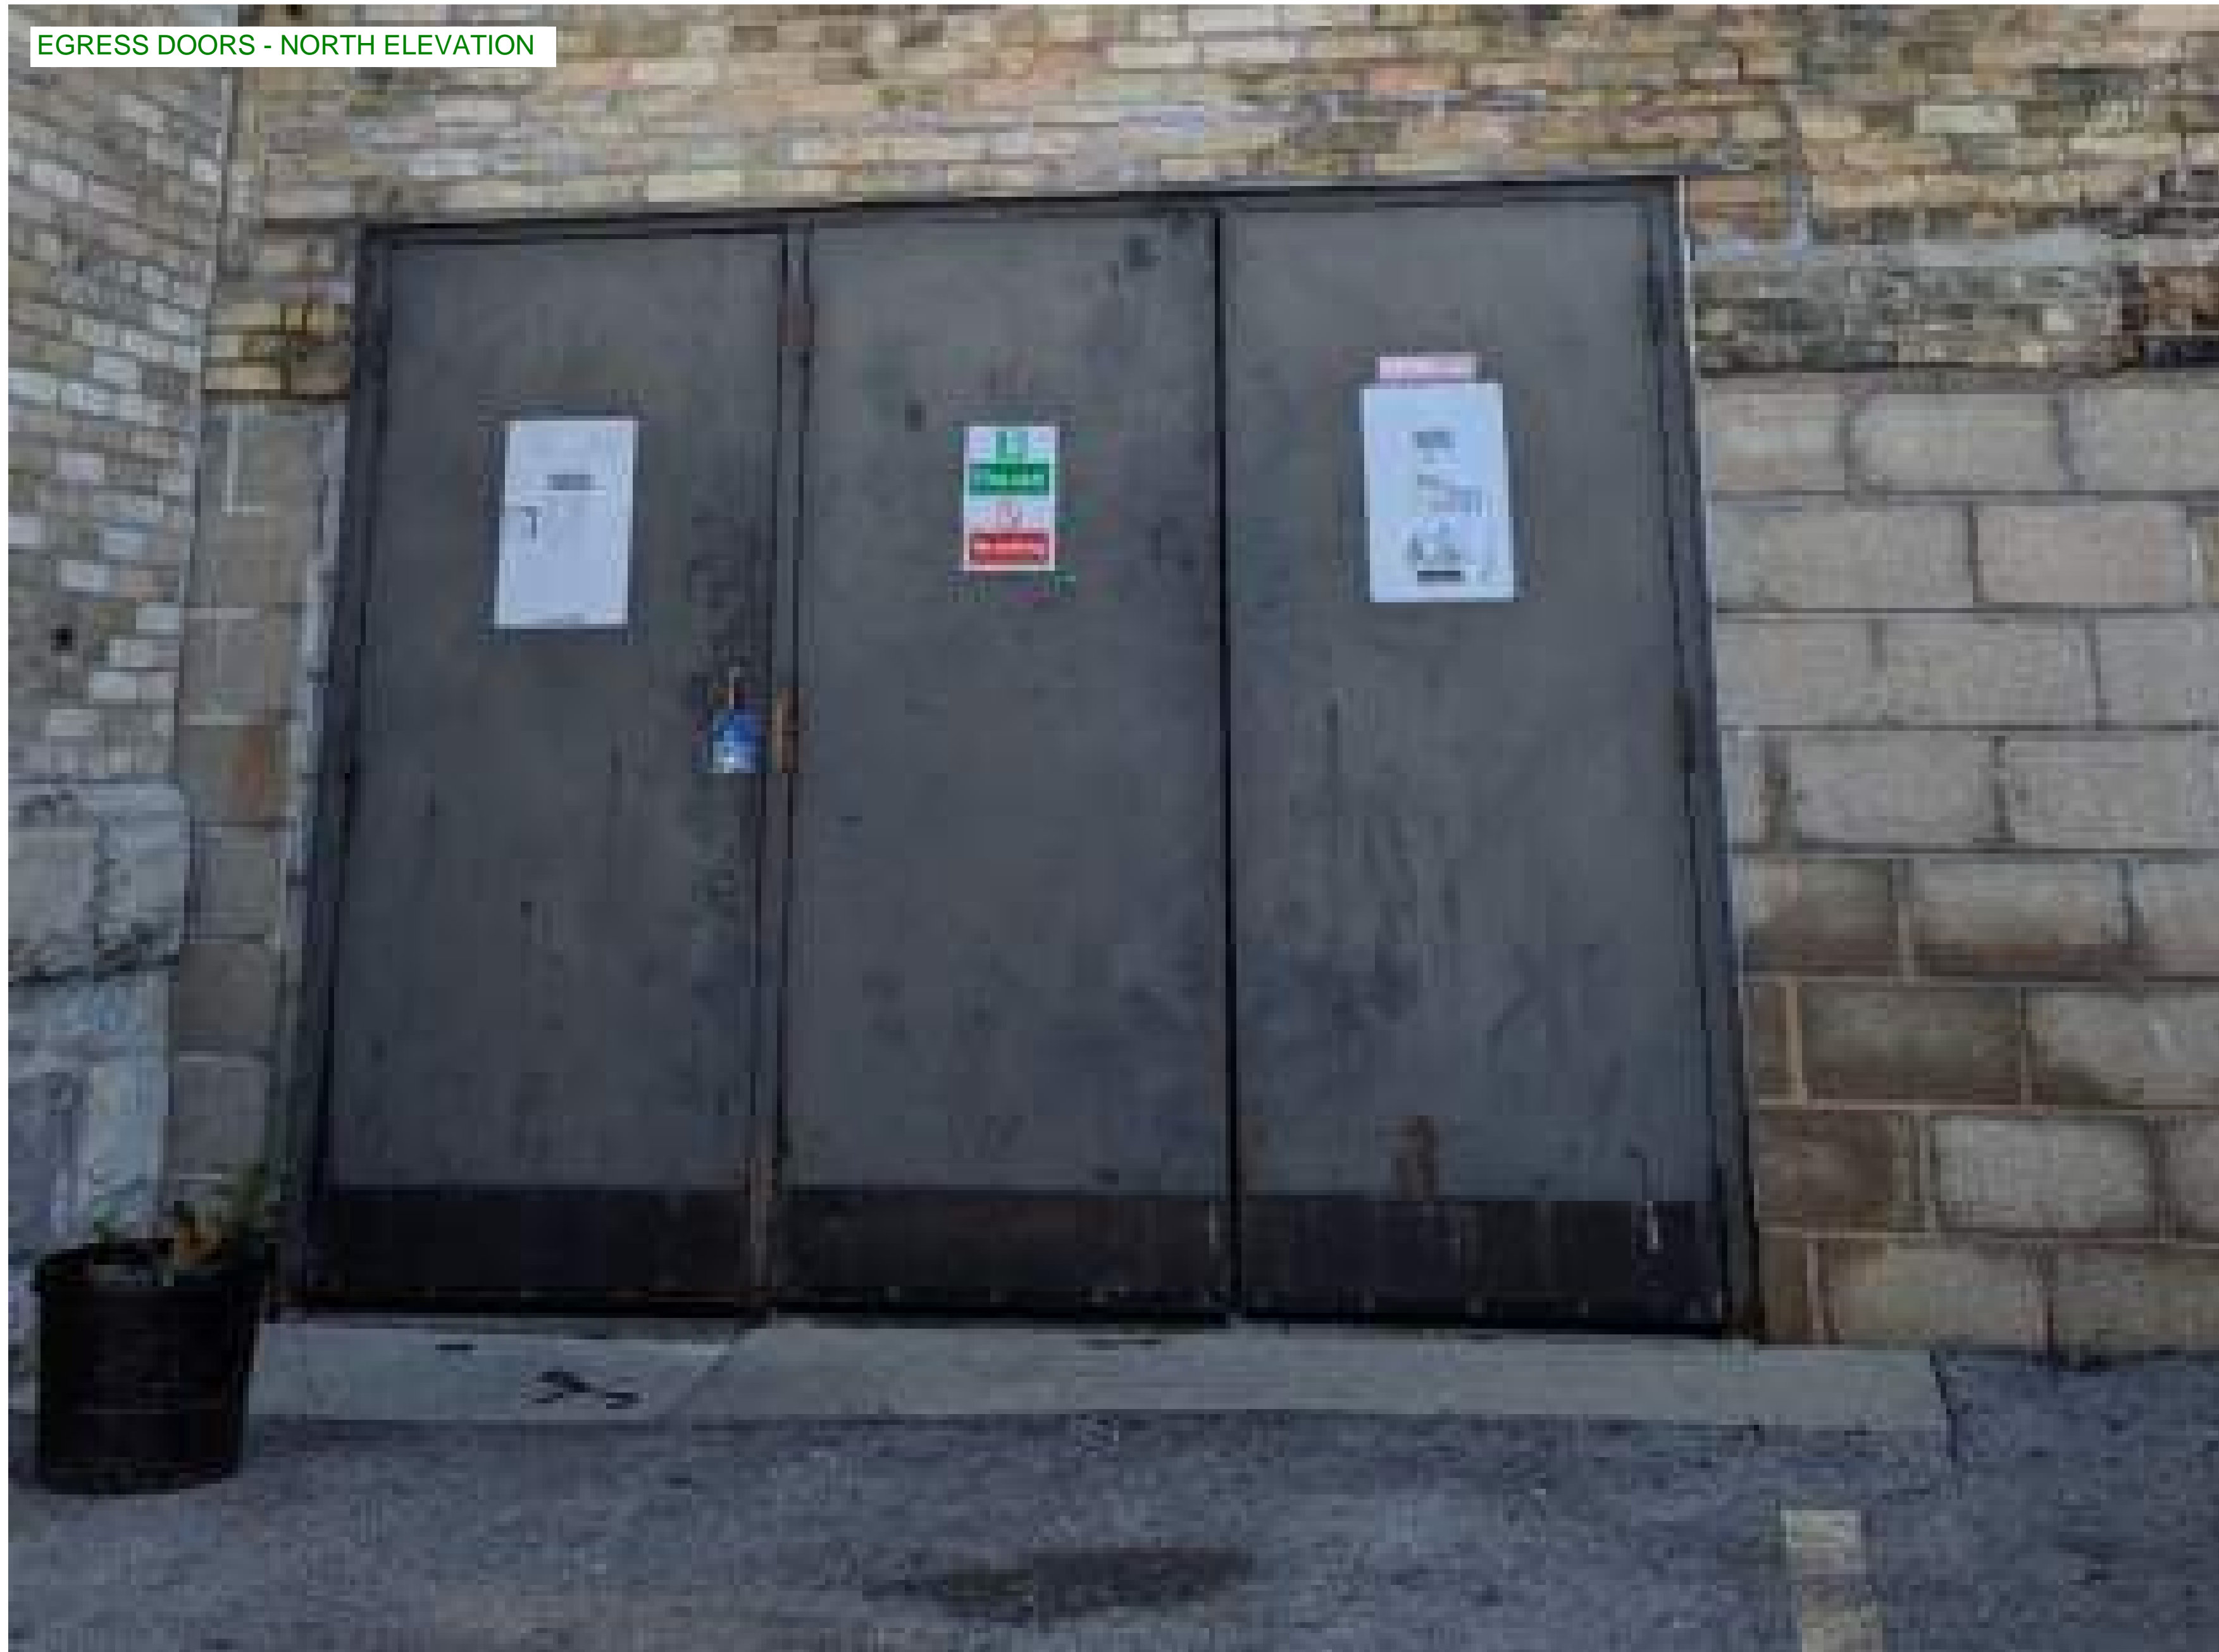
EGRESS DOORS - NORTH ELEVATION

Non-original metal doors, in non-original opening to be replaced with new metal single panel doors. Doors and frames to be painted cream to match adjacent historic brick

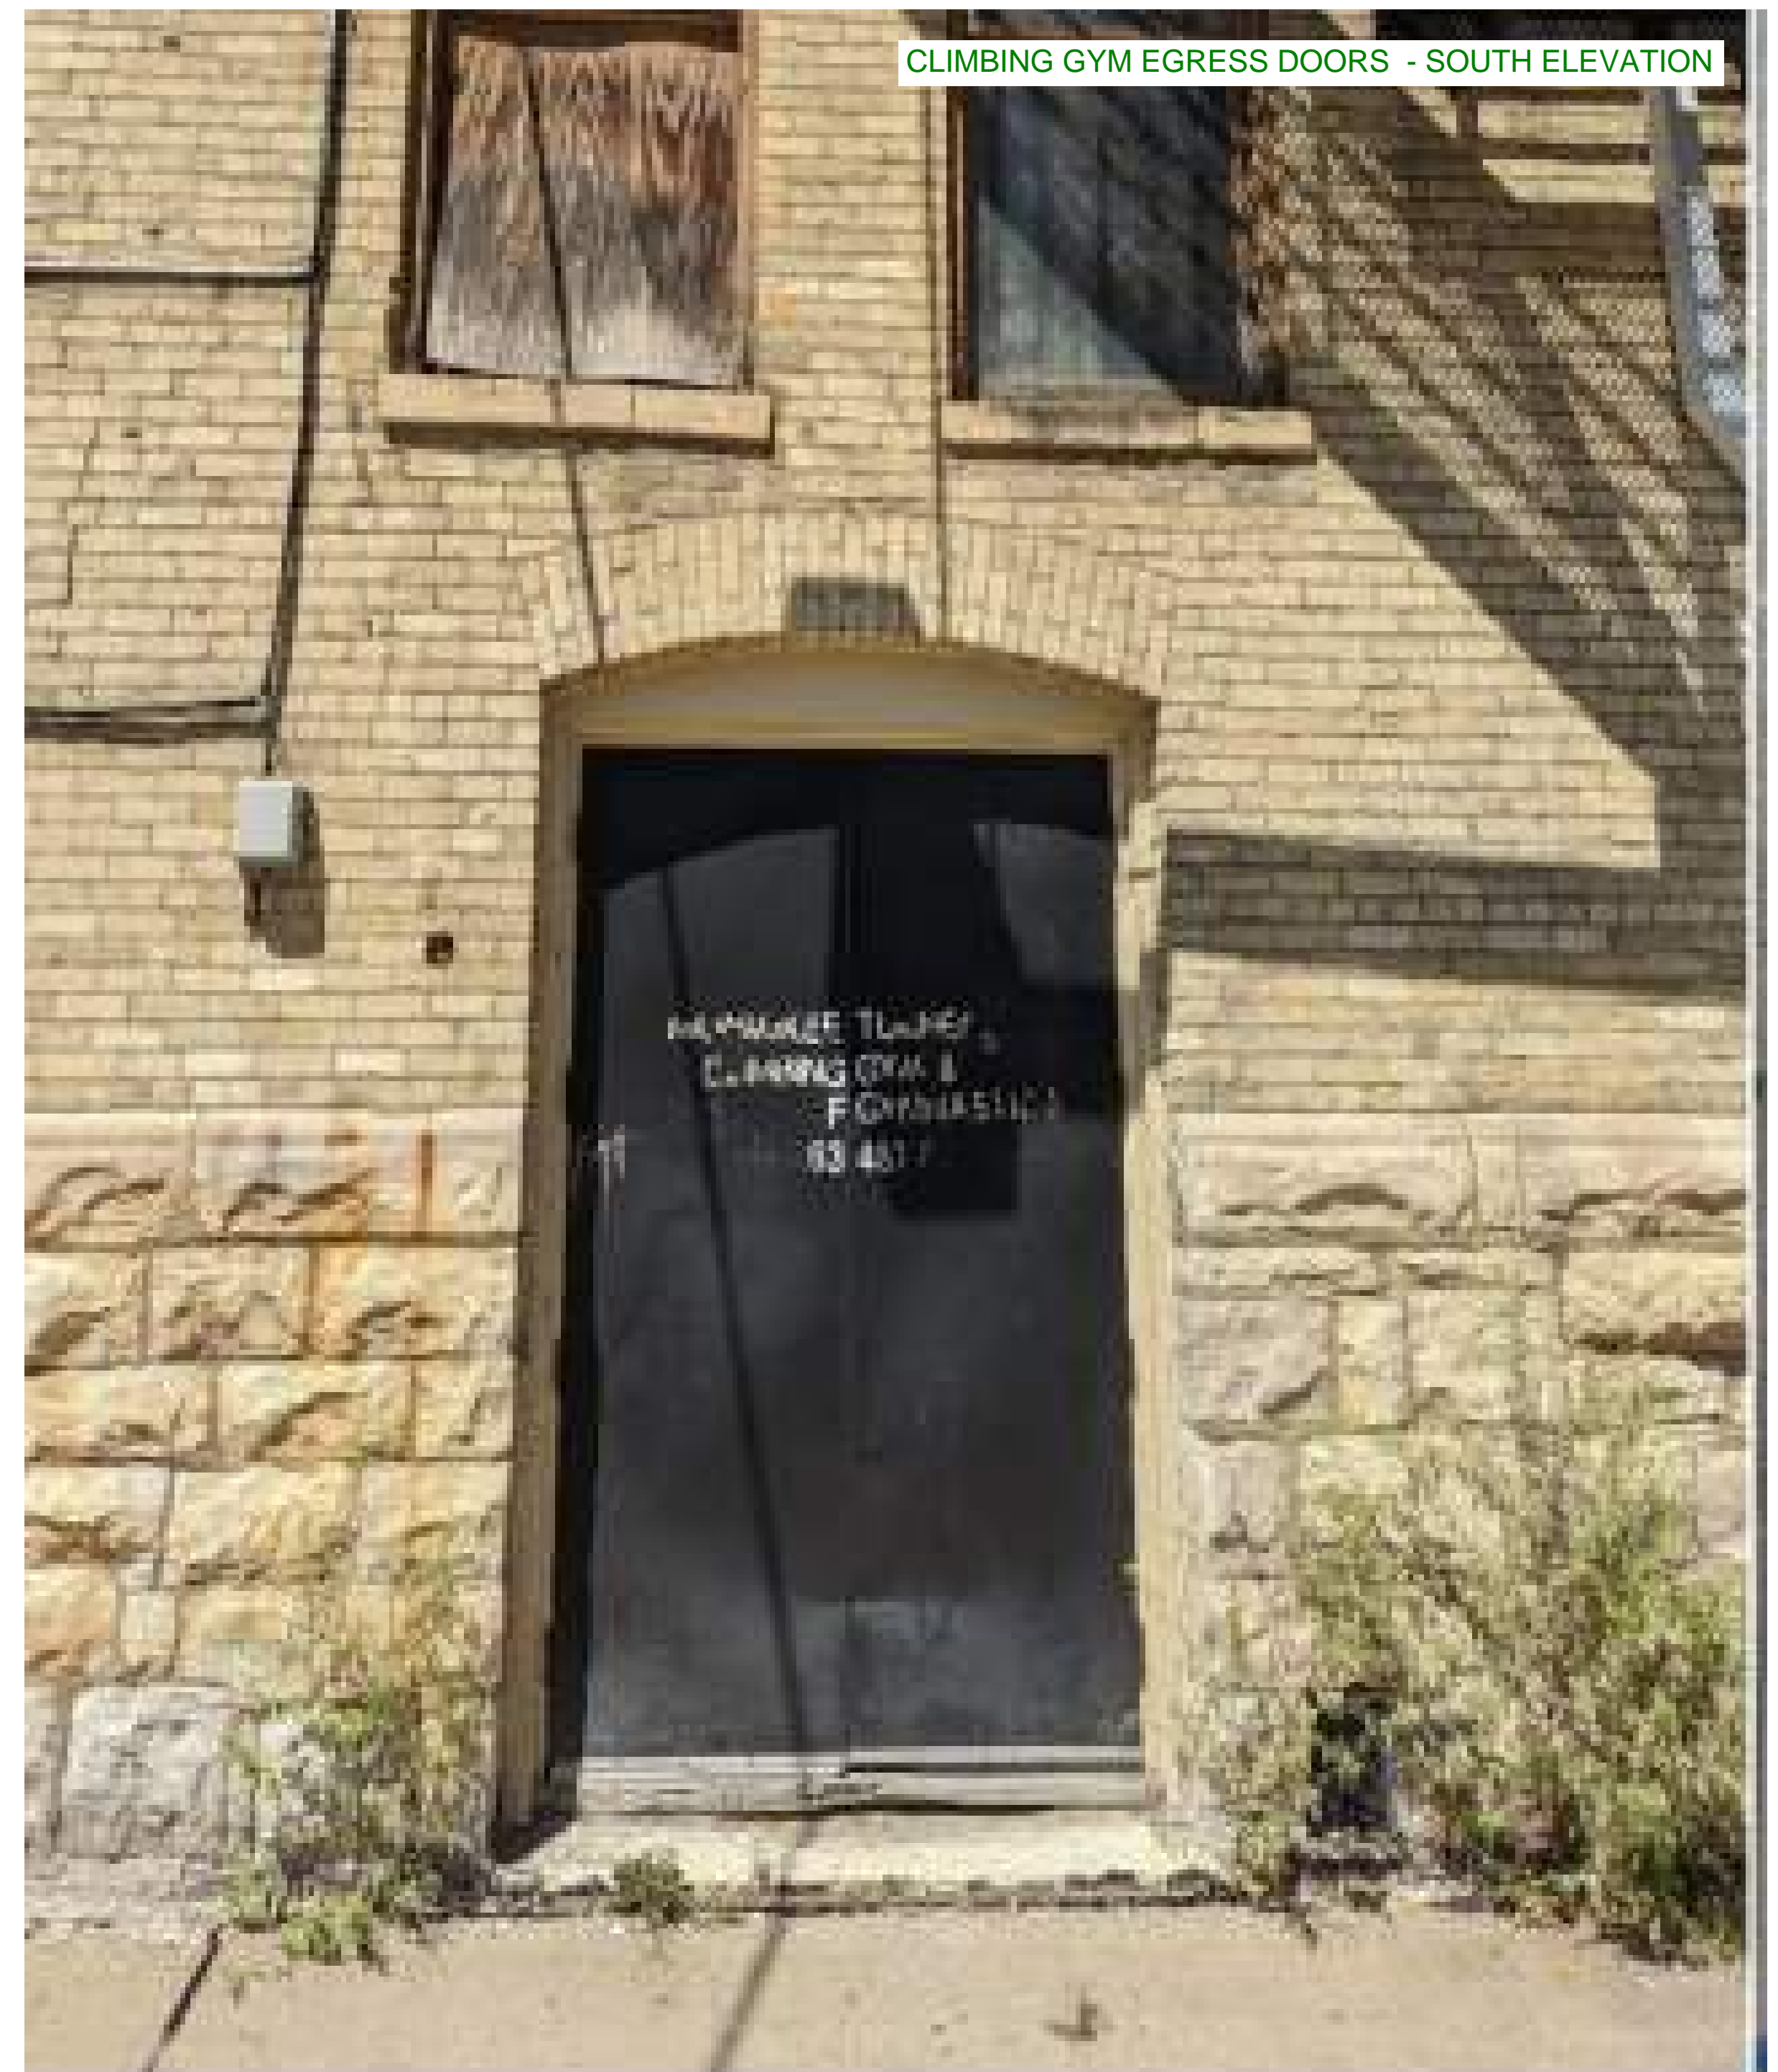
CLIMBING GYM EGRESS DOORS - SOUTH ELEVATION

Non-original metal double doors in historic open. Historic opening to remain intact. New single panel metal double doors to be installed in existing opening. Original door configuration unknown.

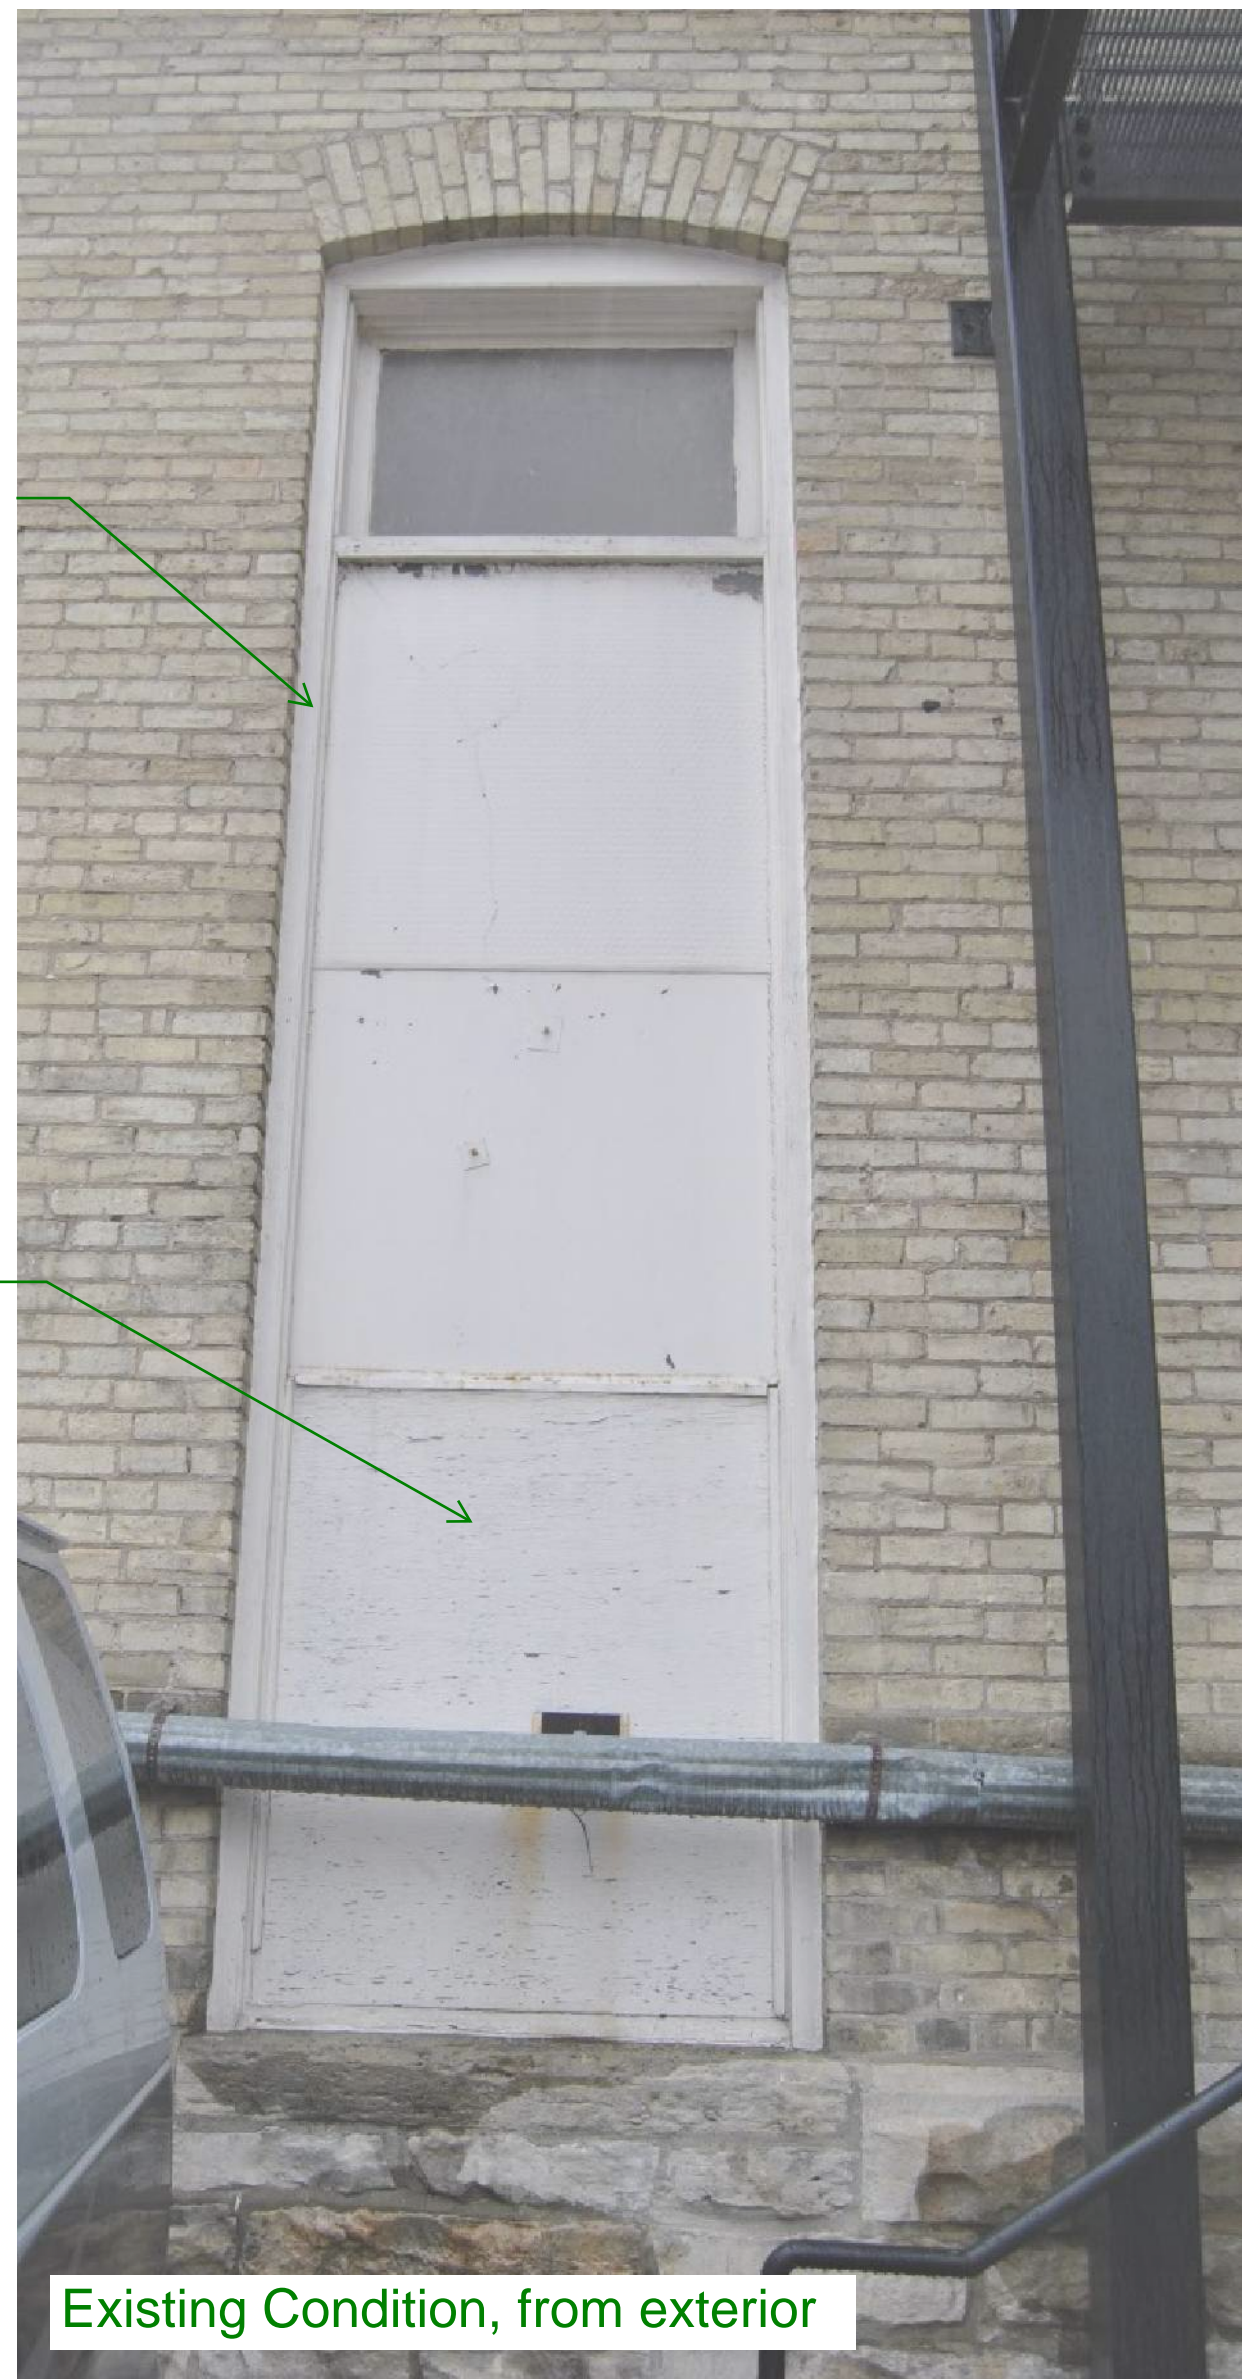
Existing Condition, from exterior

Original wood windows at the Climbing Gym. Rigid insulation protective panels have been applied from the interior. Beneath the protective panels, some of the original wire glass exists, but if it does, it has been painted from the exterior and most of the panes are broken. Several of the panes have also been replaced with wood panels.

Repair and restore existing wood frame

Remove wood infill panels, where occurs

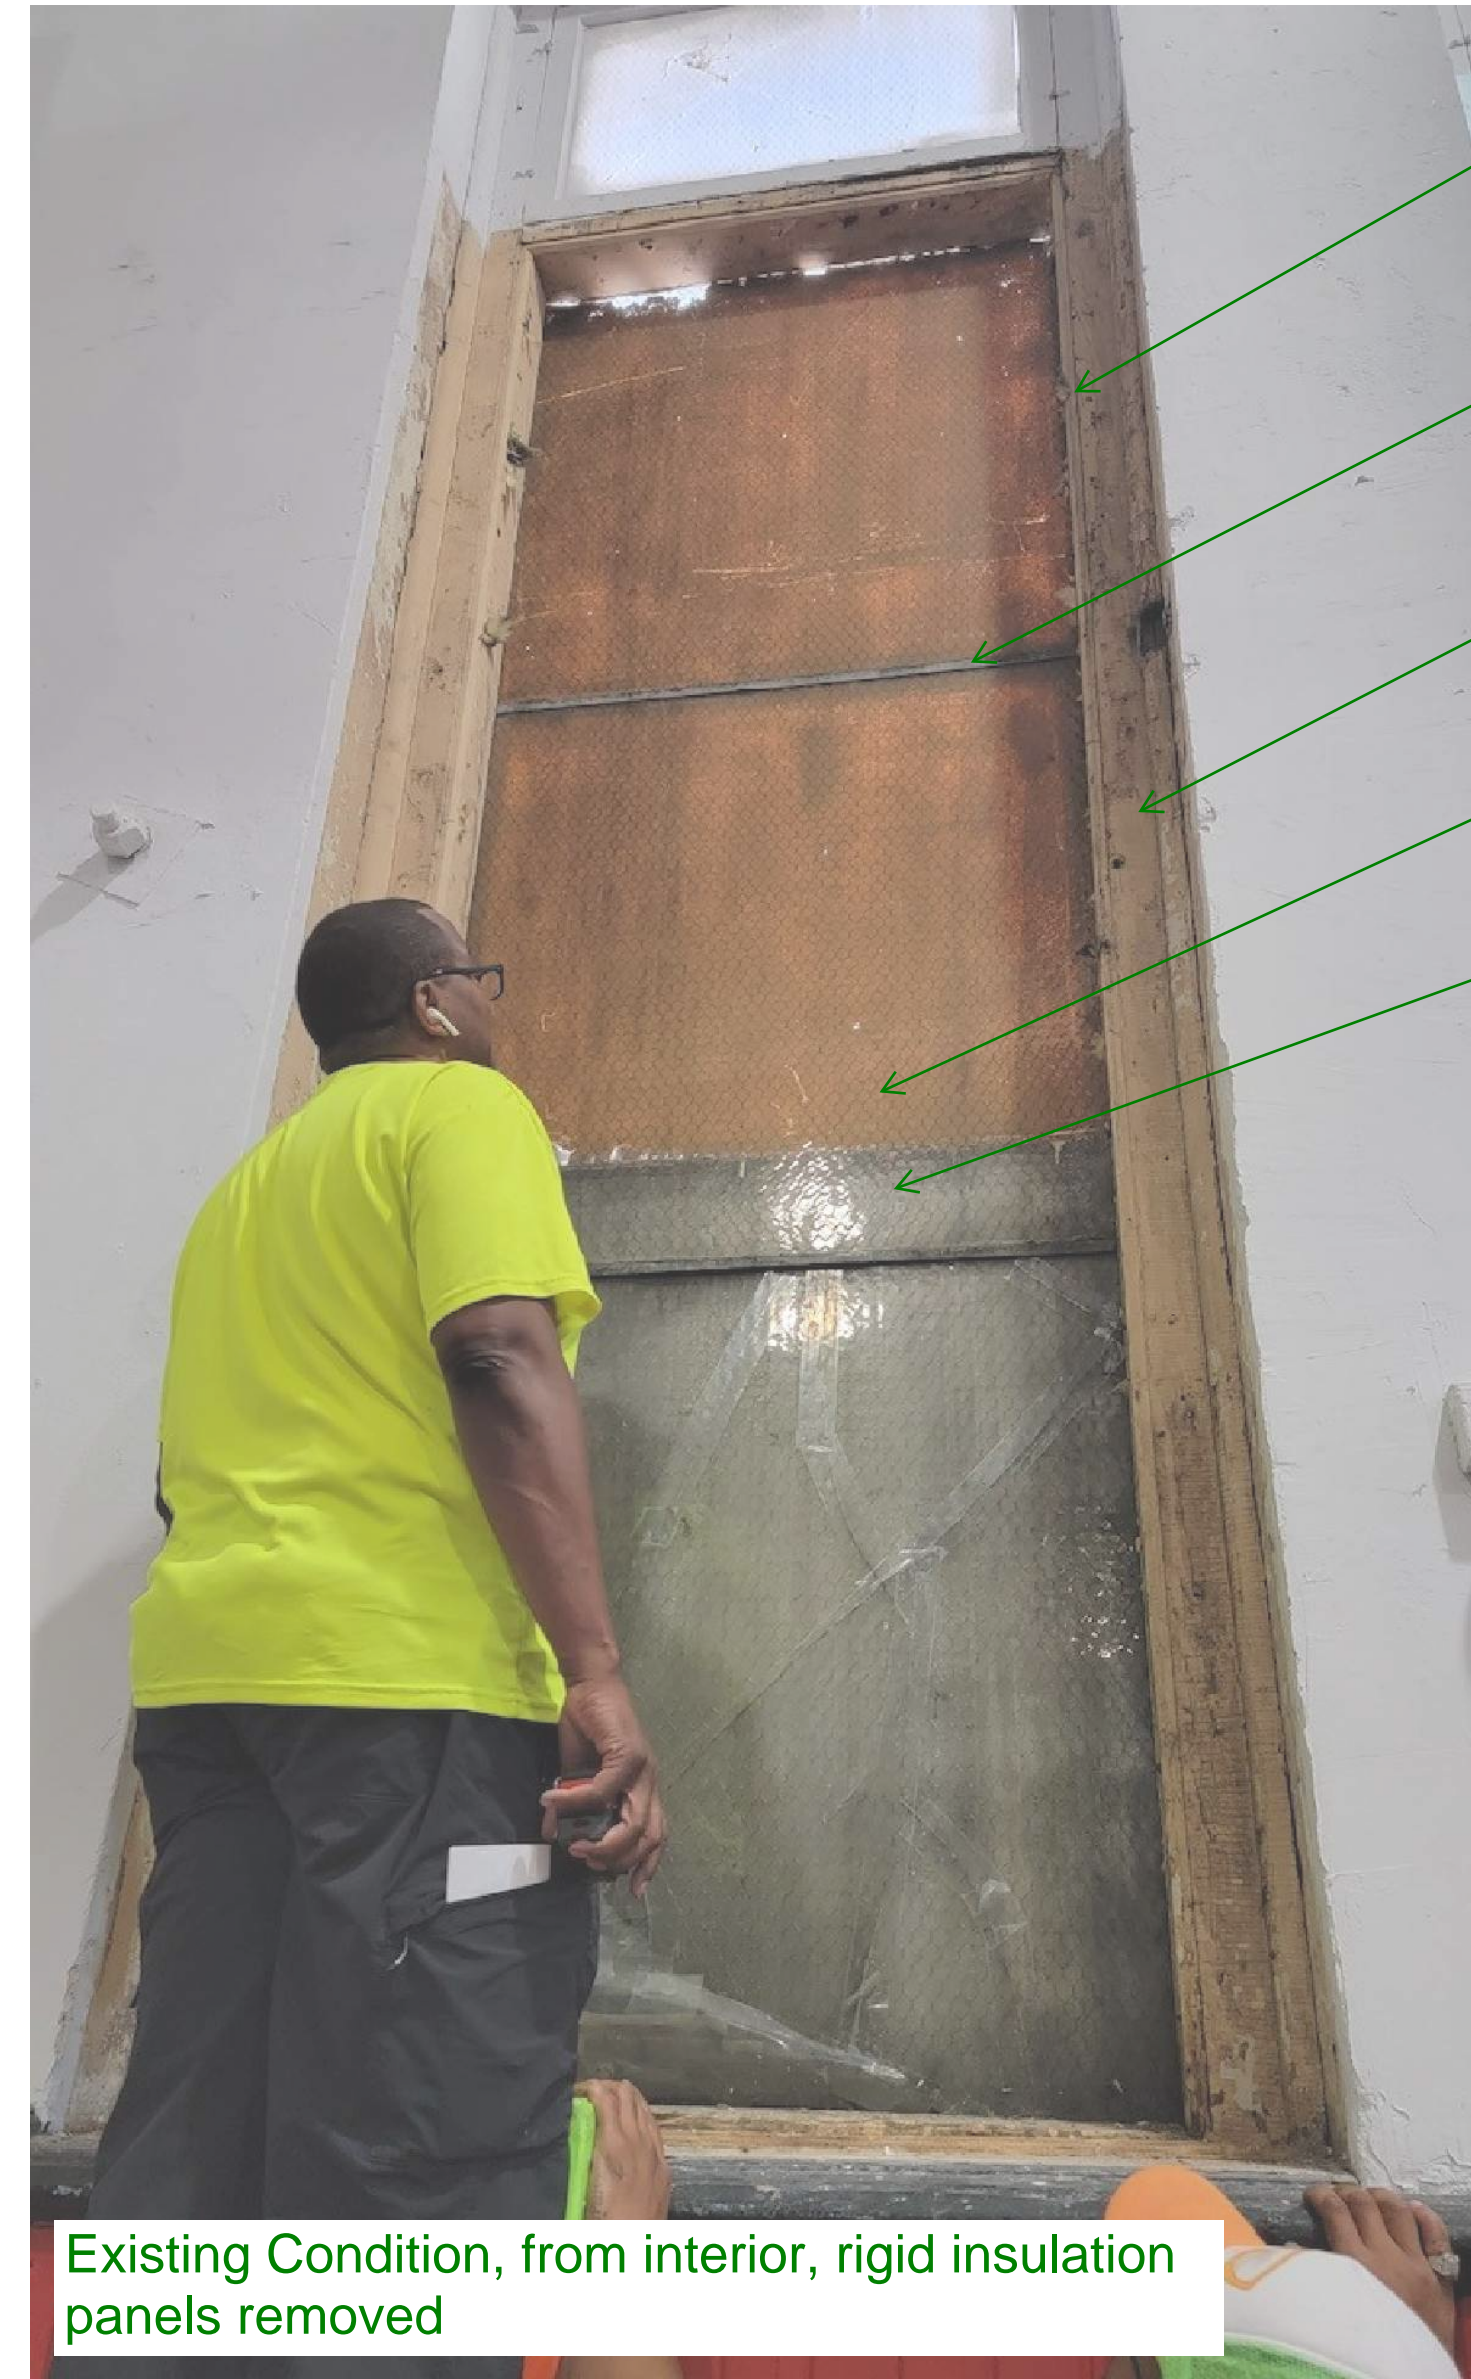
Existing Condition, from interior, rigid insulation panels removed

Remove and repair existing sash when feasible. If sash is too deteriorated, provide new to match existing.

Replace existing metal channel with new metal channel, to accommodate new glazing

Repair and restore existing wood frame

Replace existing glazing with new safety glass

Install new 8 Mil Safety and Security series Llummar window film.
