Turner Hall
1034 N Vel R Phillips Ave
Milwaukee, WI 53203

FEMA Grant Safety and Security Project
Certificate of Appropriateness Application
Drawing and Photo Exhibits

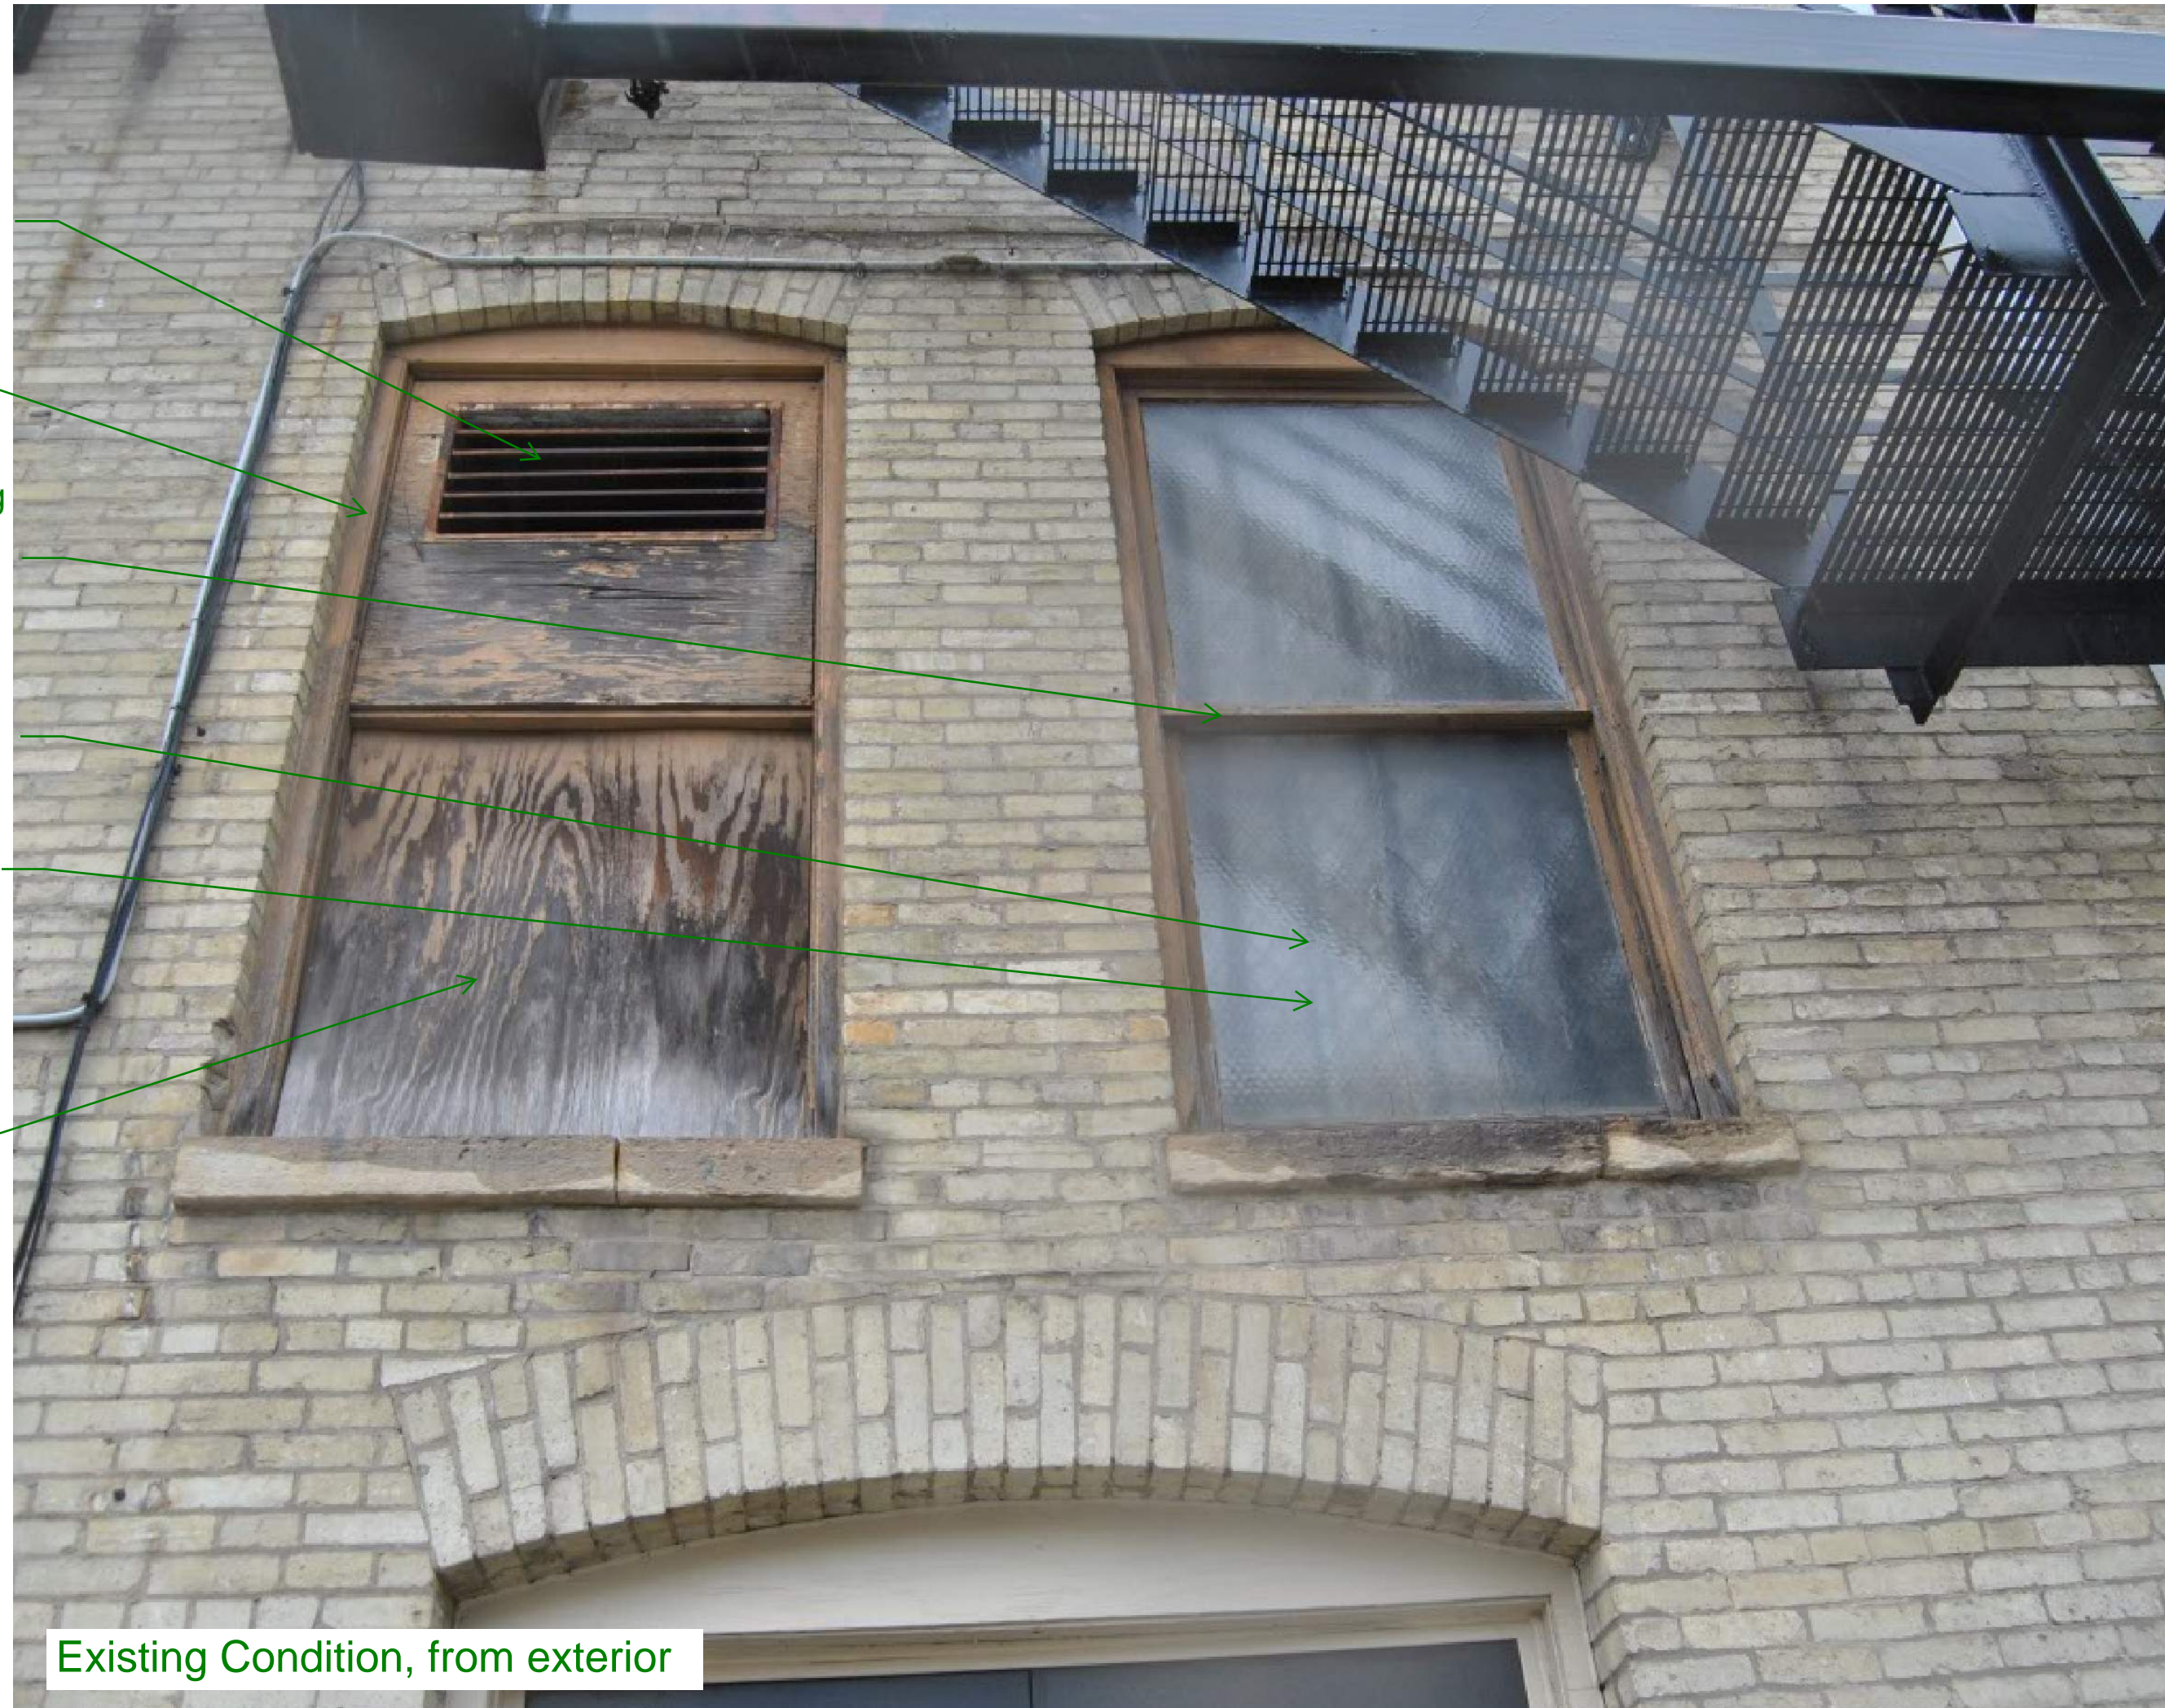
Existing Condition, from exterior

Original wood windows at the Climbing Gym. Protective panels have been applied from the interior. Beneath the protective panels, some of the original wire glass exist.

Provide new metal louver and infill panel. Paint to match window frame/sash color.

Repair and restore existing wood frame

Remove wood infill panels, where occurs

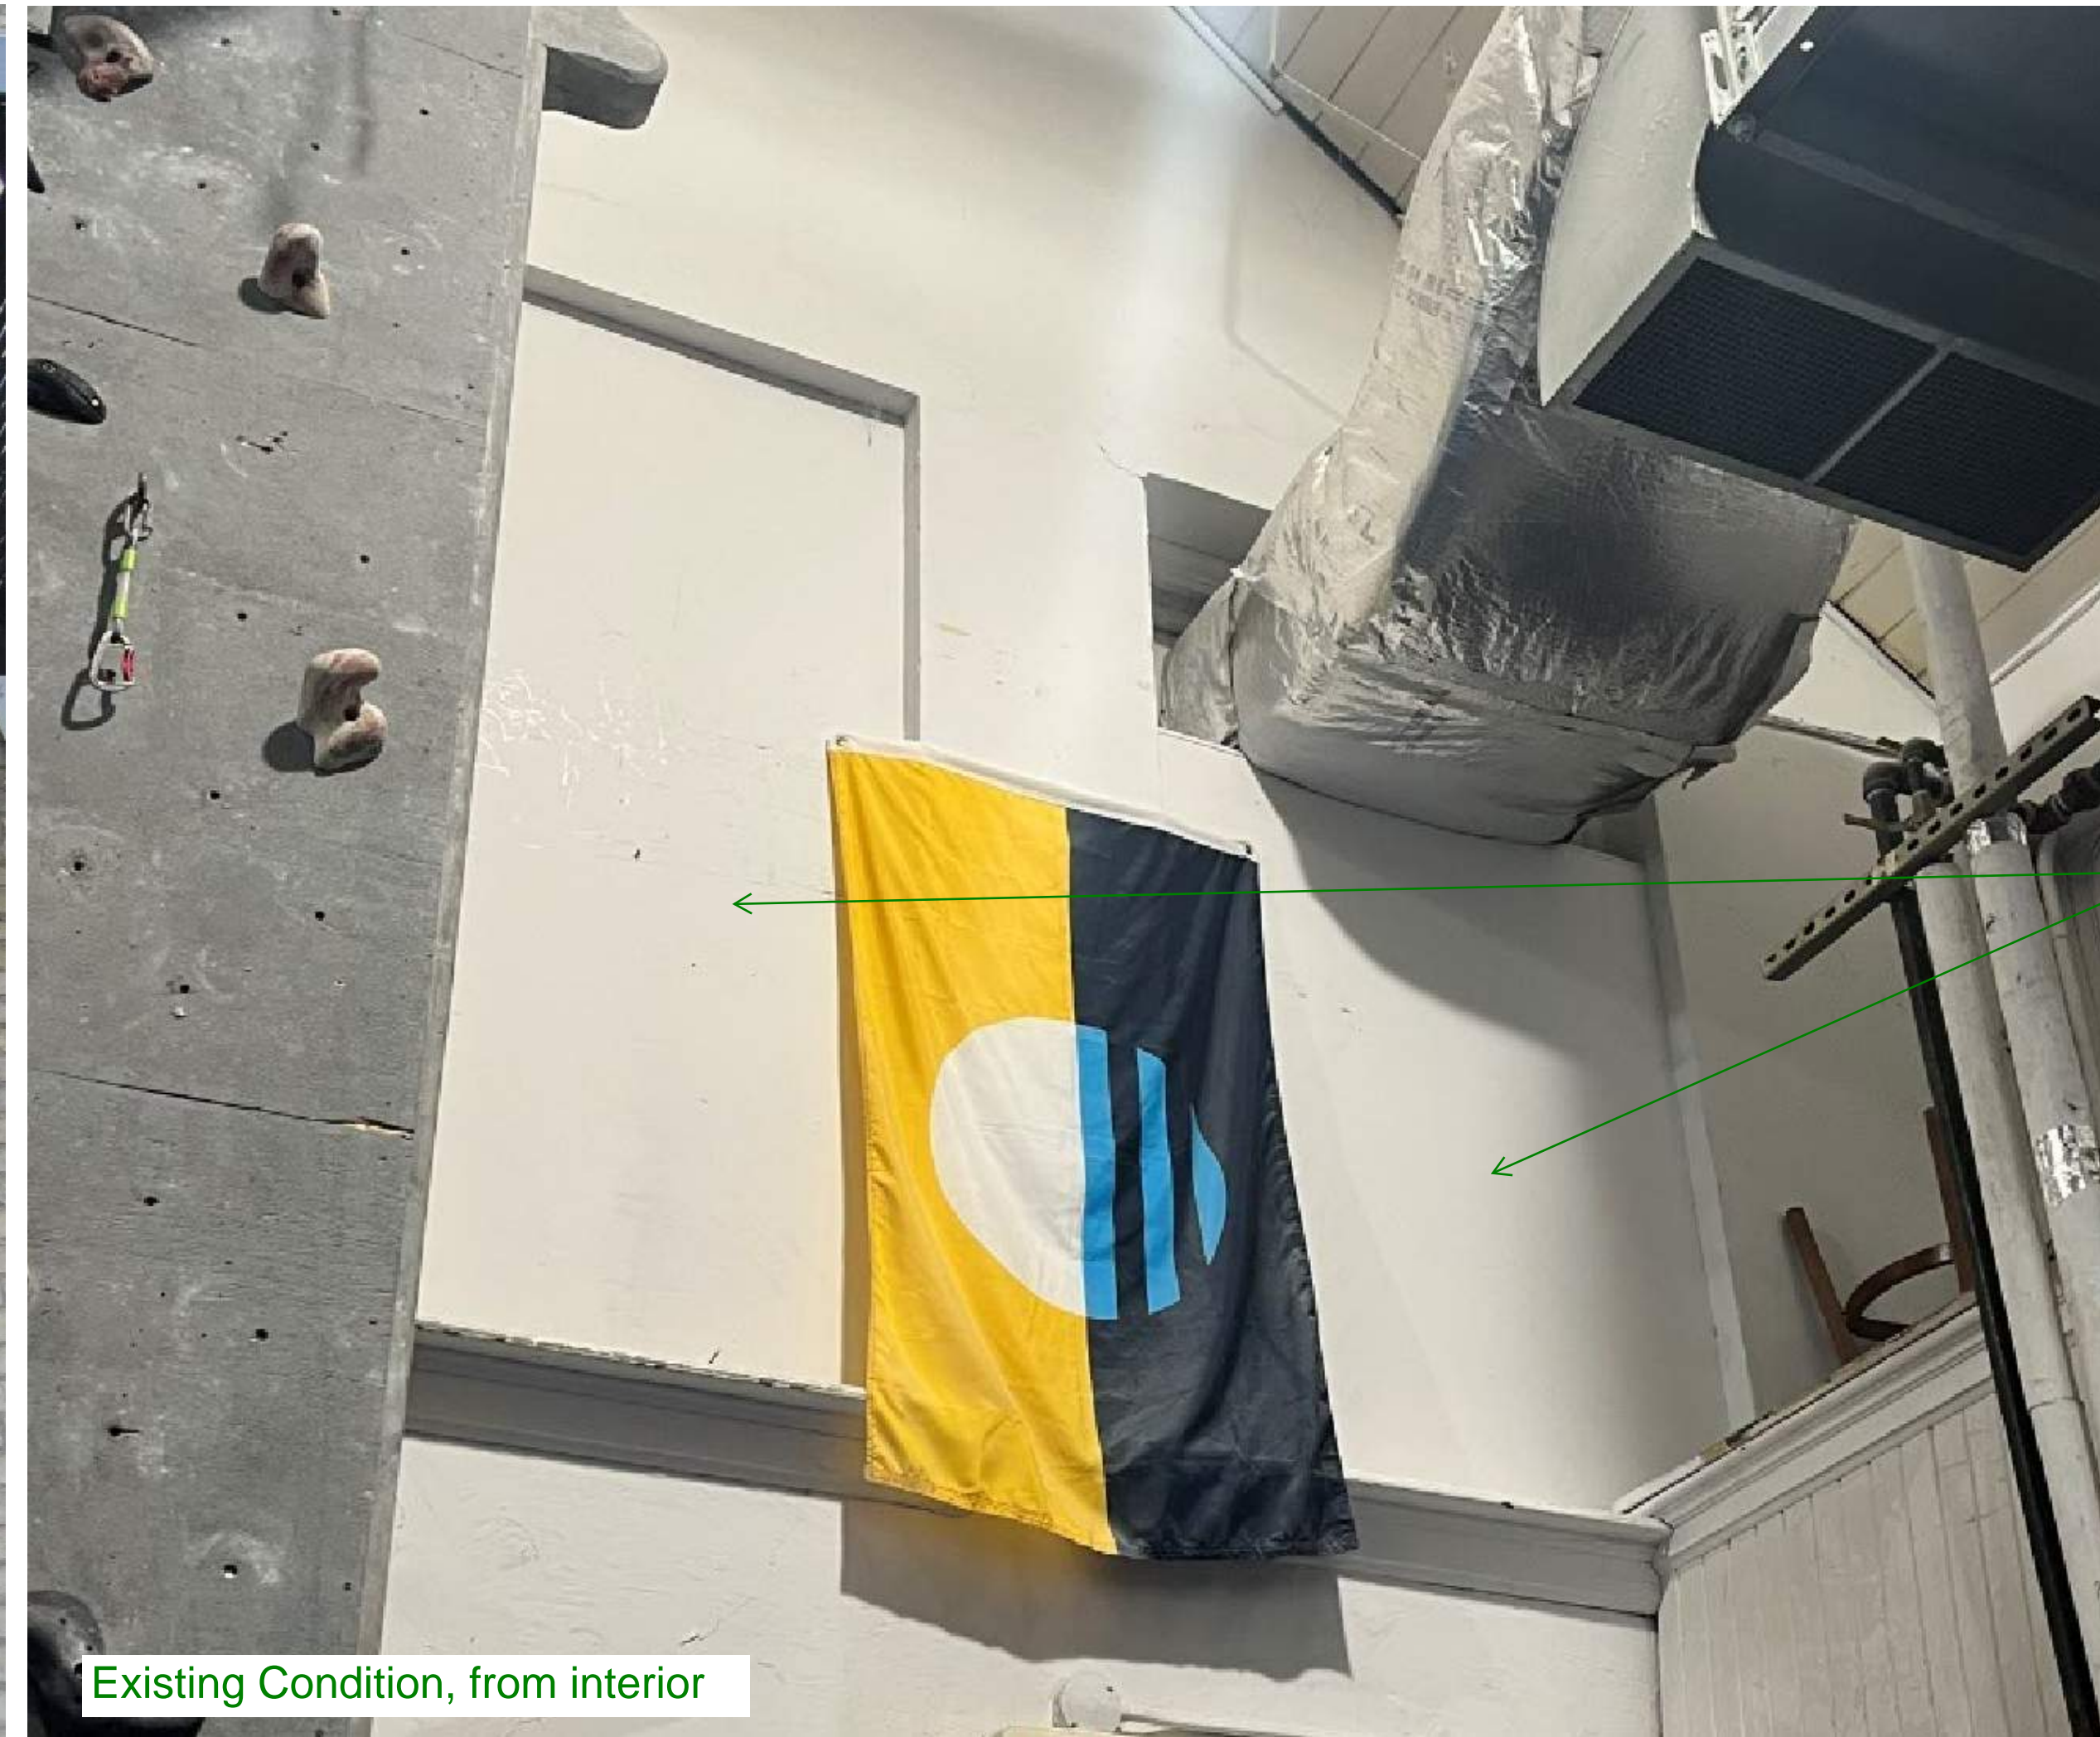
Existing Condition, from interior

Remove and repair existing sash when feasible. If sash is too deteriorated, provide new to match existing.

Replace existing glazing with new safety glass

Install new 8 Mil Safety and Security series Lumar window film.

Remove interior protective panels

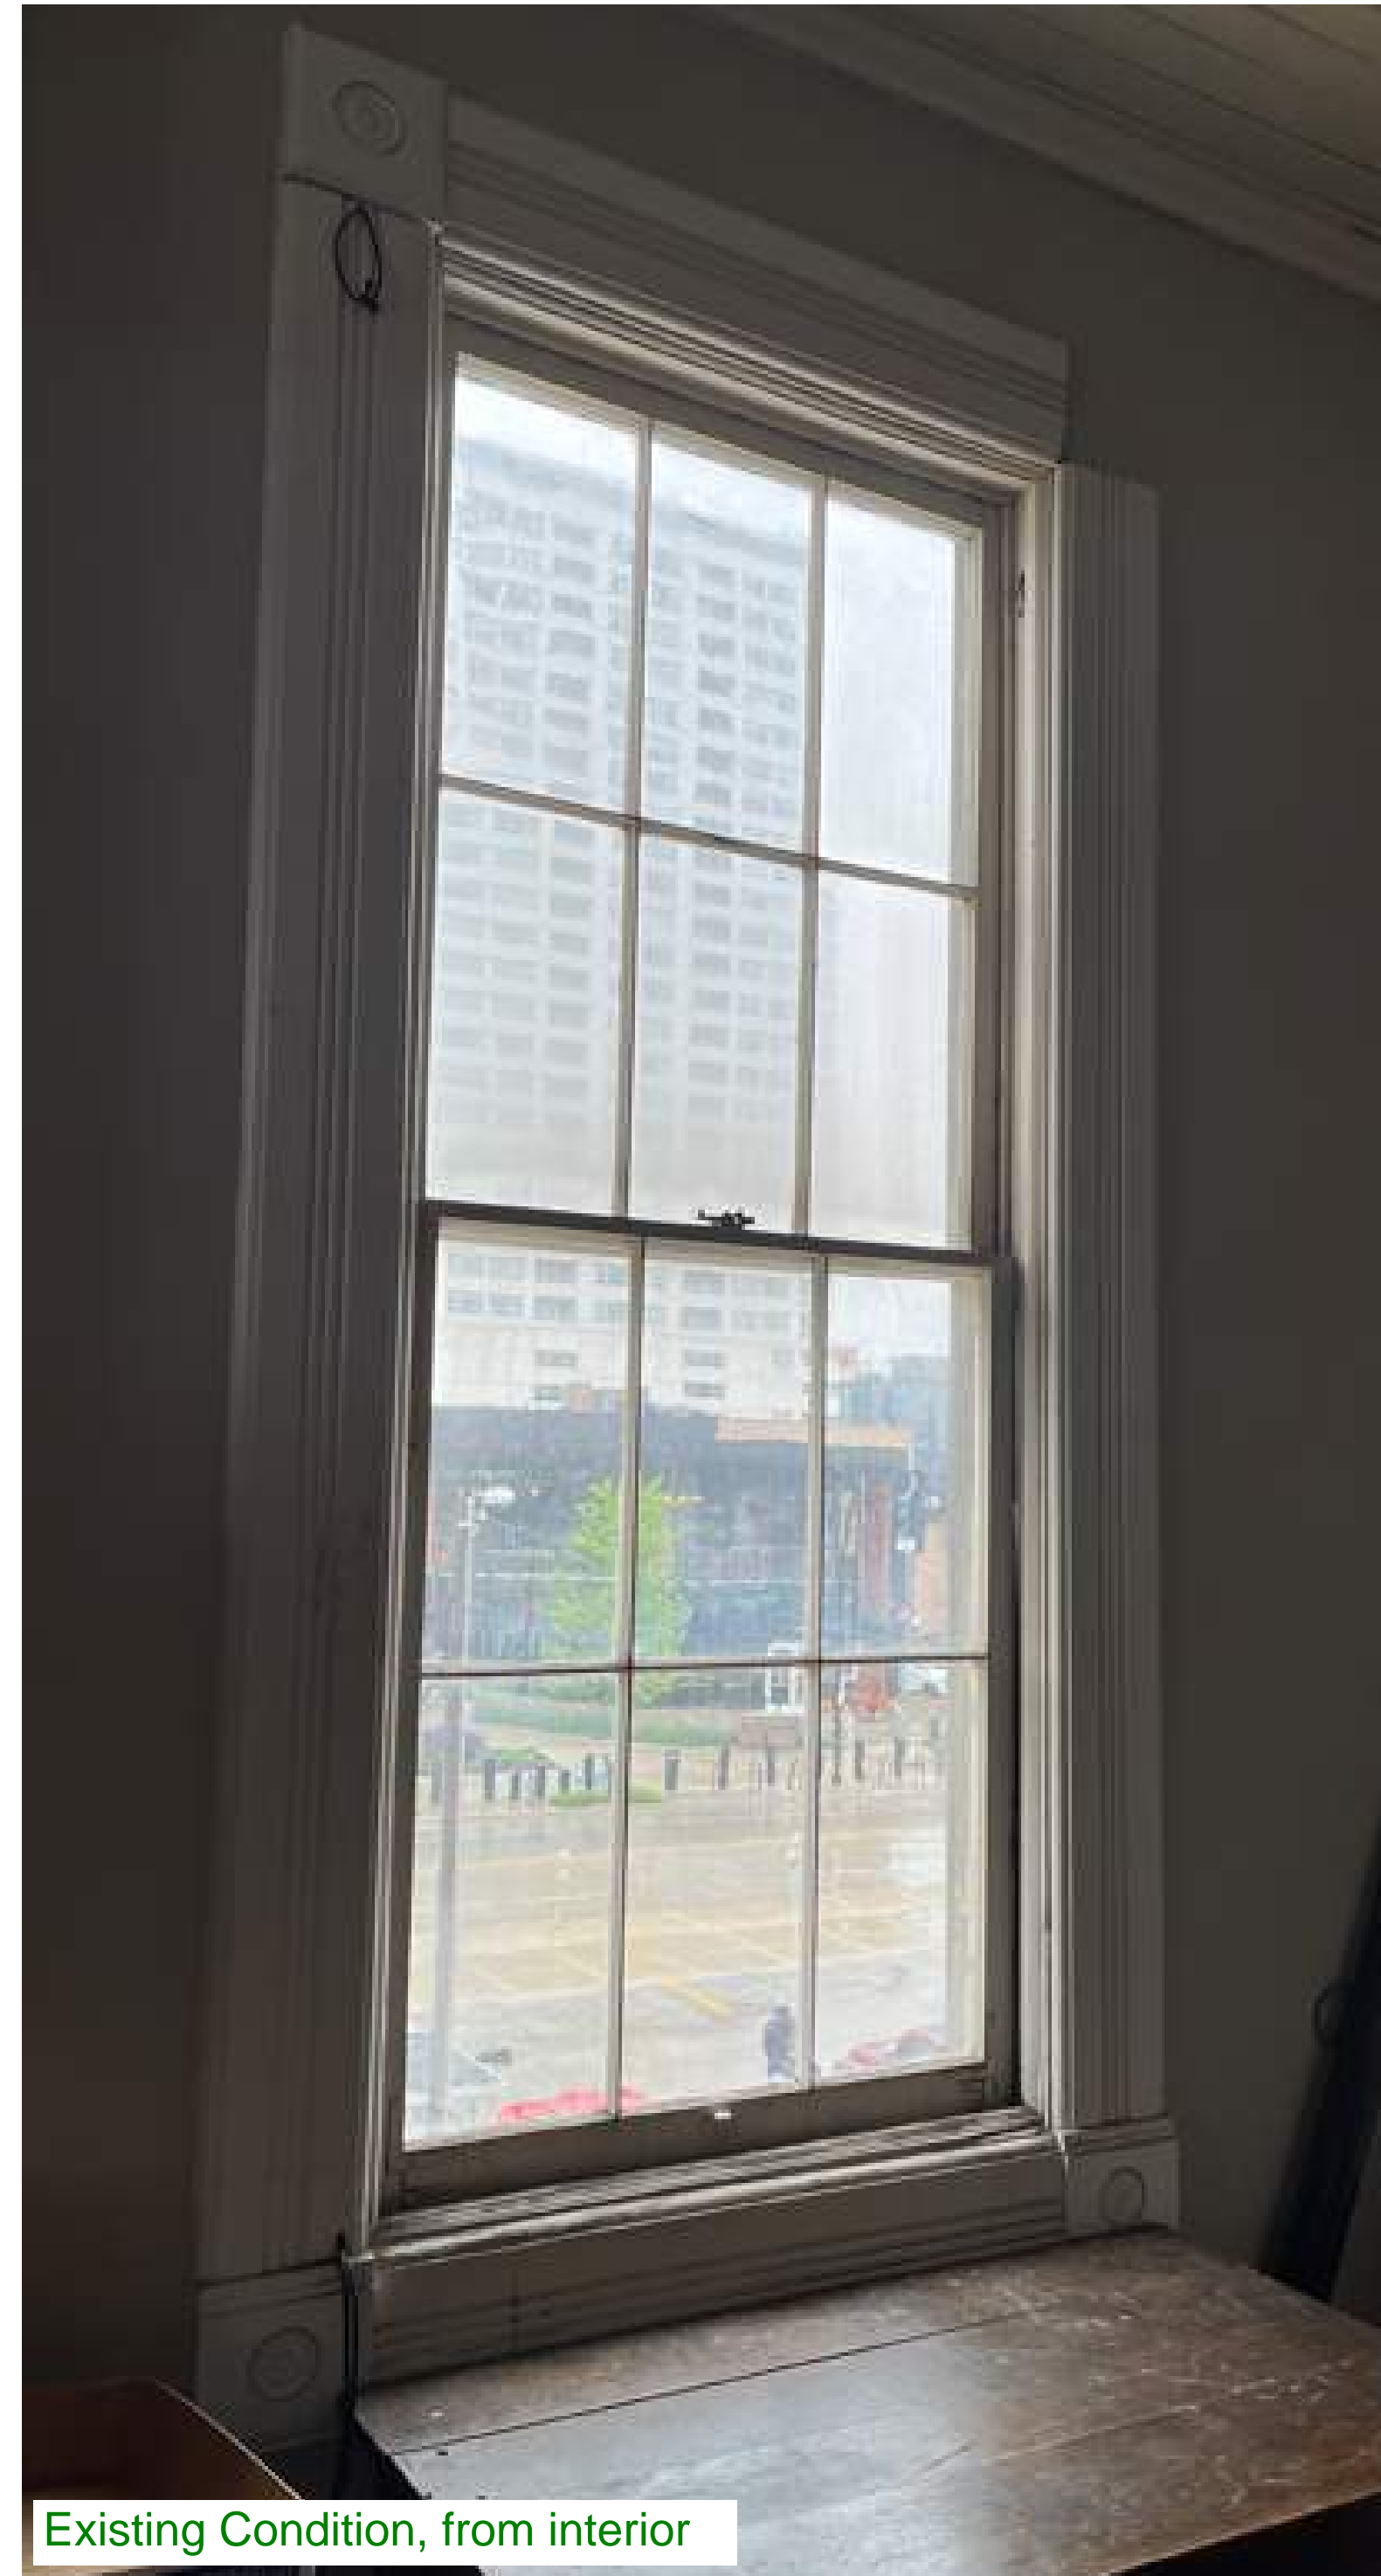
Existing Condition, from interior

Original wood window at the Office Storage room. Wood rot and previous poor quality repairs have made it infeasible to repair this window. The previous repairs have made the window sash too small to fit in the current frame.

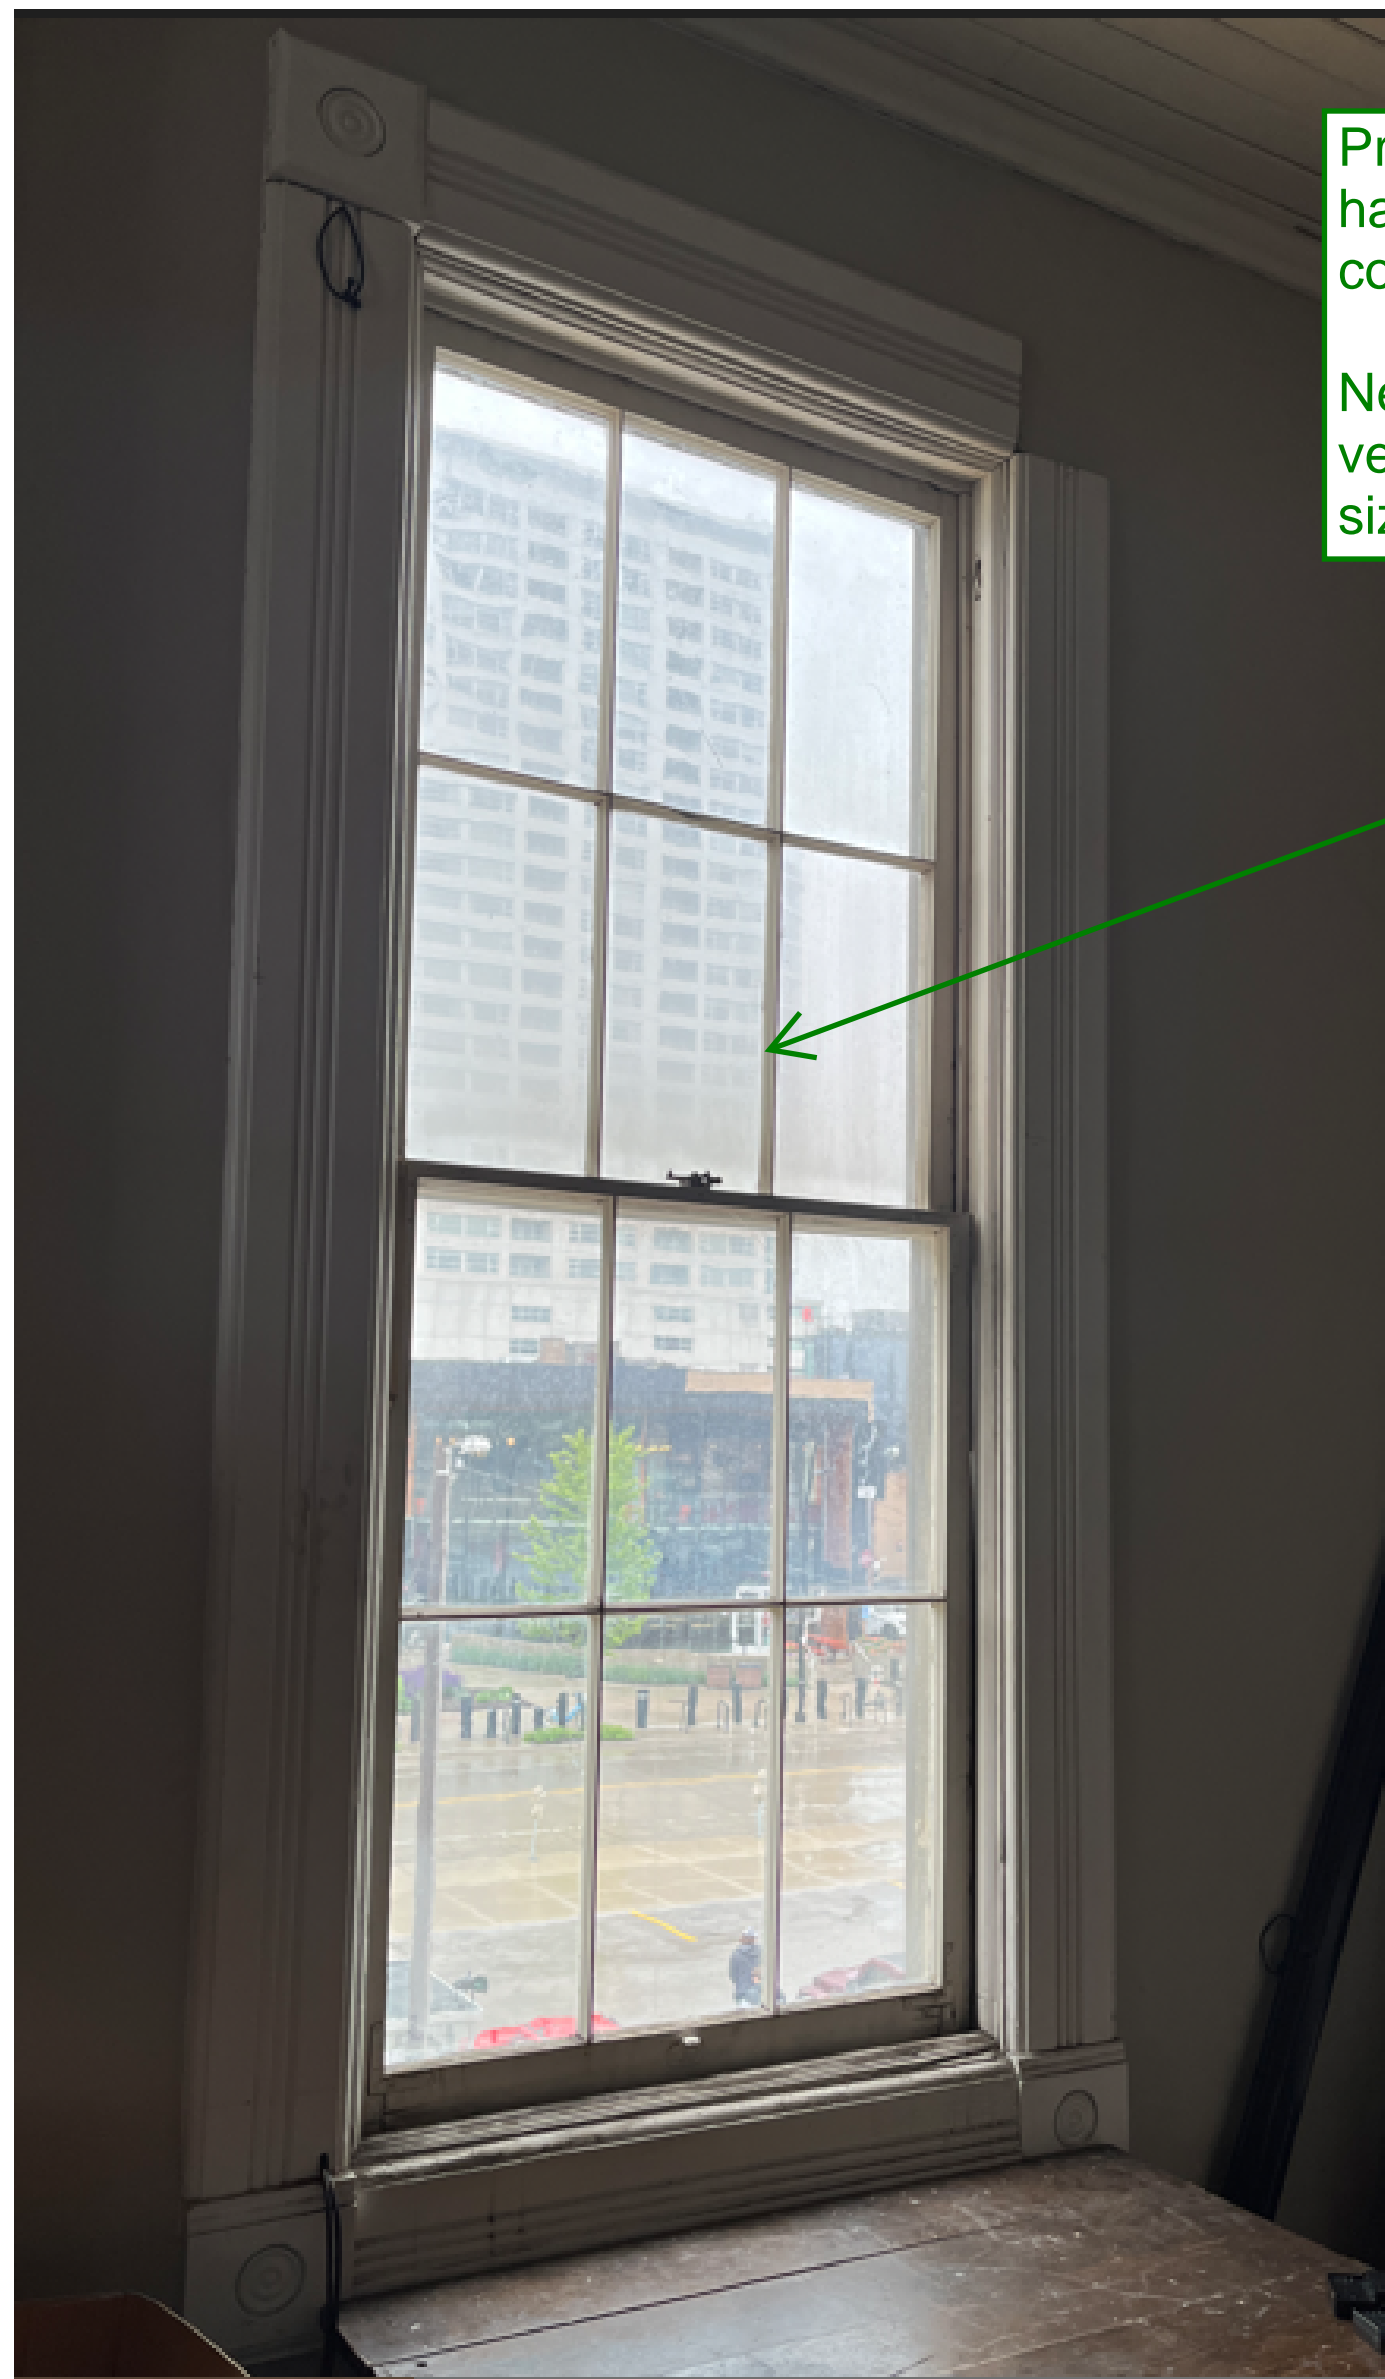
Ultimate Wood Double Hung Magnum

The scope of work for this window proposes to replace this window in kind, with a new wood window of the same configuration and profile. After the new window is installed, 8 Mil Safety and Security series Lumar window film will be installed over the new glazing.

Proposed New wood window to have divided lights in same configuration as existing window.
 New window dimensions to be verified in field, to match existing size.

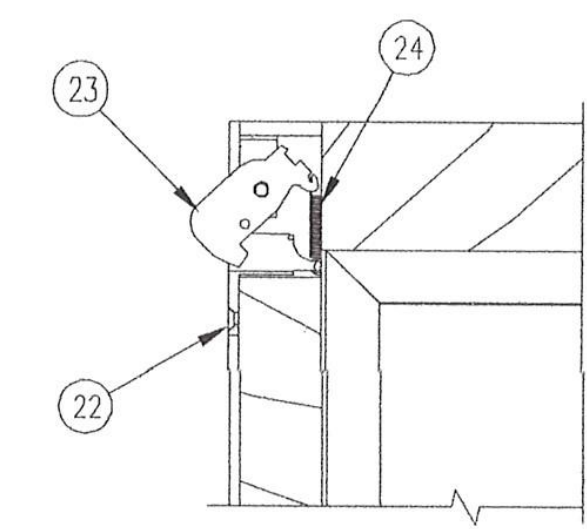
HEAD JAMB AND SILL DETAIL

1. Top Brick Mould Casing, W1047
2. Top Blind Stop
3. Tilt Latch
4. Parting Stop Weather strip, V945
5. Head Jamb
6. Parting Stop, W8883
7. Screen Frame
8. Screen Mesh
9. Glazing Bead
10. Top Rail
11. Sash Keeper
12. Sash Lock
13. Insulated Glass
14. Bottom Check Rail
15. Top Check Rail
16. Check Rail Weather strip, V031
17. Bottom Rail
18. Bottom Rail Weather strip, V147
19. Sill Liner, W8914
20. Subsill, W2134
21. Sill
22. End Plate
23. Locking Blade
24. Extension Spring
25. Side Brick Mould Casing, W1047
26. Jamb
27. Vinyl Jamb Carrier, V1375
28. Jamb Liner, W8880
29. Stile
30. Exterior Jamb Filler (Lower), W8927
31. Balance Cover
32. Interior Jamb Filler, W8878
33. Frame Weather strip, V1419
34. Jamb Blind Stop
35. Sash Balance Tube
36. Jamb Liner Stop, A1402
37. Exterior Jamb Filler (Upper)
38. Sill Bracket

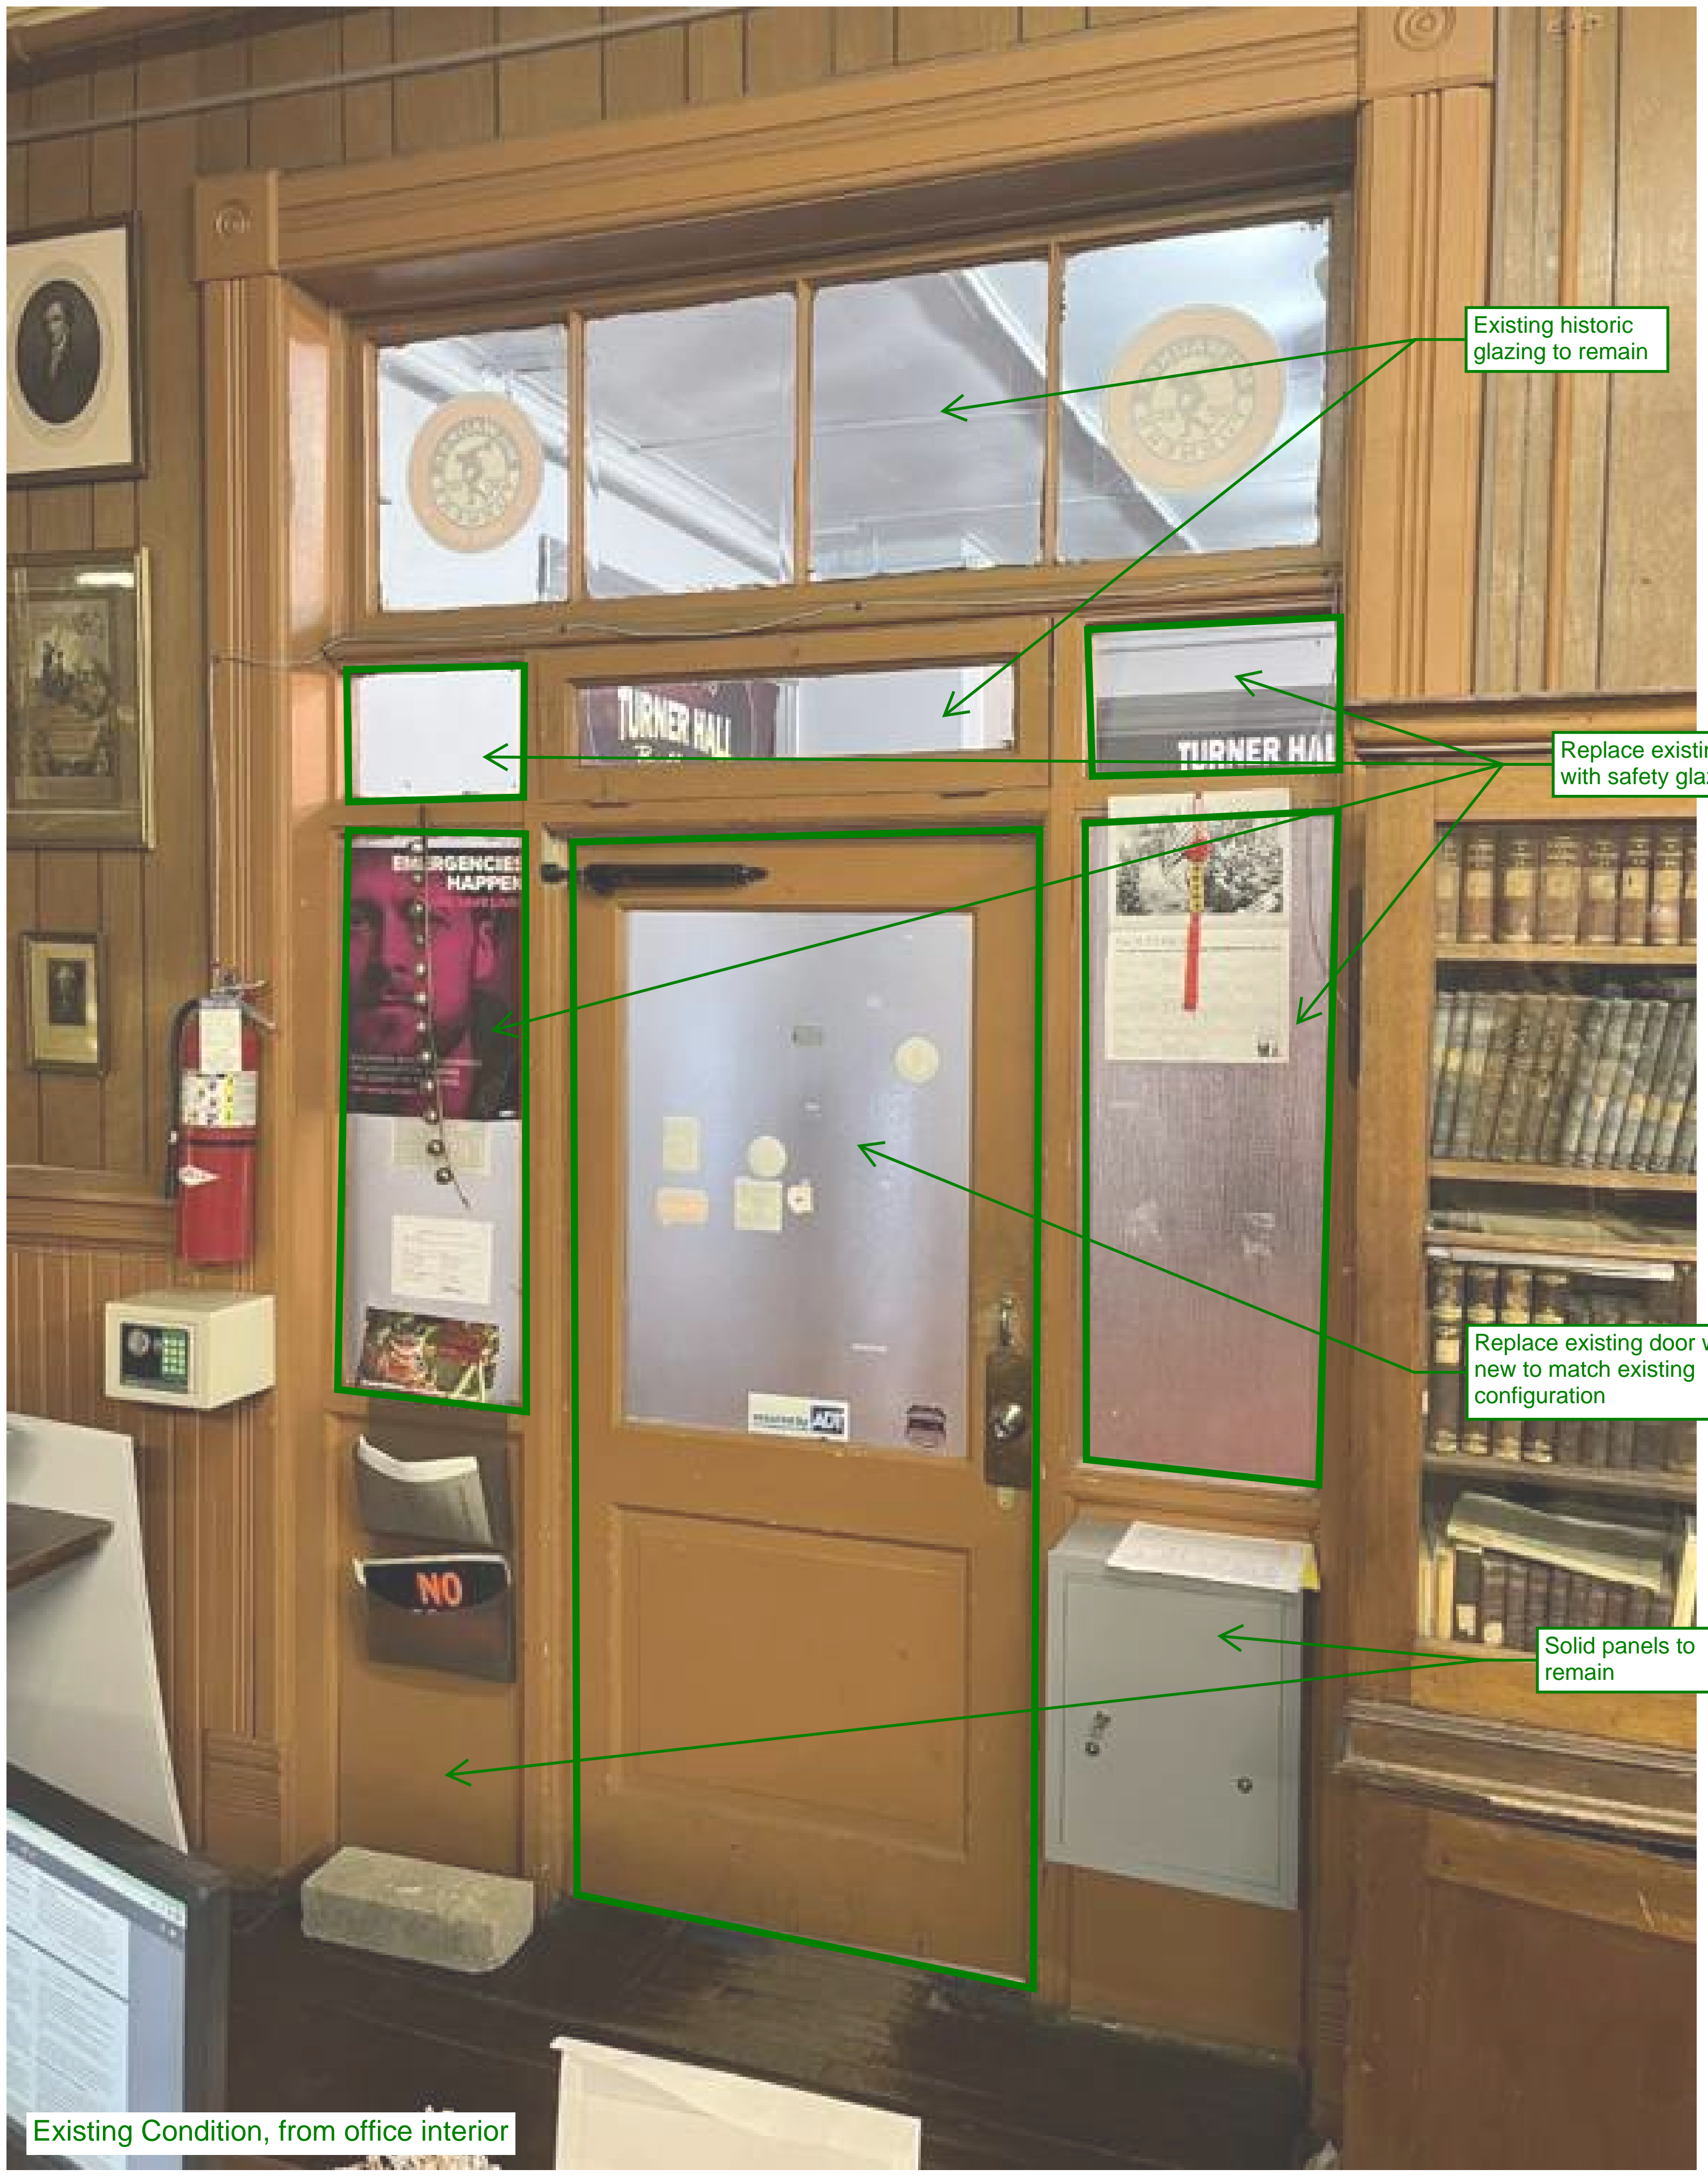
9 Replace Doors or Windows in Kind
Office Entry Door (Interior)

Existing historic glazing to remain

Replace existing glazing with safety glazing

Replace existing door with new to match existing configuration

Existing Condition, from office interior

The existing Office Entry door has been significantly altered over the years. Most of the lower divisions appear to have been replaced over time, and the door is believed to be salvaged from a different location within the building.

The proposed scope of work includes replacing the door and sidelight glazing. The new glazed panels will consist of a safety glass of a similar thickness to the original glass (in the transom) and the door will match the existing configuration.
