Turner Hall
1034 N Vel R Phillips Ave
Milwaukee, WI 53203

FEMA Grant Safety and Security Project
Certificate of Appropriateness Application
Drawing and Photo Exhibits

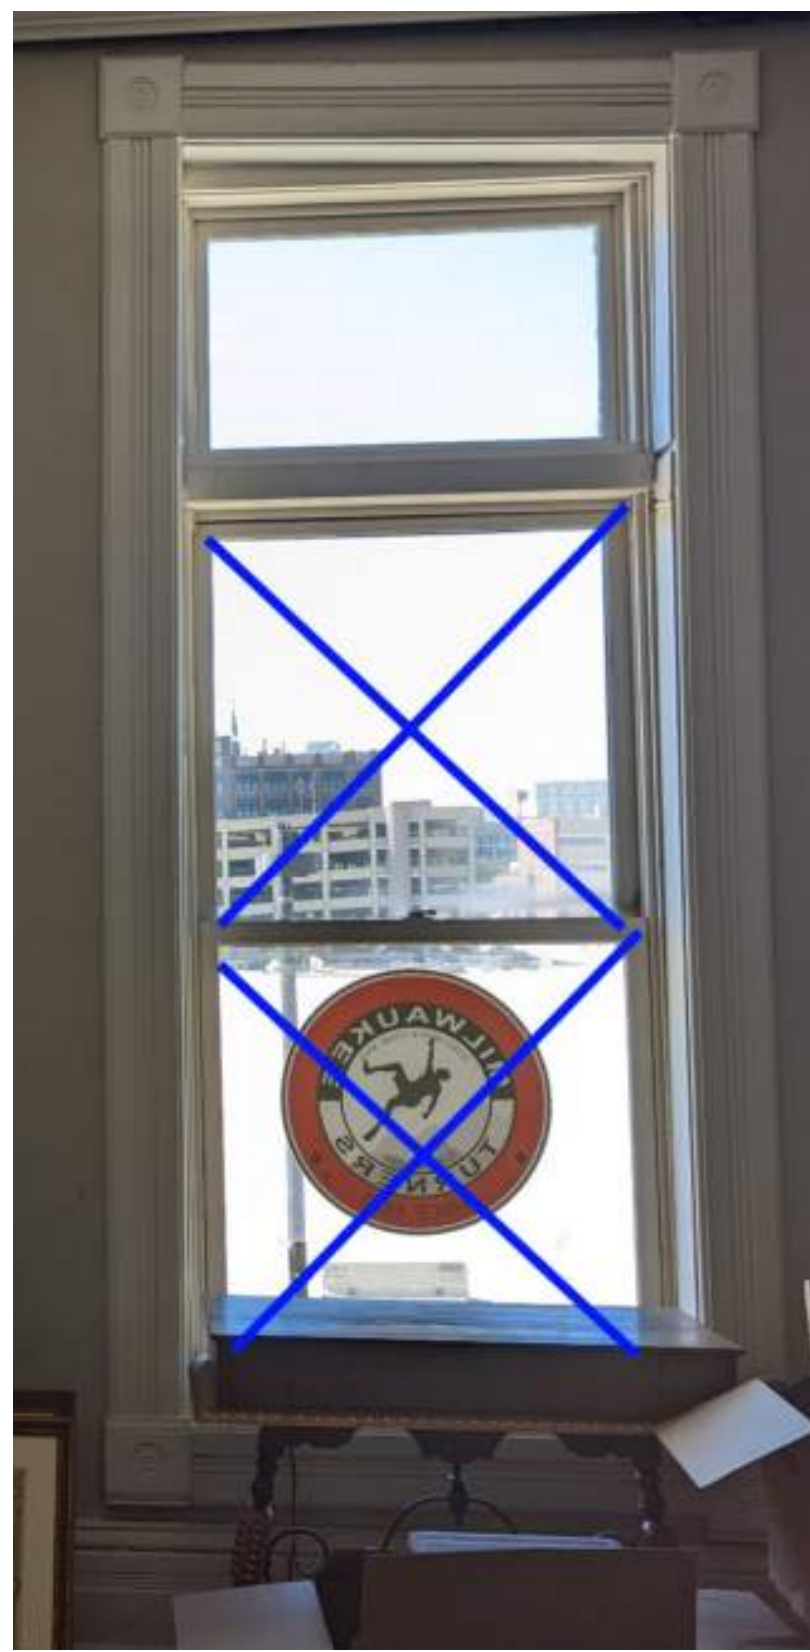
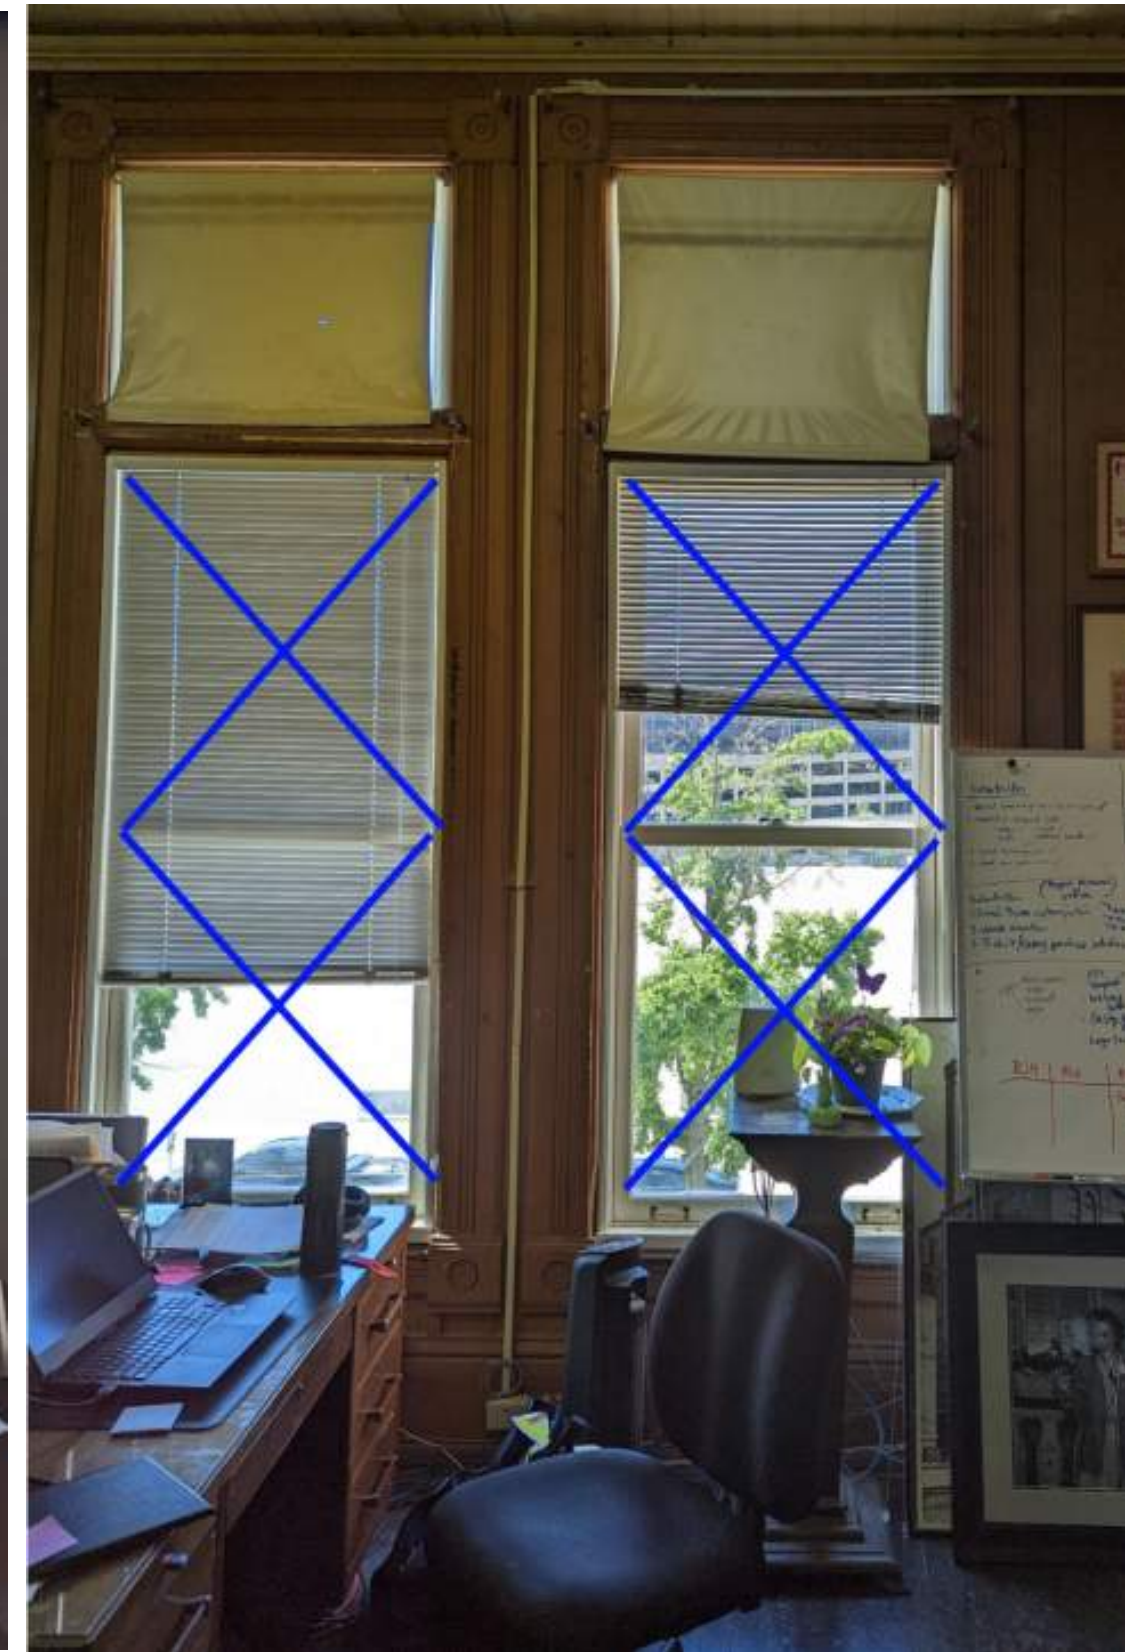
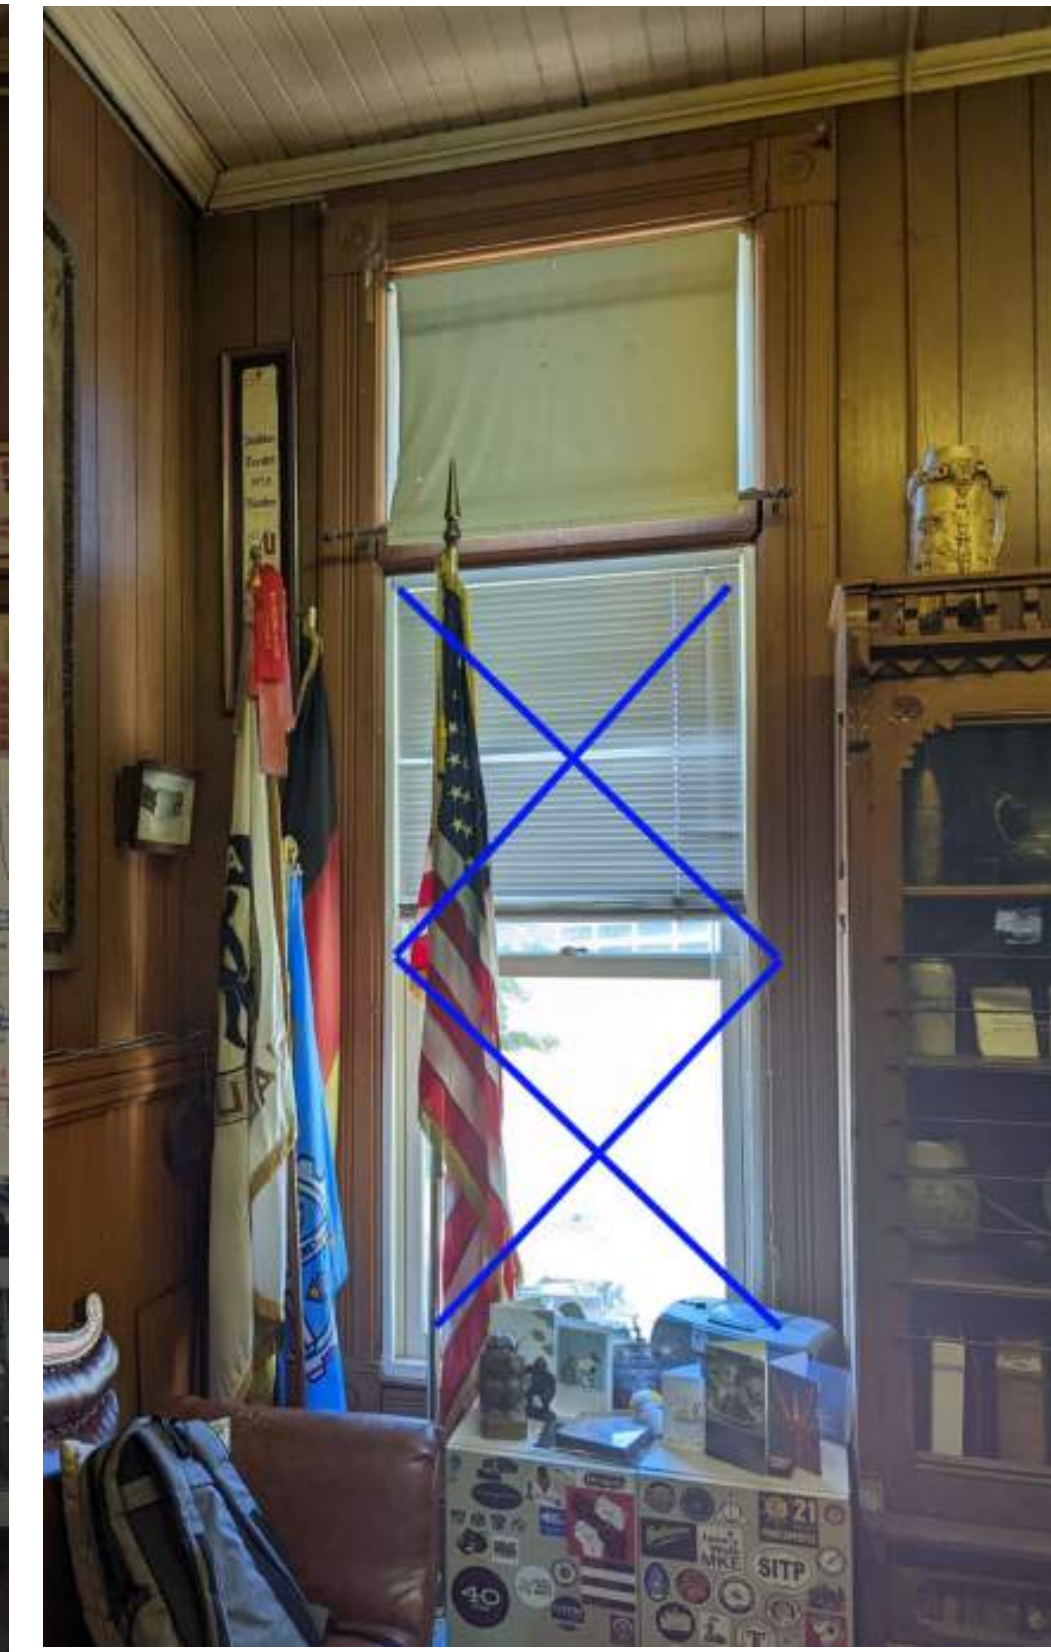
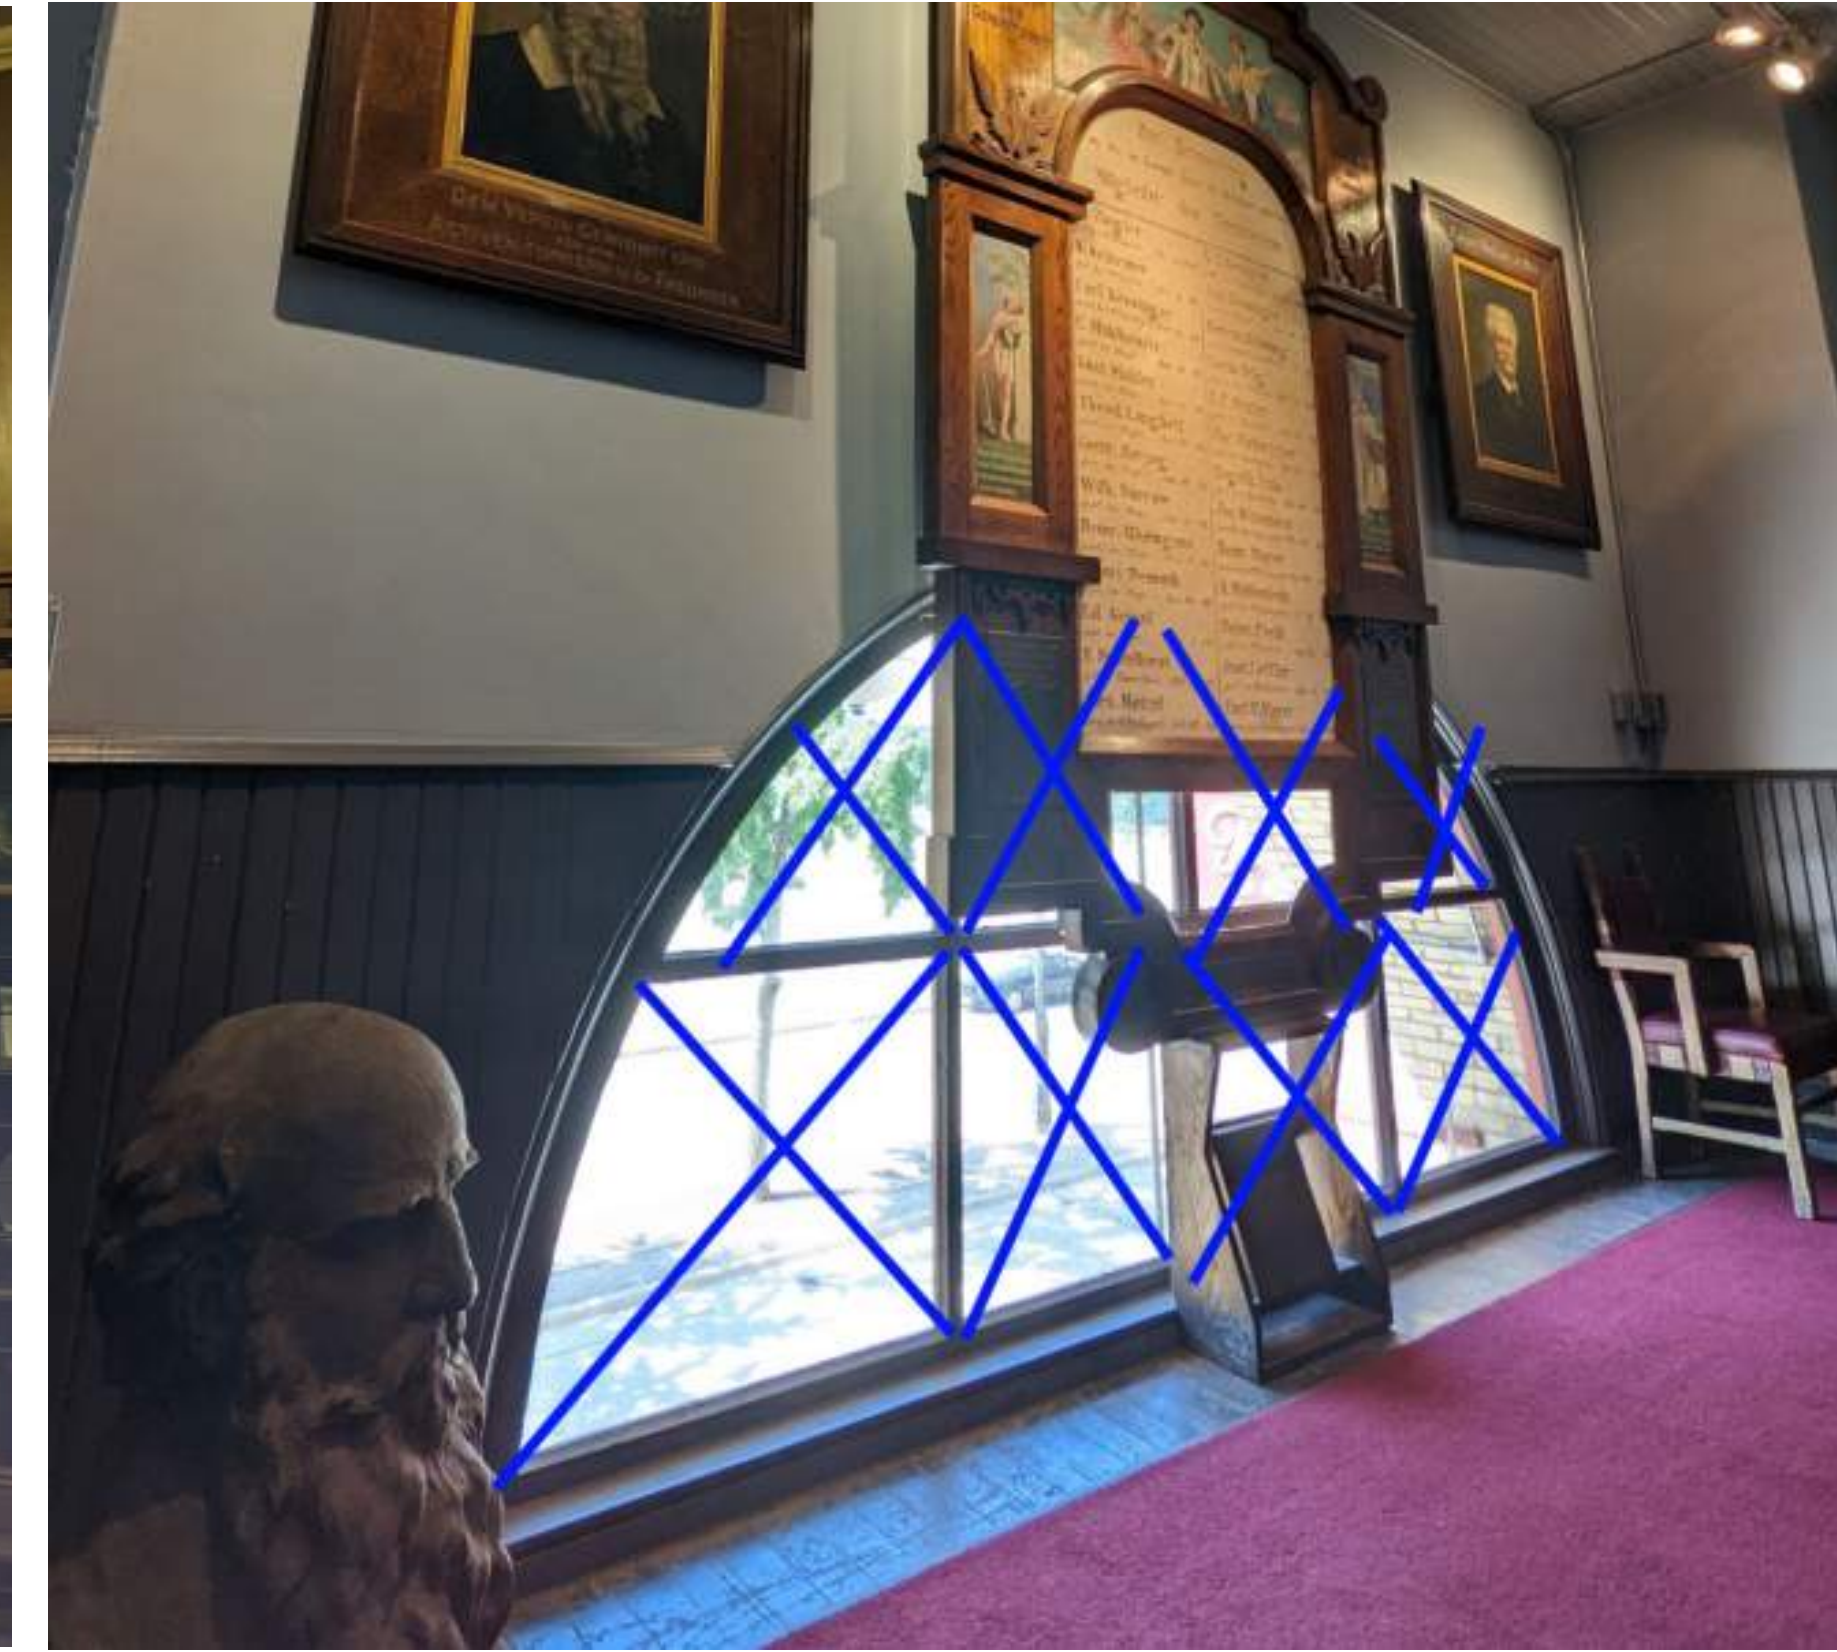
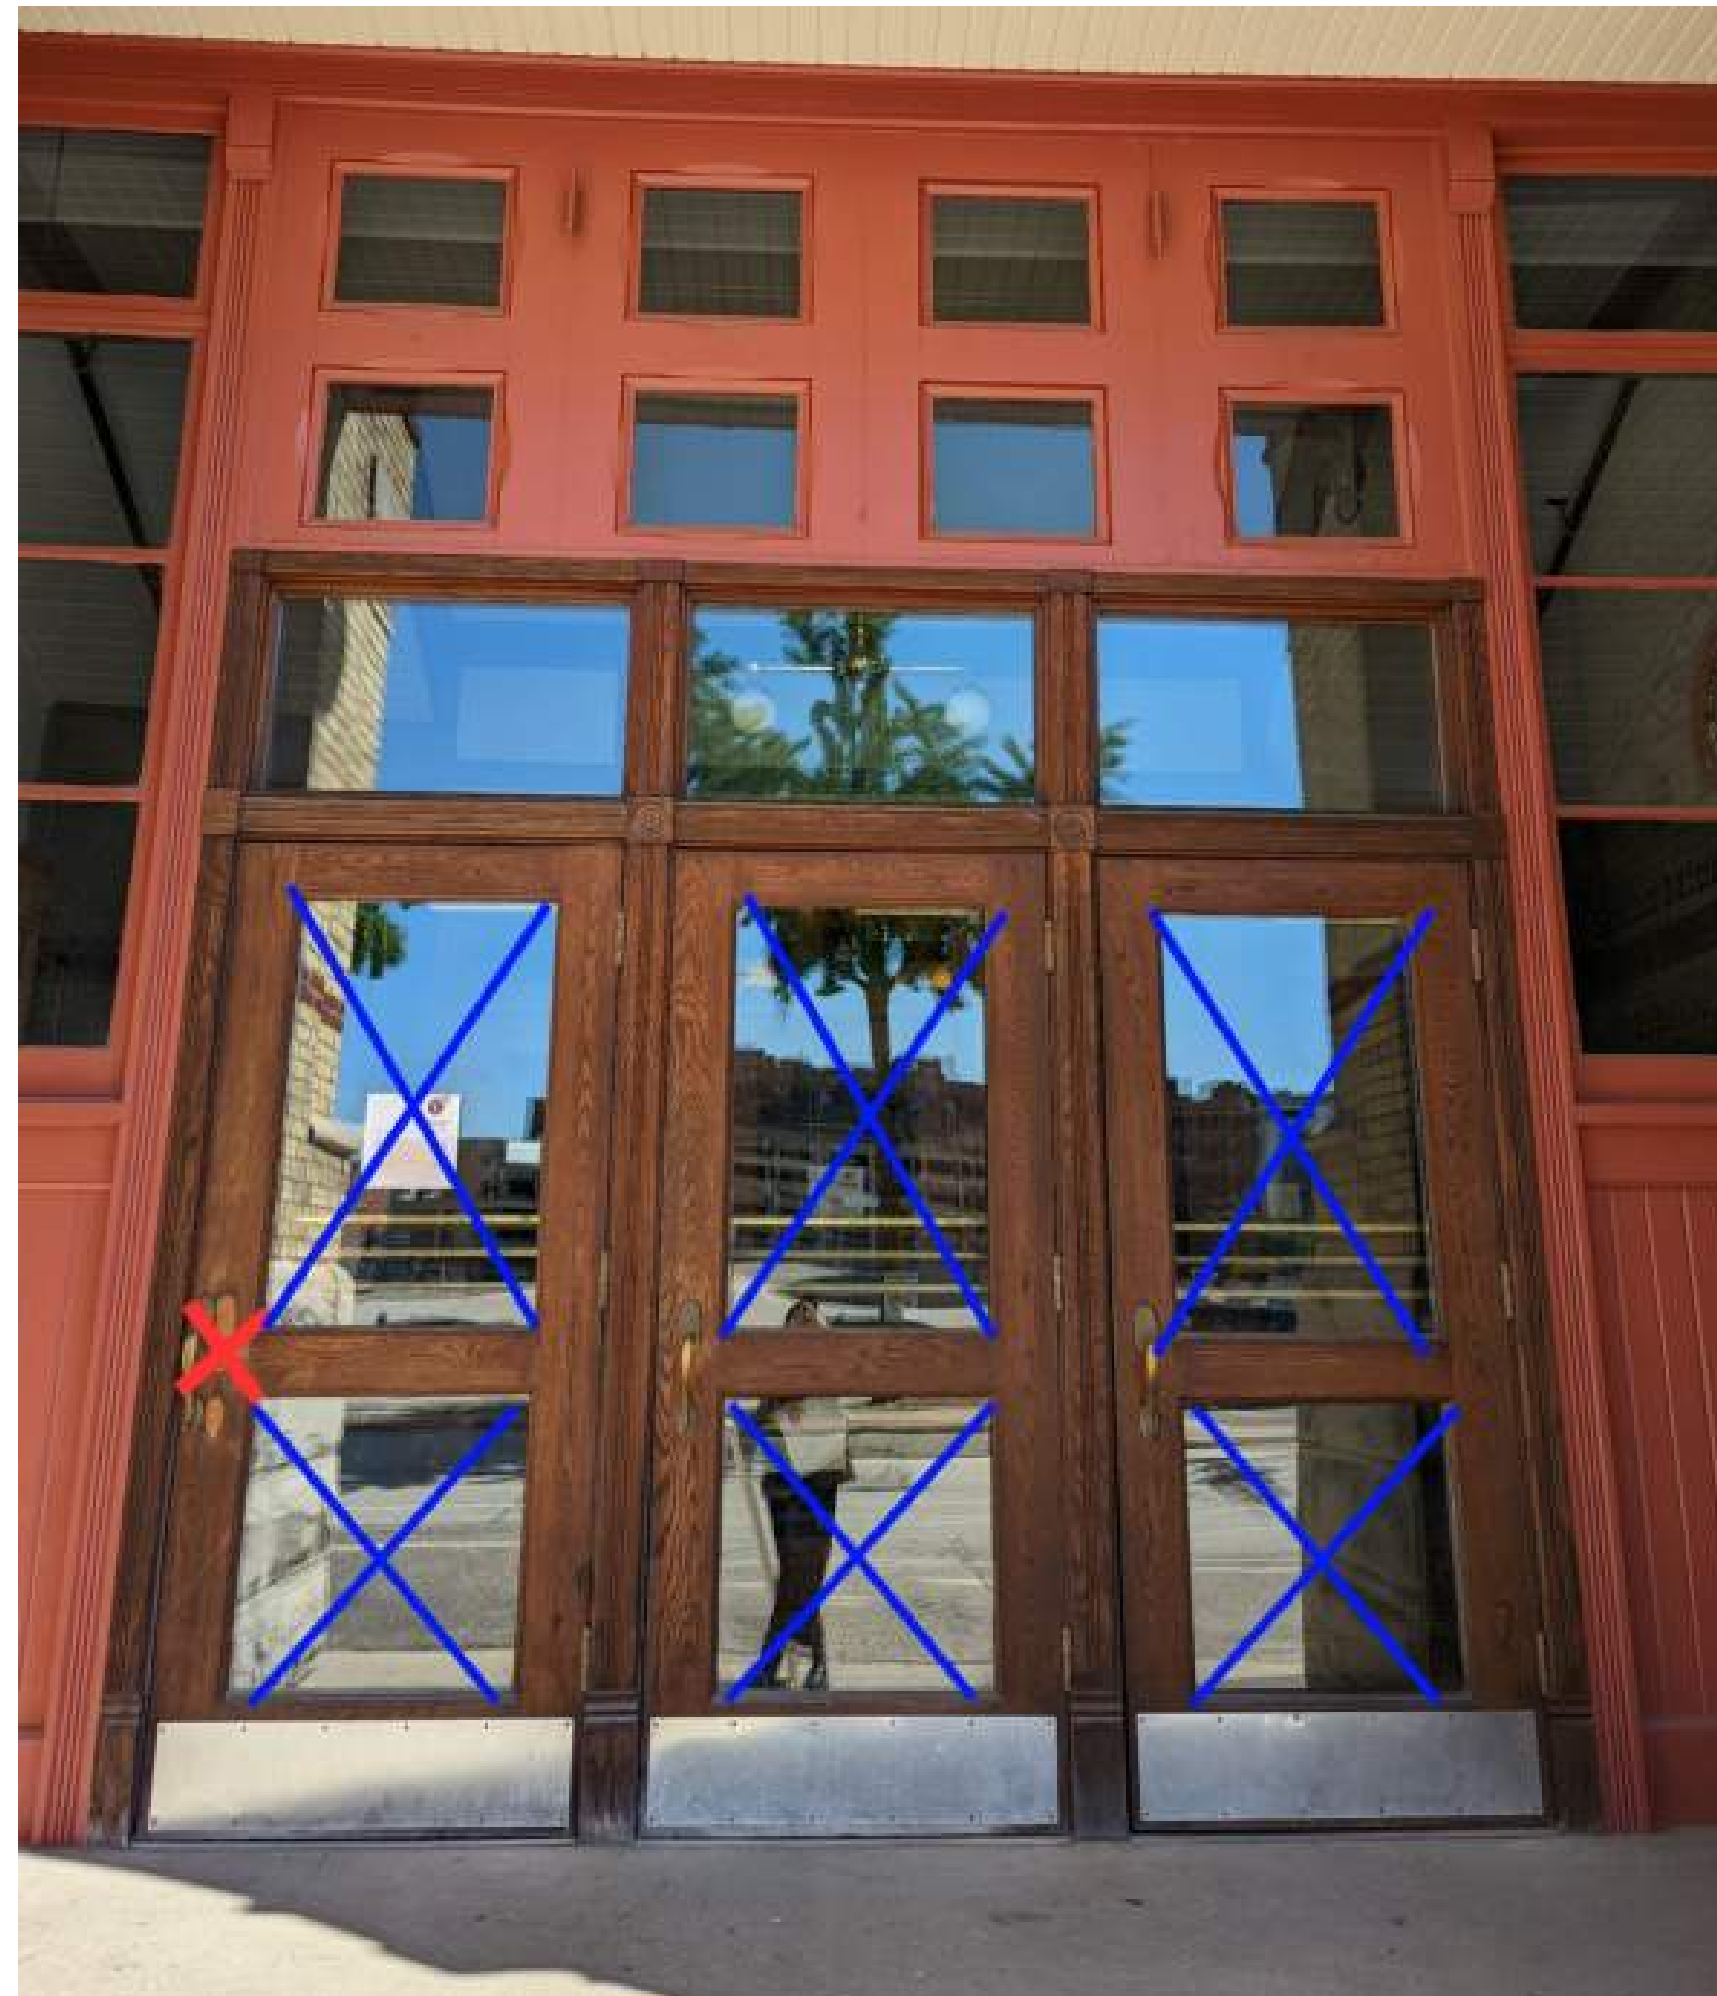
See Elevation Drawings for location of windows and doors that are to receive the Safety and Security Film.

Film will be applied directly to the interior surface of the existing glazing. The film is .008" (or 8 mil) thick, and will have a clear appearance.
