Certificate of Appropriateness

Property	322 E. Michigan St.	East Side Commercial District
Description of work	Applicant proposed to generally rehab the southern and eastern facades of the building. This includes the renovation of select façade and cornice elements with limited street-scaping.	
Date issued	7/10/2019	PTS ID 114780 COA: general rehab

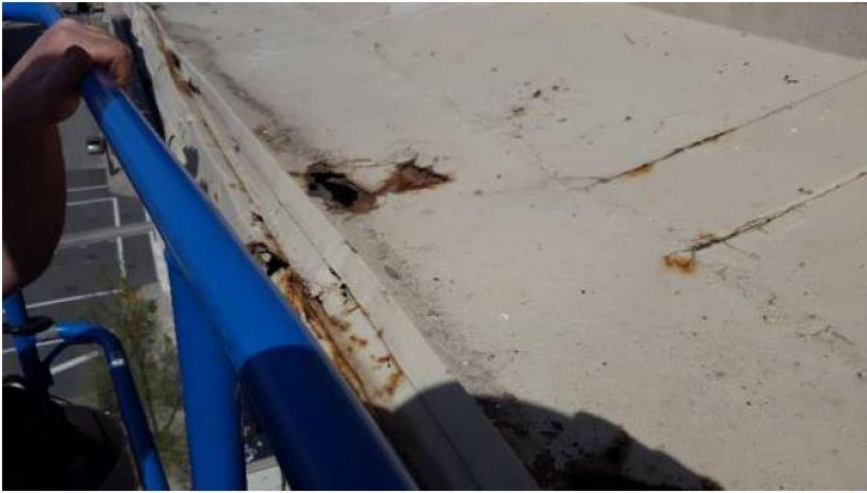
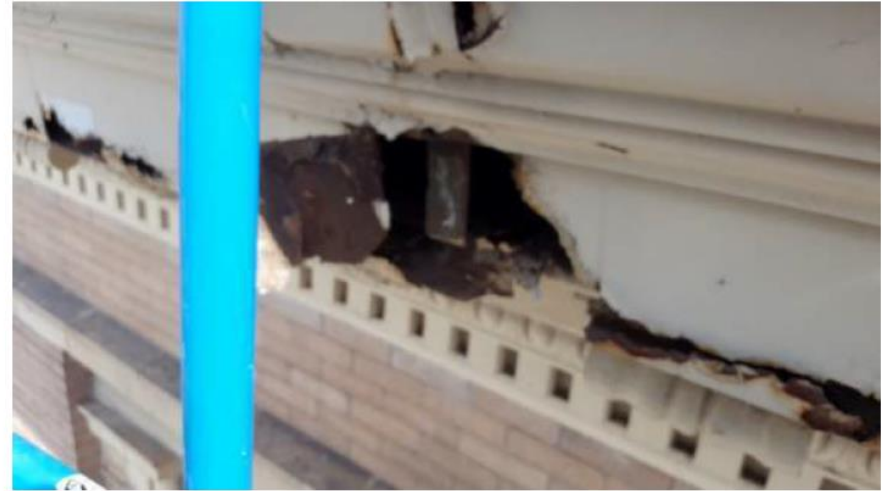
Photos 5, 6 – Corroded formed, painted metal cornice trim. South elevation, western-end.

Photos 11-14 – Sidewalk level window frame, sills, typical condition. South elevation views.

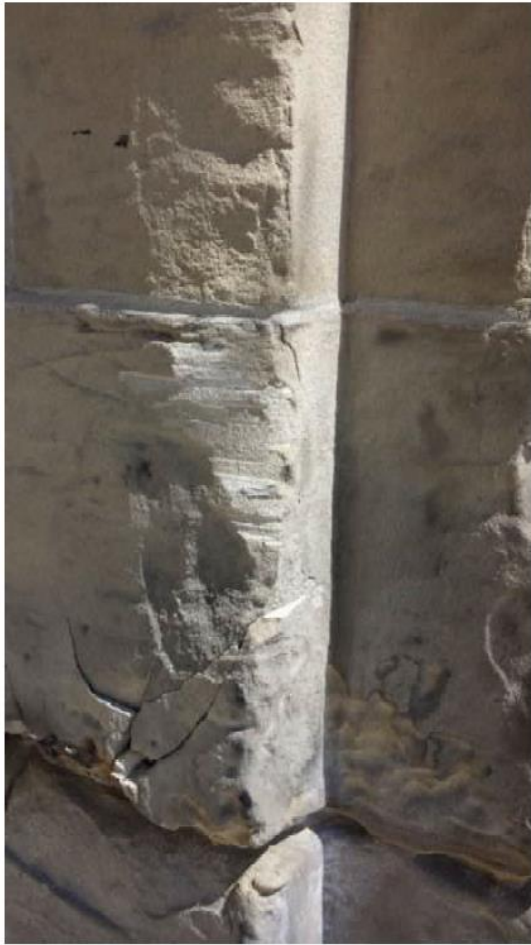
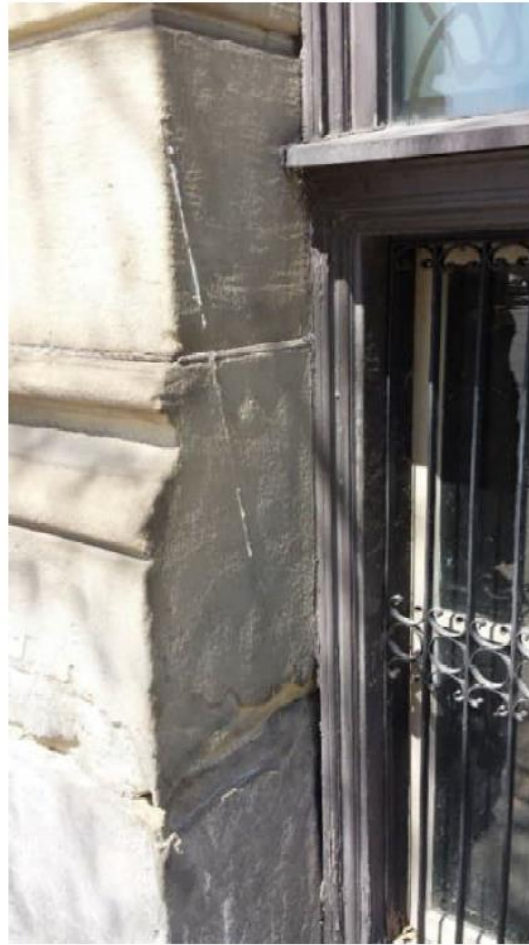
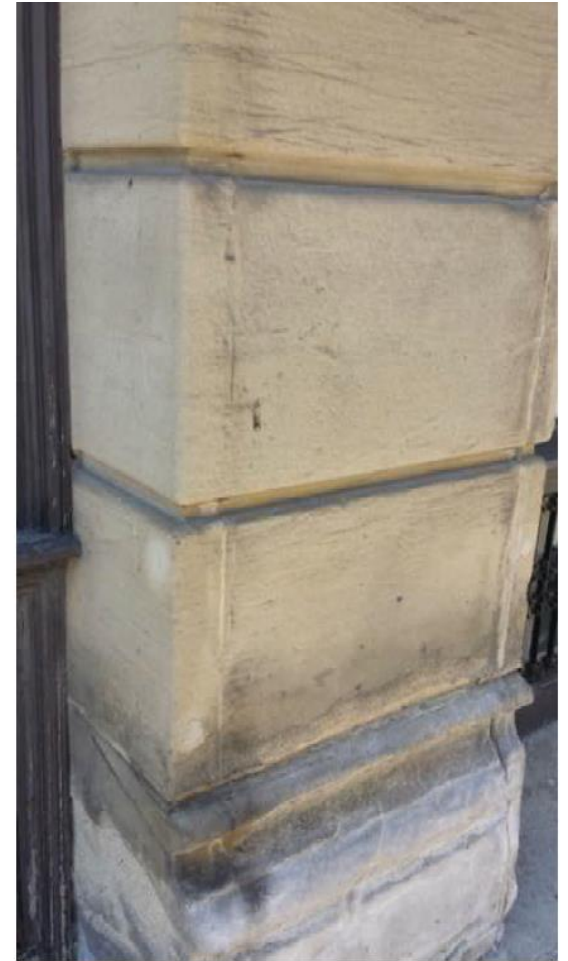
Photos 17-19 – Typical conditions of Cleveland sandstone corners, pilaster base.

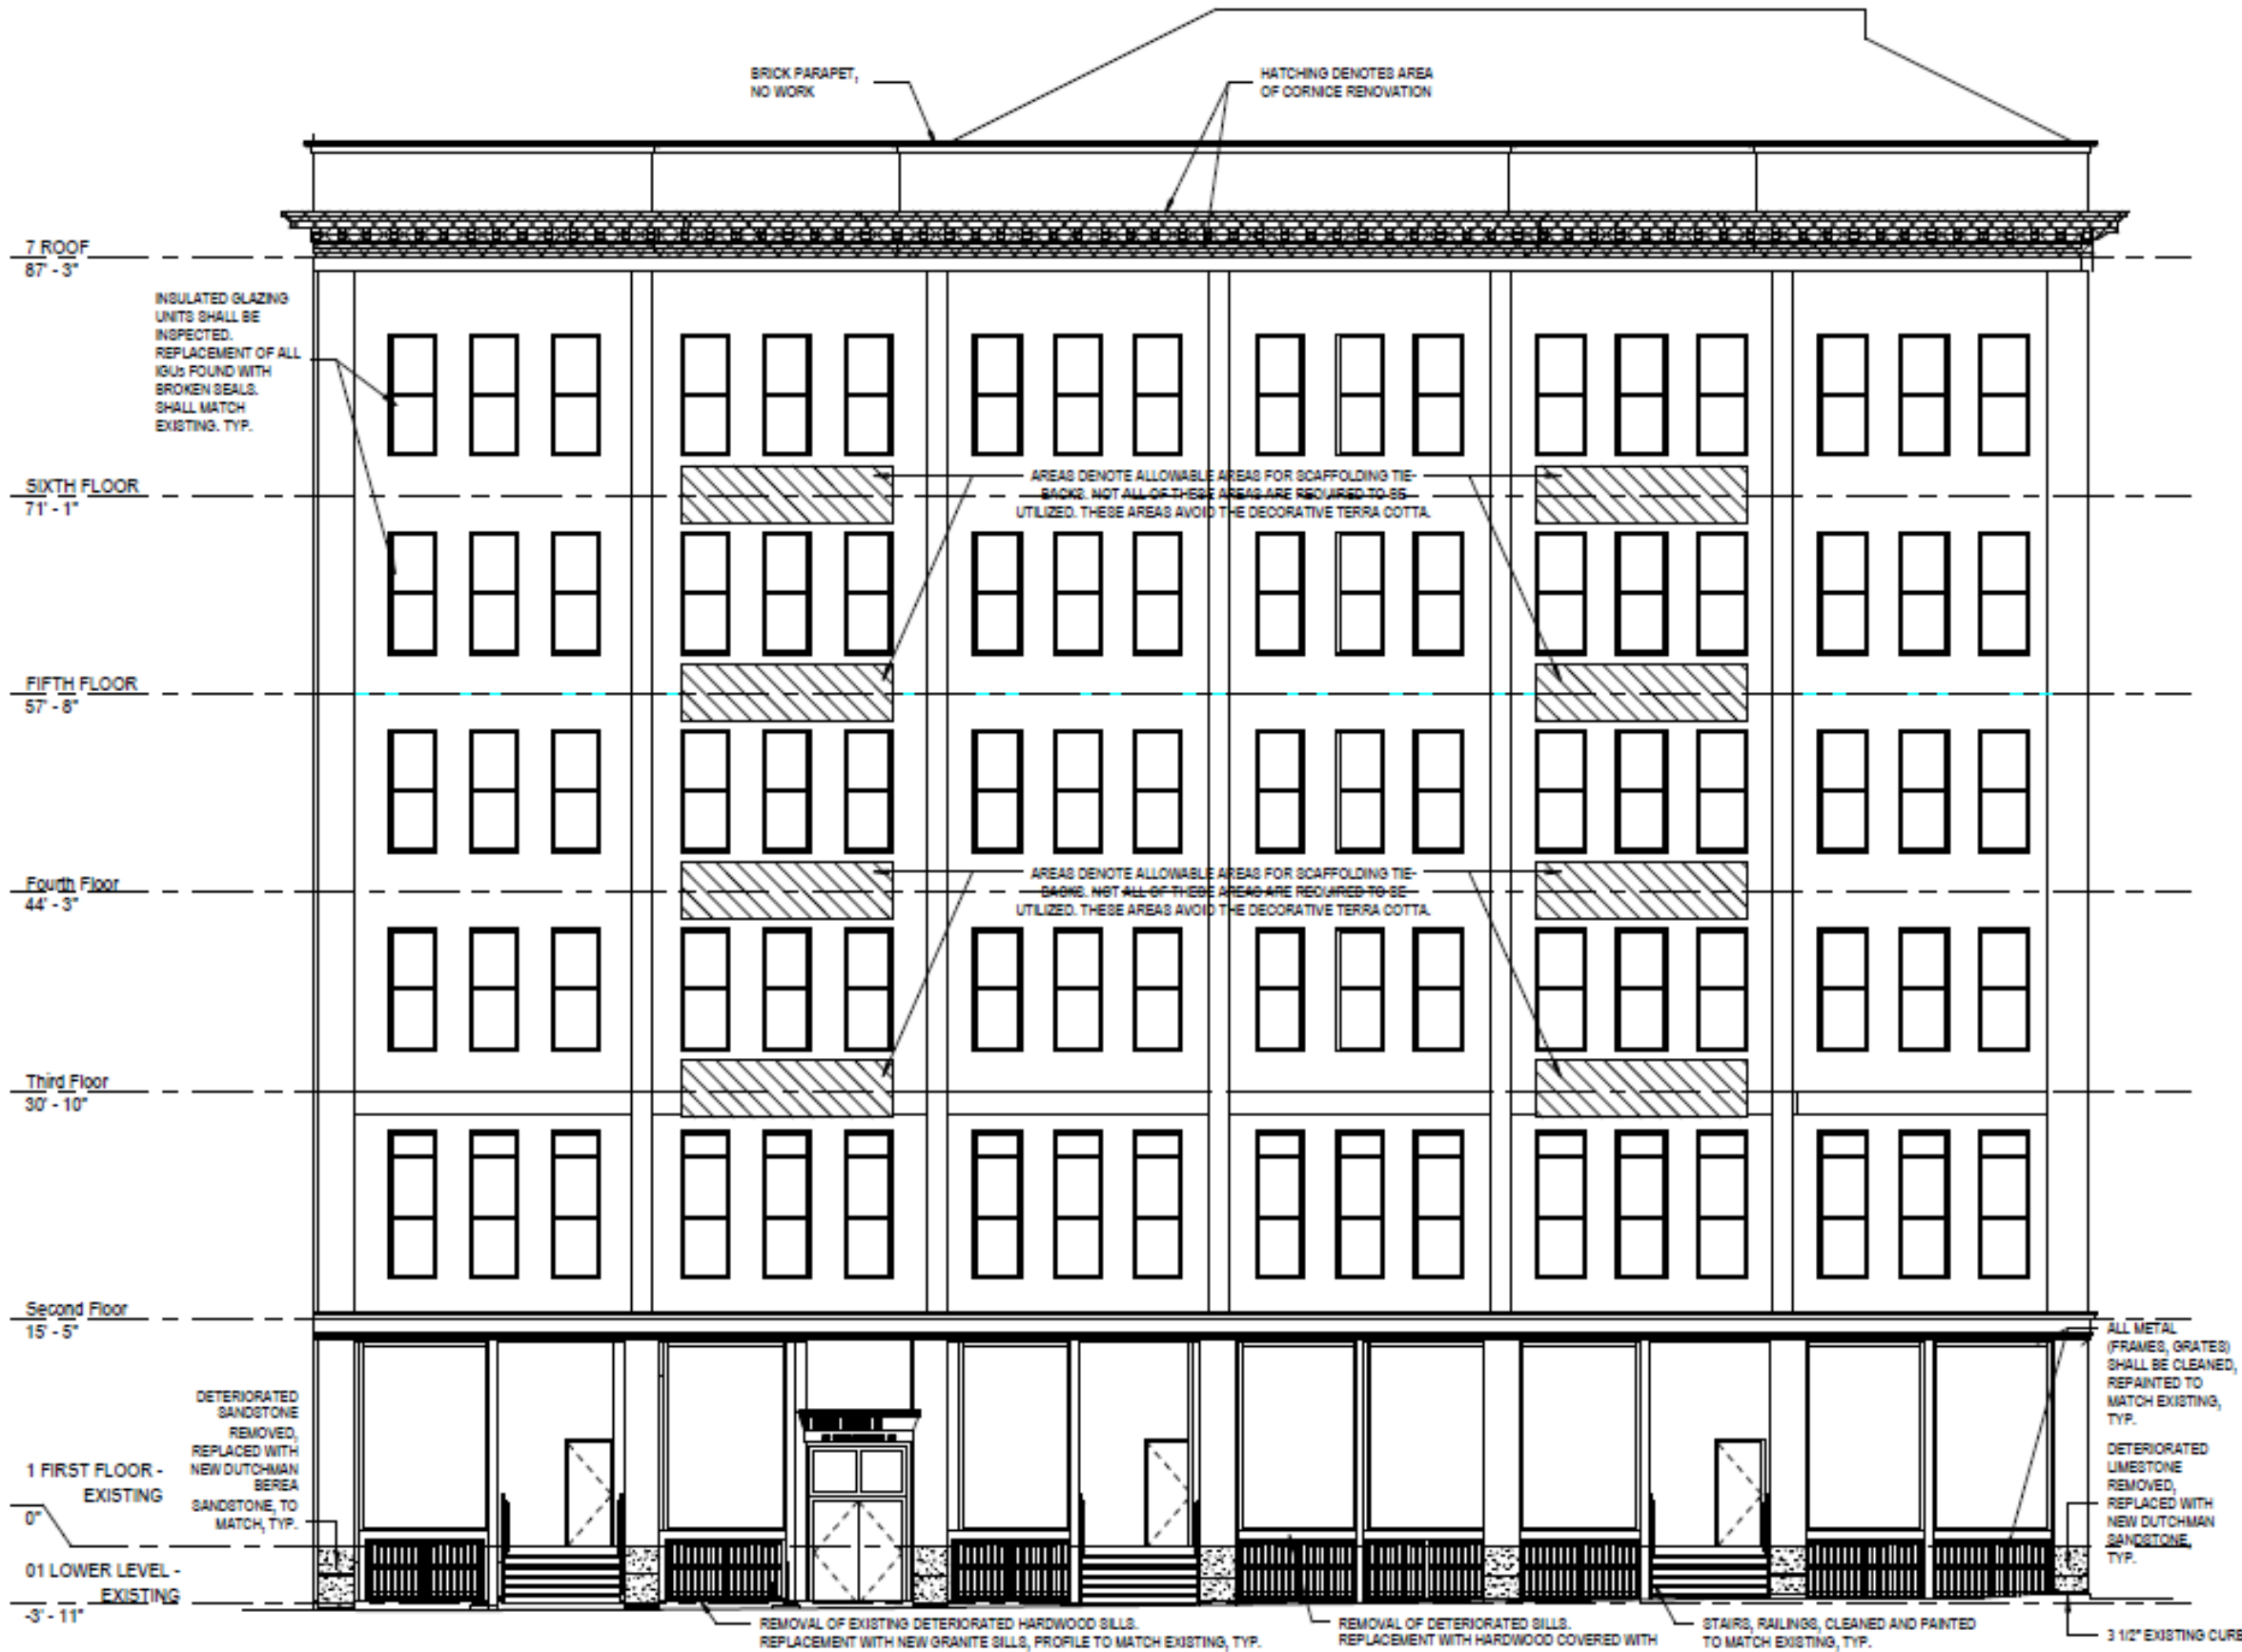
1 SOUTH EXTERIOR ELEVATION
A201 SCALE: 1/8" = 1'-0"

INSULATED GLAZING UNITS SHALL BE INSPECTED. REPLACEMENT OF ALL IGUS FOUND WITH BROKEN SEALS SHALL MATCH EXISTING, TYP.

AREAS DENOTE ALLOWABLE AREAS FOR SCAFFOLDING TIE-BACKS. NOT ALL OF THESE AREAS ARE REQUIRED TO BE UTILIZED. THESE AREAS AVOID THE DECORATIVE TERRA COTTA.

DETERIORATED SANDSTONE REMOVED, REPLACED WITH NEW DUTCHMAN BERE SANDSTONE, TO MATCH, TYP.

ALL METAL (FRAMES, GRATES) SHALL BE CLEANED, REPAINTED TO MATCH EXISTING, TYP.

DETERIORATED LIMESTONE REMOVED, REPLACED WITH NEW DUTCHMAN SANDSTONE, TYP.

REMOVAL OF EXISTING DETERIORATED HARDWOOD SILLS. REPLACEMENT WITH NEW GRANITE SILLS, PROFILE TO MATCH EXISTING, TYP.

REMOVAL OF DETERIORATED SILLS. REPLACEMENT WITH HARDWOOD COVERED WITH FORMED SHEET METAL (LCC), PAINTED, TYP.

STAIRS, RAILINGS, CLEANED AND PAINTED TO MATCH EXISTING, TYP.
