Facilities Condition Assessment Program

Facilities Development and Management

DPW - Buildings

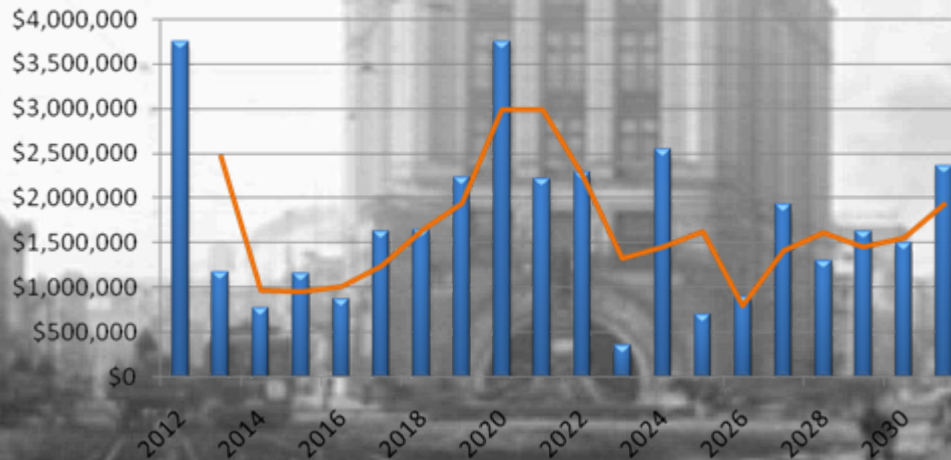
Projected Annual Expenditures Based on 2011 Analysis

DPW FCAP FCAP Summary	20 Year Total Cost	CRDM	2012	2013	2014	2015	2016	2017
Projected Capital Improvements Per Year								
Building Name								
123 Building	\$3,092,000	\$5,000	\$5,000	\$433,000	\$10,000		\$44,000	\$568,000
Education Center	\$1,577,000			\$52,000			\$80,000	\$210,000
Forestry South HQ	\$2,482,000	\$11,000	\$11,000	\$395,000			\$510,000	\$234,000
Lincoln Garage Complex	\$12,184,000	\$2,232,000	\$2,232,000	\$95,000	\$622,000	\$952,000	\$47,000	\$98,000
RA Anderson	\$5,687,000	\$1,174,000	\$1,174,000	\$149,000		\$27,000	\$76,000	\$9,000
Sanitation Central II	\$2,153,000	\$35,000	\$35,000	\$16,000			\$73,000	\$267,000
Southwest Shop	\$2,531,000	\$231,000	\$231,000	\$6,000	\$134,000	\$168,000		\$41,000
Tow Lot	\$4,930,000	\$64,000	\$64,000	\$25,000			\$40,000	\$194,000
Total 20 Year Cost	\$34,636,000	\$3,752,000	\$3,752,000	\$1,171,000	\$766,000	\$1,147,000	\$870,000	\$1,621,000
		CRV	\$27,470,134	\$28,202,543	\$28,951,648	\$29,723,132	\$30,516,084	\$31,330,600

FCI	0.13	0.04	0.01	0.04	0.02	0.03
