Certificate of Appropriateness

1114-1116 W. HISTORIC MITCHELL ST. Mitchell Street Historic District

PTS ID 111979 COA Rebuild Facade

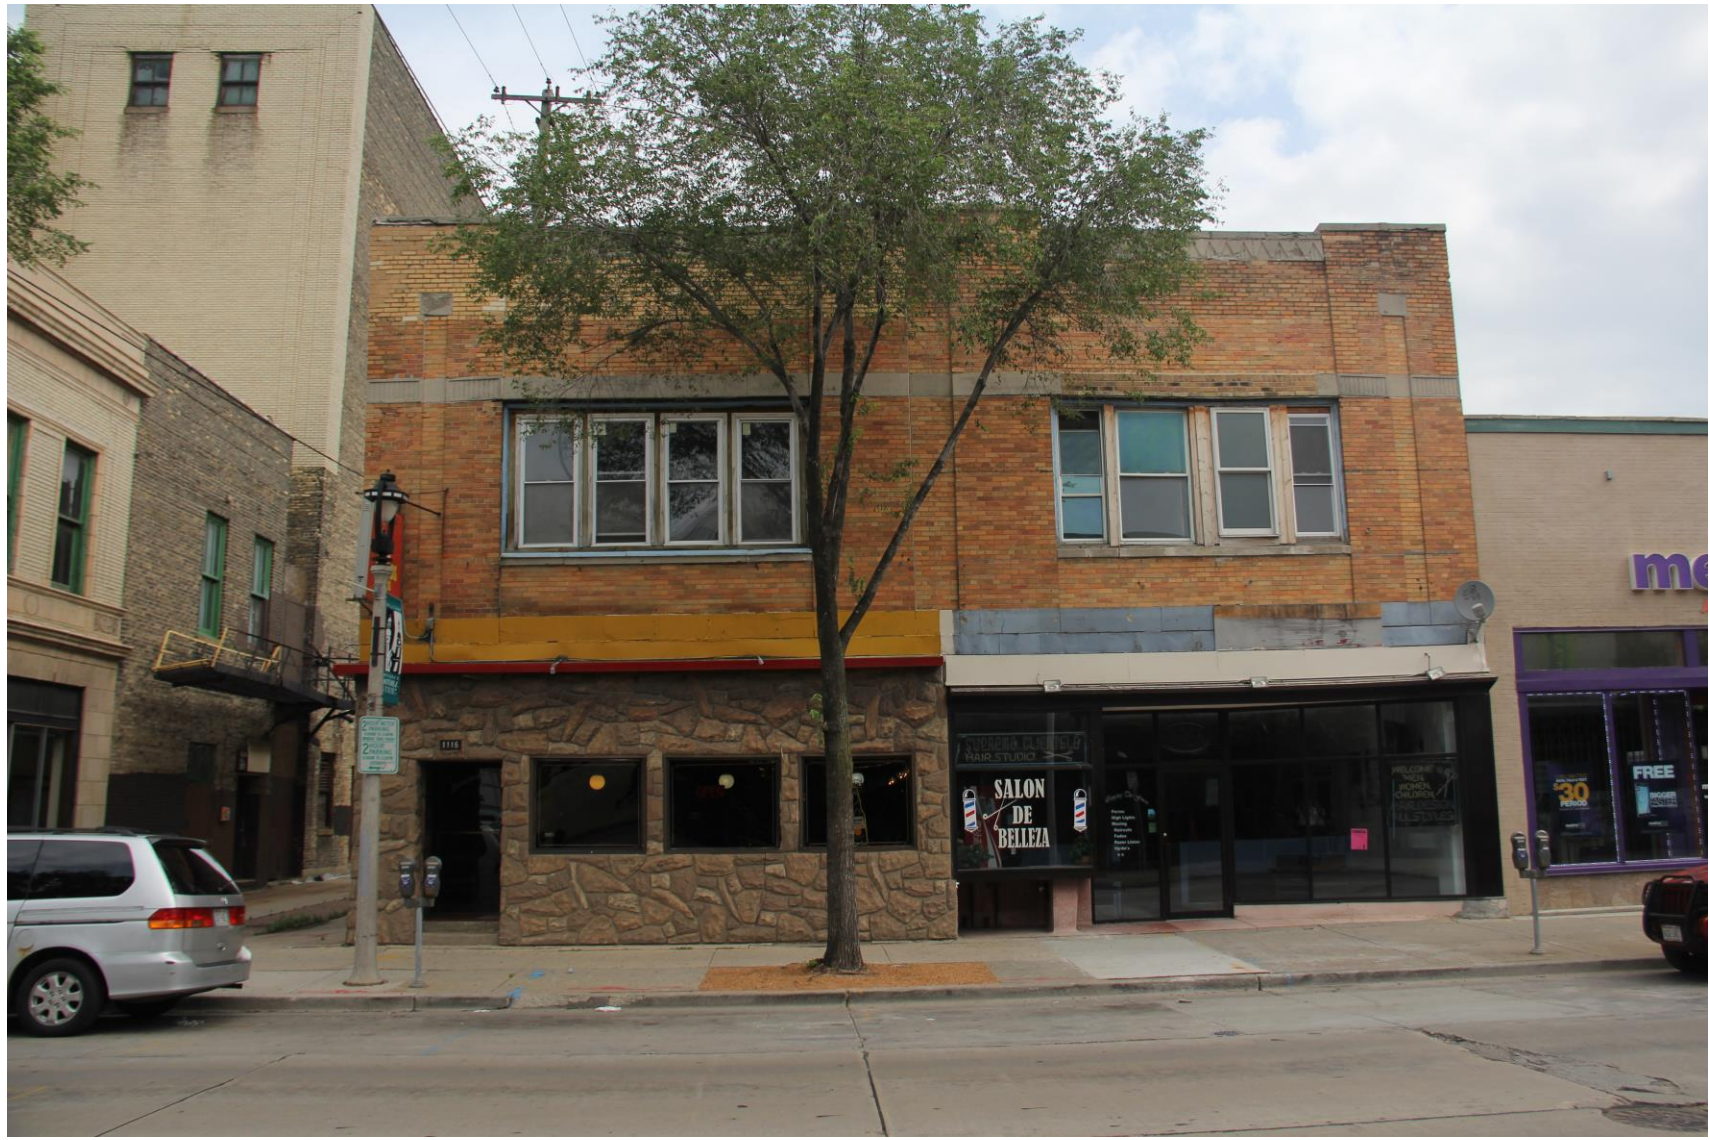
Current condition of façade 2016.

Years of remodeling and possible poor workmanship has led to the separation of the facade from the remainder of the building. The parapet is deteriorating, brick is spalling, cracks have developed through the masonry and bulges have also appeared. Cast stone trim is deteriorating.

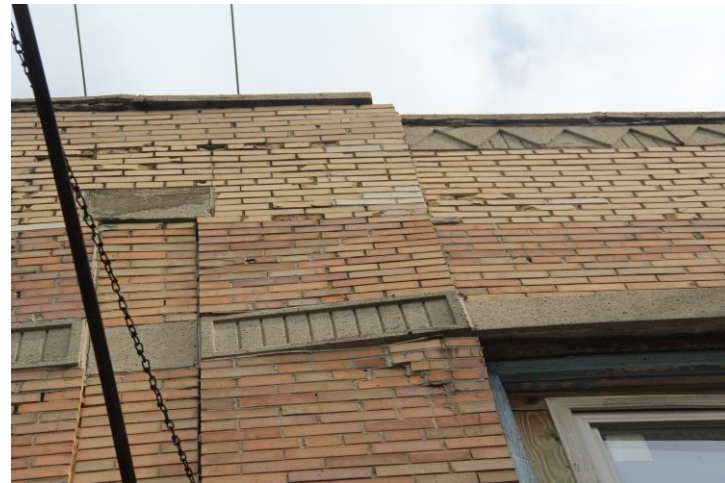
Separation of the facade is evident at left. The separation is pushing out masonry at front.

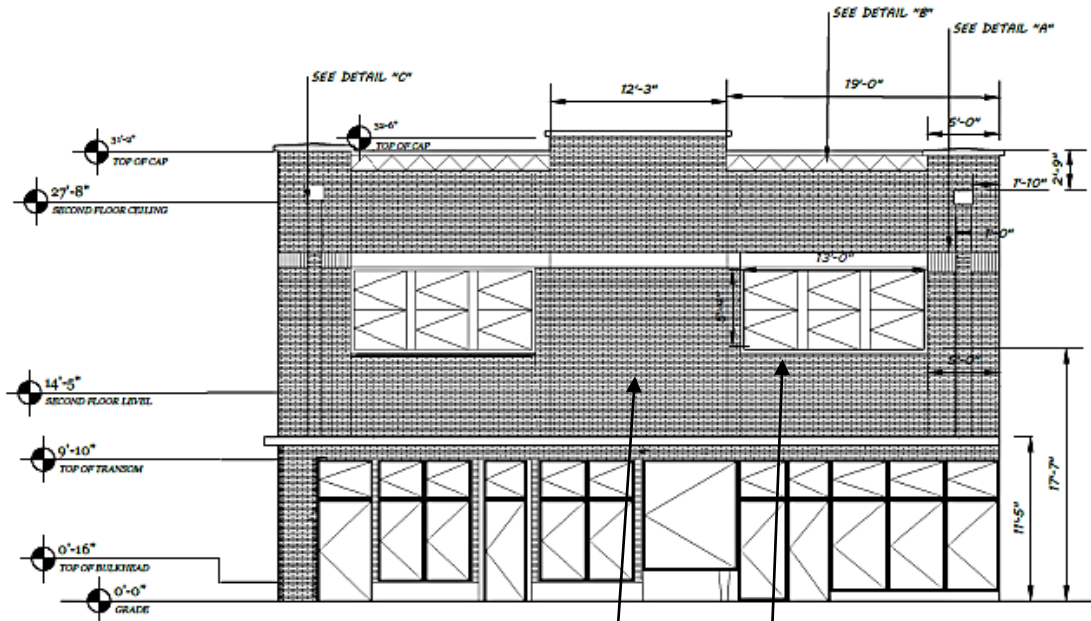
7 SOUTH FACADE
AS 1/4" = 1'-0"

Proposed façade. Note: there will be four windows on second story and not three. Center vertical channel will be added to match current façade.

The proposed project will completely remove the front facade from the building and rebuild it with closely matching brick and detail to match the original. The original trim cannot be reused due to deterioration so new cast stone will be used. A new storefront will be installed in No. 1116 and resemble the salon's front next door at No. 1114 which will not be replaced. Upper windows on the second story will be replaced.
