Facilities Condition Assessment Program

Parking Operations - Parking Structures Update

June 2012

FACILITIES
CONDITION
ASSESSMENT
PROGRAM

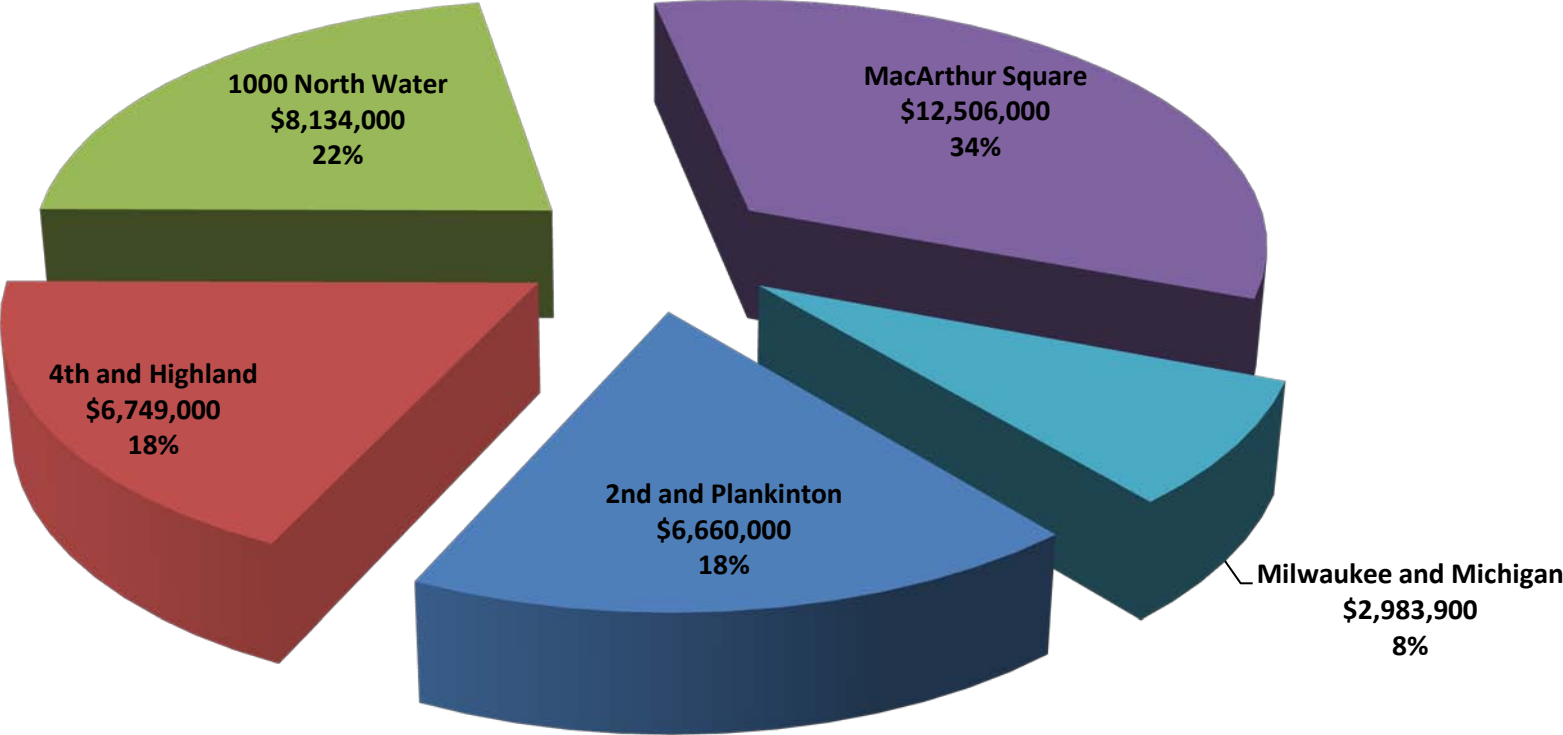
Parking Garages 20 Years Capital Expenditures

FCAP includes three overview graphs. The pie chart compares the capital improvement project costs at each parking garage over the 20-year span. The first bar graph depicts the annual capital expenditures at all parking garages. The second bar chart indicates the annual capital expenditures at each parking garage.

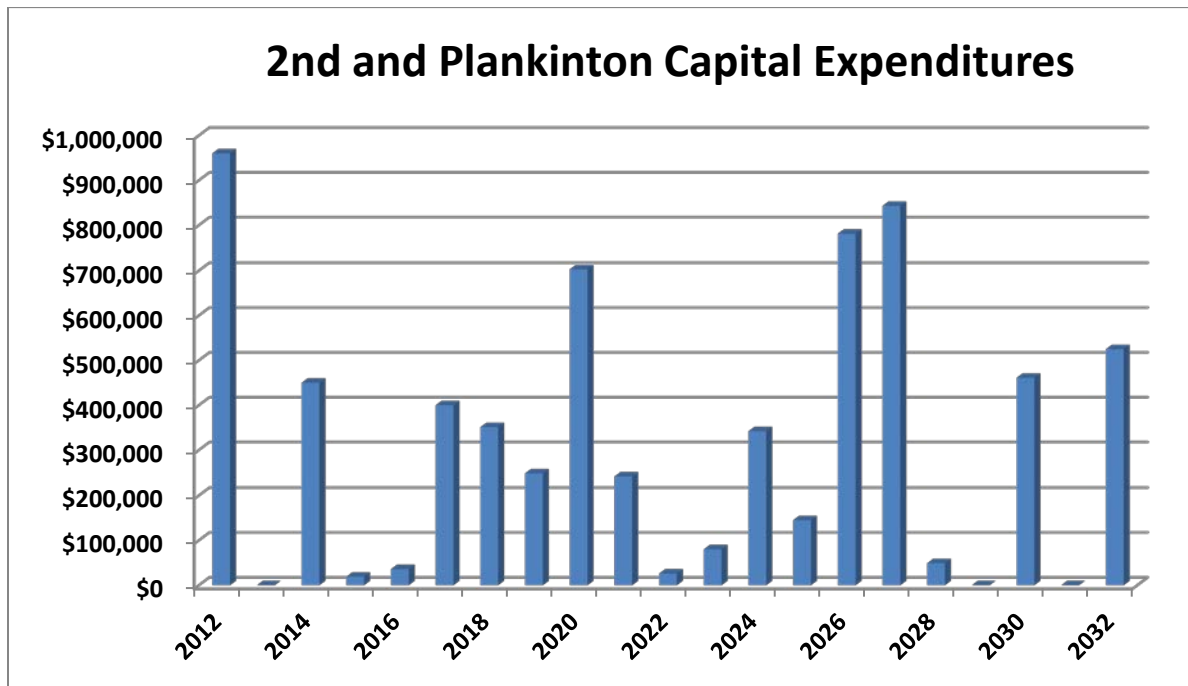
Projected capital expenditures for the 2nd and Plankinton vary from year– to –year as indicated from the graph below.

Priority	Year	Near Term Projects
High	1	Structural – Concrete Surface Repairs, Epoxy Overlay, Expansion Joints, Membrane Application, Pavement Markings Services – Elevator
	2	
Moderate	3	Structural – Paint Finish Application
	4	Structural – Façade Inspection Ordinance Examination
	5	Services – Security System
	6	Structural – Concrete and Masonry Façade Repairs, EIFS Paint and Repairs Exterior and Finishes – Roof Replacements

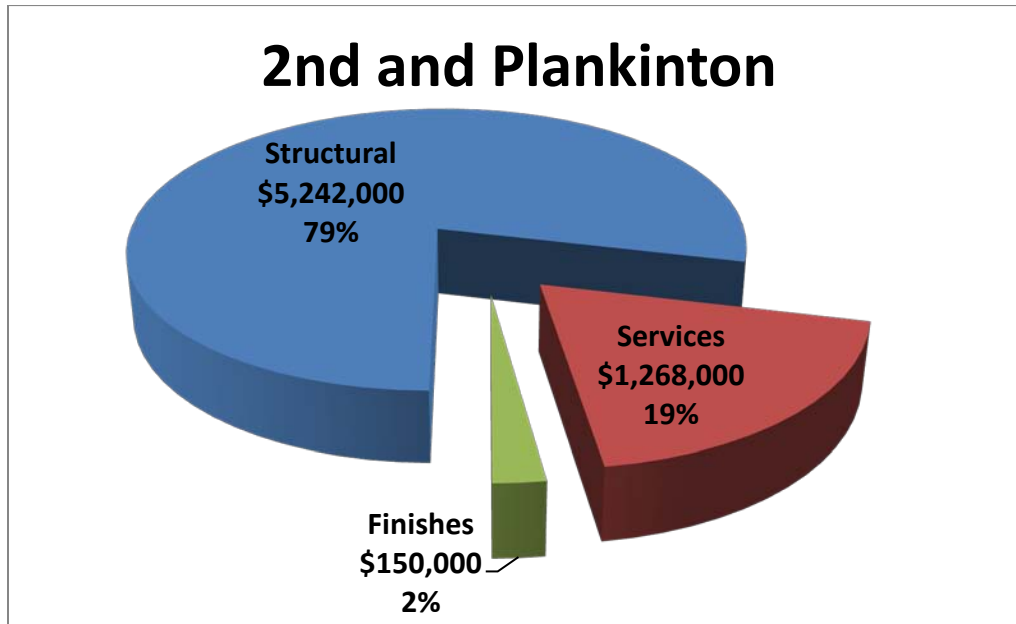
The most significant category of 2nd and Plankinton expenditures pertains to **structural** repairs as shown below.

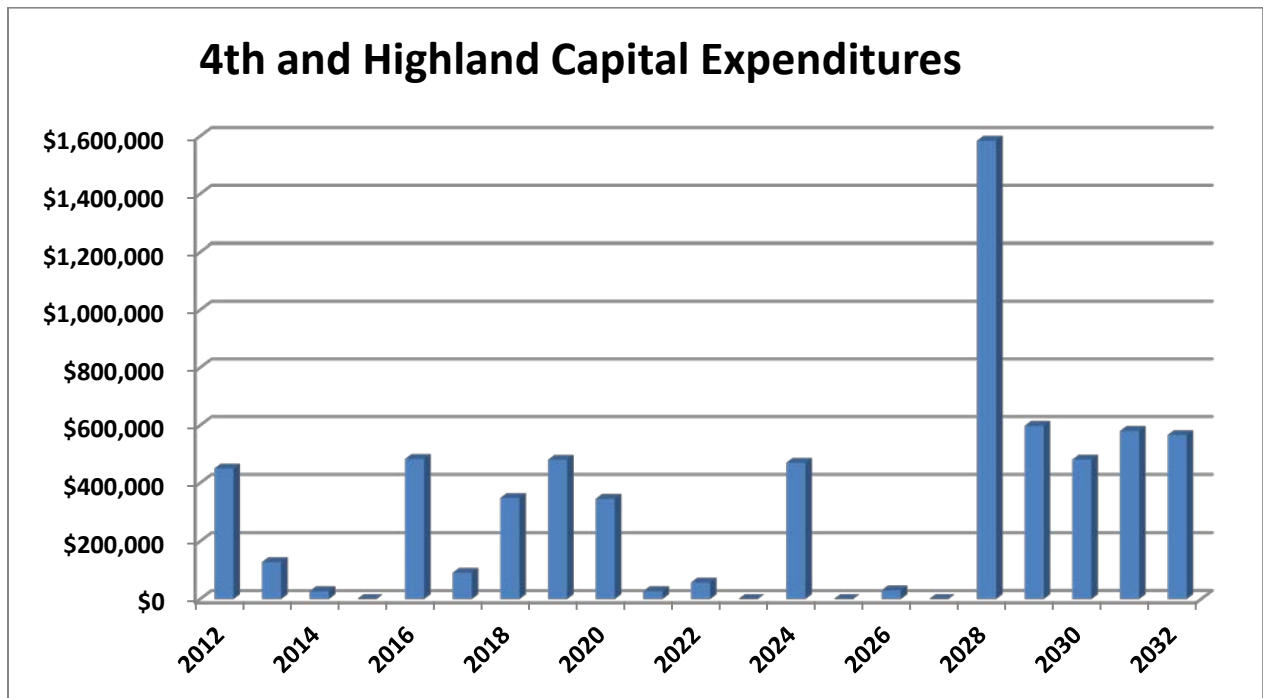
Annual expenditures for the 4th and Highland vary from year- to -year as indicated from the graph below.

Priority	Year	Near Term Projects
High	1	Structural – Concrete Surface Repairs, Water Repellant Sealer Application, Joint Sealant (Caulk)
	2	Commercial – HVAC Replacement
Moderate	3	Services – Emergency Back Up Batteries
	4	
	5	Structural – Paint Finishes, Concrete Repairs, Expansion Joints
	6	Commercial – Life Safety System, Roof Replacement

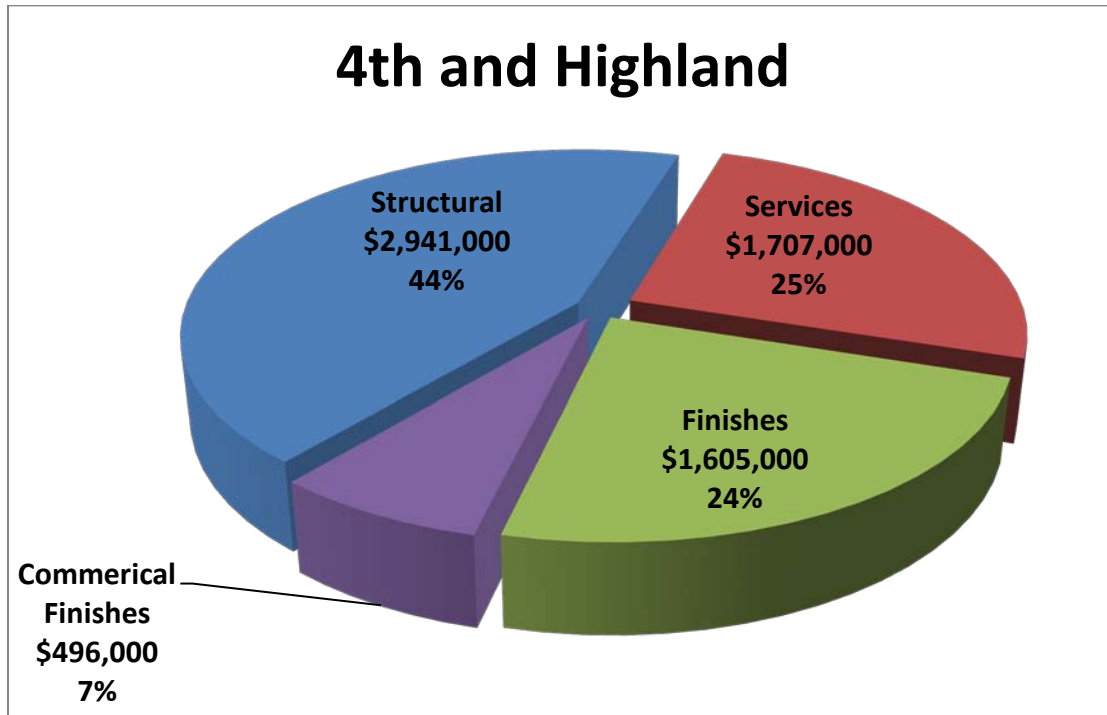
The most significant category of 4th and Highland expenditures pertains to **structural** repairs as shown below.

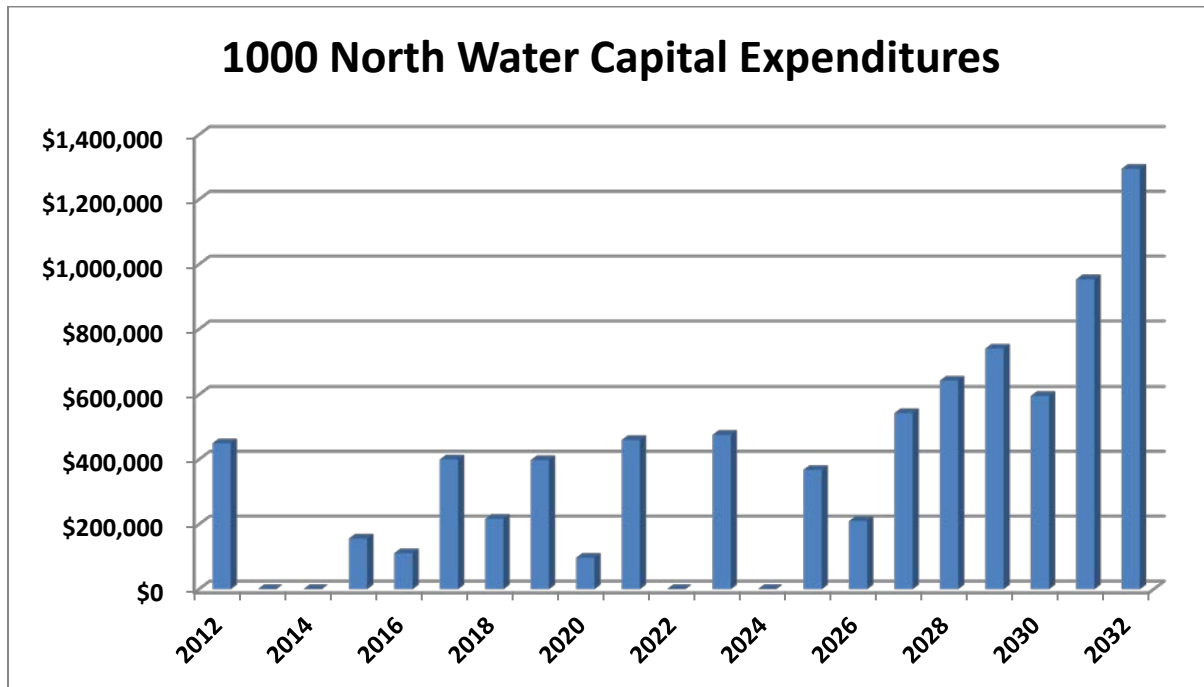
Annual expenditures for the 1000 North Water vary from year– to –year as indicated from the graph below.

Priority	Year	Near Term Projects
High	1	Structural – Expansion Joints, Paint Finish Application
	2	Commercial – HVAC Replacement
Moderate	3	Services – Security System
	4	Structural – Façade Examination Services – Carbon Monoxide System Upgrades
	5	Structural – Sealer Applications, Expansion Joints, Pavement Markings
	6	Services – Life Safety System

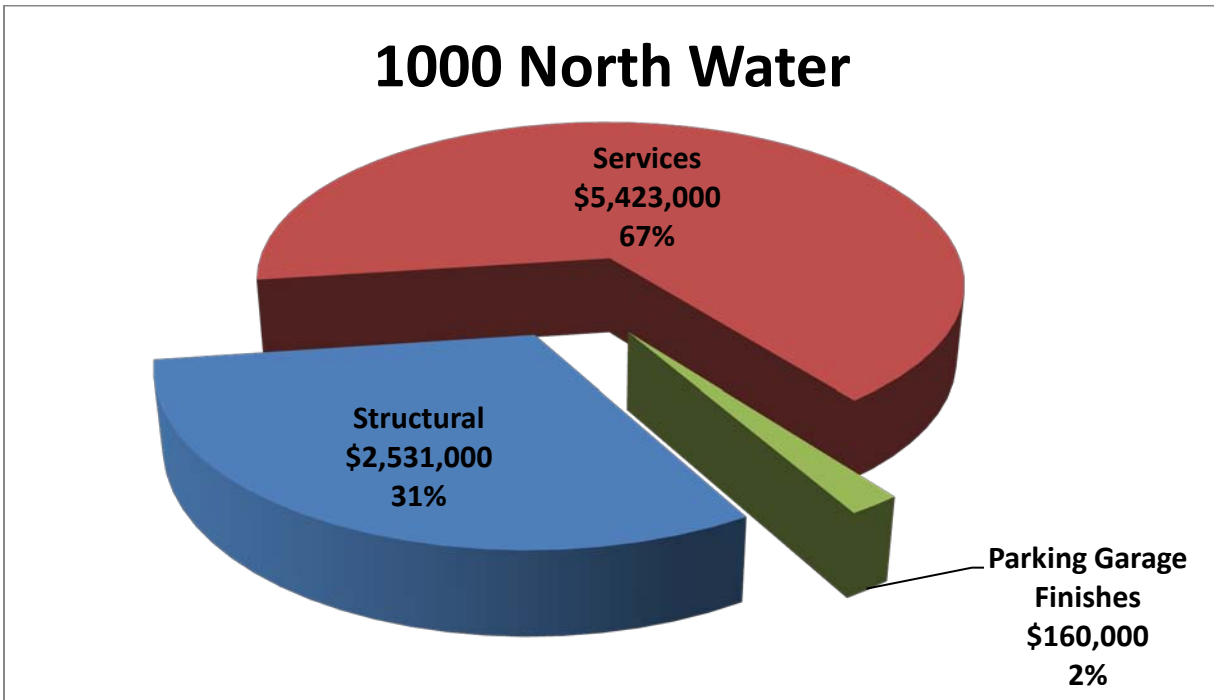
The most significant category of 1000 North Water expenditures pertain to **services components** as shown below.

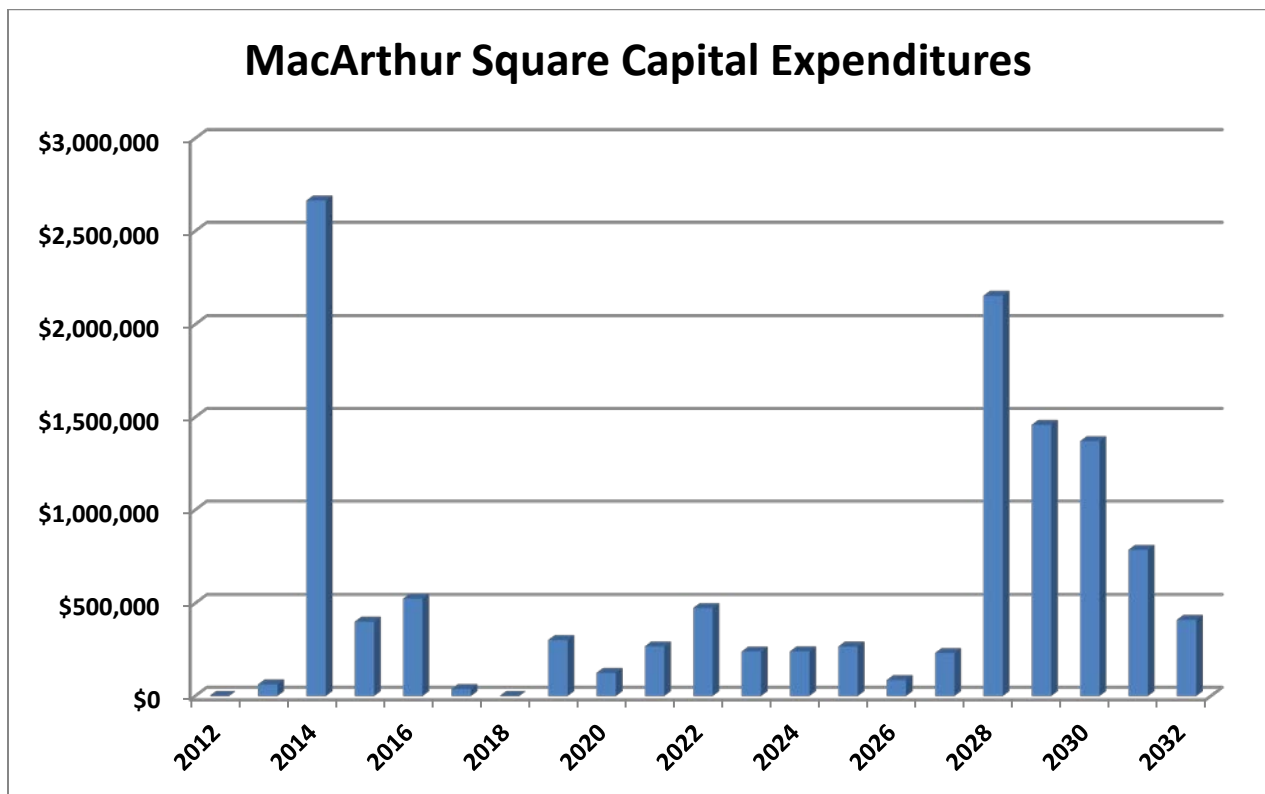
Annual expenditures for the MacArthur Square vary from year– to –year as indicated from the graph below.

Priority	Year	Near Term Projects
High	1	
	2	Services – Electrical Evaluation and Design
Moderate	3	Structural – 7 th Street Level and Ramps: Membrane Application, Concrete Repairs, Pavement Markings Services – Electrical Upgrade
	4	Structural – Lower Level: Paint Finish, Concrete Repairs, Pavement Markings 7 th Street Level: Expansion Joint Replacement
	5	Structural – 9 th Street Level: Membrane Application, Concrete Repairs, Pavement Markings, Expansion Joint Replacement
	6	Finishes – Door Replacements

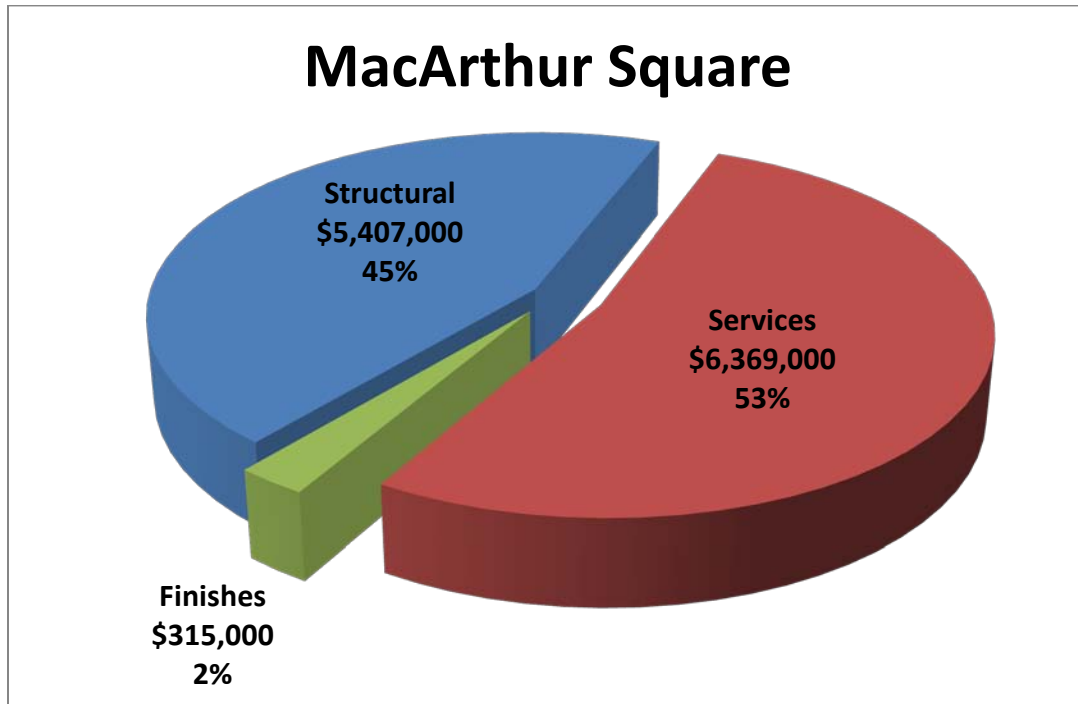
The most significant category of MacArthur Square expenditures pertains to **services**

components repairs as shown below.

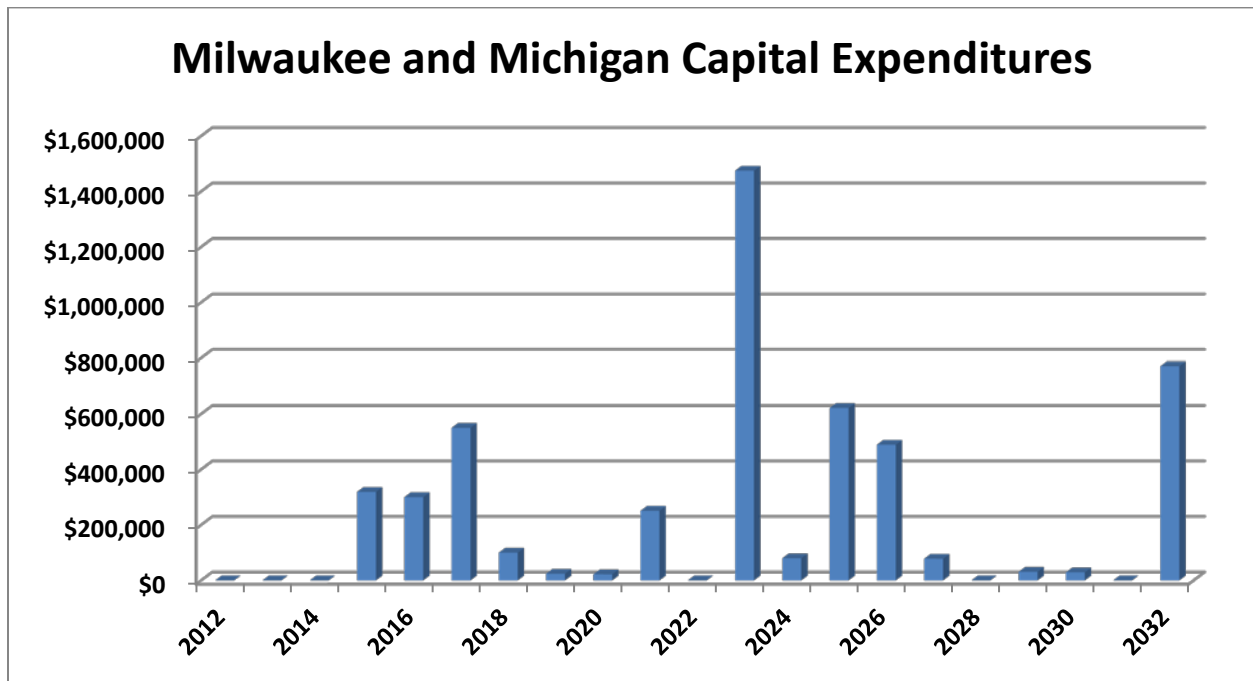
Annual expenditures for the Milwaukee and Michigan vary from year- to -year as indicated from the graph below.

Priority	Year	Near Term Projects
High	1	
	2	
Moderate	3	
	4	Structural – Paint EIFS and Concrete, Façade Examination
	5	Structural – On-Grade Concrete Repairs
	6	Structural - Membrane Application, Concrete Repairs, Pavement Markings

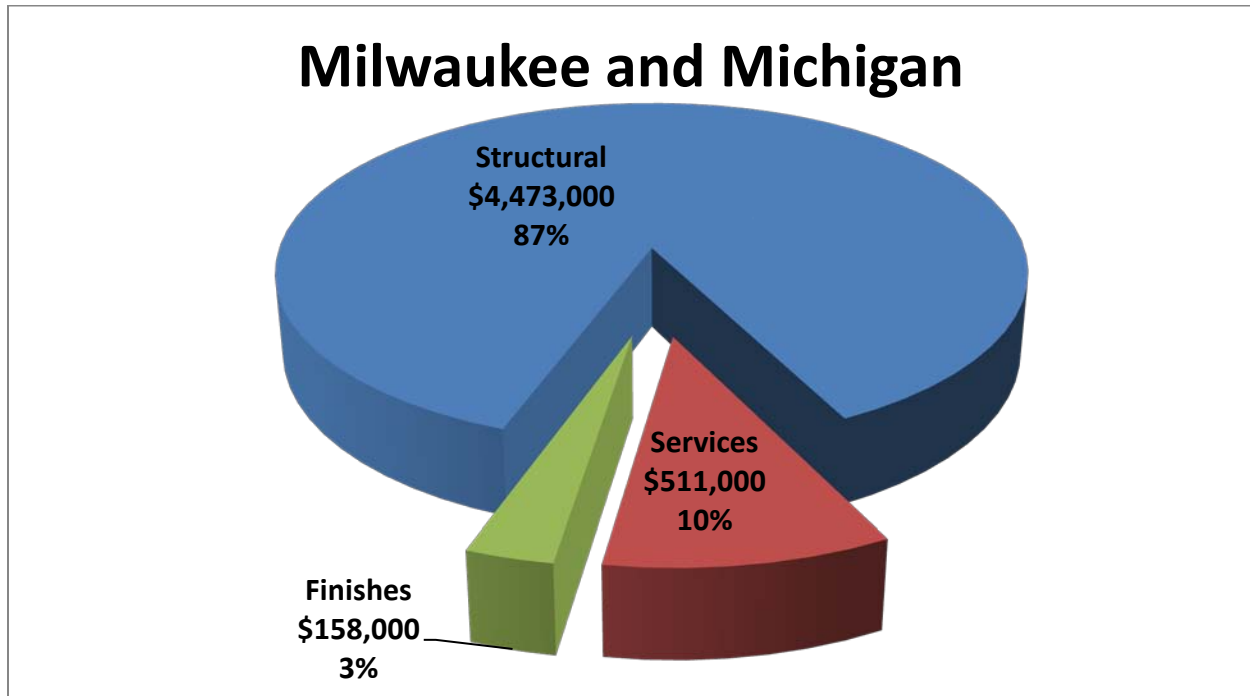
The most significant category of Milwaukee and Michigan expenditures pertains to **structural** repairs as shown below.

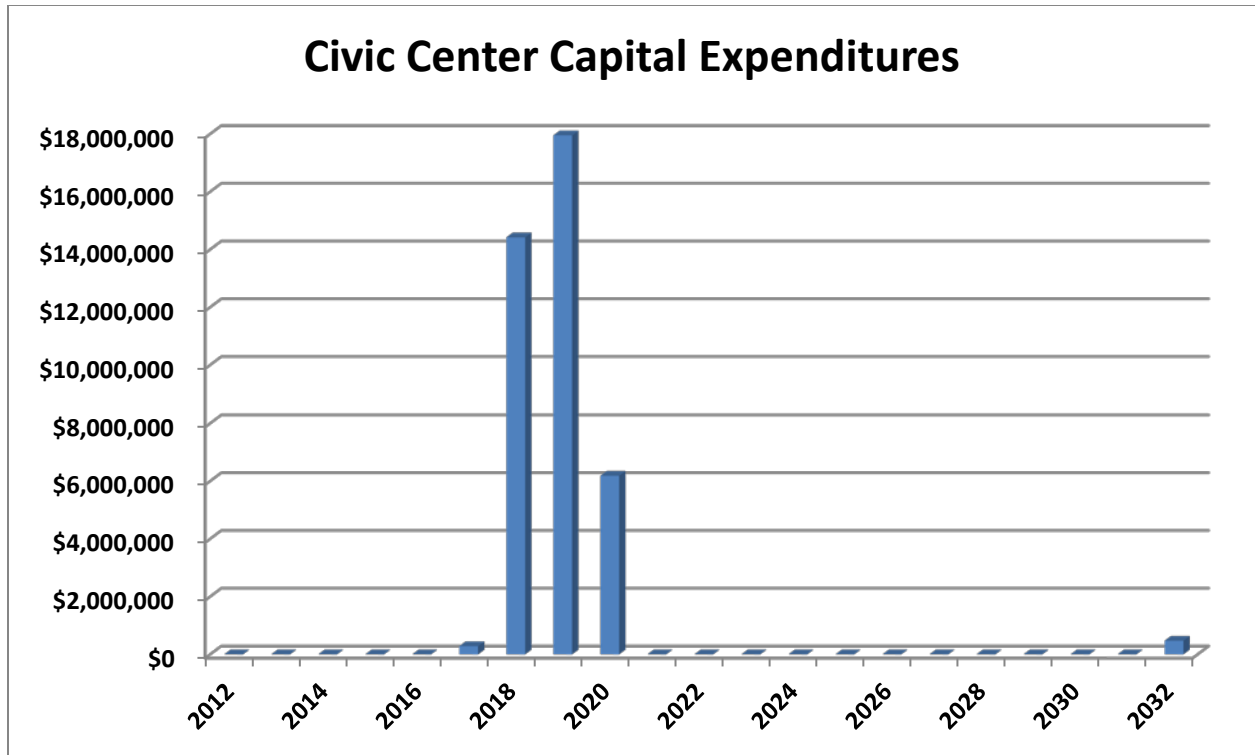
Annual expenditures for the Civic Center vary from year– to –year as indicated from the graph below.

Priority	Year	Near Term Projects
High	1	
	2	
Moderate	3	
	4	
	5	
	6	Civic Center Plaza – Roof Design

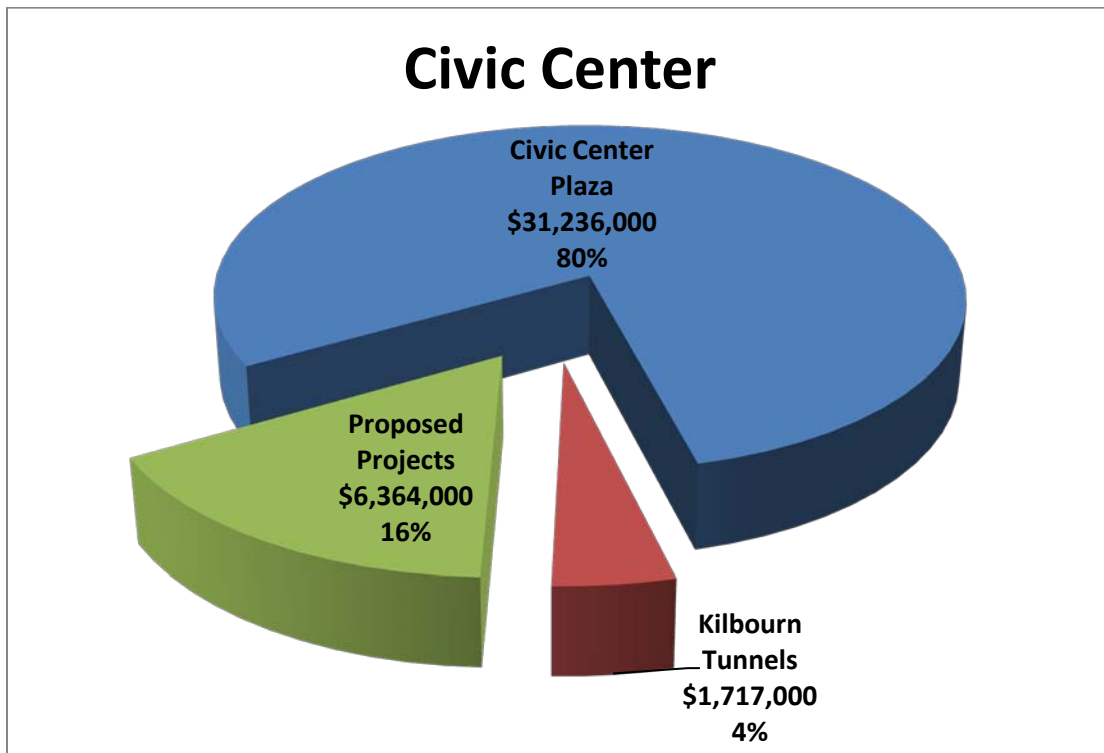
The most significant category of Civic Center expenditures pertains to **plaza** repairs as shown below.
