*Building 24/25, Pabst Brewing Company Complex
1003-1023 West Juneau Avenue, Milwaukee, Wisconsin*

extract from Narrative prepared by:

MacRostie Historic Advisors LLC

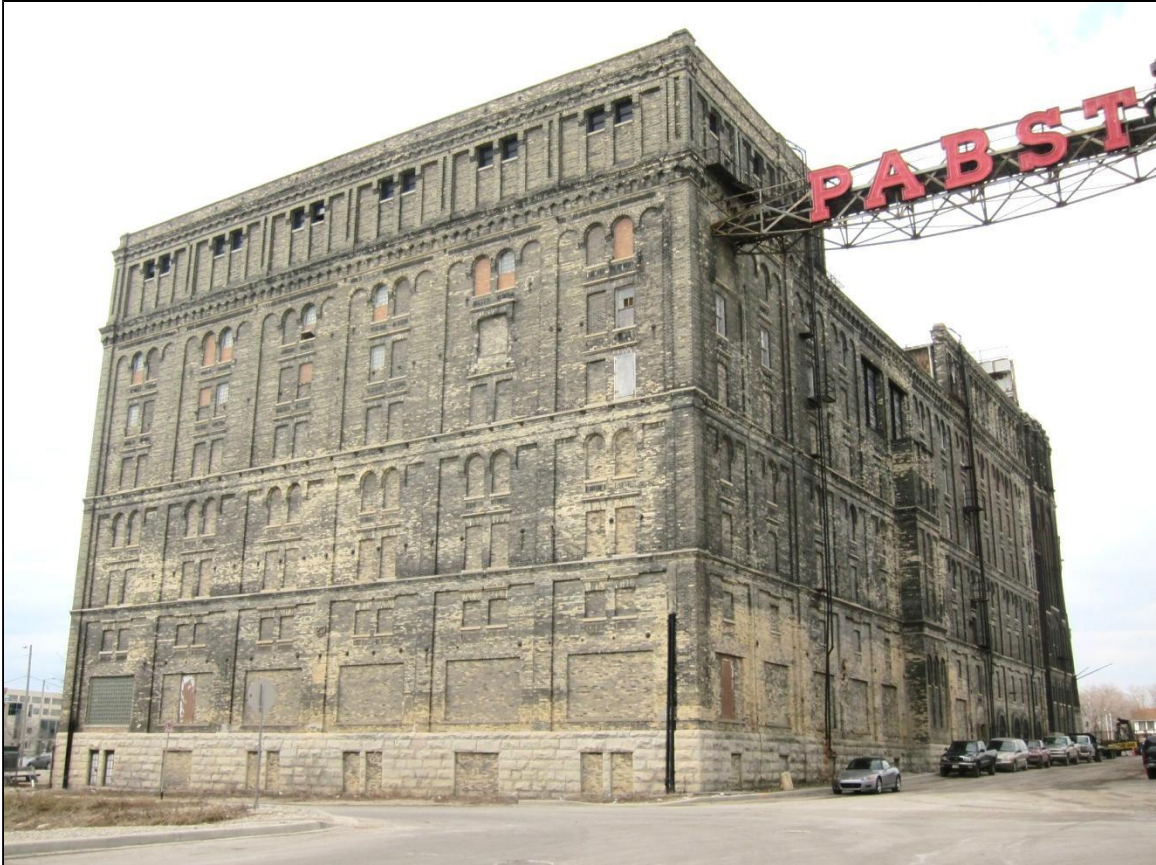
Building 24/25 is a six-to-eight-story cream brick block which rests on a rock-face, regularly coursed limestone foundation. Architecturally and historically the building is a prominent component of the Pabst Brewing Company Complex (listed on the National Register in 2003) located on a hill at the northwest edge of Milwaukee's central business district. The block is composed of Building 24 (Malt Elevator) and Building 25 (Malt House) which are similar stylistically, were physically connected historically, and were built to serve an overall function.

Building 24/25 is located at the southwest corner of West Juneau Avenue and North 10th Street in the heart of the historic brewery complex. The rectangular-shaped building is composed of two blocks – the massive east/west rectangular footprint of Building 25 at the corner of West Juneau and North 10th and the slimmer north/south footprint of Building 24 which abuts Building 25 on the west. Historically part of a densely built-up manufacturing complex, to the north of the building (across West Juneau Avenue) is Building 20/21 which, together with Building 24/25, supports the iconic “PABST” sign which spans West Juneau Avenue at the buildings' roof lines.
