## Interpreting The Secretary of the Interior's Standards for Rehabilitation

**Subject:** Completing Never-Built Portions of a Historic Building

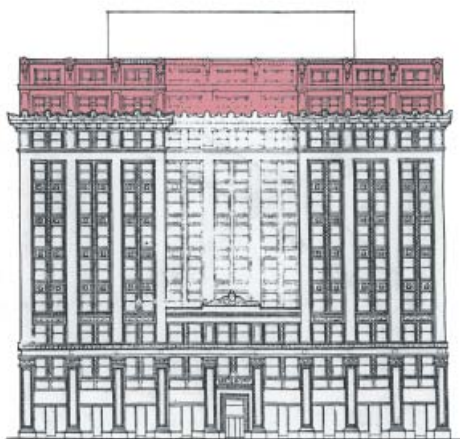
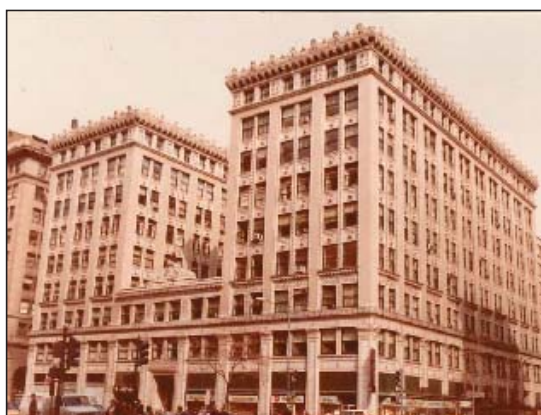
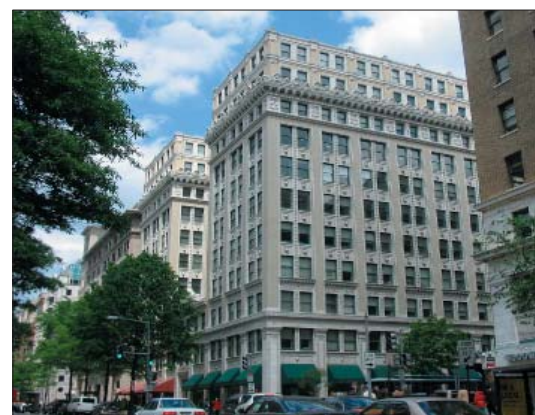
*Above is an elevation of the original design concept; the shaded areas indicate the two stories which were never built. To the right is the building as originally constructed, and to the far right, the building after the two-story addition was built.*

Extensive research into the history of the building clearly showed that the architect's original design envisioned an eleven-story building rather than the nine-story structure that was eventually built. This was documented in the historic structural drawings, original promotional material, and in the structural support for the future addition found on the roof. Such documentation, however interesting, was of little relevance since the historic character of the building was defined by what had actually been constructed, that is, a nine-story structure with a very distinctive cornice. Accordingly, constructing the proposed two-story rooftop addition, even though it followed the never-built design, was not a compatible treatment because it changed the height and proportions of the building, diminished the prominence of the cornice and, thus, negatively impacted the building's historic character. The project did not meet the Standards.

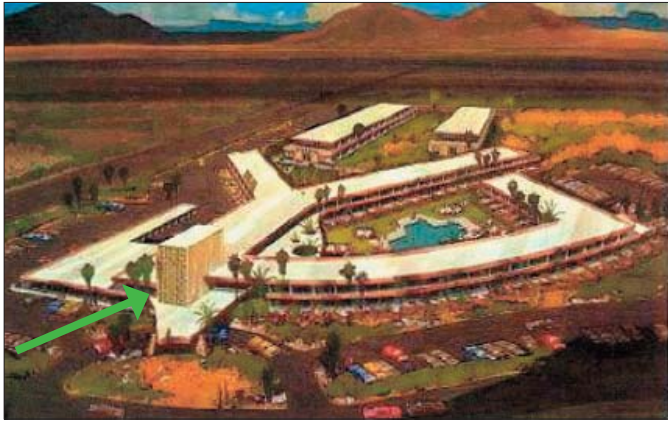
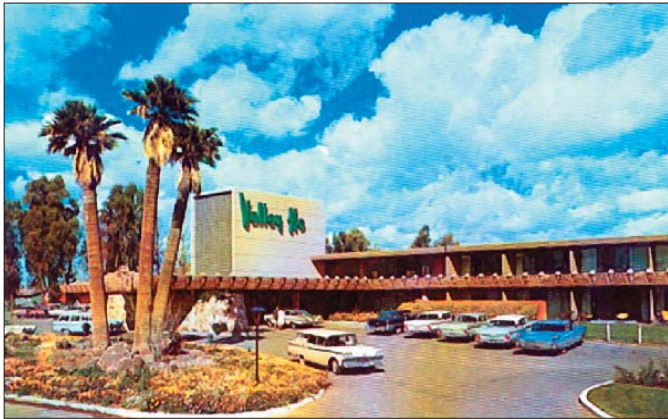
The image at the top is an architectural rendering of the original design for the hotel from 1957, which includes a tower element. Below this image is a postcard showing the main entrance to the complex as completed in the 1950's. As can be evidenced in these illustrations, the proportions of the three-story tower pylon highlighted by the long horizontal lines of the surrounding construction are part of the complex's distinctive visual character. The third image from the top shows the tower and porte-cochere before rehabilitation. While the tower's original architectural finish concrete has been covered with stucco and the original sign has been removed and replaced, its primary form remains as it was originally constructed.

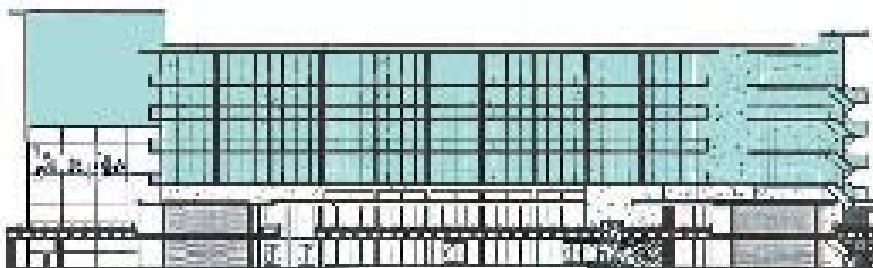
The shaded portions of this elevation drawing show the new tower addition as proposed. Even though the design for the new addition may have been planned when the building was originally conceived, the height and massing of the new construction would have substantially altered the character of the historic resort hotel.

A significant component of the rehabilitation was the proposal to construct a tower addition that was included in the original plans for the complex but was never built. The rehabilitation proposal called for constructing a four-story tower above the existing two-story portion, thereby completing the architect's original design concept (see below). As in the previous example, the completion of the un-built portion of the original design would have significantly changed the appearance of what was actually built and had acquired historic significance. If completed, the proposed four-story tower addition would have inserted a strong vertical element in this hotel complex that had essentially always been defined by its horizontality. Therefore, the construction of the tower would have substantially altered the historic character of the hotel and, thus, the proposed project did not meet the Standards. As an alternative approach, it was suggested that the new construction be added at another location on the site.
