LION-HAWLEY-BLOODGOOD HOUSES 1241 N. Franklin PI.

FLOOR PLANS - ALL LEVELS

BUILDING **ELEVATIONS**

PHOTOS OF EXISTING

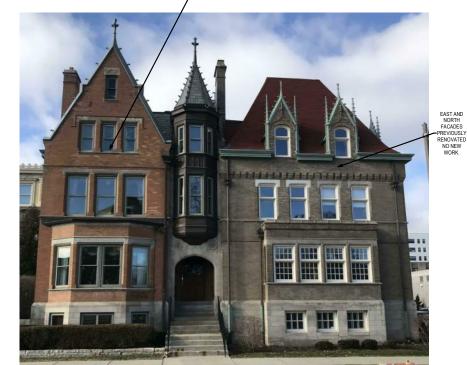
HAWLEY HOUSE BLOODGOOD HOUSE 18 EAST ELEVATION - EXISTING

—DORMER ORNAMENTAL
METAL WORK TO BE
REPLACED TO MATCH
EXISTING WITH MISSING THIS
WORK WILL MATCH THE
PREVIOUS ORNAMENTAL
METAL WORK REPLACED ON
REST OF FACADES. WINDOW
IN DORME TO HAVE
REPLACEMENT SASH WITH
1/2* INSULATED GLASS
INSTAL I FD

—2 STORY WOOD
CLAPPBOARD SIDED PORCH
ADDITION ENCLOSED WITH
WINDOWS TO BE REMOVED
TO EXPOSE ORIGINAL
EXTERIOR OF HOUSE.

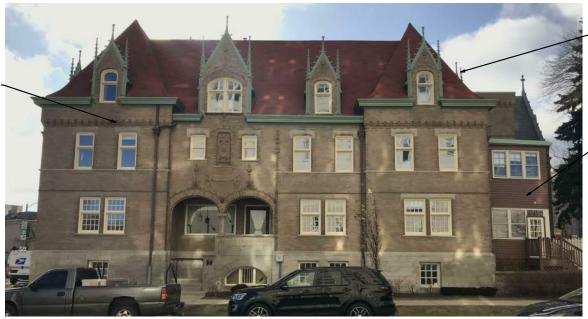
NORTH ELEVATION - EXISTING 1/4" = 1'-0"

WINDOWS TO REMAIN.
REPLACEMNT SASH WITH 1/2"
INSULATED GLASS TO BE
INSTALLED, REPAIR WOOD
FRAME AS REQUIRED. (THIS
WILL MATCH THEN THE REST
OF THE WINDOWS SASH IN THE
HOUSE REPLACED ALREADY)

FENCE TO BE EXTENDED
BACK TO TEHE ORIGINAL
HOUSE FACADE TO ENCLOSE
TRASH COLLECTION AND
HVAC CONDENSING UNITS.

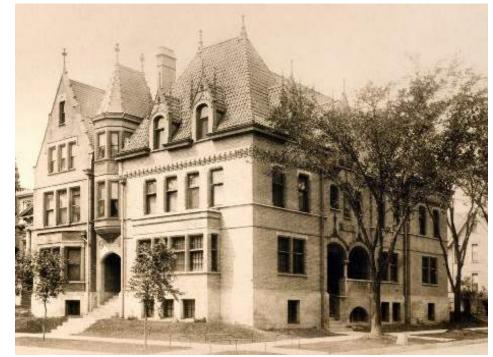
(3) HISTORIC PHOTOGRAPH - CLAY TILE

BLOODGOOD HOUSE WITH CLAY TILE ROOF.

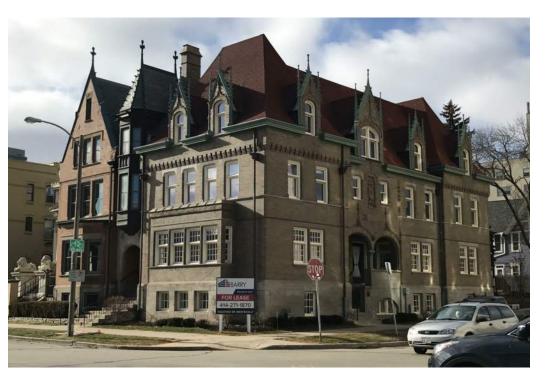
HISTORIC PHOTOGRAPH - EXISTING

CONDITIONS
