Milwaukee Historic Preservation Commission November 7, 2022

Resolution relating to a Certificate of Appropriateness for window replacement on the lower levels at 1015 N. 9th Street, St. Benedict the Moor Roman Catholic Church, an individually designated historic property, for the Province of St. Joseph of the Capuchin Order..

Resolution relating to a Certificate of Appropriateness for the construction of a new house at 2409 N. Terrace Avenue, in the North Point North Historic District, for Terrace 2409 LLC.

Resolution relating to a Certificate of Appropriateness for rebuilding the rear porch at 2549 N. terrace Avenue, in the North point North Historic District, for Maria K. Roloff TOD

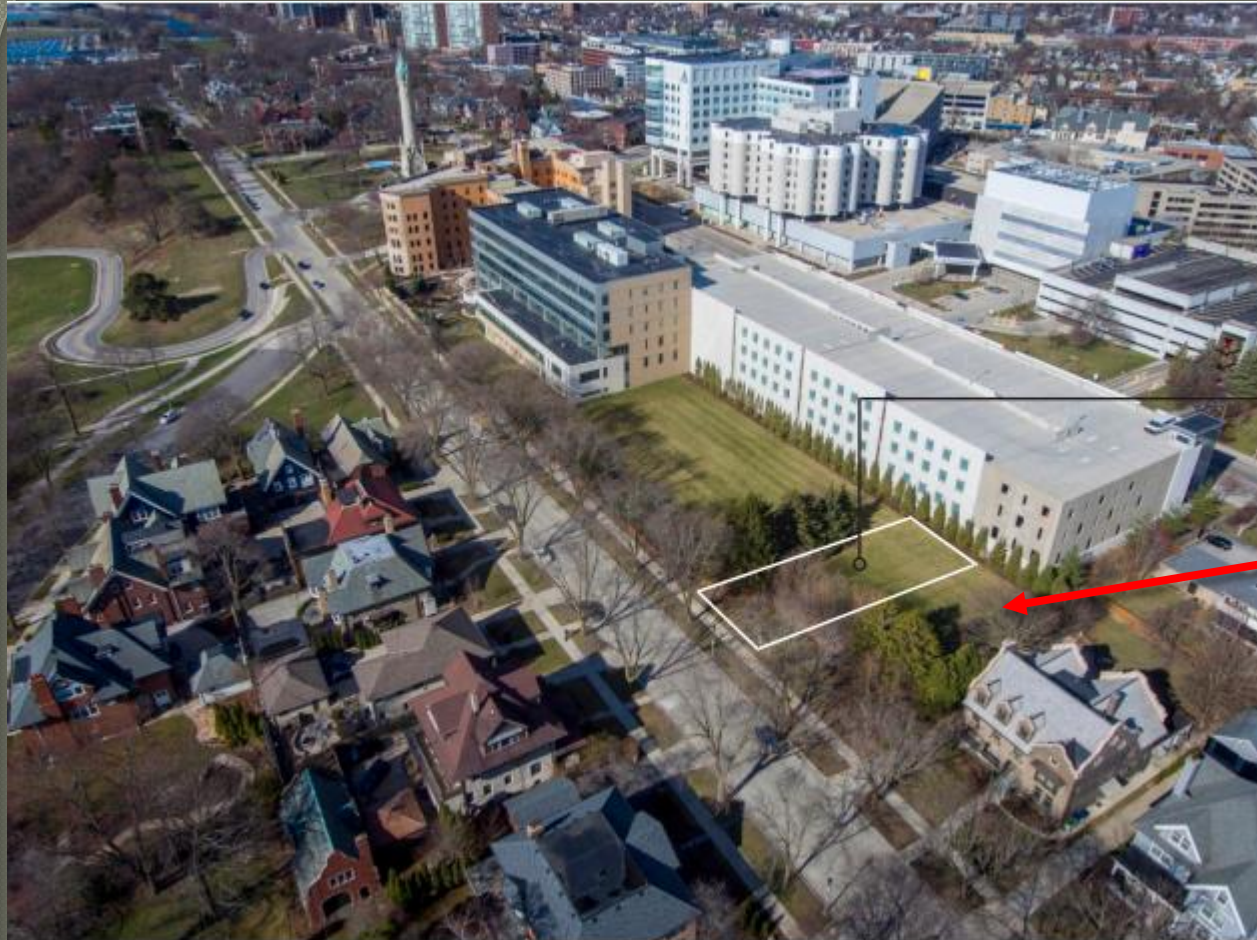
PLAT OF SURVEY

2409 N. Terrace will
be here

The Land Area of the subject property is 0.321 square feet or 0.1908 acres.

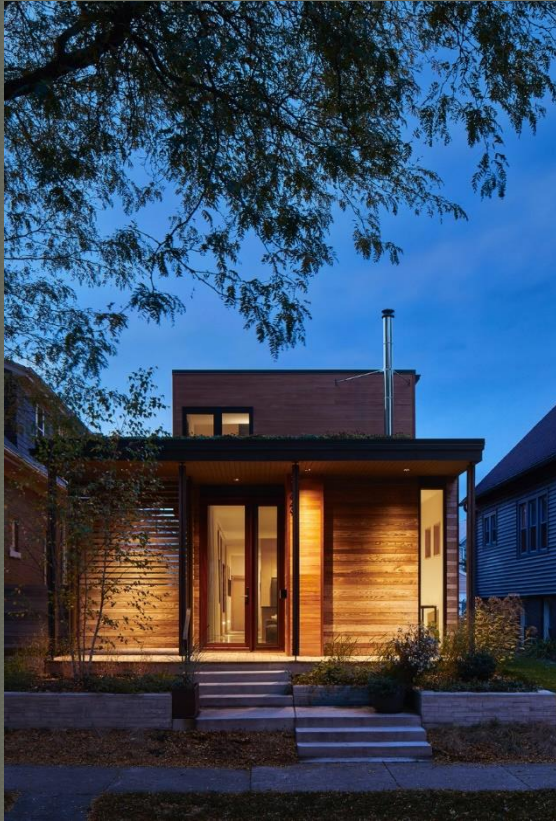
THERMALLY MODIFIED WOOD

1. HEAT AND STEAM USED TO PRESERVE WOOD (390 DEGREES)
2. NO HARMFUL CHEMICALS OR ELEMENTS
