Re: Our File Number: 2021-KS-4710
Nature of Loss: Unmarked Water Line
Date of Loss: 11/15/2021
Loss Location: At or Near 1210 S. 23rd St., Milwaukee, WI

KS Energy Services, LLC (KSE) is in receipt of Mid City Corporations Invoice for the repair of an unlocated water line that was damaged by KS Energy Services while working on cleared locate request 2021-44-03195. After the affected water line was damaged, KSE contacted the City of Milwaukee and was instructed to hire a plumber to fix the damaged line and pursue reimbursement through The City of Milwaukee. AS KSE recently received Mid City Corporation's invoice for that repair, KSE is requesting reimbursement in the full amount of repairs, \$1,427.45.

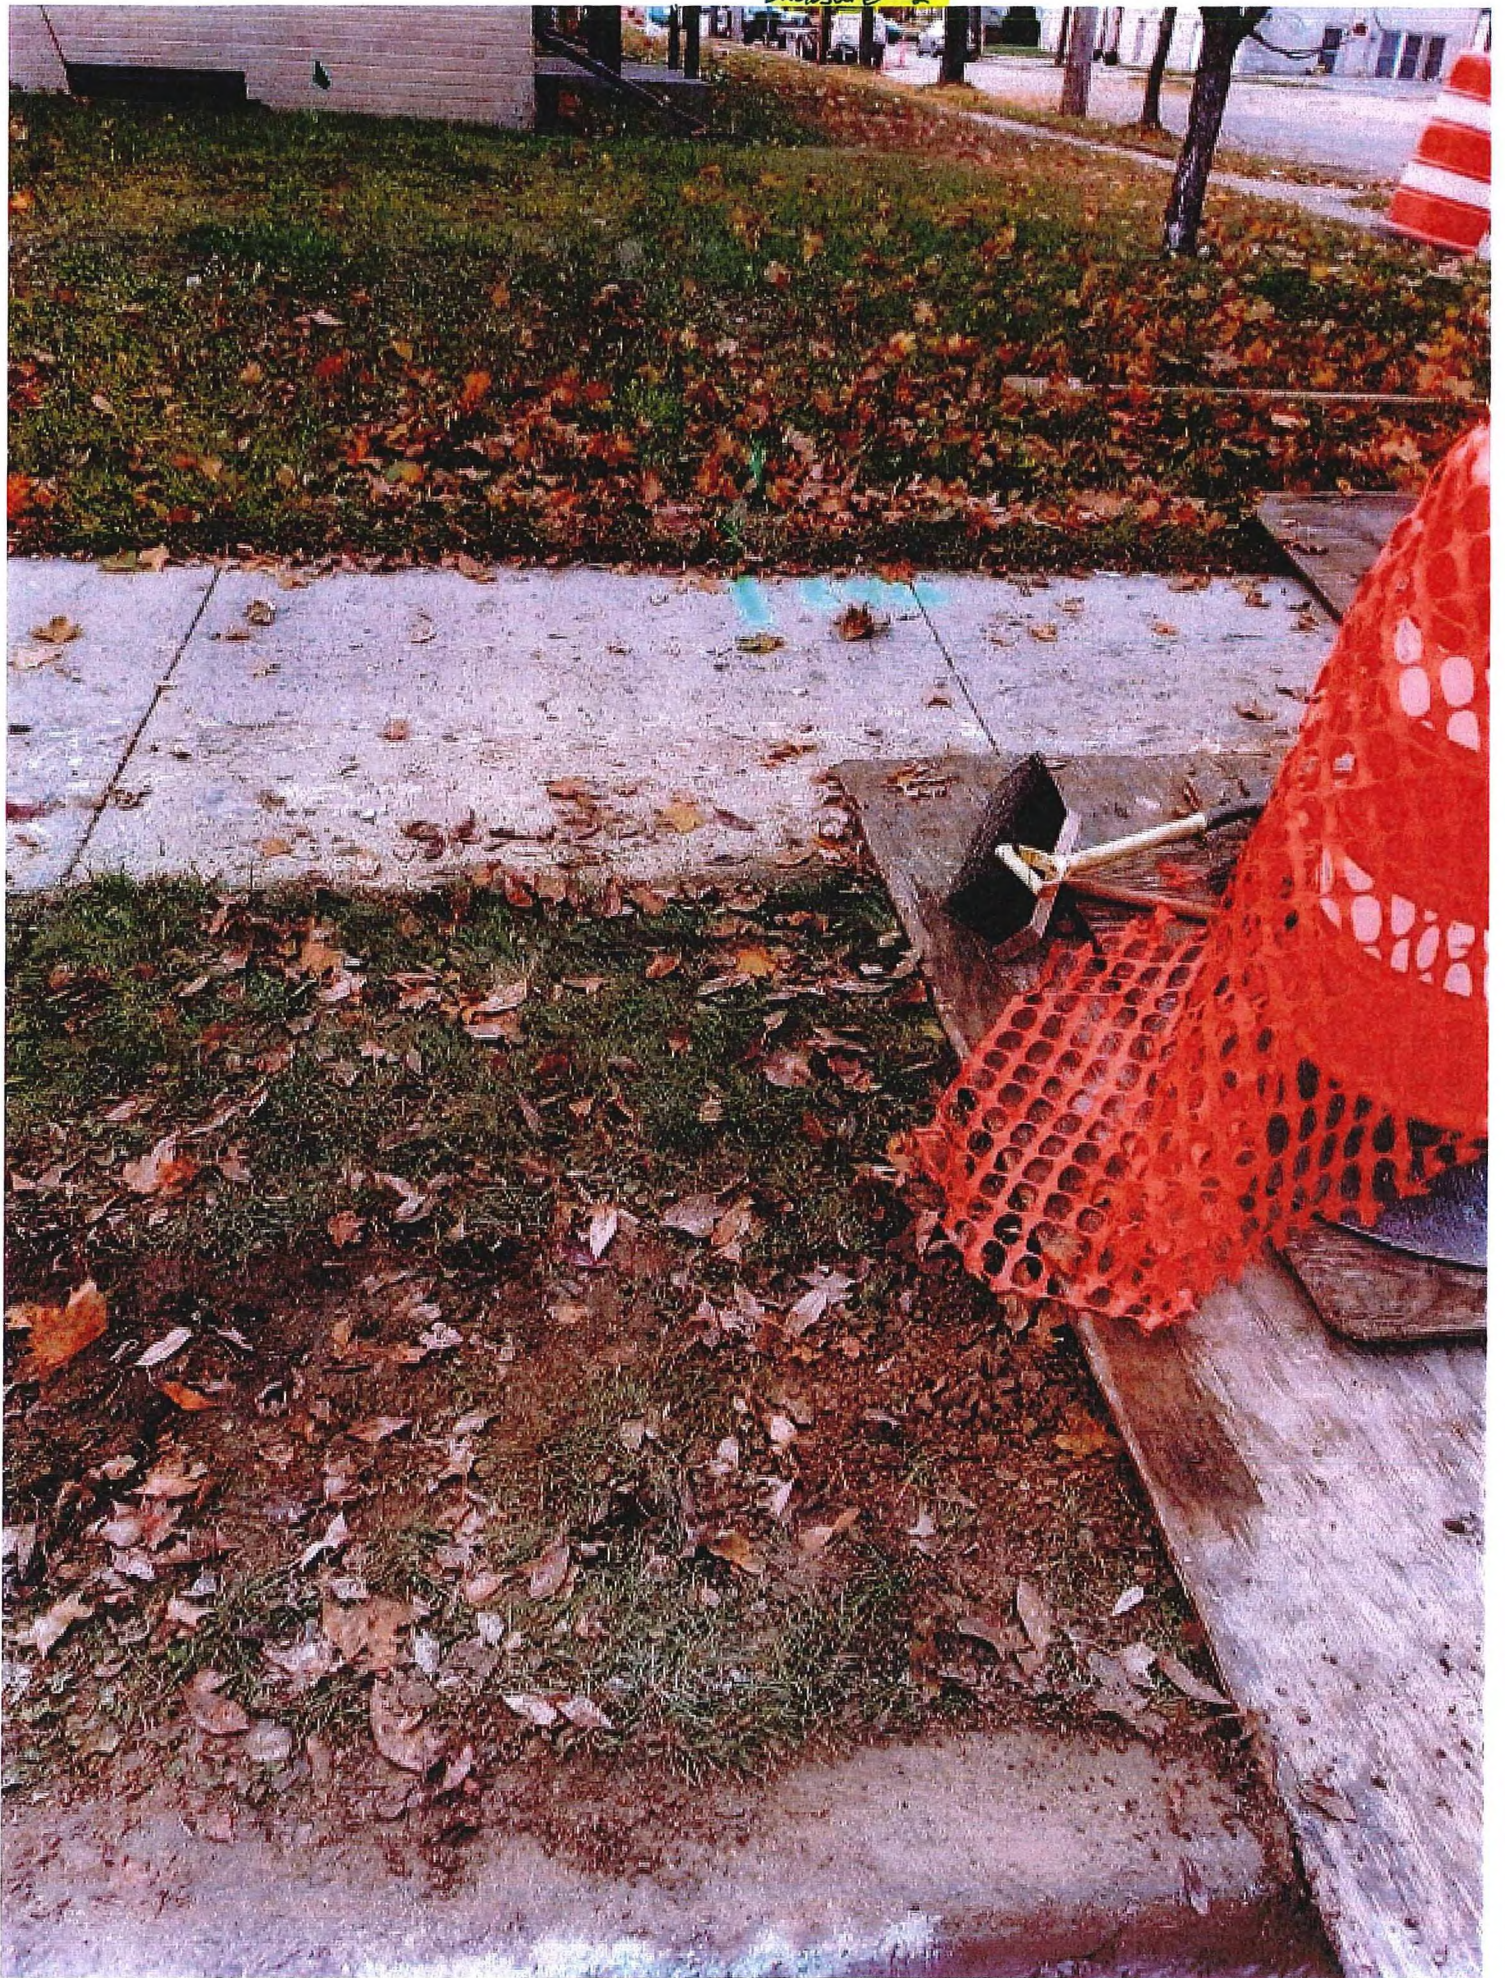
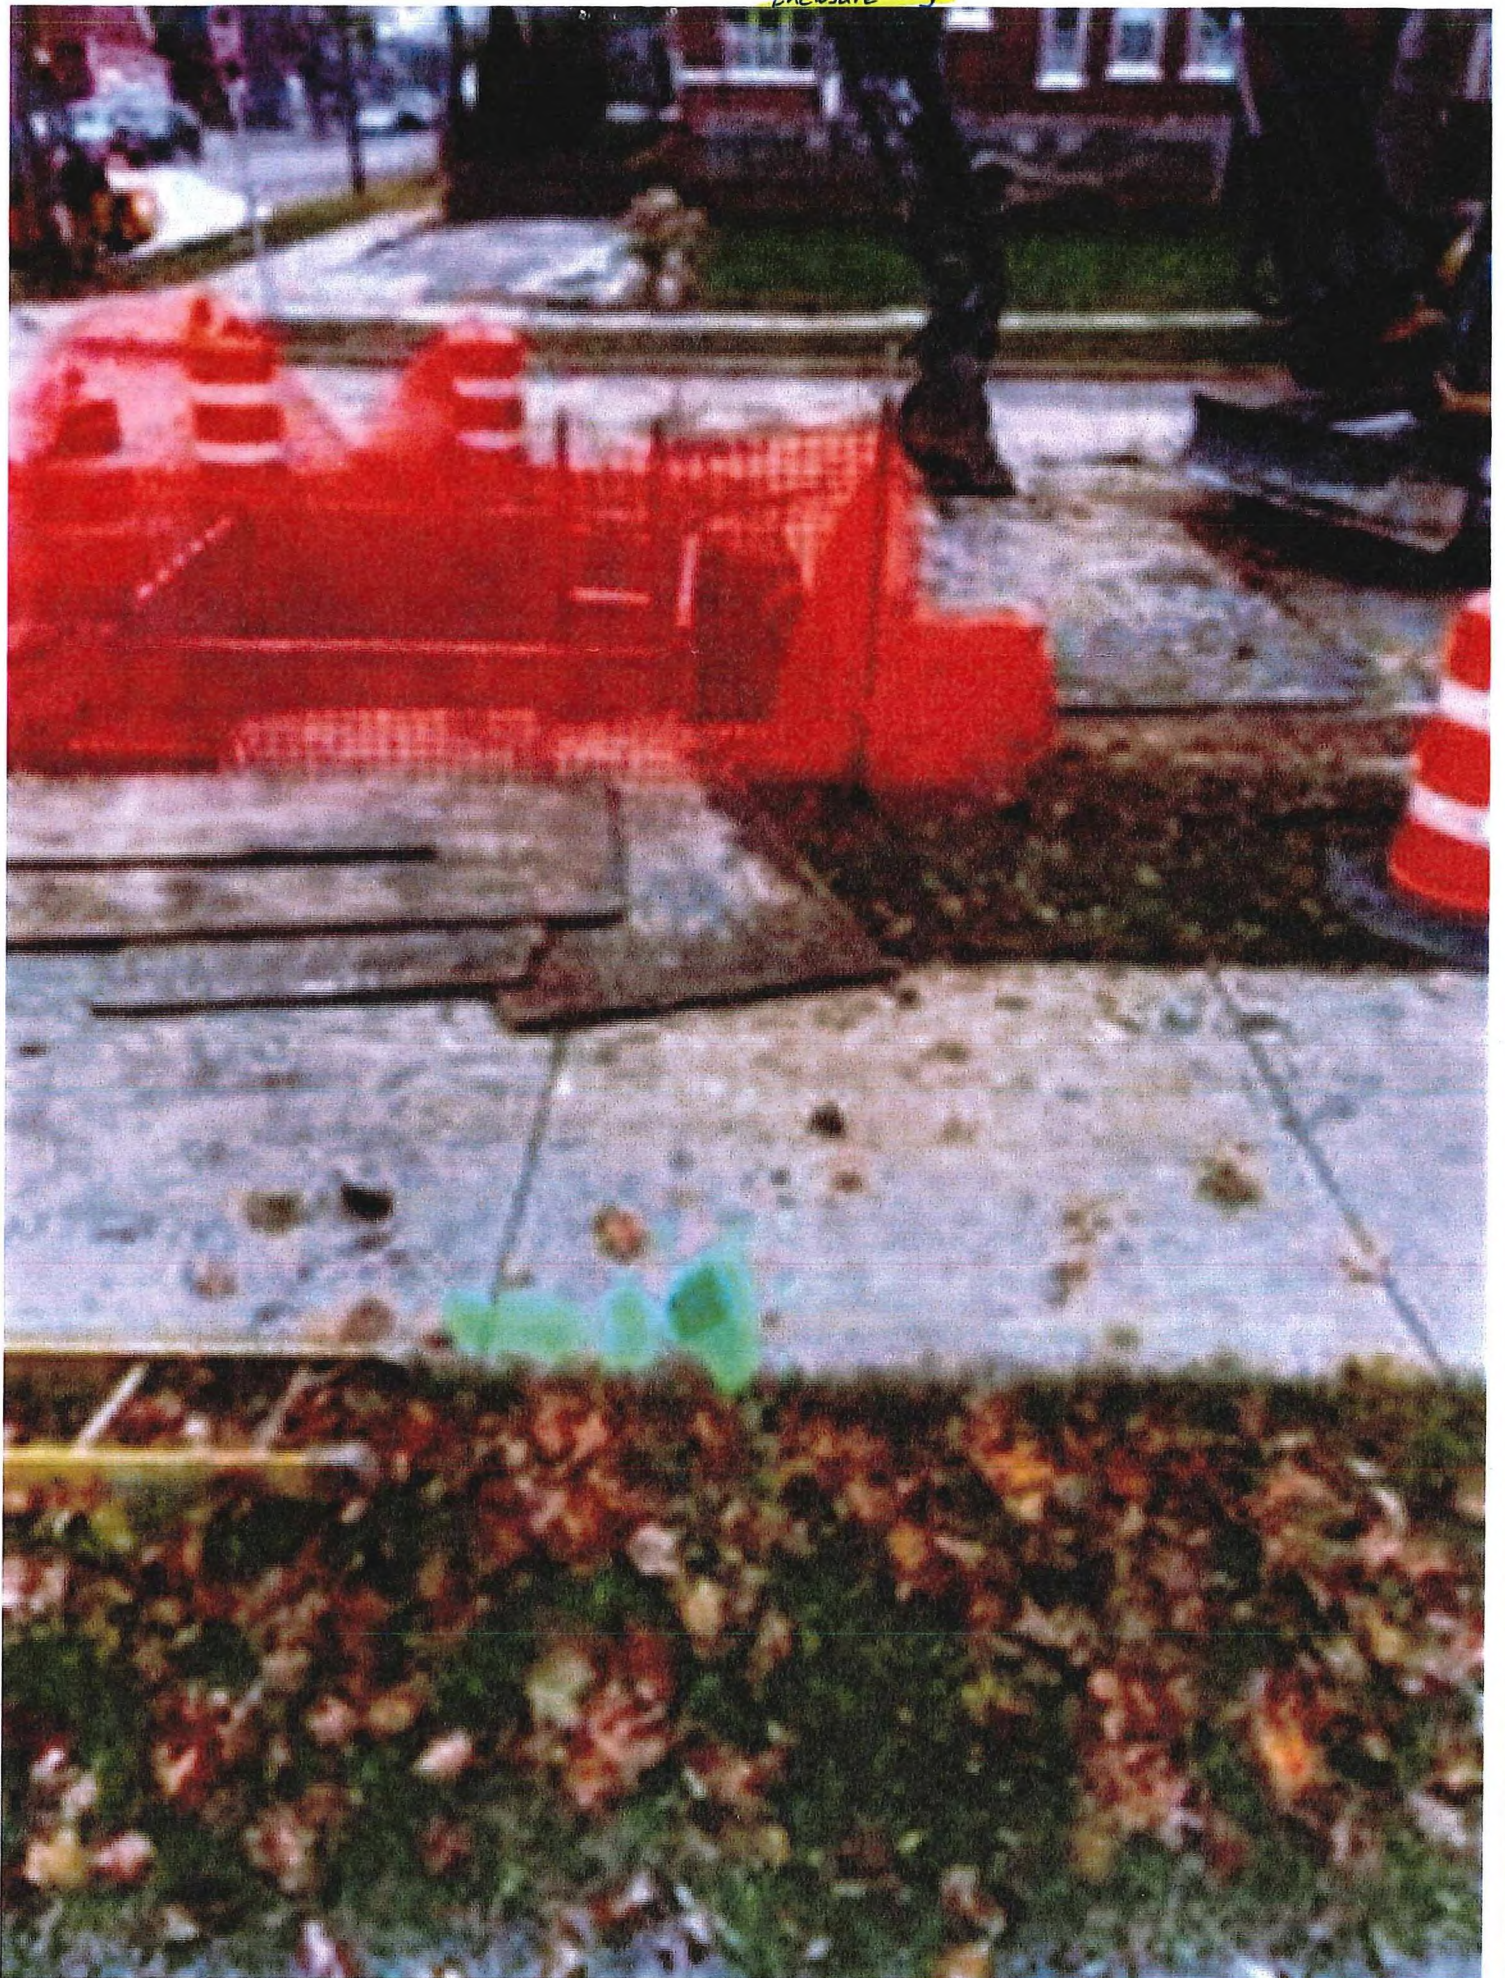
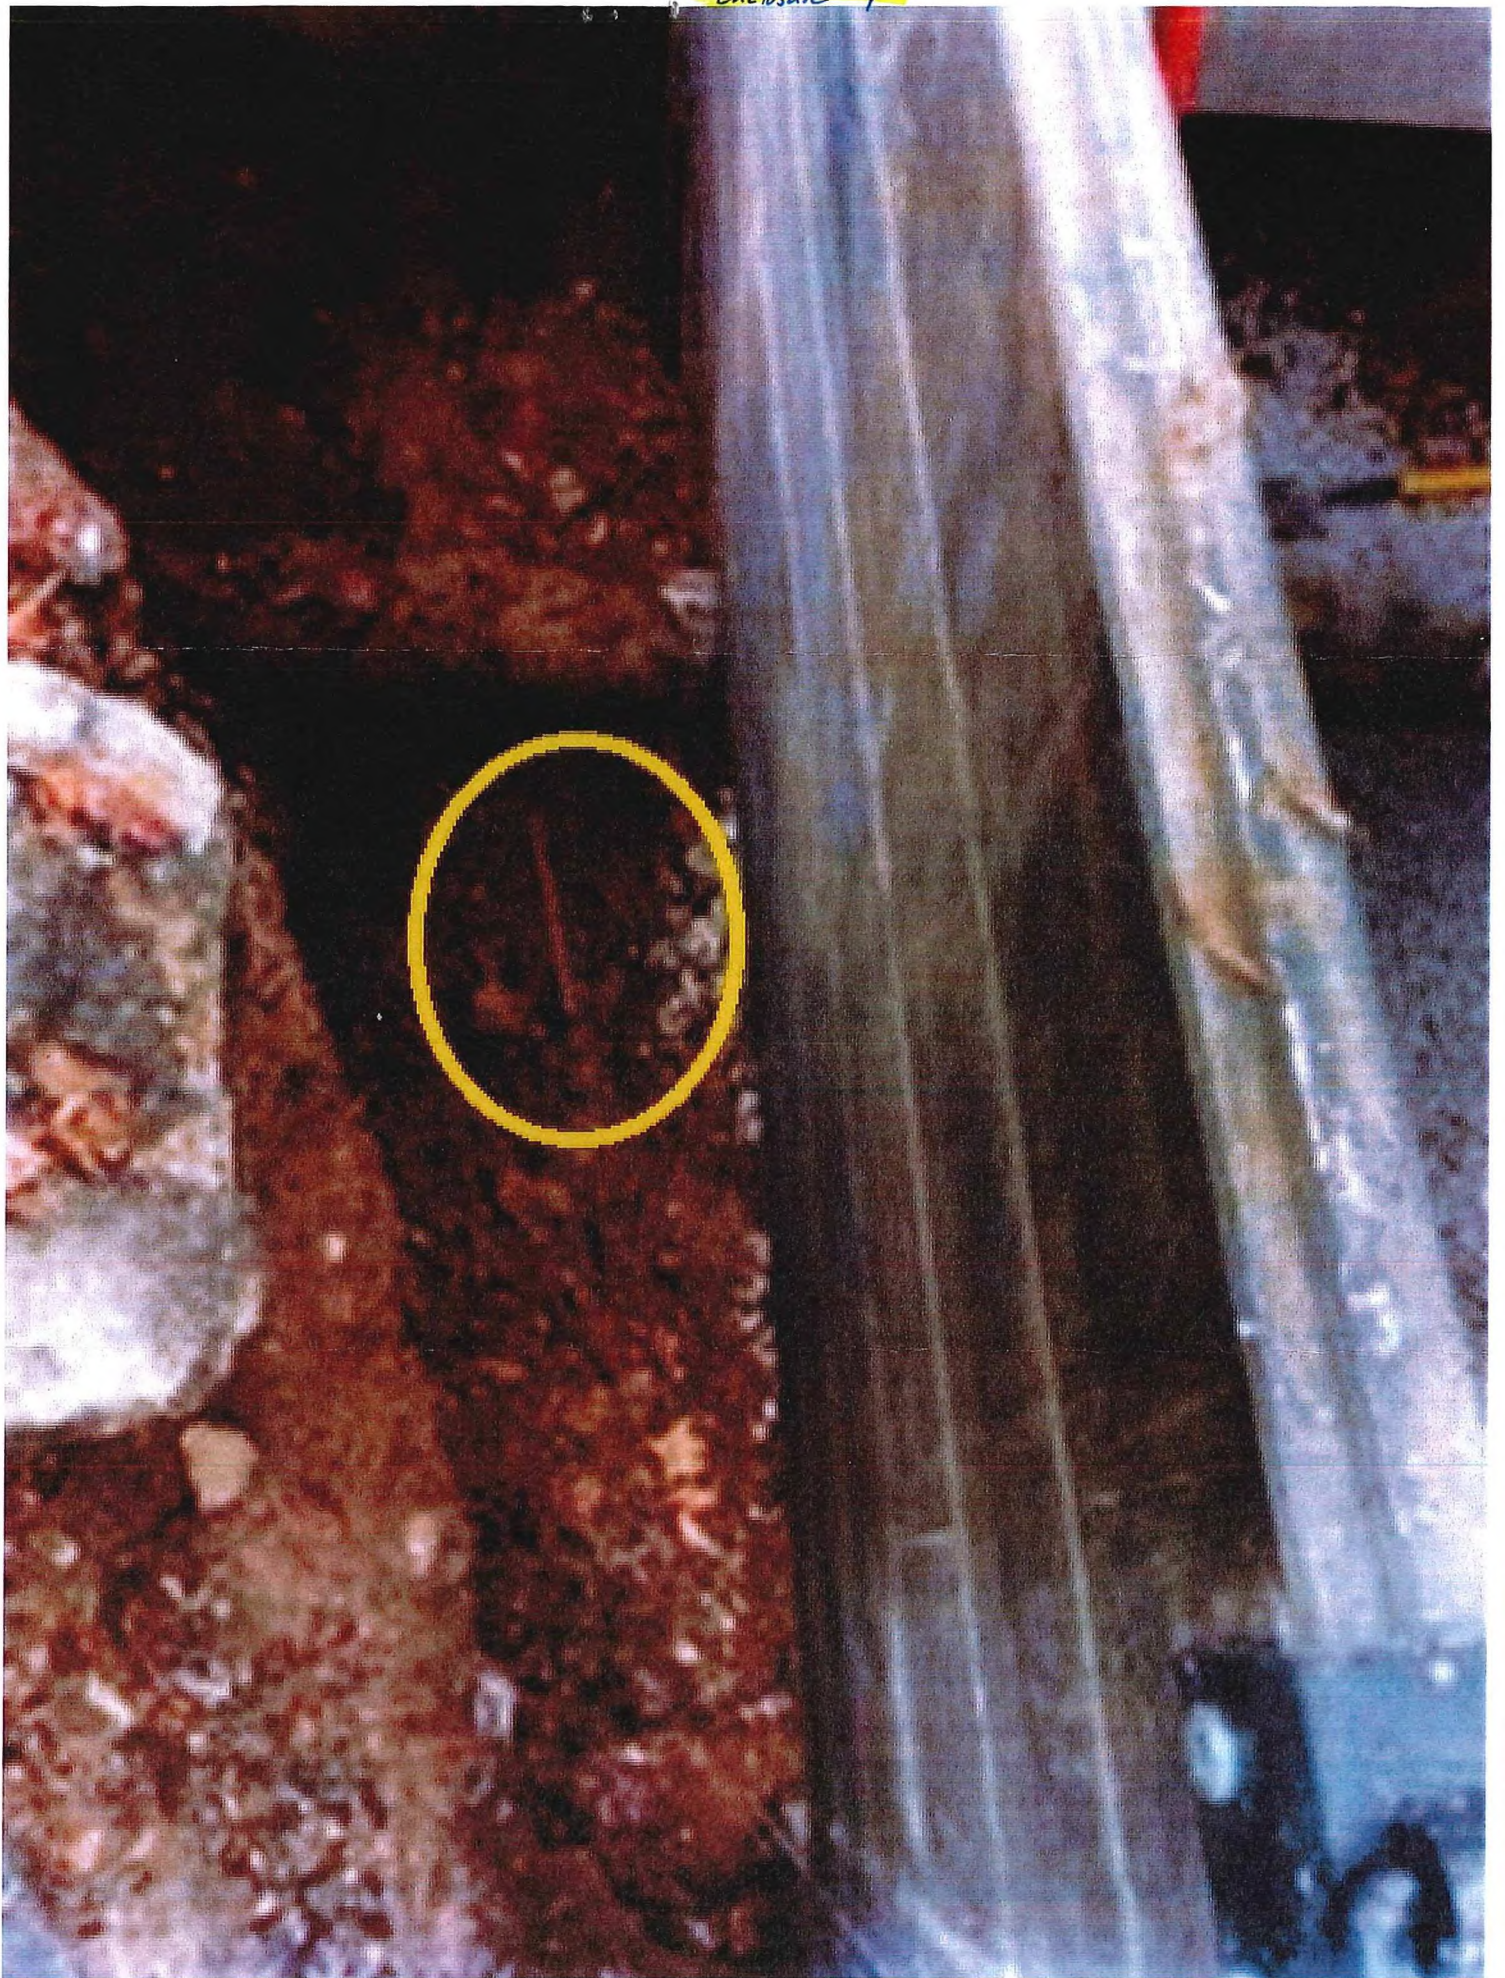
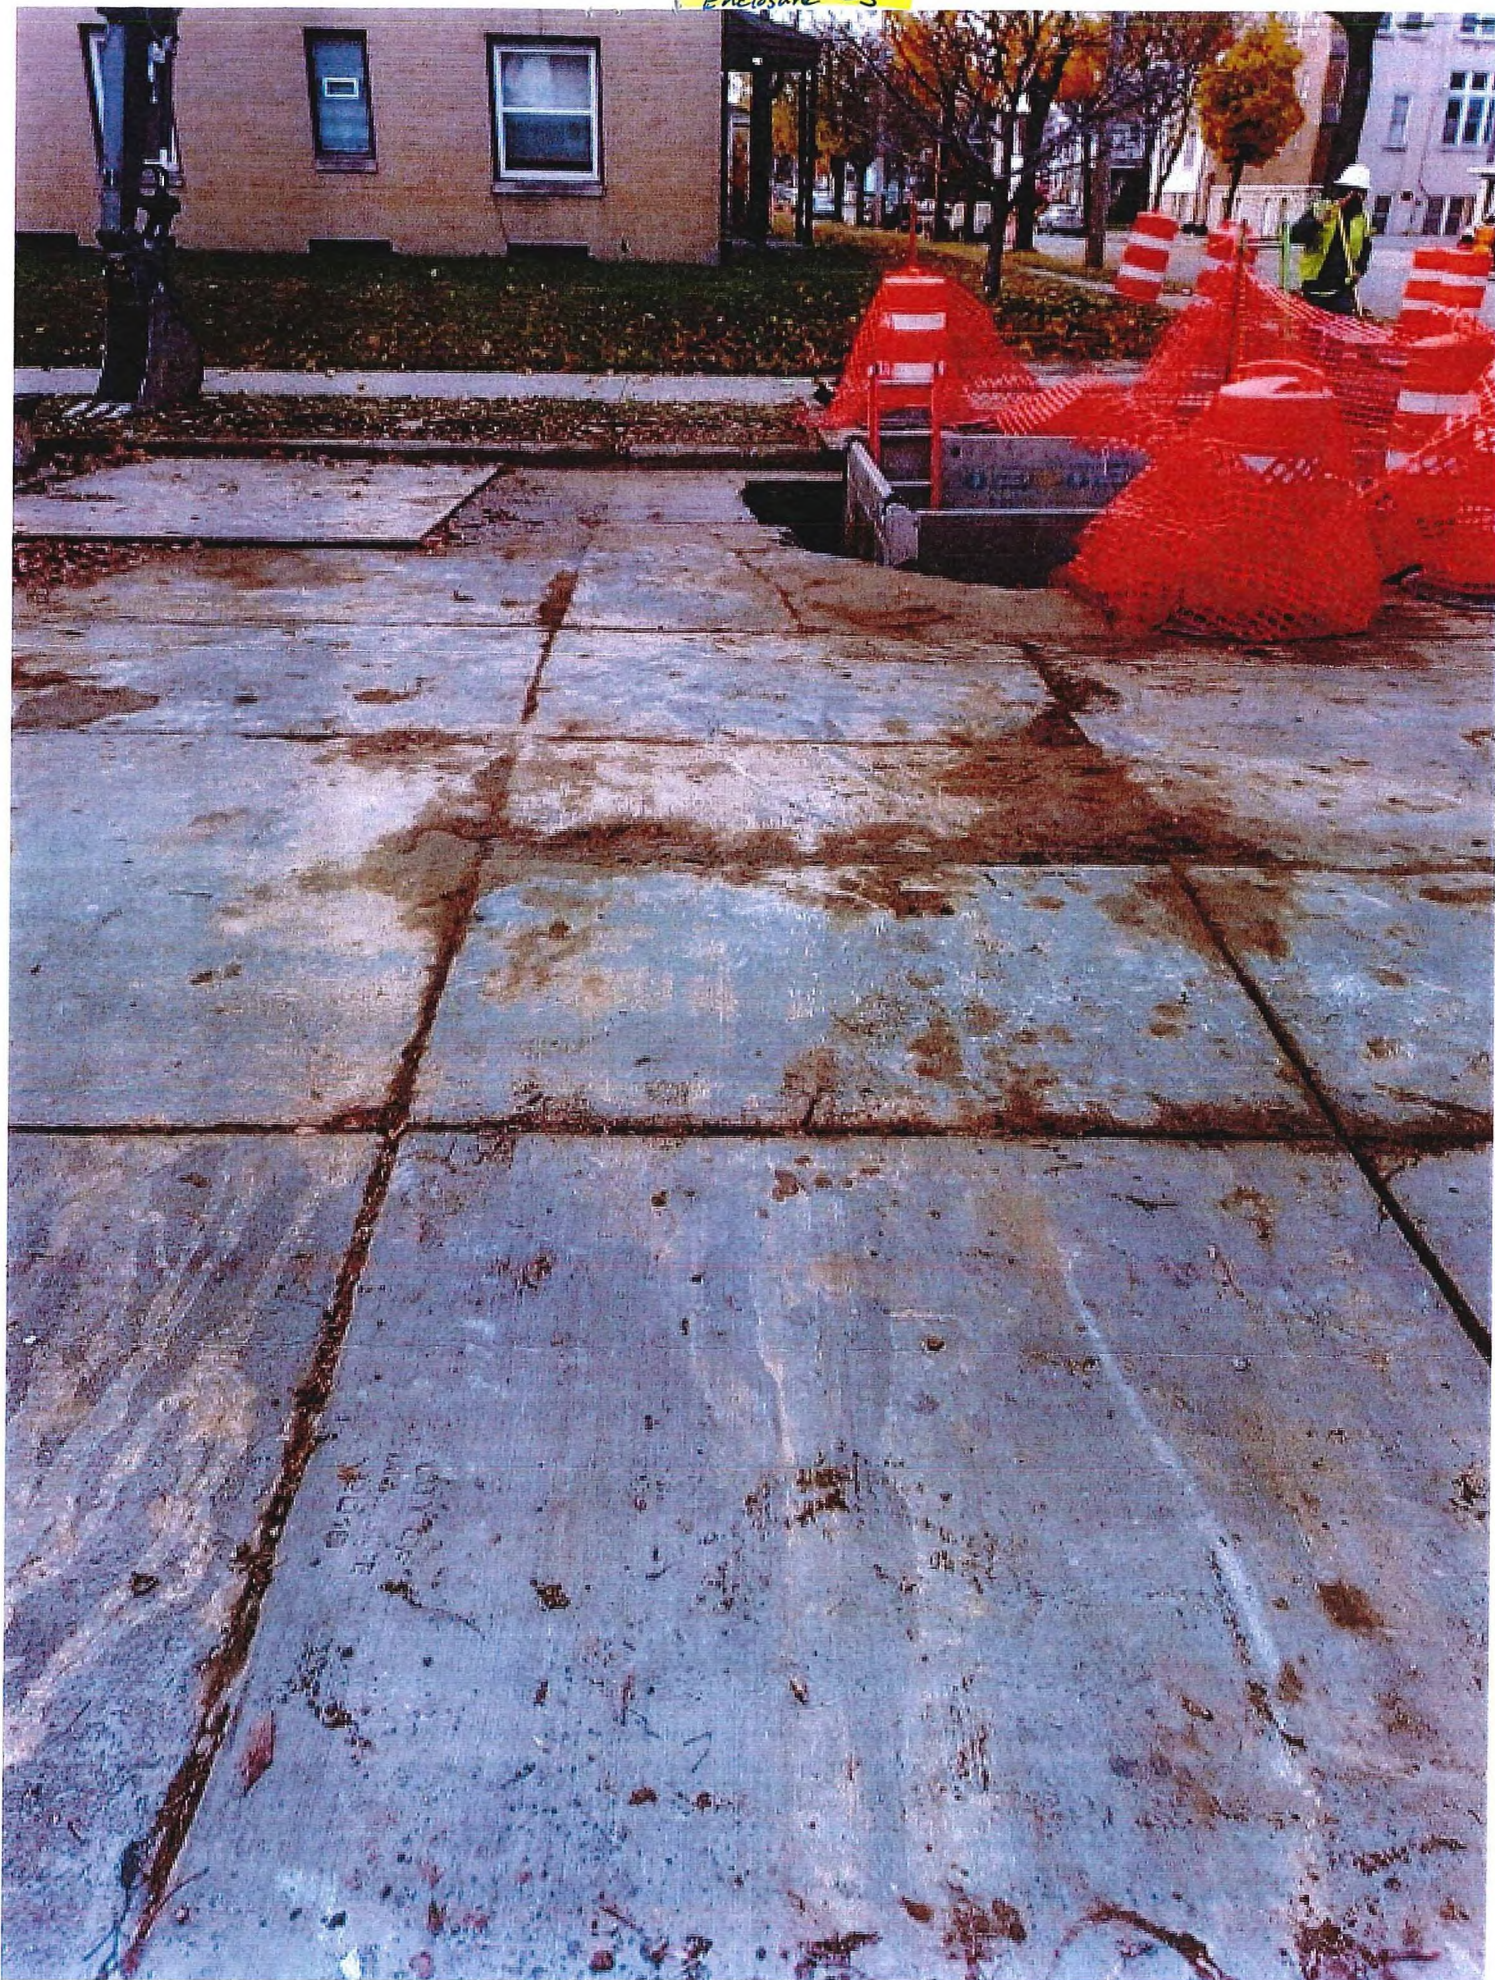
- Mid City Corporation invoice (Enclosure #1).
- 4 Photos showing the damaged 1inch copper water line (Enclosures #2-#5).

According to the information provided, KSE properly notified the one-call system prior to the 11/15/2021 excavation at the location of the water pipe's damage, but based on the photographic information enclosed, there were no water marks on site. According to the above cited State Statute 182.0175 (1m)(c), liability is assigned to the entity not complying with the locate request. Please issue a reimbursement payment to KS Energy Services, LLC in the amount of \$1,427.45 and mail to the following address:
