LIVING WITH HISTORY

Certificate of Appropriateness

959 N. 34 TH Concordia Historic District

PTS ID 113428 COA Remodel Porch

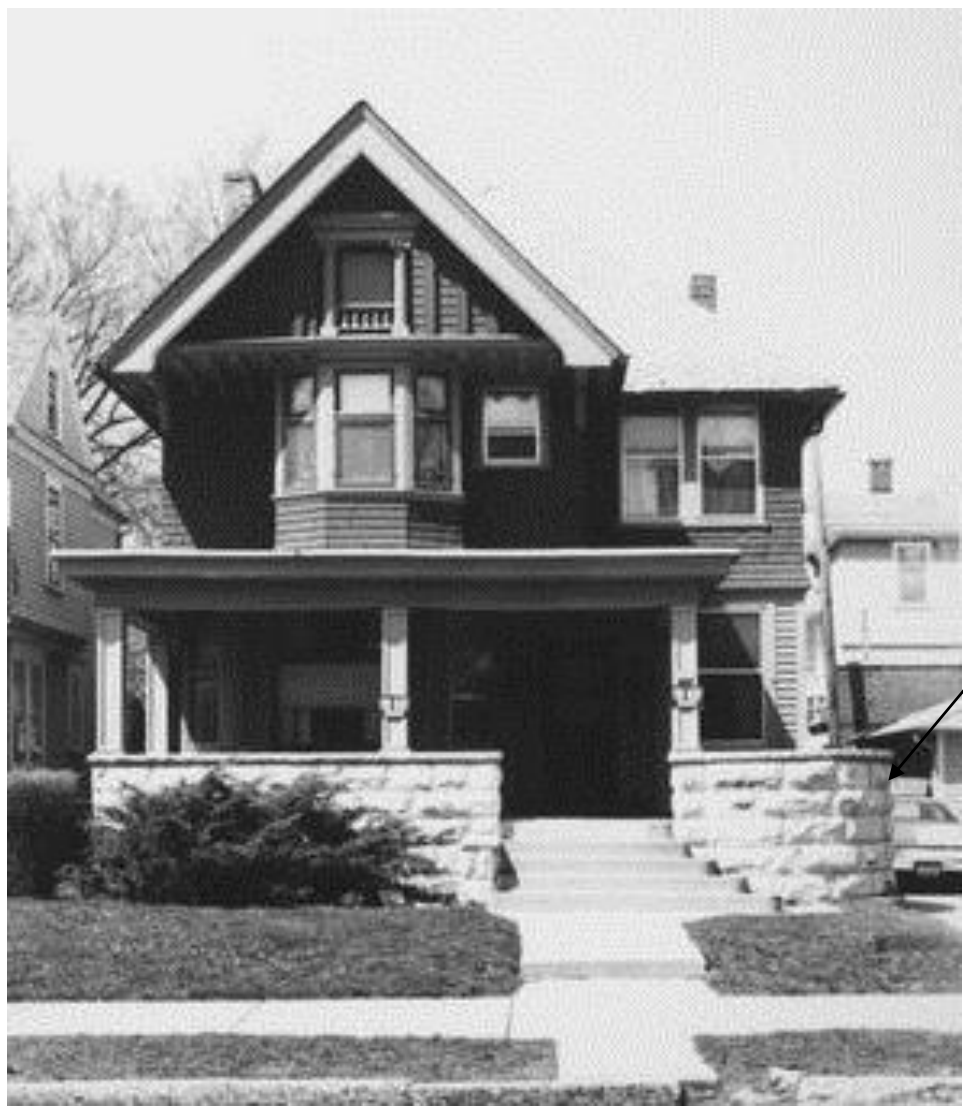
Front porch will be carefully deconstructed and rebuilt using the same stone. The stone walls are five courses high with an interior of brick.

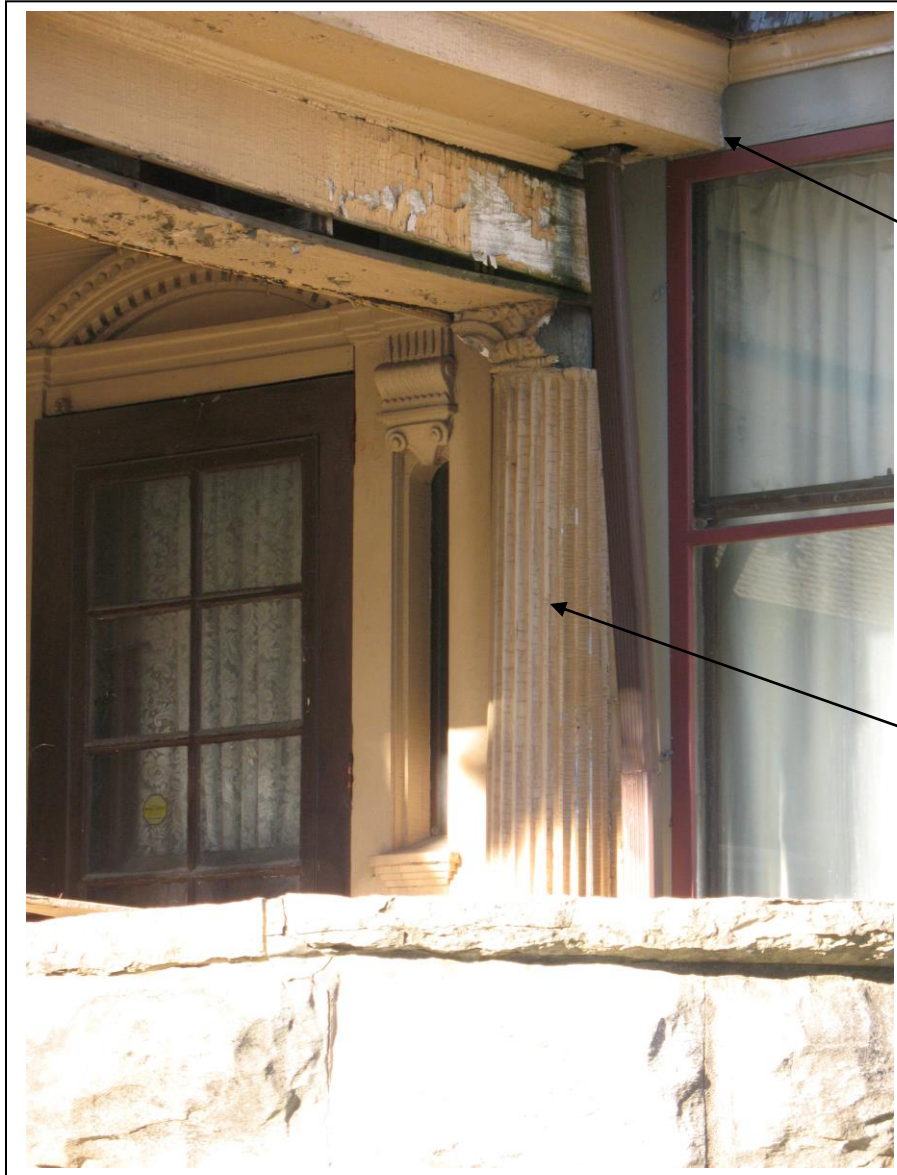
New porch will be positioned slightly higher and not require alteration to this window.

- The porch roof will be constructed as shown in the application and will not impact the first floor window to the north or right of the entry door.**
- The current stone will be re-used for the porch. Mortar must be historically appropriate and not consist of all Portland cement.**
- The porch posts will be removed and replaced with columns as seen in the 1980 survey photograph of the property.**
- The small window to the north of the front bay on the second story will be removed. The opening will be clad in shingles that match the size and wood species of the adjacent shingles.**

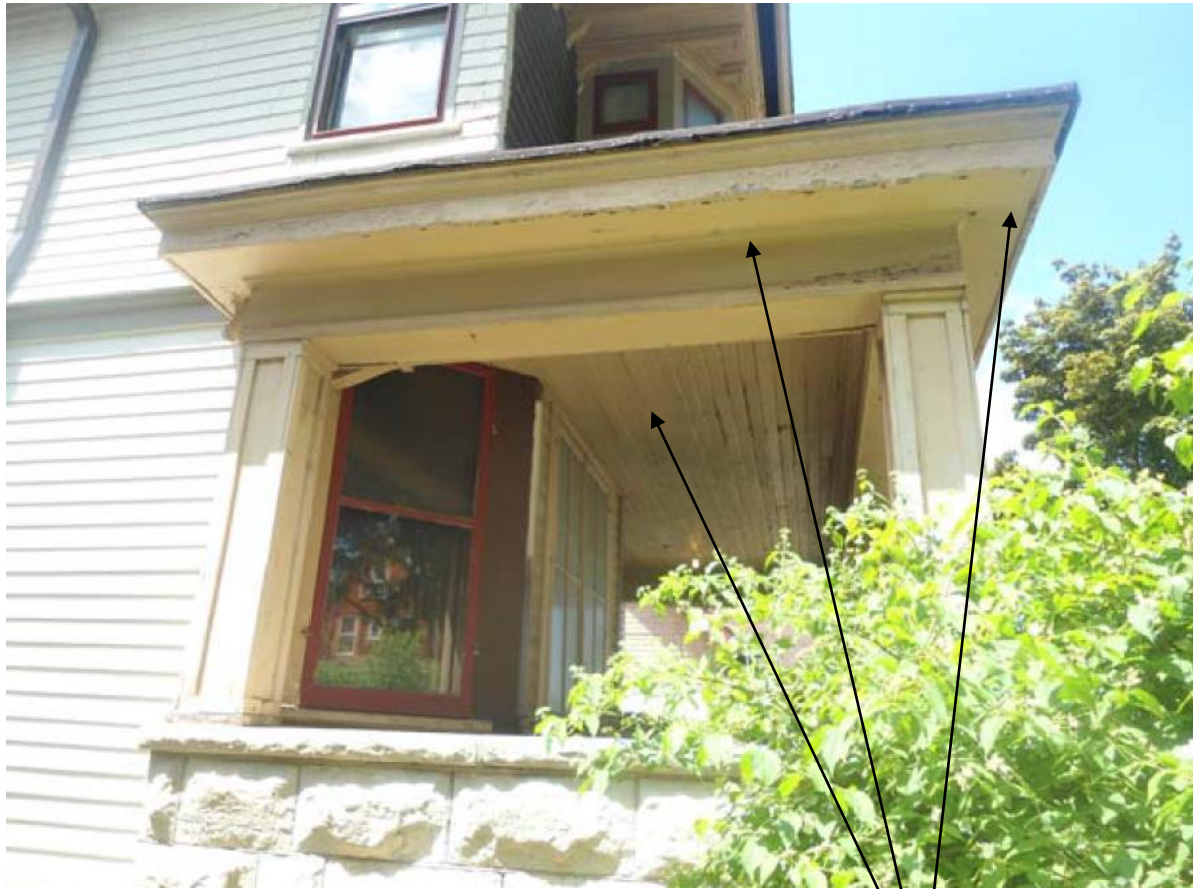
Replacement porch roof will have the same features as the current one with overhangs, appropriate molding profiles and beadboard/tongue-in-groove ceiling.

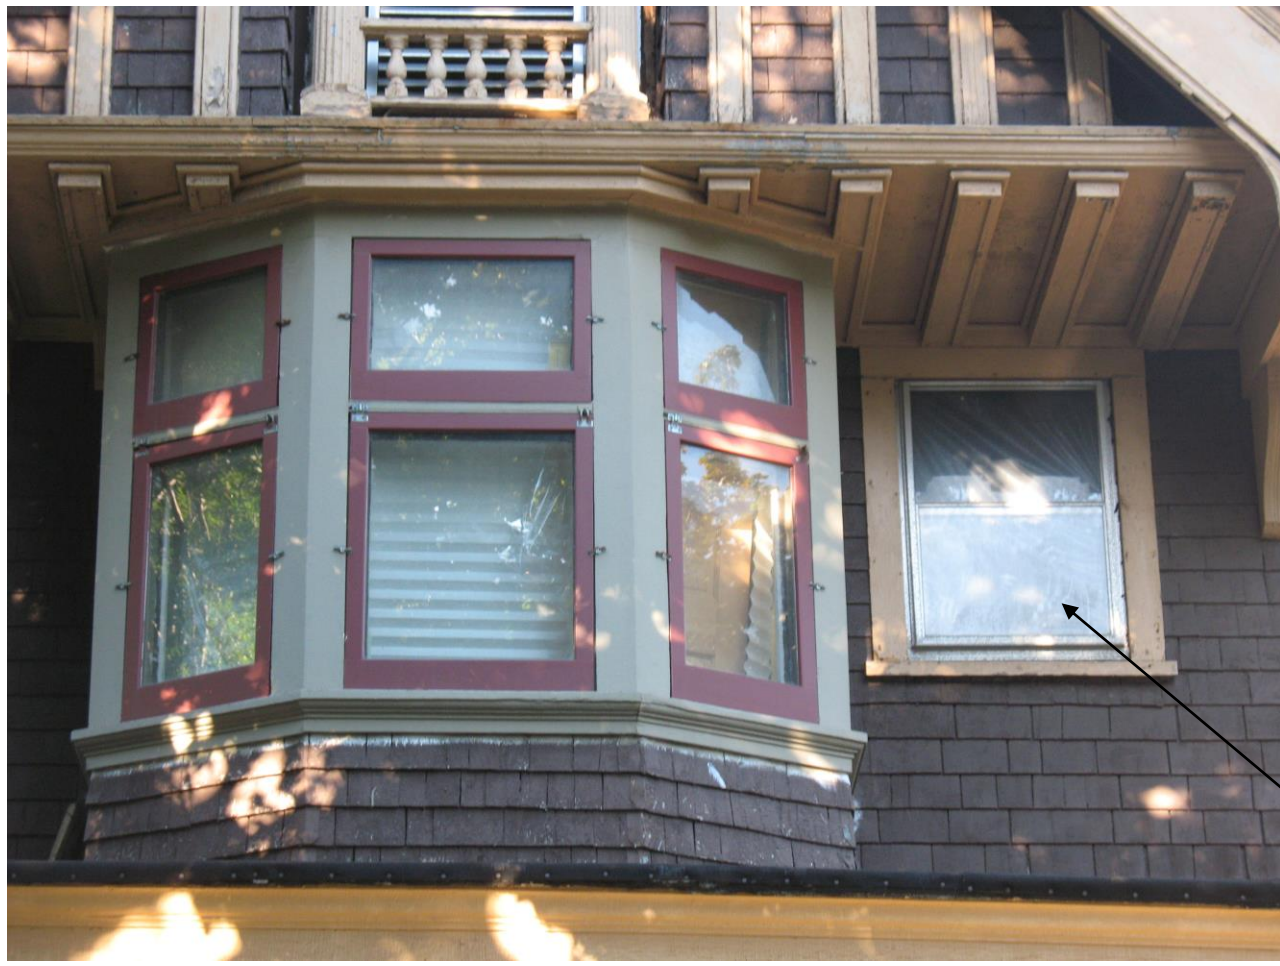
This window appears to have been added after World War II. It will be removed. The resulting opening will be sheathed over with wood shingles that match the existing and have the same exposure.

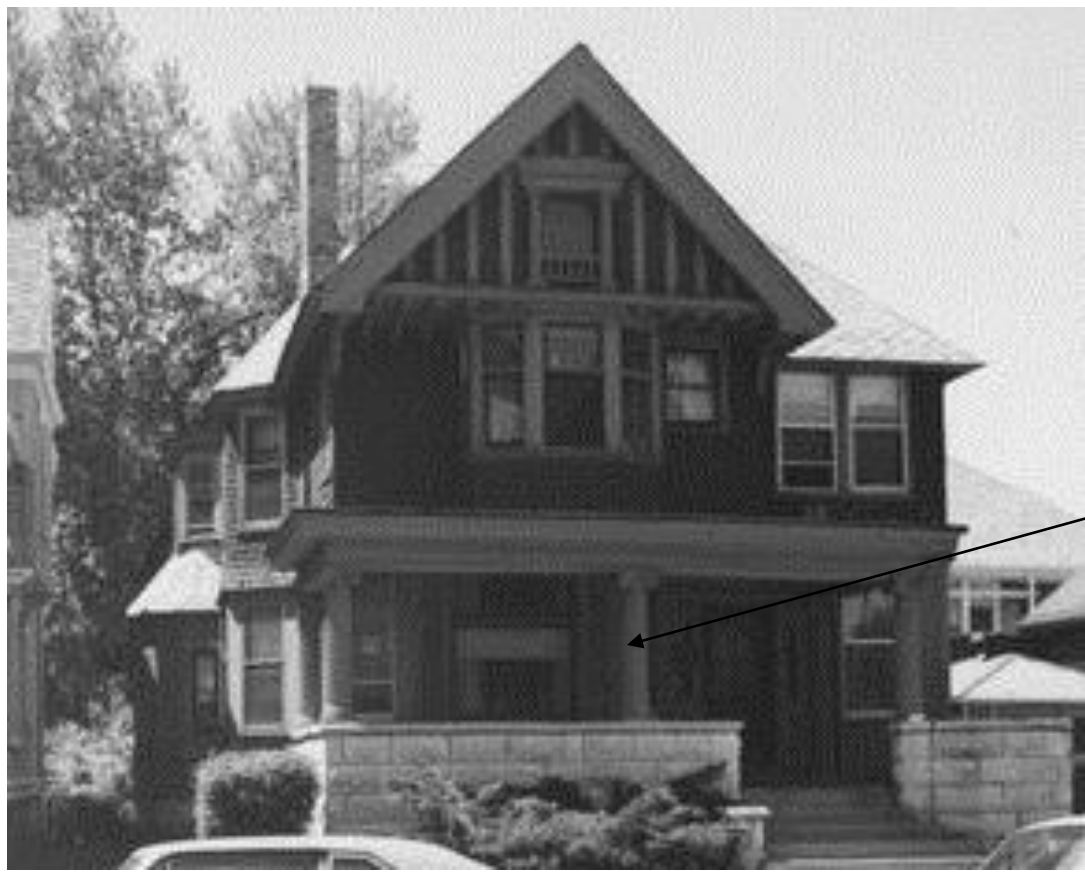
This 1980 survey photo shows the original porch columns.
