**National Register of Historic Places
Registration Form**

historic name **McCullough and Dixon Steam Laundry and Soap Company**
other names/site number

street & number	419 West Vliet Street	N/A	not for publication
city or town	Milwaukee	N/A	vicinity
state Wisconsin	code WI	county Milwaukee	code 079
			zip code 53212

Section 7 Page 1

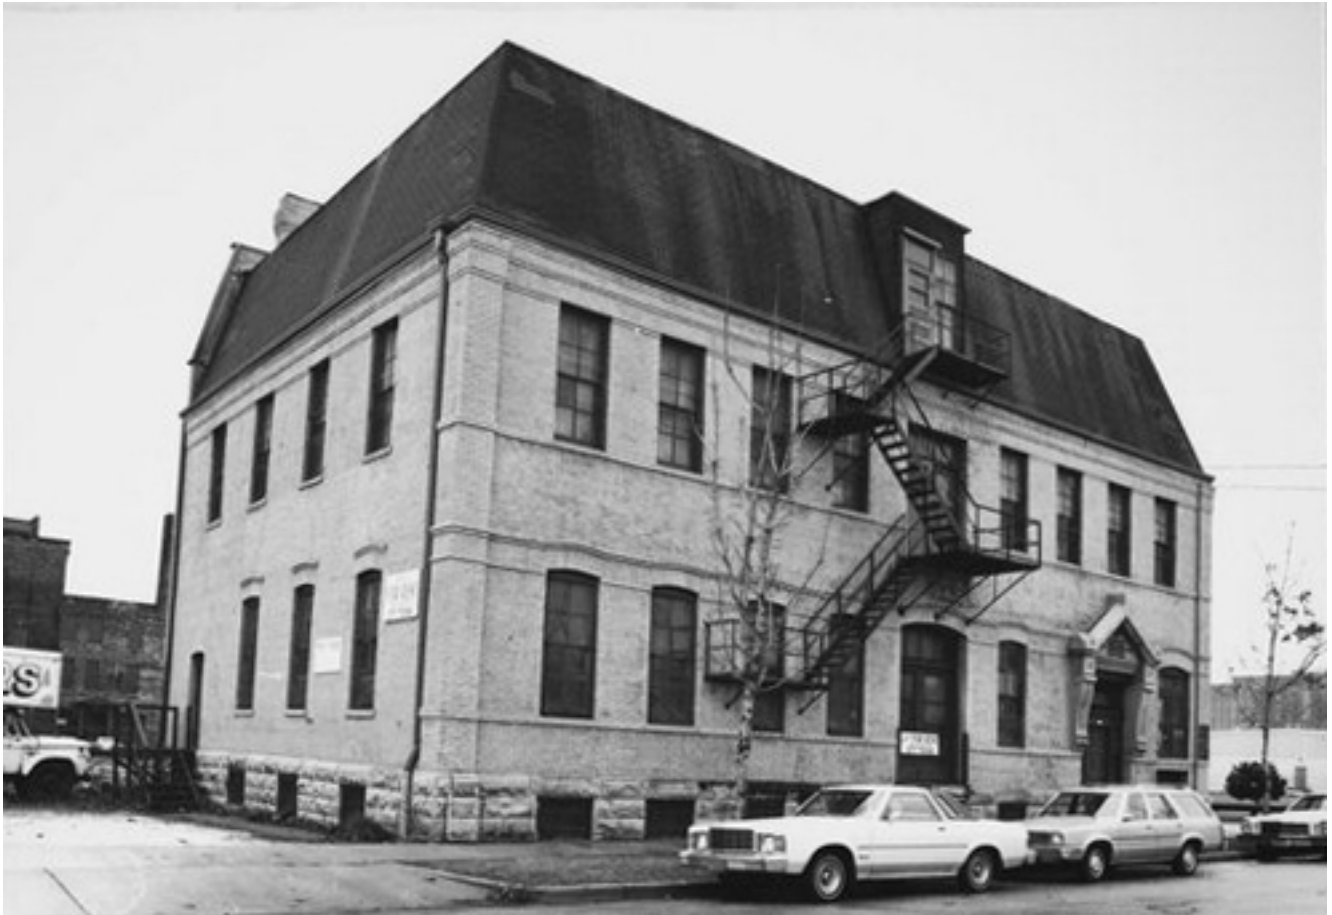
Figure G: Undated historic photo of McCullough and Dixon Steam Laundry, courtesy of Milwaukee County Historical Society.

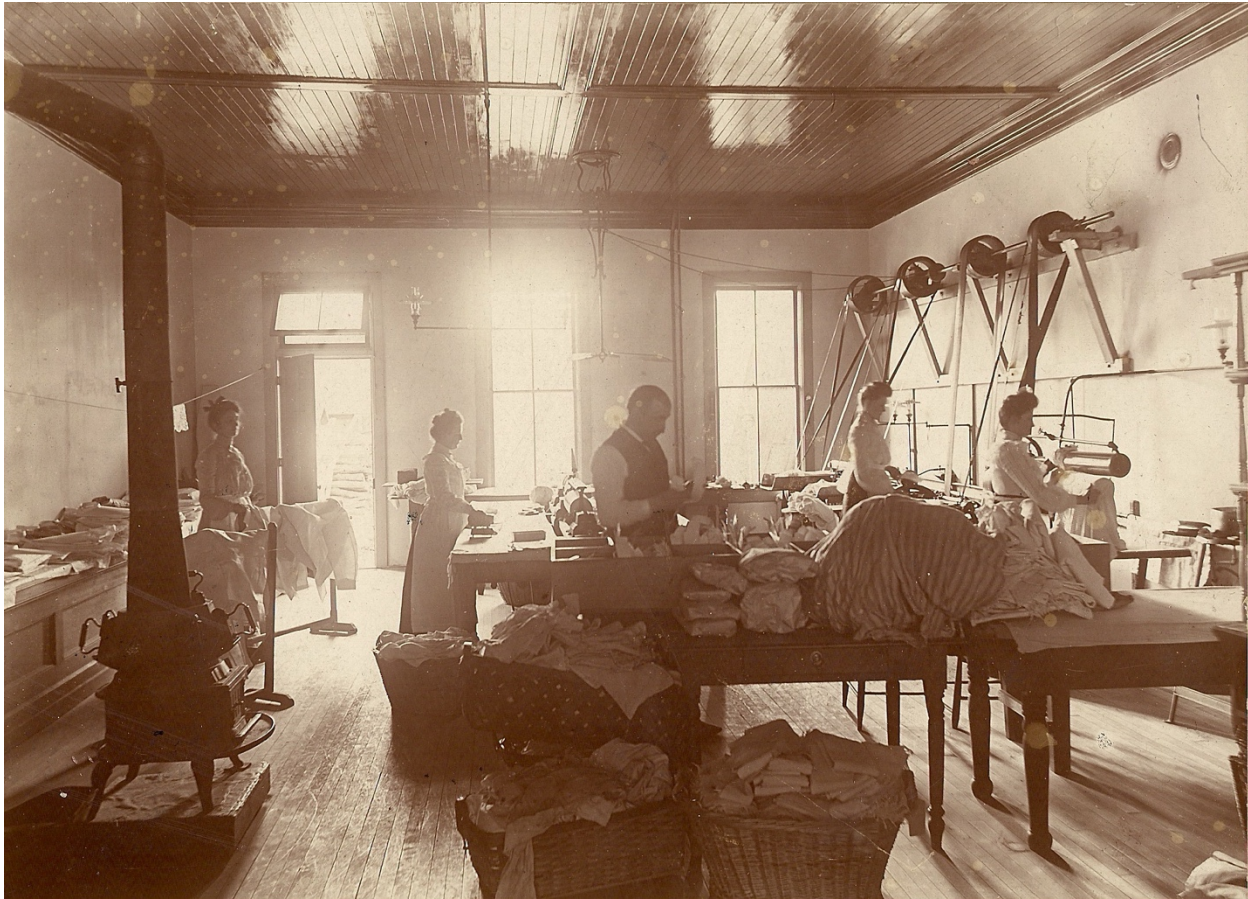
Figure H: Laundry interior at 110 East Huron Street in Berlin, Wisconsin, courtesy of Berlin Area Historical Society.
