Certificate of Appropriateness

2647 N Wahl Avenue

North Point North Historic District

TUCKPOINTING OF BRICK MASONRY

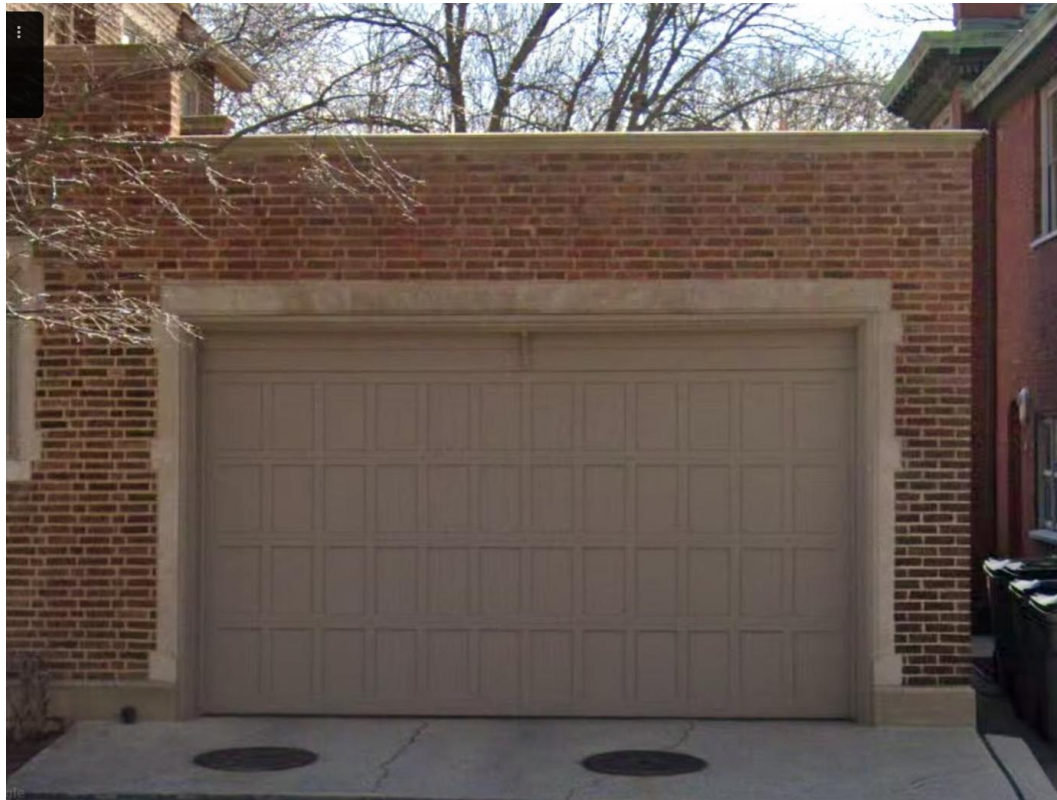
Area of coping stones to be treated with sealant, presumably to address efflorescence issue.

Stone copings on top of garage shall have joints routed ¼" deep. Joints shall be free of dust, caulked, and dusted with a fine grade sand to match appearance of stone AS CLOSE AS POSSIBLE.

Per conversation with homeowner, stone copings shall receive a flood coat of Prosoco stone repellent (as preferred by homeowner over chemtrete product we typically use). This will be applied by means of a pressure type sprayer so as to completely saturate stone surface. As discussed in walk-thru, due to unfamiliarity with product, we are assuming the stone will take 5 gallons of product. If more or less is used, homeowner will be notified of price change. Quote does NOT include any cleaning of stone or brick prior to application.

Stone sealant shall be used only on skyward surface of the stone. The vertical surfaces and underside must remain untreated.
