Milwaukee Historic Preservation Commission November 7, 2022

Resolution relating to a Certificate of Appropriateness for window replacement on the lower levels at 1015 N. 9th Street, St. Benedict the Moor Roman Catholic Church, an individually designated historic property, for the Province of St. Joseph of the Capuchin Order..

Resolution relating to a Certificate of Appropriateness for the construction of a new house at 2409 N. Terrace Avenue, in the North Point North Historic District, for Terrace 2409 LLC.

Resolution relating to a Certificate of Appropriateness for the repair of masonry at the front porch and other locations, at 1060 E. Juneau Avenue, in the First Ward Triangle Historic District, for GMC Miller House LLC, MRC Miller House..

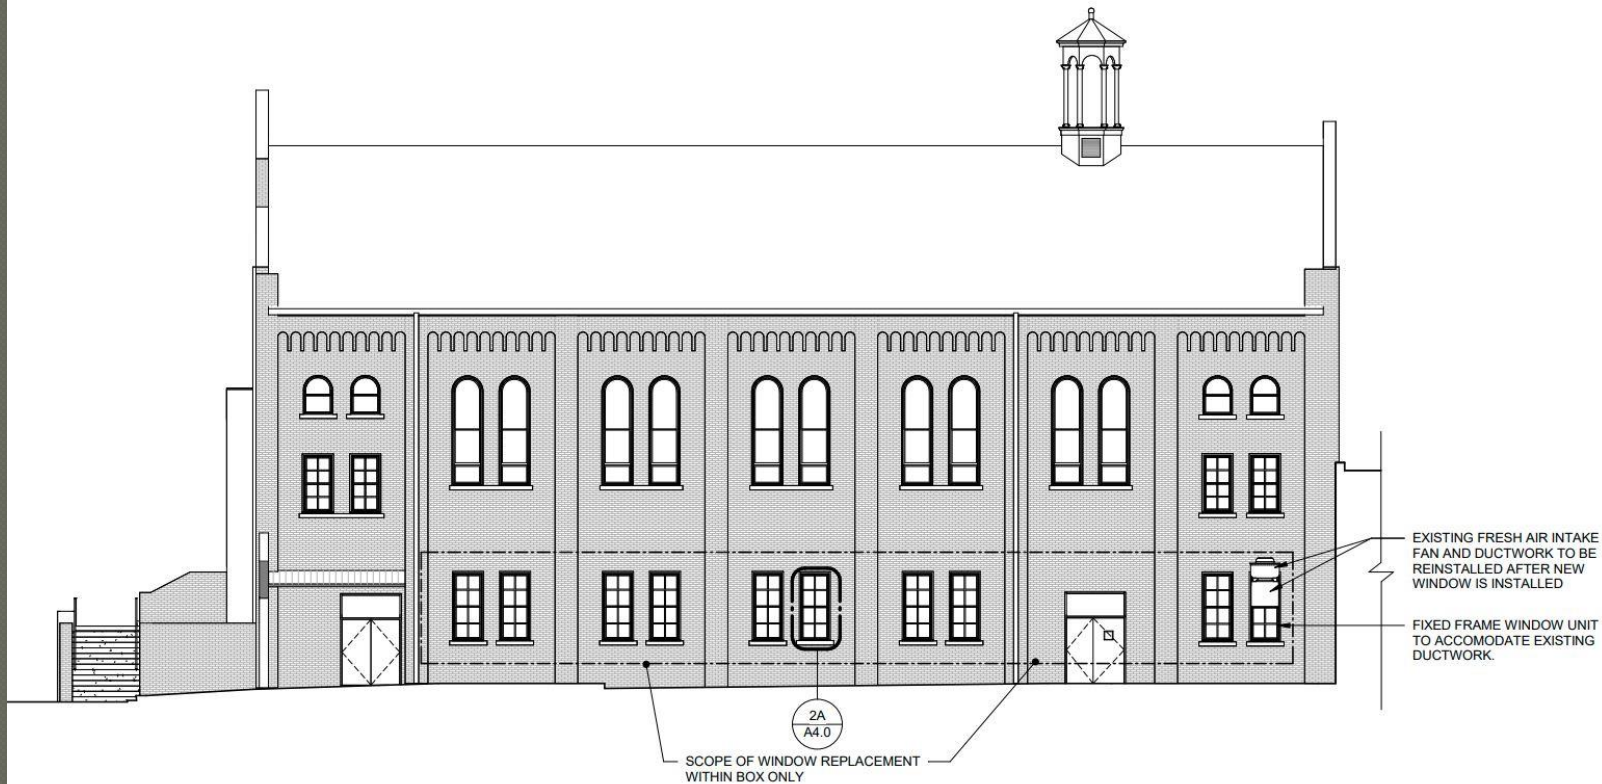
A2.1
 09/06/22

EXTERIOR ELEVATION - EAST
 3/32" = 1'-0"

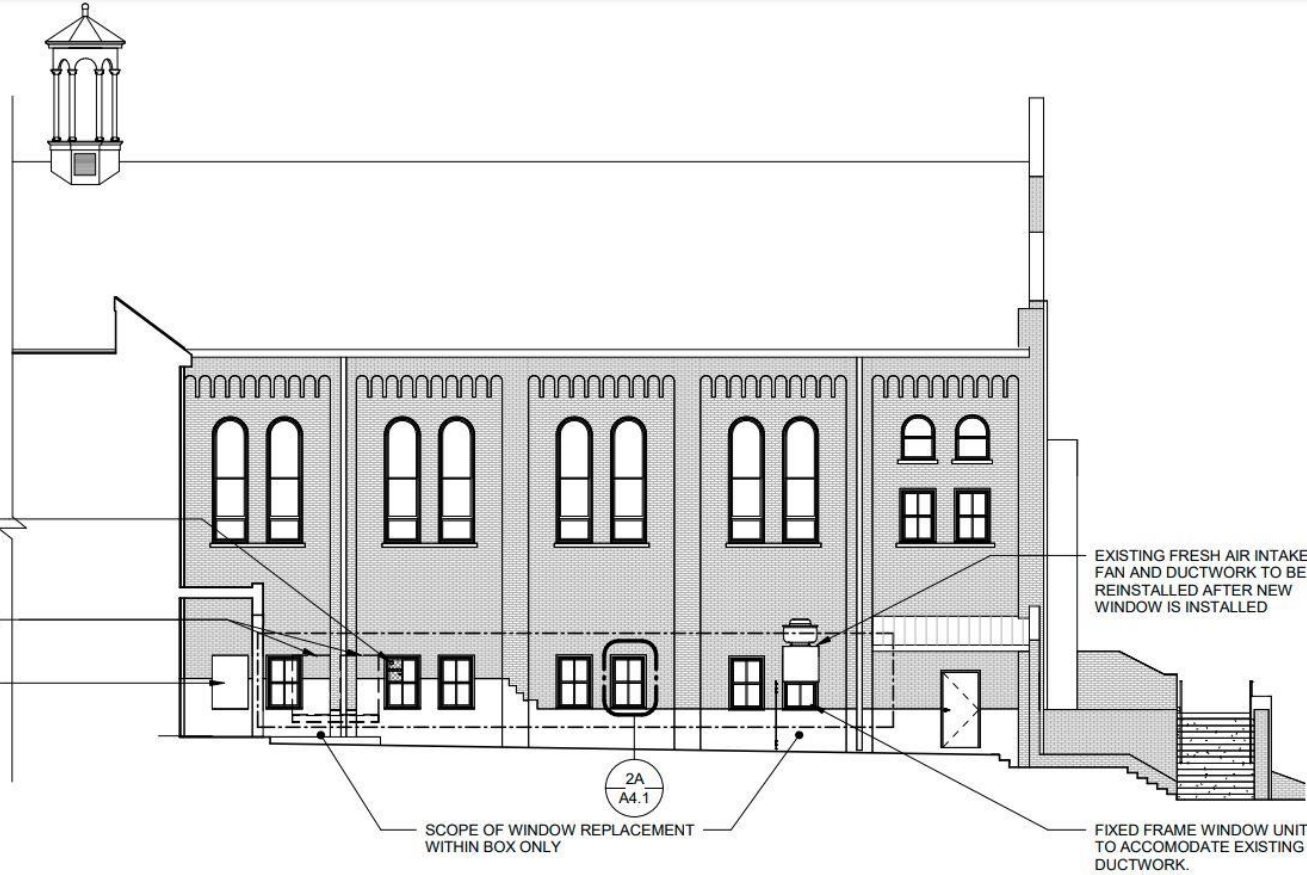
A2.2
 09/06/22

EXTERIOR ELEVATION - WEST
 3/32" = 1'-0"

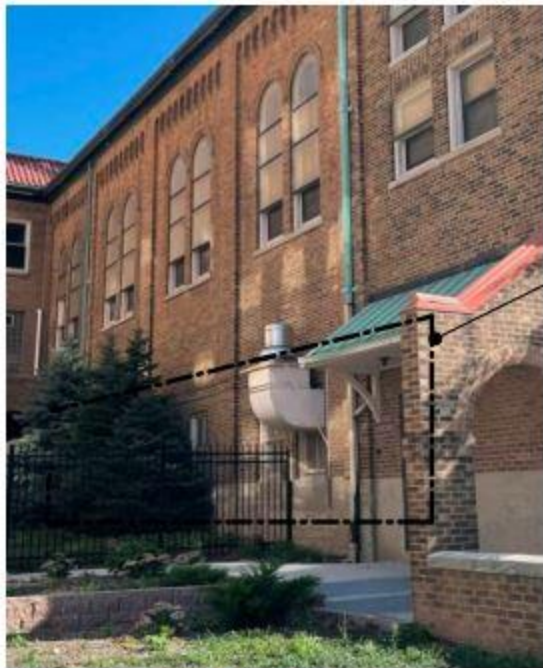
SCOPE OF WINDOW
REPLACEMENT
WITHIN BOX ONLY
