PERMANENT HISTORIC DESIGNATION STUDY REPORT
William Spence Investment Houses 1&2
September 13, 2021

Common Name: William Spence Investment Houses 1 & 2

II. LOCATION 2275 & 2279 North Summit Ave

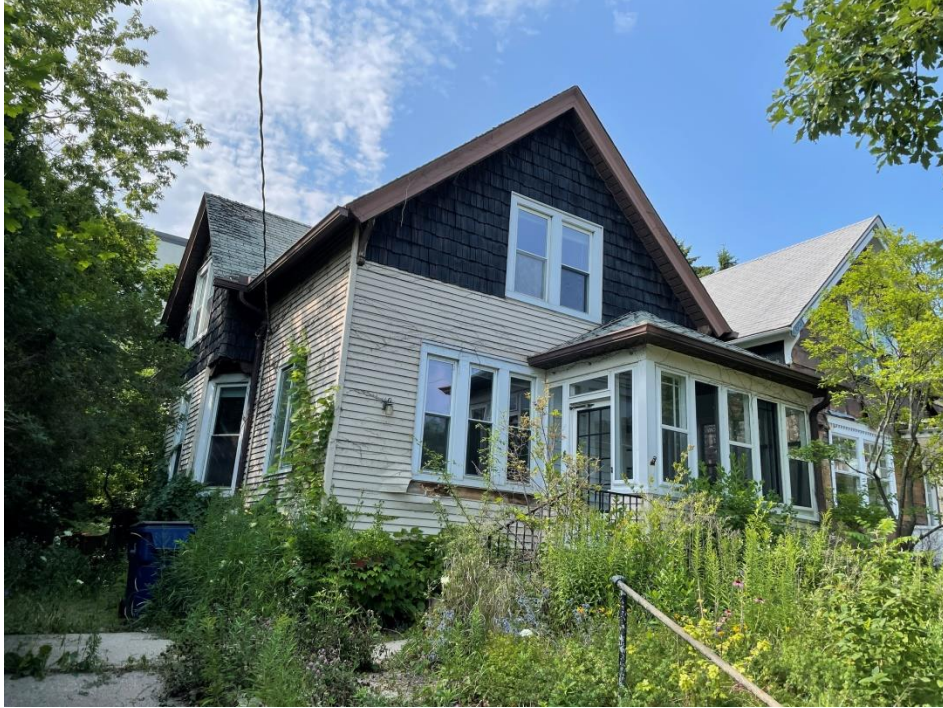
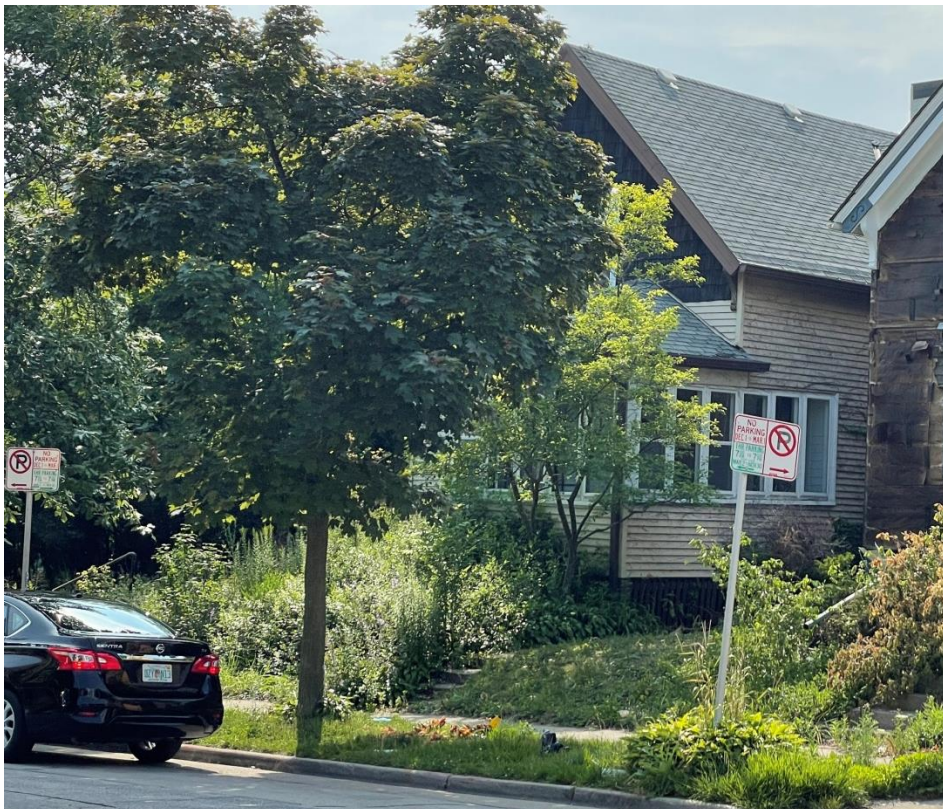
2275 N Summit

2275 is a one-and-a-half-story vernacular gable end cottage with subtle Queen Anne detailing. It has a green asphalt roof. Permit and map records suggest it was built as a substantial twin to the house to the north. The original porch was demolished and replaced with the current one in 1935. The southeast elevation of the house features a covered porch with a hip roof and unoriginal windows. The top story's gable arch is covered by a brown bargeboard that matches the connecting gutters. The soffit for the bargeboard appears to be shiplap drop siding and is supported by a modest wooden bracket. The southeast and northwest sides of the top story each have a cross-gable dormer with two non-original single hung windows. The first story is covered by beige aluminum siding, while the house's dormers are covered in square shake siding.

The house at 2275 likely started as a copy of 2279. Building permits suggest that it reached its present appearance around 1935 when the porch was enclosed. It now is more of a vernacular cottage with some surviving Queen Anne details. This change was so long ago that it adds to the story of the neighborhood where few houses have had a stylistic change (cf., 2549 N. Terrace Avenue).

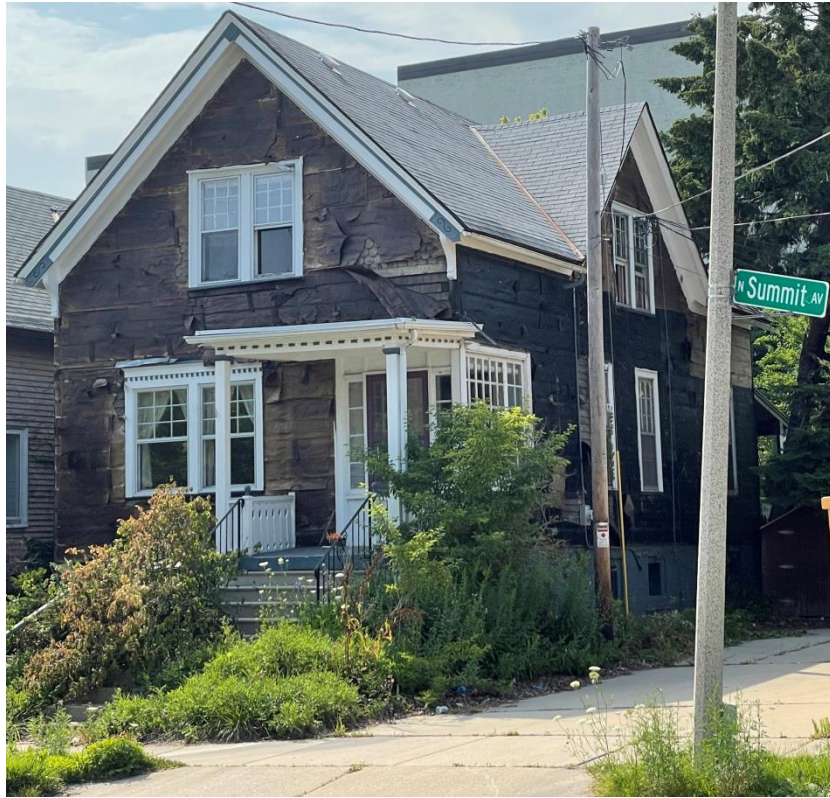
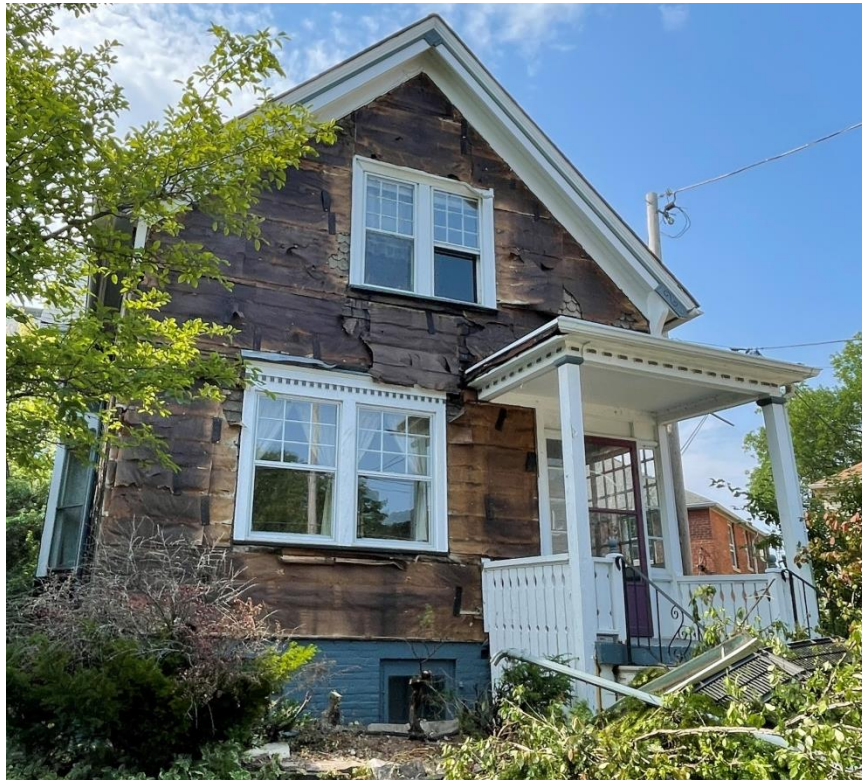
2279 N Summit

2279 is a folk Victorian style house in the form of a one-and-a-half-story vernacular gable end cottage with a gray asphalt roof. The front elevation of the house features a smaller porch with a flat roof, with a dentil course cornice. The top story's gable arch features a white, pointed bargeboard with a Prussian blue trim, as well as a white rake board and soffit. The ends of the bargeboard each have a blue decorative pendant that is either engraved with an S or a Z, and the entire bargeboard is supported by a modest wooden bracket on each end. The top story of the southeast and northwest sides has a cross-gable dormer with two non-original hung windows. The foundation of the house is made of Prussian blue-painted brick to match the house's since-removed siding. The siding's removal has exposed the original octagonal wooden shingles on the top floor, as well as the square shake siding on the main floor.
