## Certificate of Appropriateness

2479 N. Sherman Blvd. Sherman Boulevard HD (Greater Mount Zion Missionary Baptist

Church, FKA Immanuel Reformed Church)

PTS ID 114878 COA roof repairs

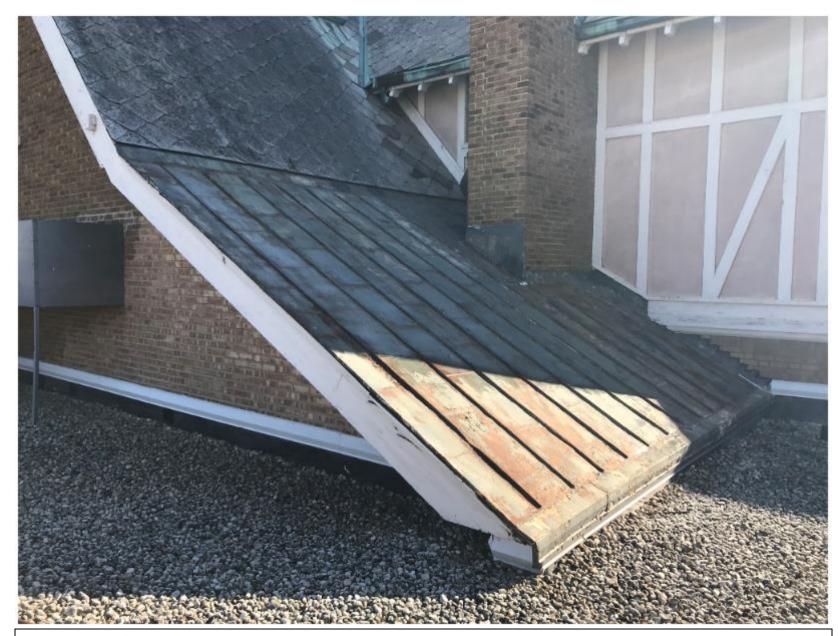
View of upper roof region to be repaired.

**Description of work** Repairs to the existing roof to address leakage problems. This includes installing insulation, EPDM rubber membrane, and 24-gauge prefinished galvanized steel trim along the east wall and upper asbestos shingle roof. At the area of the roof above the front door, shingles will be removed, an underlayment will be installed, and missing shingles will be replaced.

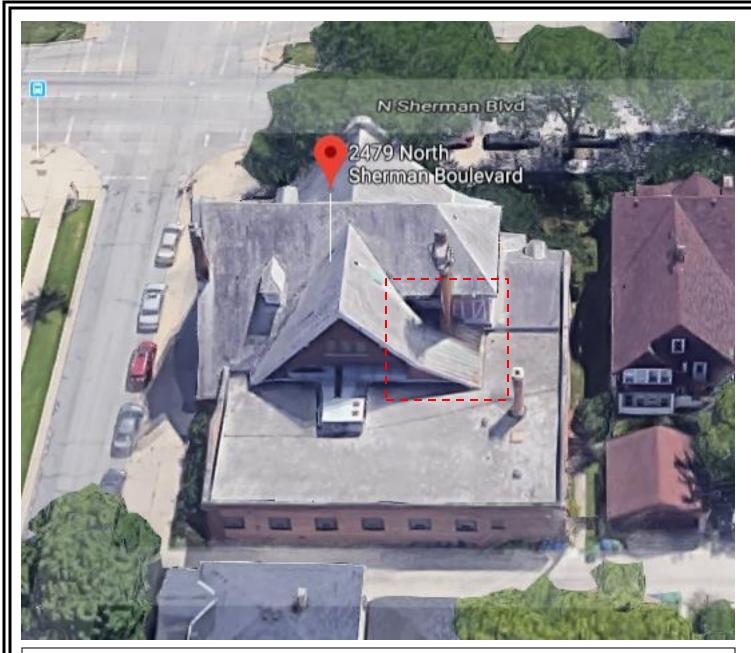
Area of upper roof to be repaired in relation to entire roof (region indicated in red)

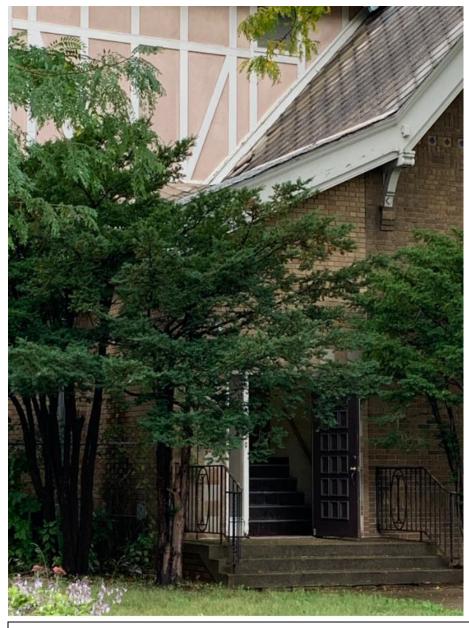
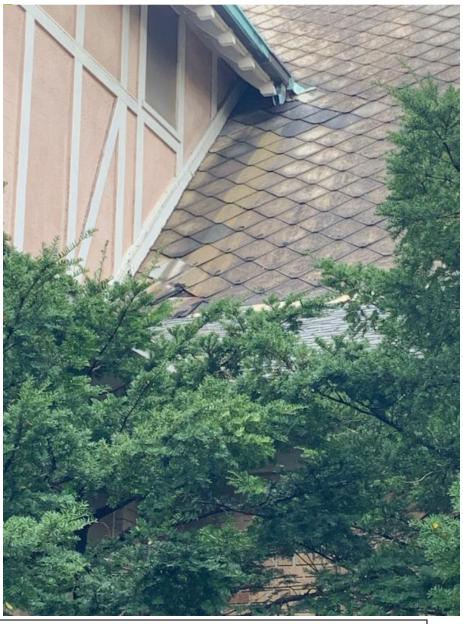
Area of concern above the front doors at the east side of the building. Asbestos shingles appear to be missing and water is actively leaking into the entrance. Up to 10 shingles will be removed, an Ice & Water Shield underlayment will be installed, removed shingles will be reinstalled and missing shingles will be replaced with asbestos shingles that match the existing size, color, and thickness.
