## LAMERS BLOCK

### 830-832(A) S. 5<sup>th</sup> Street

HISTORIC DESIGNATION REPORT

MAY 2023

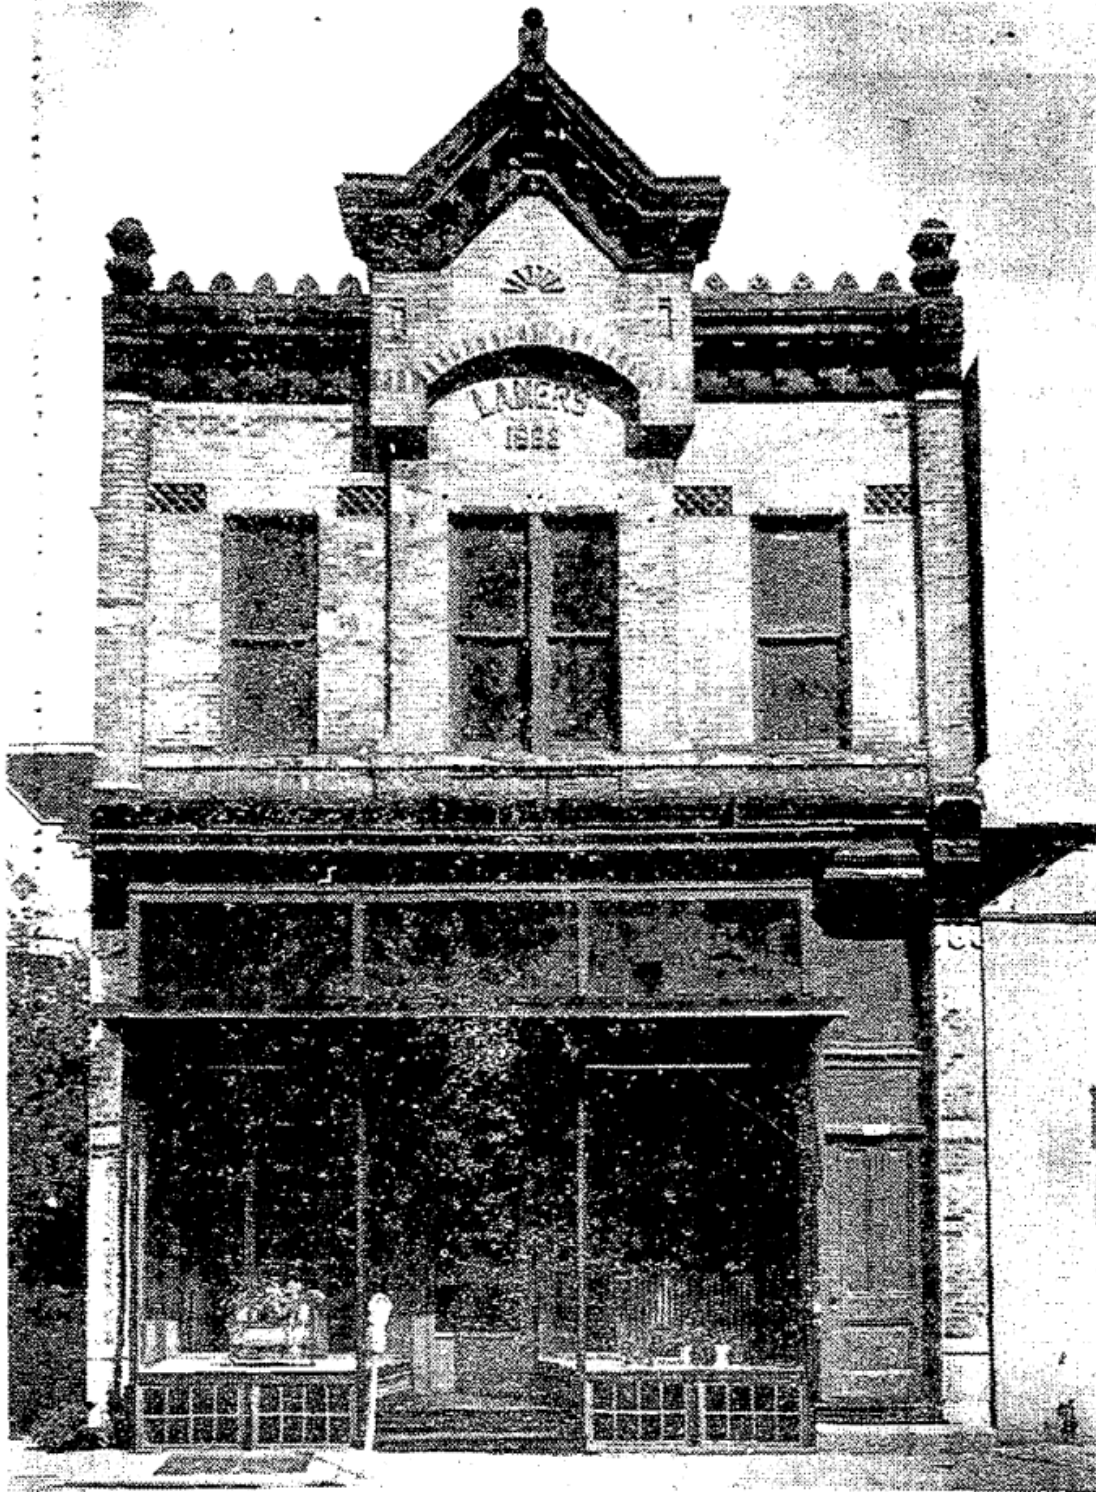
Figure 9. *Milwaukee Journal*, September 25, 1977.

Green paint was stripped from the first floor facade of the Lamers building at 830 S. 5th St., and the metal was painted black, the wood caramel. The owner, sculptor Celine Farrell, did most of the work herself.
