Neighborhood Flood Mitigation Projects

Existing Conditions – Copernicus Park

Design of Storm Water Improvements – Copernicus Park

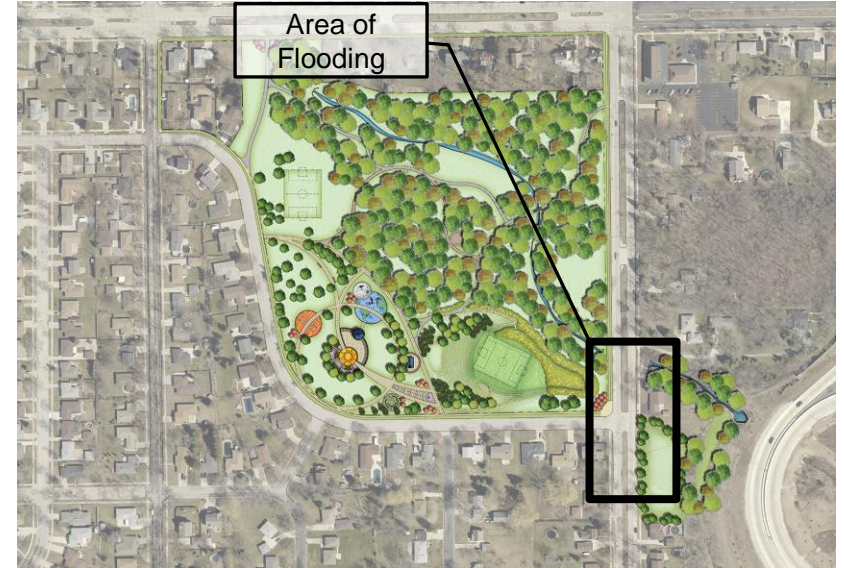
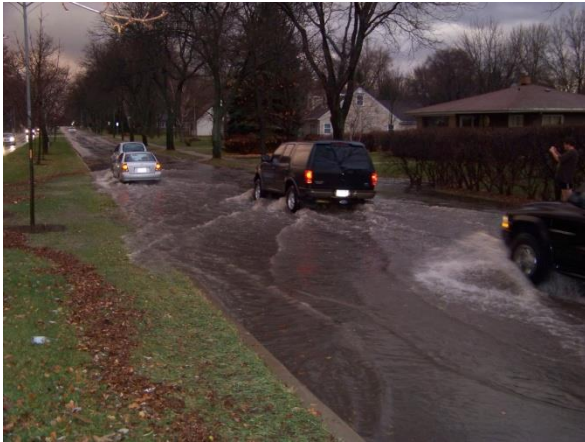
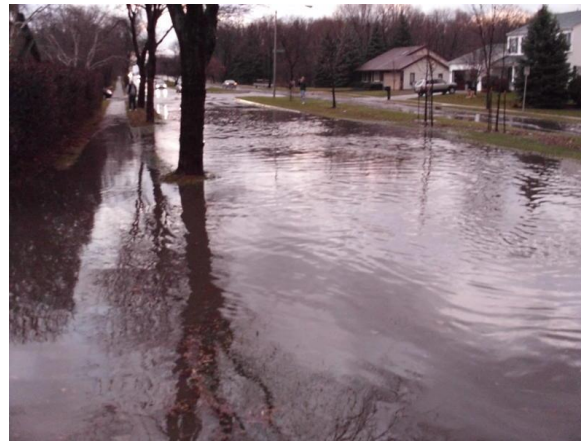
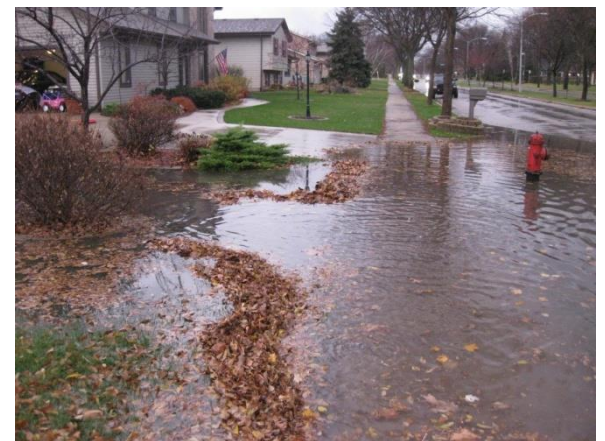
- Area has a history of repeated surface flooding and basement back-ups during heavy storm events
 - Historical events of 2008, 2009, and 2010
- Topography results in surface flooding through residential properties at the intersection of S. 20th St. and W. Klein Ave.
- 3 houses (5664, 5674 and 5710 S. 20th St.) have been demolished to diminish flooding concerns

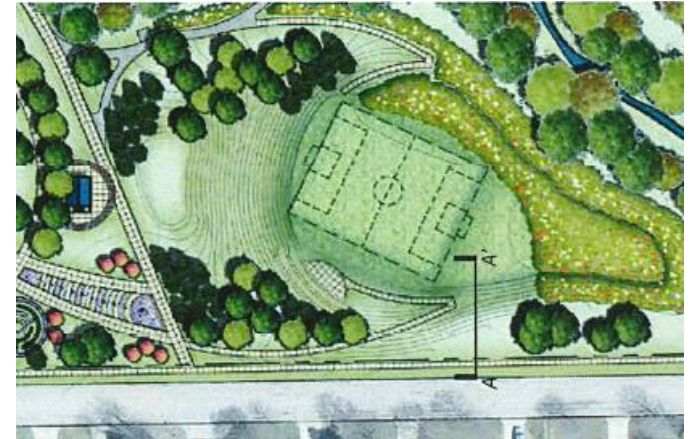
- Construct a 1.5 acre dry pond capable of detaining the 100-Year storm event in Copernicus Park.
- Located in non-programmed open grass areas.
- Re-route existing storm sewers into the proposed detention pond.
- Facility is incorporated into the park and becomes programmable space to promote park activities.

*Estimated drain down time for the stormwater management facilities is 24 to 48 hours.

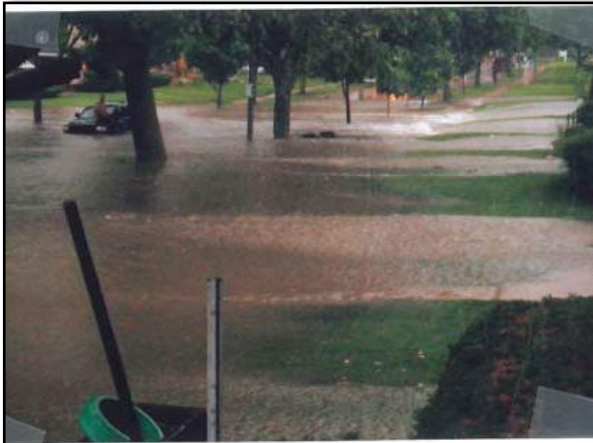
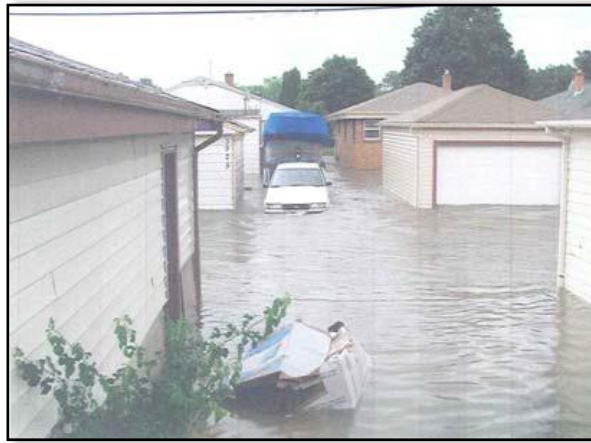
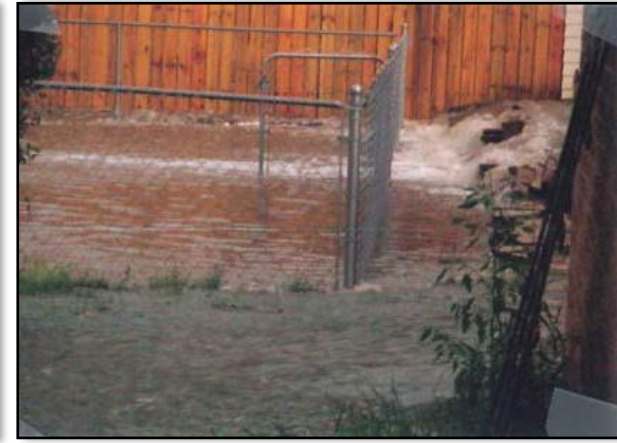
- Area has repeated surface flooding and basement back-ups during heavy storm events.
 - Historical events of 2008, 2009, and 2010
- Topography results in surface flooding through residential and commercial properties from lack of an overland flow path.
- 2013 Dineen Park Neighborhood Stormwater Study investigated and analyzed causes of and solutions to area flooding.

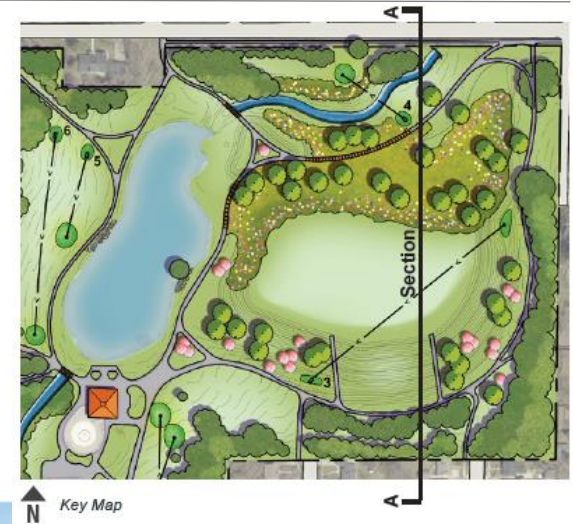
Section A-A

- Construct a 8.75 acre dry pond capable of detaining the 25-Year storm event in Dineen Park
 - Located in non-programmed open grass areas
- Facility is incorporated into the Master Plan and will be programmable space to promote park activities
