SIEVE ANALYSIS REPORT

Mortar Examination Report

Project: USHG# 20-138 2804-10 W. Kilbourn Ave, Milwaukee, WI

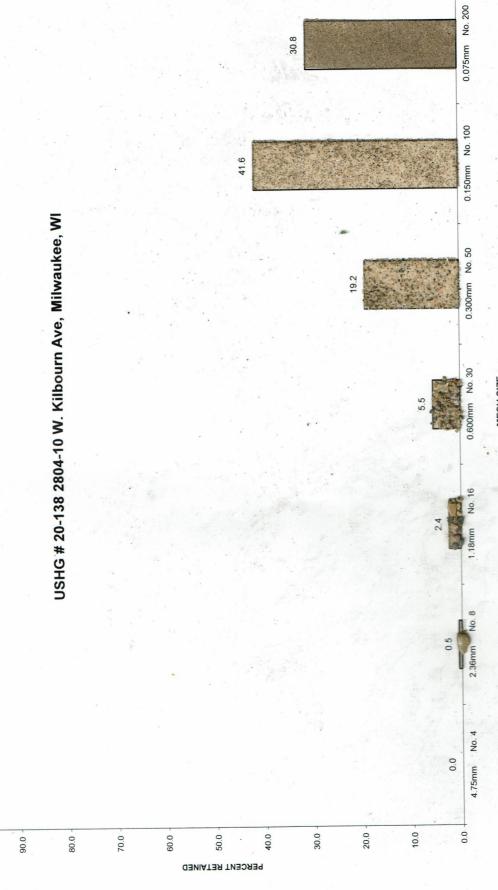
Sieve size	percent retained on each sieve [%]	Total percentage passing each sieve	Cumulative Percent Retained [%]
4.75mm	0.0	100.0	0.0
2.36mm	0.5	99.5	0.5
1.18mm	2.4	97.1	2.9
0.600mm	5.5	91.6	8.4
0.300mm	19.2	72.4	27.6
0.150mm	41.6	30.8	69.2
0.075mm	30.8	0.0	100.0

Fineness Modulus

1.09

Enclosed please find sand gradation chart representing original aggregate extracted from the mortar sample.
