**Forsythe House
Peltz Galley**

1119 E Knapp Street
Milwaukee, WI
53202

Application for Certificate of Appropriateness

Location: Front Building Windows

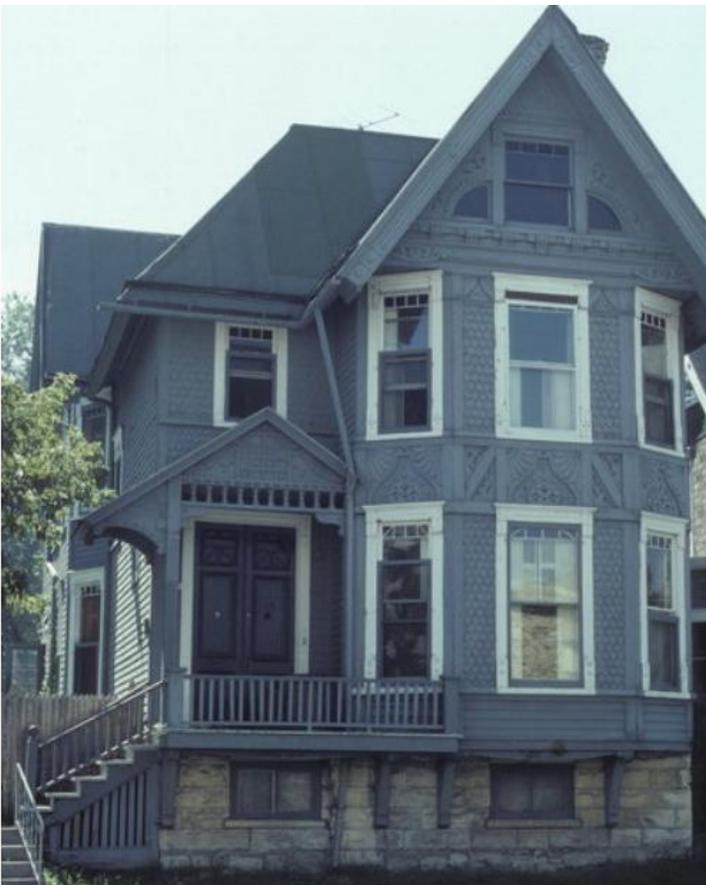
The current owner, WSP Peltz House has purchased a building with outstanding orders. They wish to complete the orders in a historically authentic and sympathetic manner. Below please find locations and drawings of the proposed remedy for your approval. Reviewing archival photos and the most recent MLS listing it is apparent the units facing the front of the building have been stripped of the original sashes containing stained glass and replaced with simple, clear glass sashes.

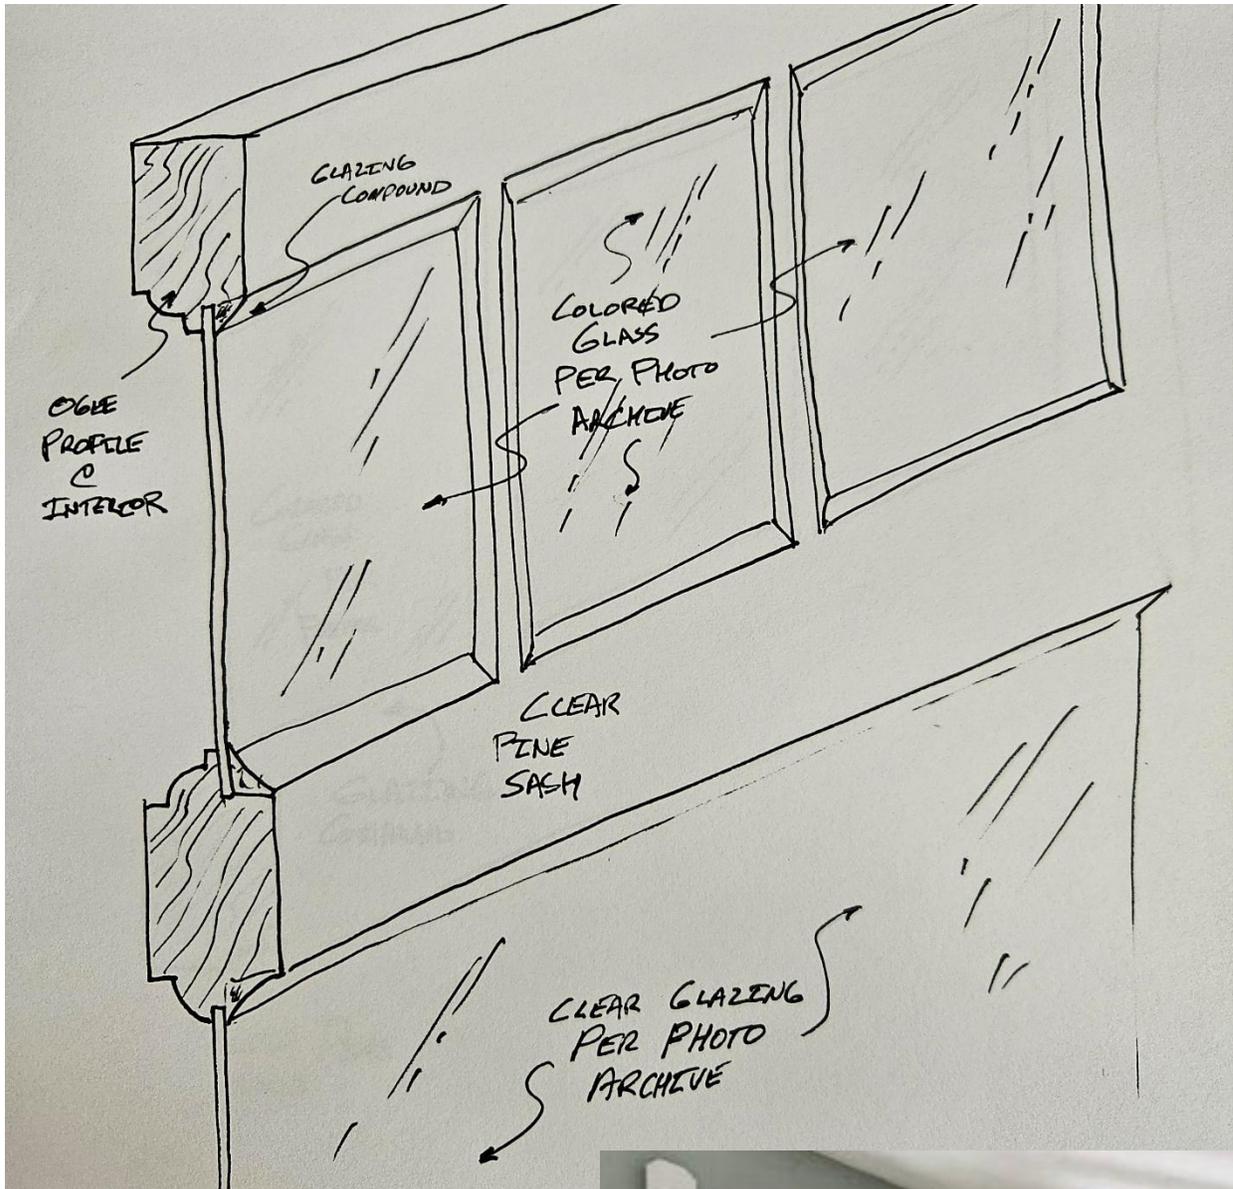
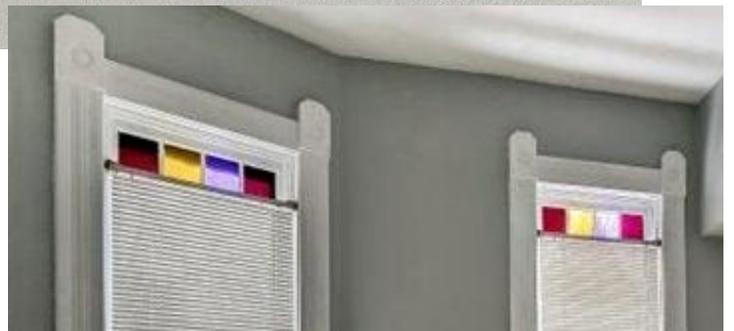
Cross Section and Description of New Sashes

Custom made of clear pine, primed and painted, the new sashes will fit into the existing frames and contain a ogee style edge at the interior and glazing compound at exterior. Stained glass is to be single pane, varied colors from green, purple, red, blue, and yellow.

Storm windows at exterior are to be wood, clear pine, primed and painted, hung at top brickmold
