Certificate of Appropriateness

Property 844 N. BROADWAY (Old) St. Mary's Roman Catholic Church & Rectory
Description of work Replace plexiglass/lexan in storm windows with laminated glass per specifications below.
Existing frames will remain.
Date issued 5/17/2018 PTS ID 114530 COA: replace glass in storm windows

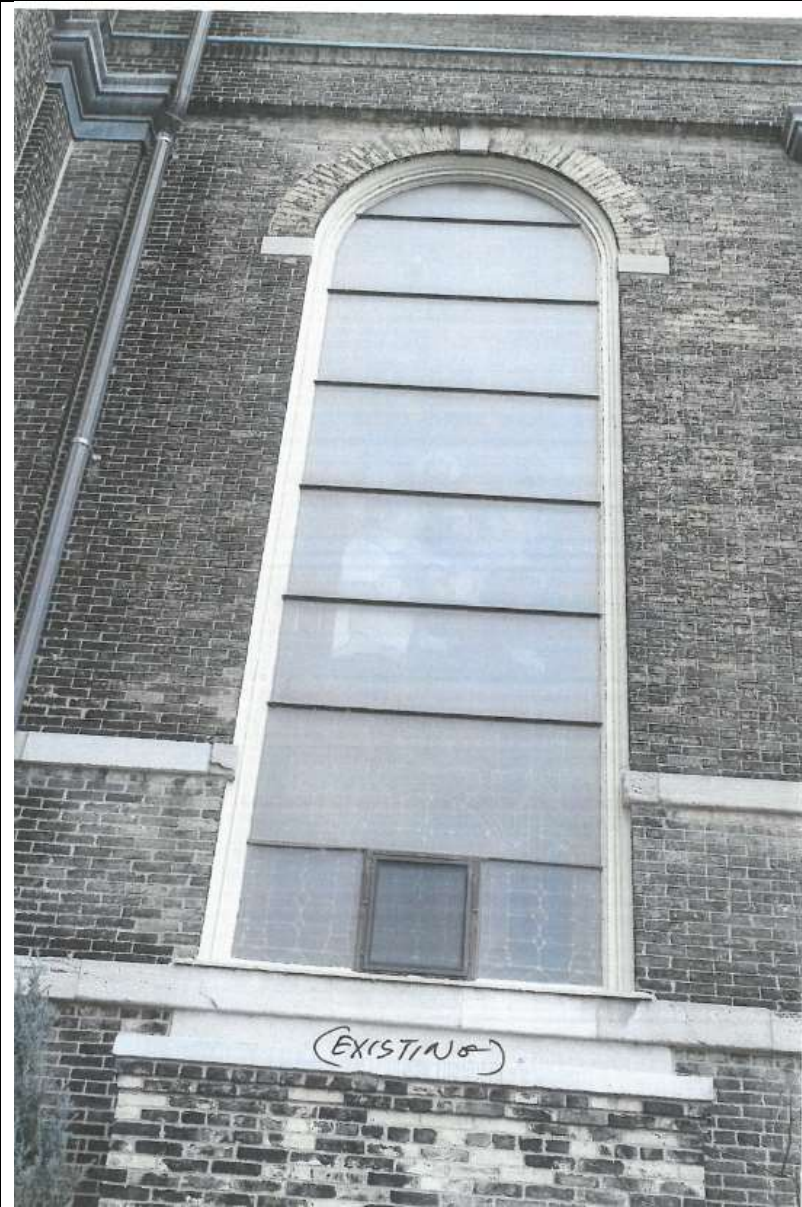
Typical Existing

Remove existing yellowed and scratched plastic Lexan coverings where it had been installed in the past to replace original clear glass.

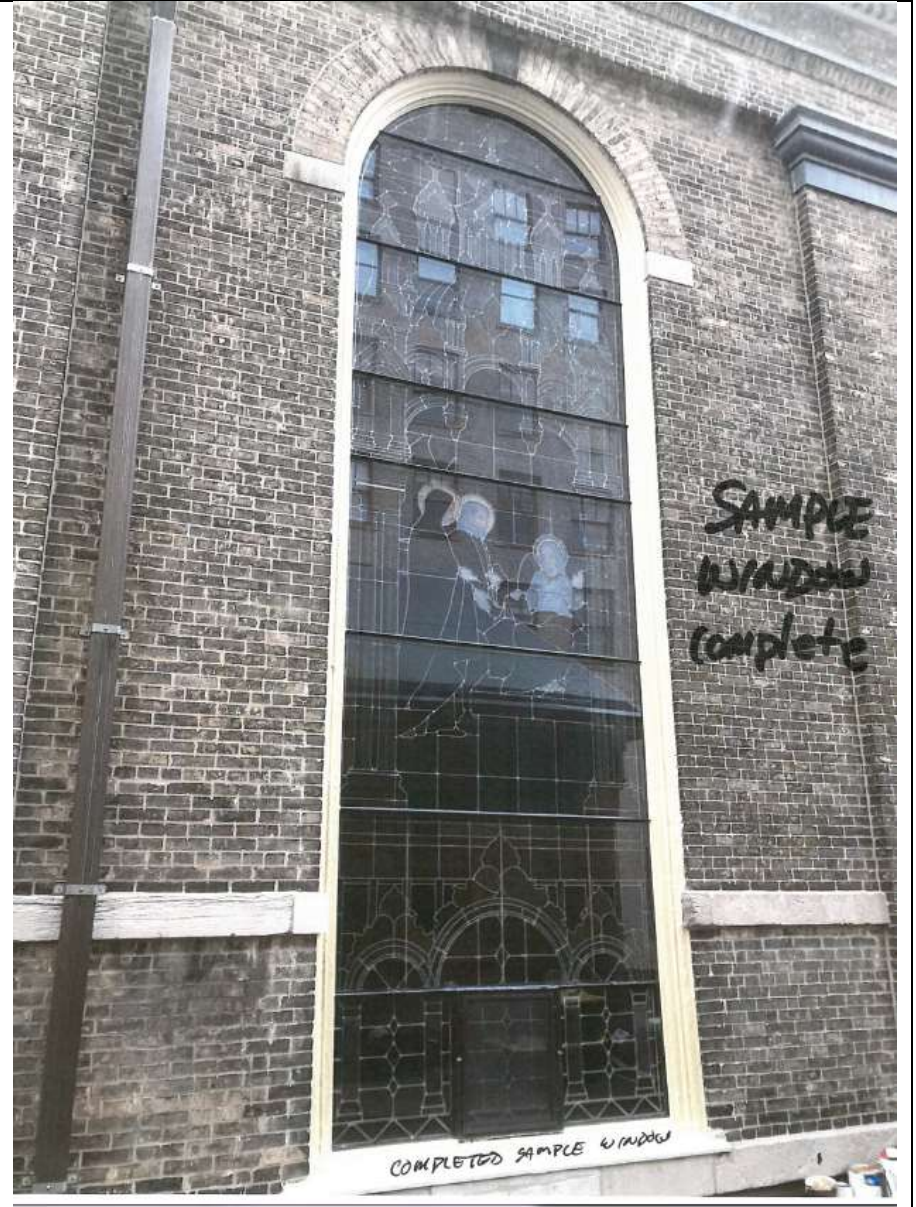
Proposed

- Exposed metal on dividing bars will be scraped, primed and painted.
- Install ¼" clear safety laminated glass within the existing frames using the existing dividing bars.

- Seal protective glass perimeters with Urethane based Dymonic Caulk.
- Holes to provide venting of the air-space will be drilled into the parting stop between the two glazings, however, the holes will not be connected to the interior at this time to save the cost of an interior scaffolding system. Once the installation is complete, owner will monitor any accumulated condensation and if necessary, the venting can be completed to the interior under separate contract at a later date.
