Certificate of Appropriateness

2519 E. Kenwood Boulevard, Fourth Church of Christ, Scientist

Restoration of the double-hung windows and new wood storm windows per the attached scope of work.

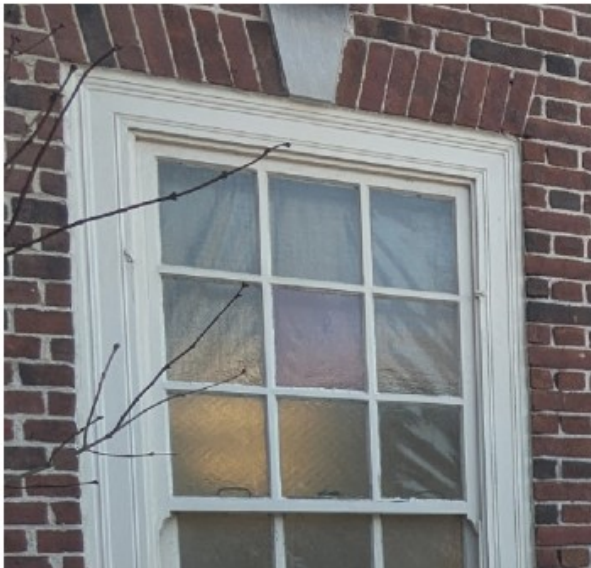
Window missing storm window, with vinyl plastic visible from exterior, as well as remnants of the closing swivels from original storm window

- Creation of storm windows from Sapele lumber using mortise and tenon joinery for assembly. The interior will have a roman ogee profile and the glass will be glazed with traditional putty glazing, resembling the original look and function of the prior existing windows exactly.
- Windows will be locked and open with interior storm windows stays.
- The center rail on the storm window will be lined exactly with partition between two sashes of interior double hung windows.

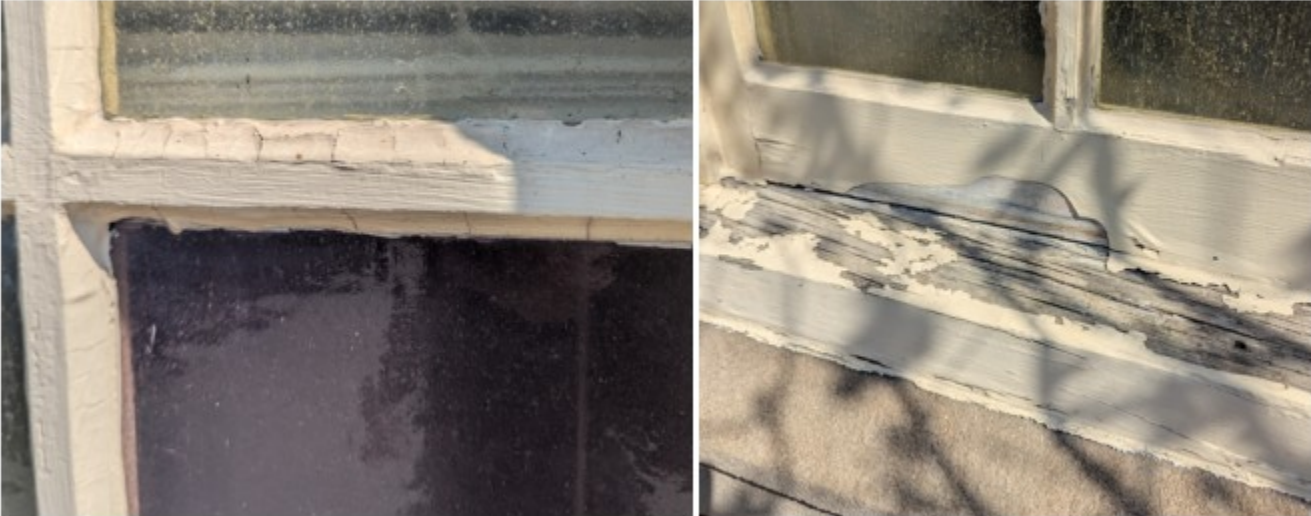
Close up of double hung windows needing repair

- scrape loose paint and re-paint with an oil based paint matching the original color (we will test the color on an interior courtyard window to ensure proper matching)
- Remove, scrape / clean, reglaze existing panes (not replacing them)
- Restore functioning of the sashes with proper weights and chains.
