CERTIFICATE OF APPROPRIATENESS APPLICATION FORM

The Pabst Mansion Pavilion

2000 W. Wisconsin Avenue, Milwaukee, WI 53233

PROPOSAL OVERVIEW

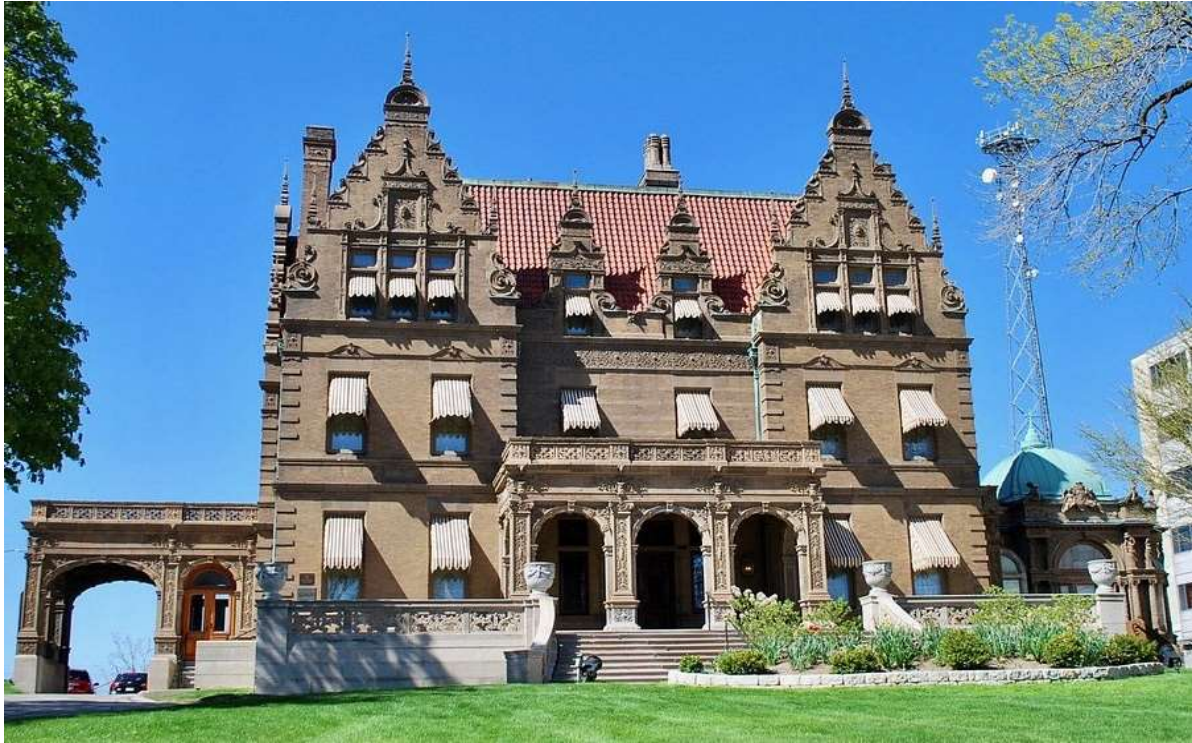
Our intention in requesting this COA is to secure the Commission's approval to engage in a very unique but necessary operation to save the pavilion at the Pabst Mansion (the small structure east of the main house). The pavilion is in an extremely deteriorated condition, and it is not possible to restore it in a traditional manner. Its current condition and restoration complexities are more fully described later in this application.

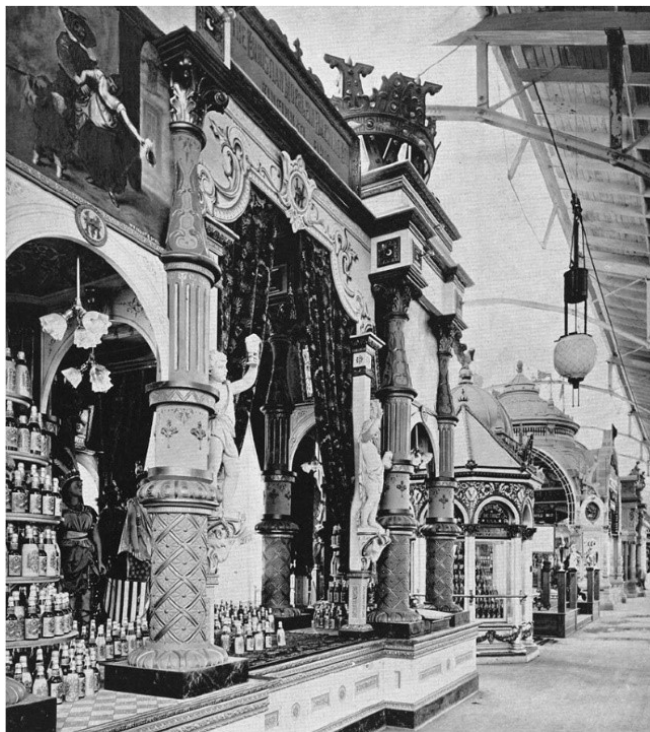
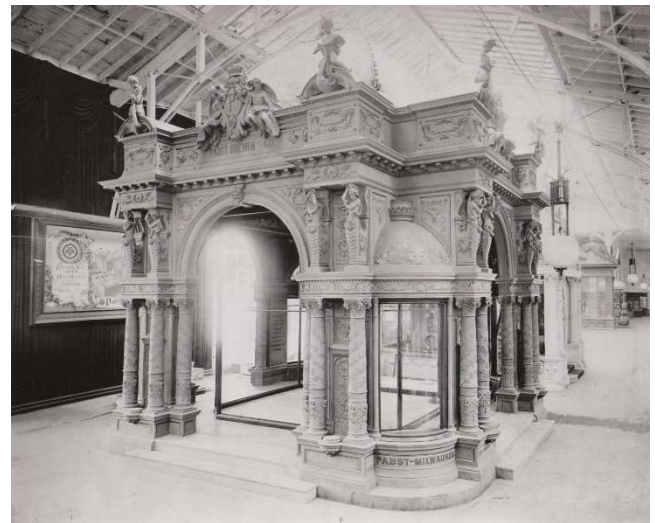
The pavilion was designed as an interior exhibit for the Pabst Brewing Company at the 1893 World's Fair in Chicago. Specifically, the Pabst Beer Pavilion was located on the gallery level at the west end of the Agriculture Building (*below right*). Note the Agriculture Building's roof featured bowstring trusses with a central glass skylight. It was located within the beer exhibit which featured over 30 similar pavilions from breweries throughout the country (*below left*). The pavilion was constructed of terra cotta hung from a steel frame. The corners had curved glass display cases which displayed Pabst Brewing Company products and were capped with quarter-dome highly ornamental stained glass. The pavilion was topped with a highly ornamental stained-glass dome.

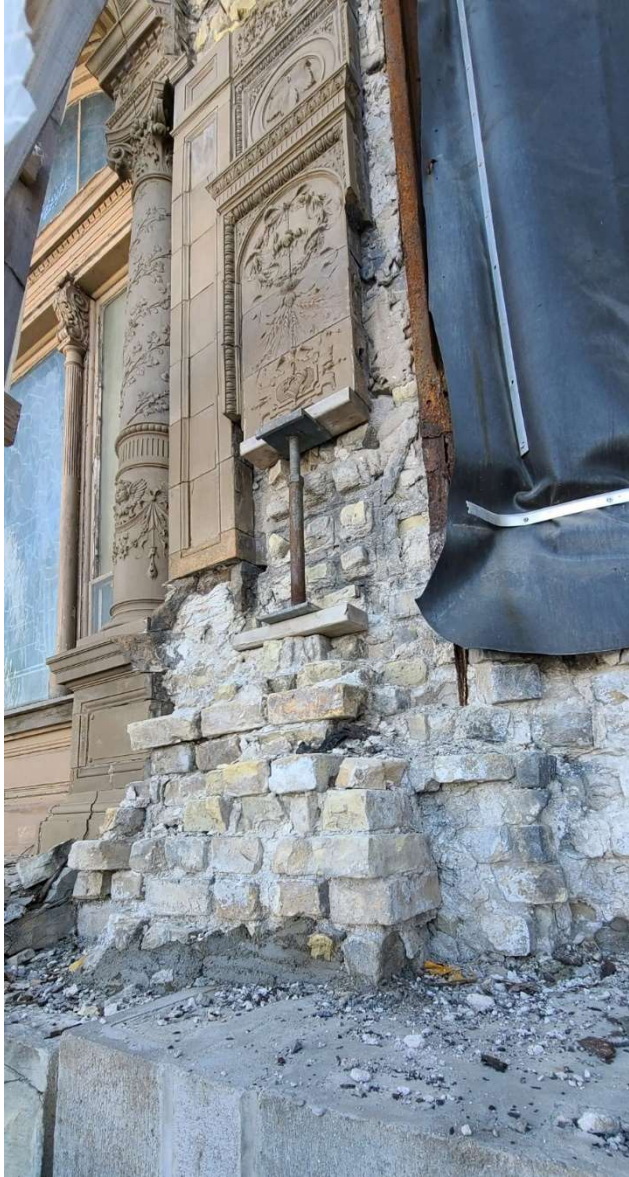
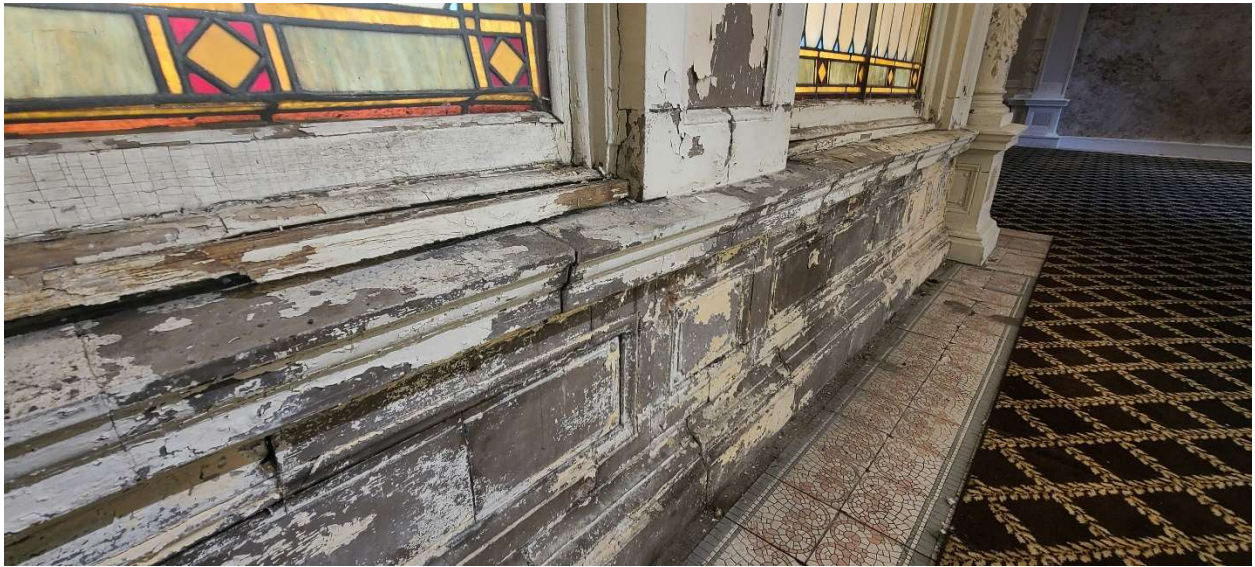
More than 100 years later, the pavilion remains attached to the mansion. Because the pavilion was not designed to be a permanent building located outside in Wisconsin's extreme weather, it was not constructed to be weather-tight with appropriate materials or details such as flashing, caulking, and insulation. The pavilion's construction combined with Wisconsin's freeze-thaw cycle create the perfect recipe for water infiltration and deterioration. The deterioration observed throughout is a cause of continuous water intrusion at the roof, walls, and windows as there was never flashing or caulking installed. Currently, the decorative terra cotta is attached to Cream City Brick (CCB) structure, not original to the building (*left*). The CCB back-up was never engineered to include movement joints, flashing materials, or proper rust-resistant anchors for the terra cotta attachment. Combining the lack of proper structure and constant water intrusion, Pabst Mansion has invested significant funds to stabilize the pavilion over the past 40 years, but these were all temporary patches. Caulks and sealant products have only covered up the inherent and fundamental problems below the surface. The north elevation is in the worst condition. Plastic was installed in 2017 to protect the structure from the elements. Wooden braces, a jack and foam column were further temporary measures taken to hold the exterior masonry in place.

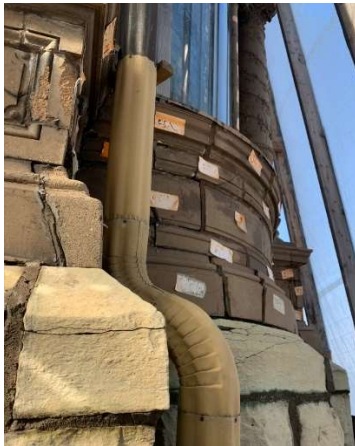
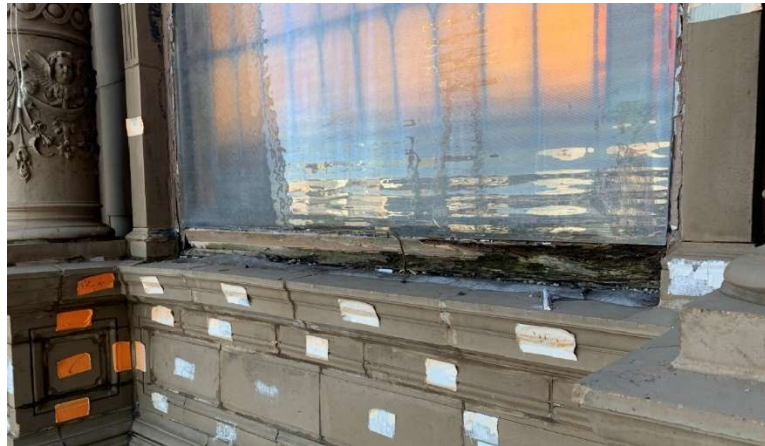
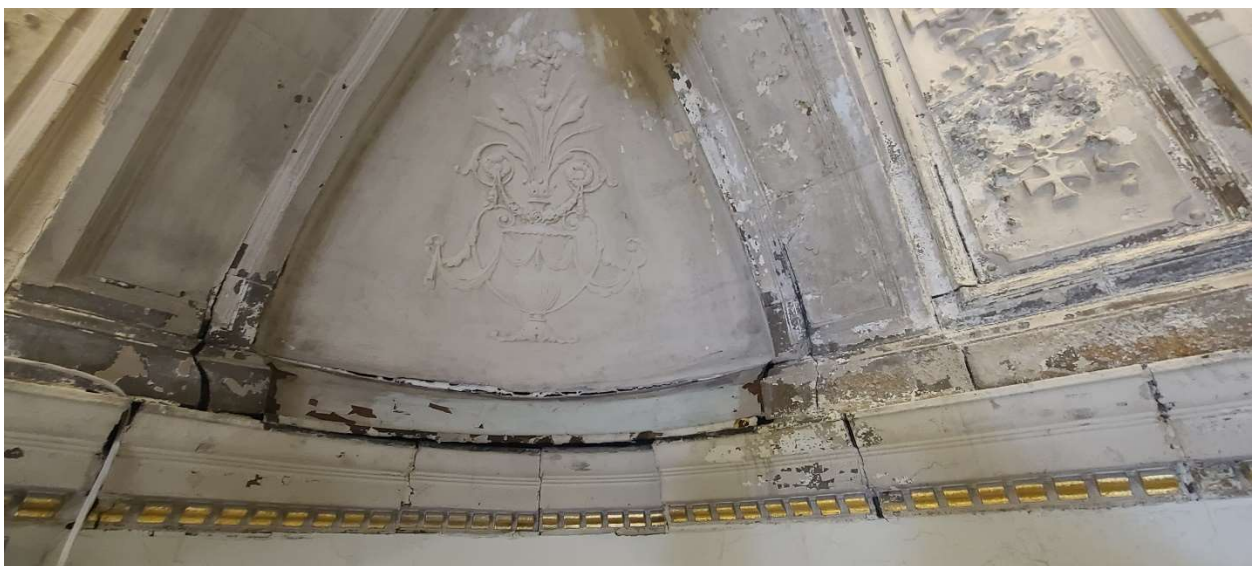
Today we can see the impact of placing a structure designed to be indoors in Wisconsin weather. Specifically, wood windowsills are rotted (*above and below*), and terra cotta is spalling and cracking due to the freeze-thaw effect of water within the walls (*below*). Most importantly, the roof (the most vulnerable location on a building) was never properly designed or installed after the building was moved to Milwaukee. Water continues to penetrate cracks and openings despite unending repair work (*below bottom*).

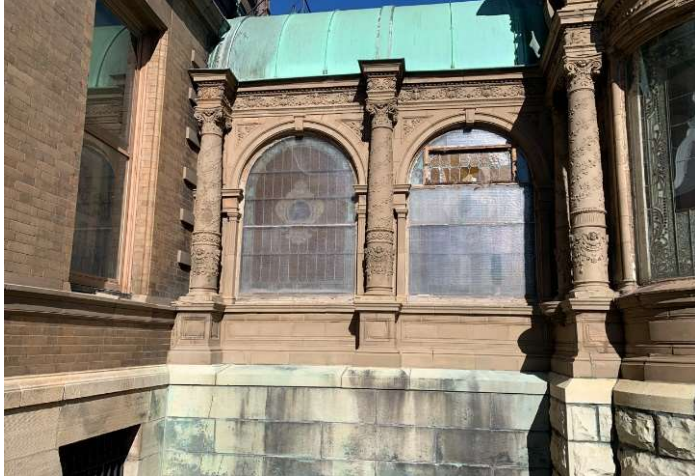
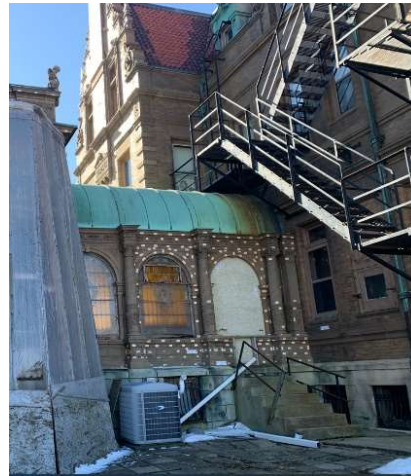
The south (*left*) and north (*right*) elevations of the non-original hyphen constructed to connect the pavilion to the mansion. Note the masonry openings retain the stained glass installed by the Archdiocese.

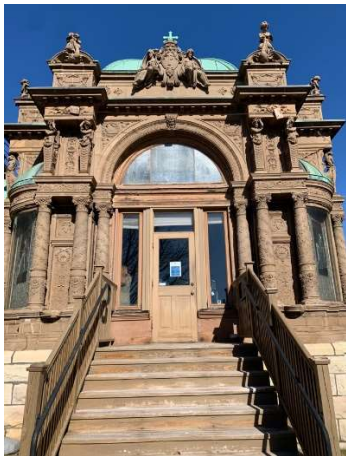
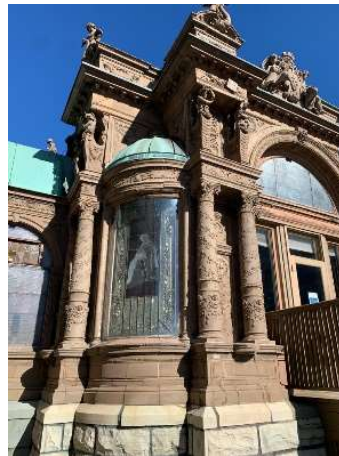
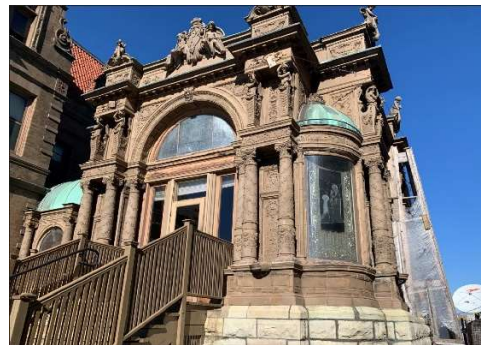
The central and corner quarter domes are copper replacing the original stained-glass domes. The south elevation also showing stained glass windows at both corners and above the non-original entrance infill. Non-original wood stair.

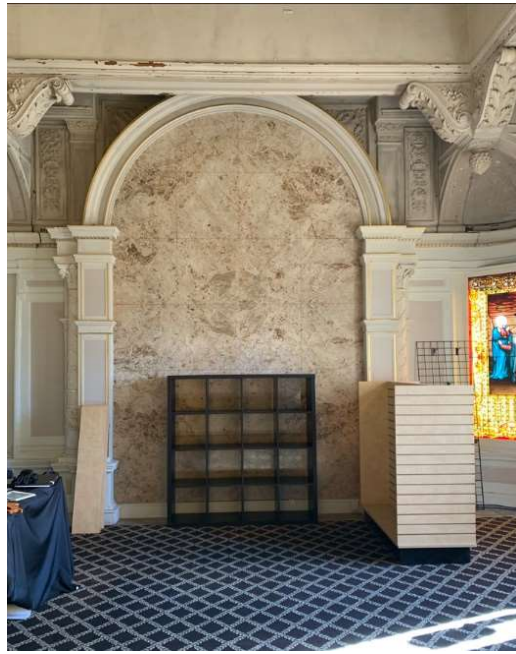
At the exterior the east elevation archway was infilled with brick including a cross (*left*). At the interior, marble was installed within this archway and the two columns were removed (*right*).

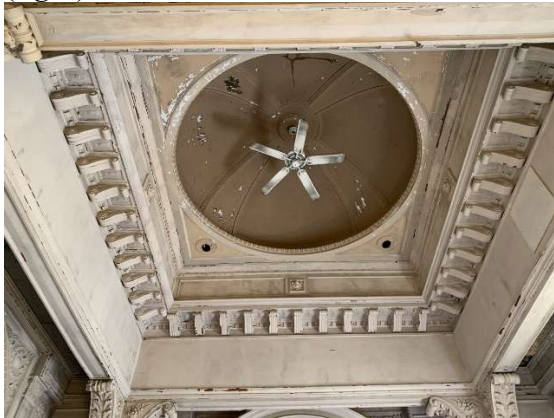
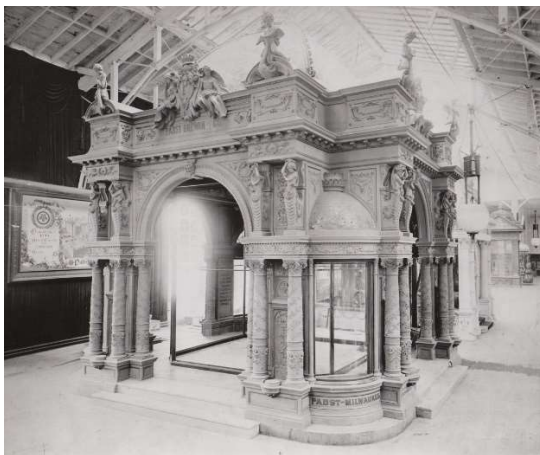
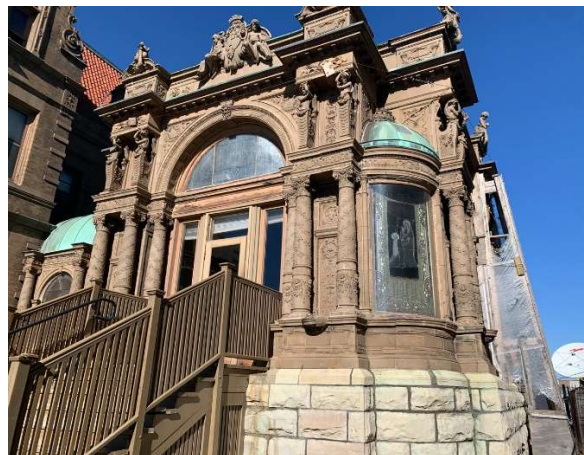
Above (*left*) is the plastered dome, and above (*right*) are the stained-glass windows all installed by the Archdiocese. The original Pabst Beer Pavilion (*below left*) at the 1893 World's Fair and a photo (*below right*) of the pavilion as it appears today. When comparing the two the compounded alterations create a different structure altogether.

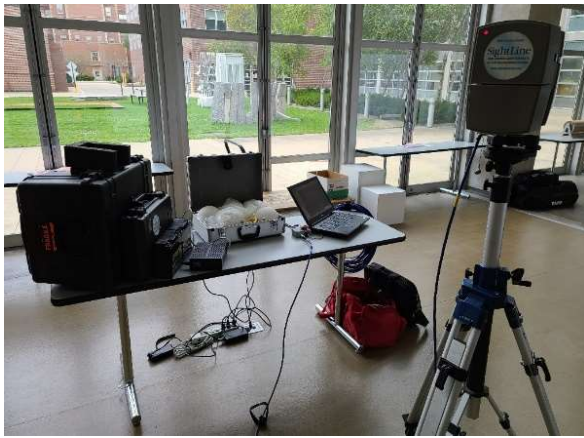
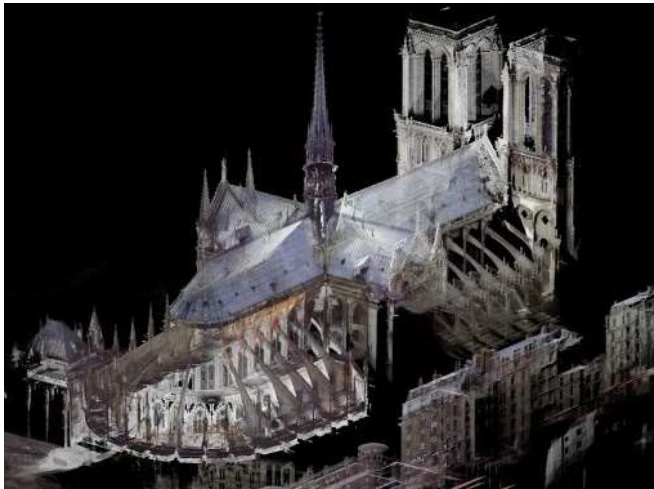
We seek approval for the first phase and will submit COAAs for the later phases. In Phase One, recording of the pavilion will be conducted using the most advanced tools available (*left*). These scans will be used in Phase Two to create new pieces with 3D printing. This eliminates guesswork and allows the construction team to have complete confidence in what ultimately is reassembled in Phase Three. Please note, it is the intention to recreate the original pavilion design as seen in 1893, the alterations the Archdiocese completed will not be part of the future reconstruction.

Laser Scanning is a recently employed technology that uses inferred laser points – similar to that of a laser pointer - to create a computerized electronic file of physical data points called a Point Cloud file. Approximately 900,000 points in space are recorded per second. The electronic data is a computer copy or twin of the original. The file is a permanent archive of the physical information about the building or object. Many owners will commit to this simple product in order to have archival information for safety purposes if anything might happen to the building. (This

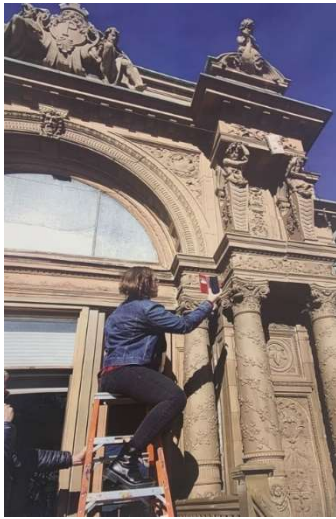
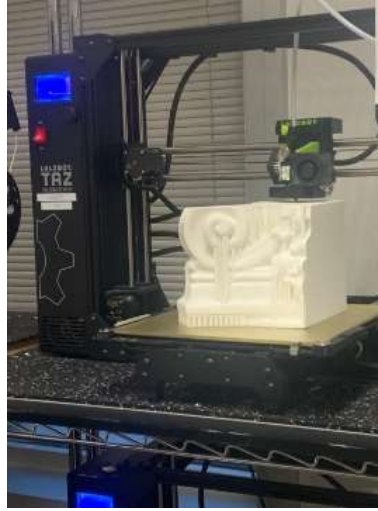
The other advantage of laser scanning is recording each individual piece (*left*). This scan information will be used to create the new pieces using a 3D printer (*left*). The 3D prints will be the positive object from which a negative mold is created. That negative is used to create the final terra cotta piece, which takes place in Phase Two.
