Project Narrative for the Building 29 Renovation (part of the Brewery Project Site) Submitted as part of the Application for Development Incentive Zone on October 21, 2014 Project Location: West Highland Avenue and 9th Street, Milwaukee, Wisconsin

Owner: Blue Ribbon Suites, LLC

Architect: HGA Architects and Engineers

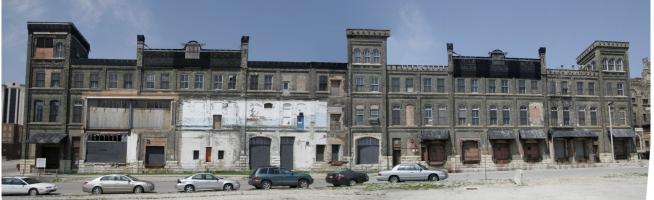
East Elevation (along 9th Street); Photo from June 2014

The exterior brick walls have been modified in numerous locations and ways: with the insertion of new loading dock doors; the addition of new window, louver and door locations; the infill of original windows (with new materials including glass block, concrete block and different types of brick); and several bridge connections and building additions (now removed). The face of the brick is very soiled and there is significant areas were mortar is missing or has been replaced with incompatible concrete mortar repairs. The tall parapets have been surveyed and while mostly intact have moved and are out of plumb by as much as 4"; many of the parapets have received temporary bracing and netting. Portions of the exterior brick face and all of the interior brick walls have been painted.

Many of the original windows in the building have been replaced with metal or vinyl replacement windows. However, some original wood and metal windows do remain – the sills and bottom sashes are typically in poor condition.
