# Certificate of Appropriateness **AMENDED**

959 N. 34 TH                      Concordia Historic District

PTS ID 113428 COA Remodel Porch

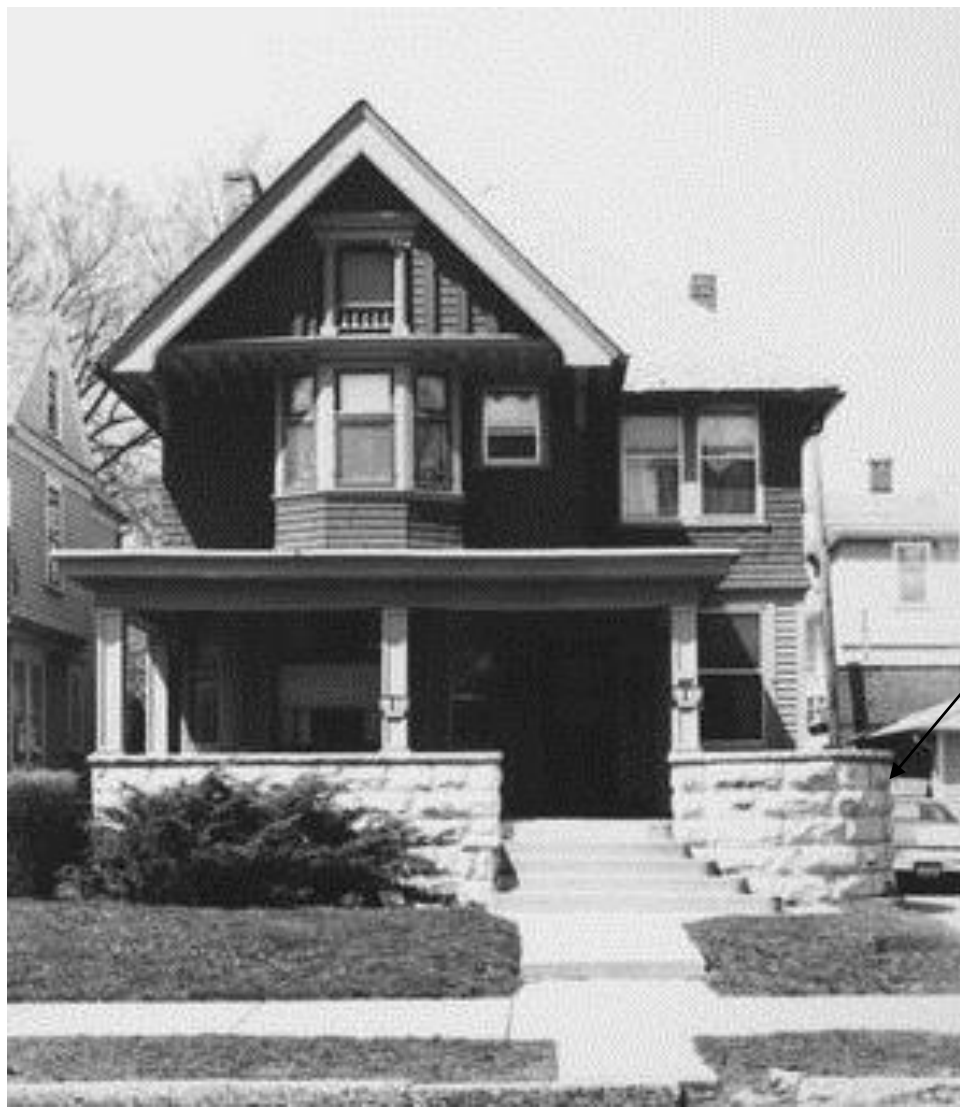
Front porch will be carefully deconstructed and rebuilt using the same stone. The stone walls are five courses high with an interior of brick.

**The current stone will be re-used for the porch. Mortar must be historically appropriate and not consist of all Portland cement.**

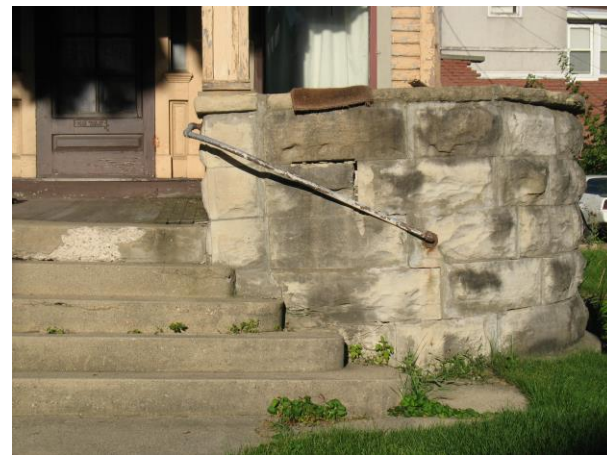
The sole surviving original fluted column on the porch.

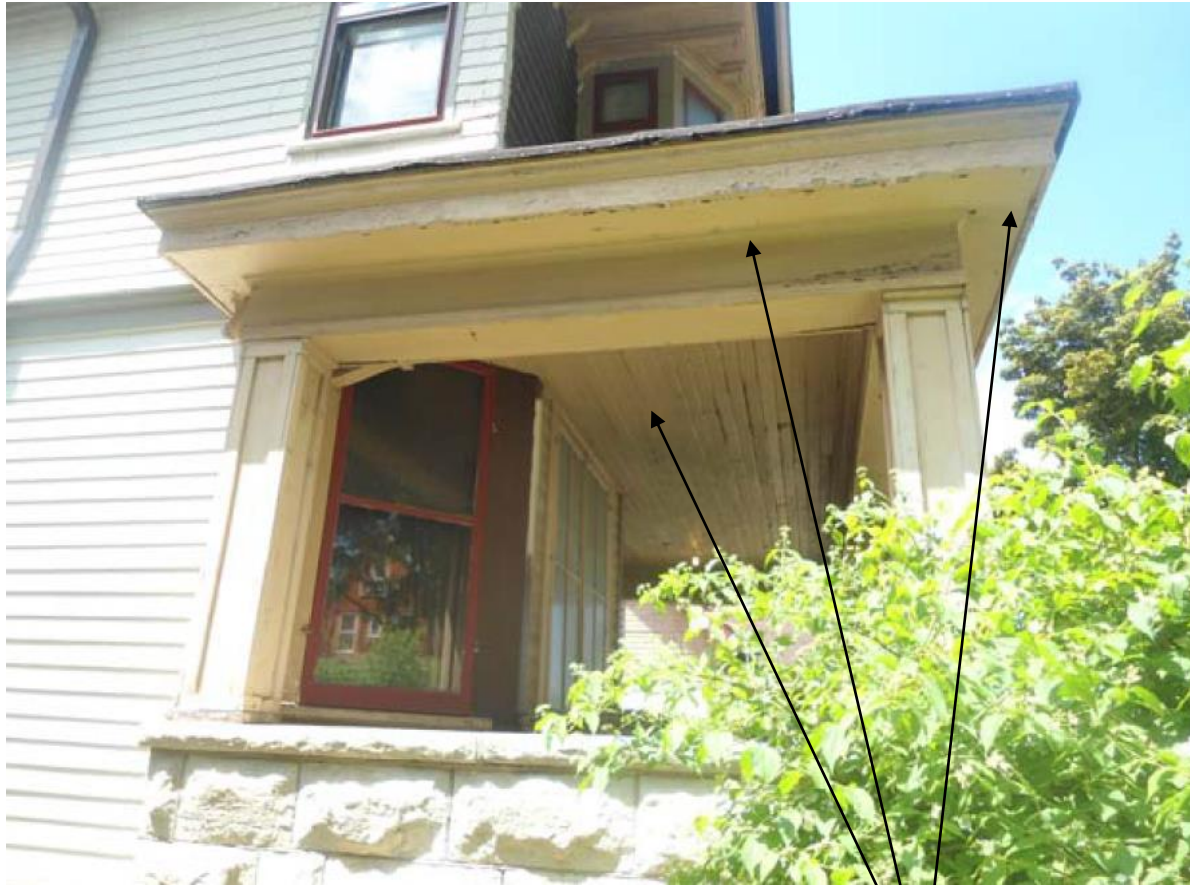
Replacement porch roof will have the same features as the current one with overhangs, appropriate molding profiles and beadboard/tongue-in-groove ceiling.

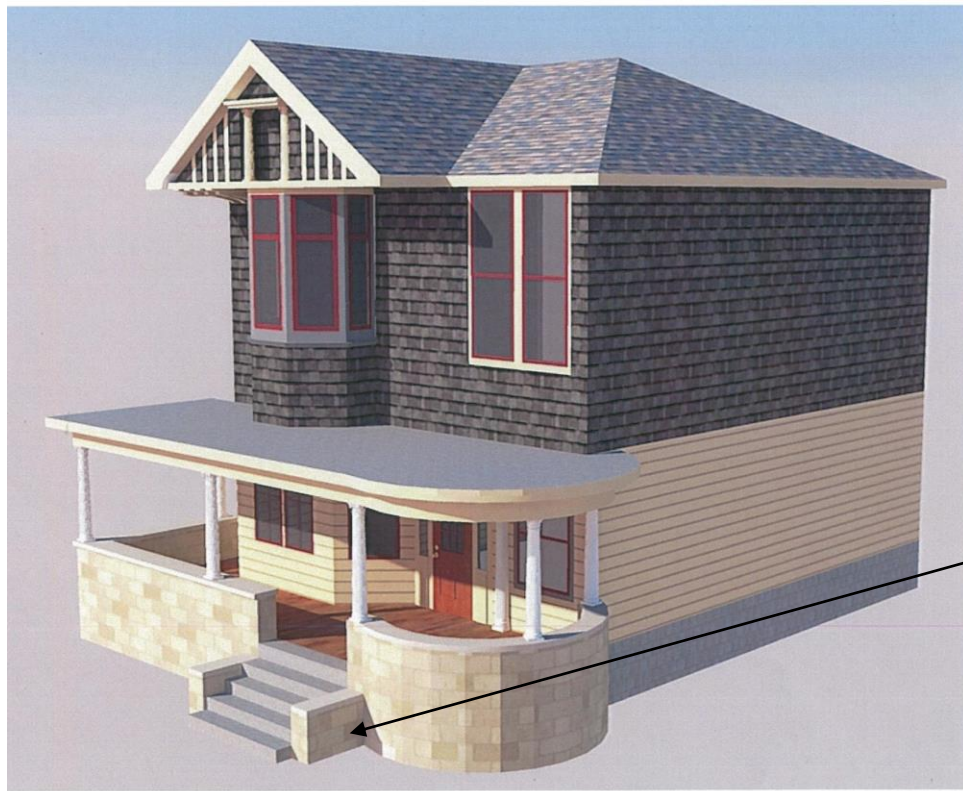
This is an image of the house as it will appear with the extended roof and rebuilt walls. Note, the current house has only knee wall, on the south side of the steps and this image shows two. The steps should be rebuilt in the current design without the north knee wall.

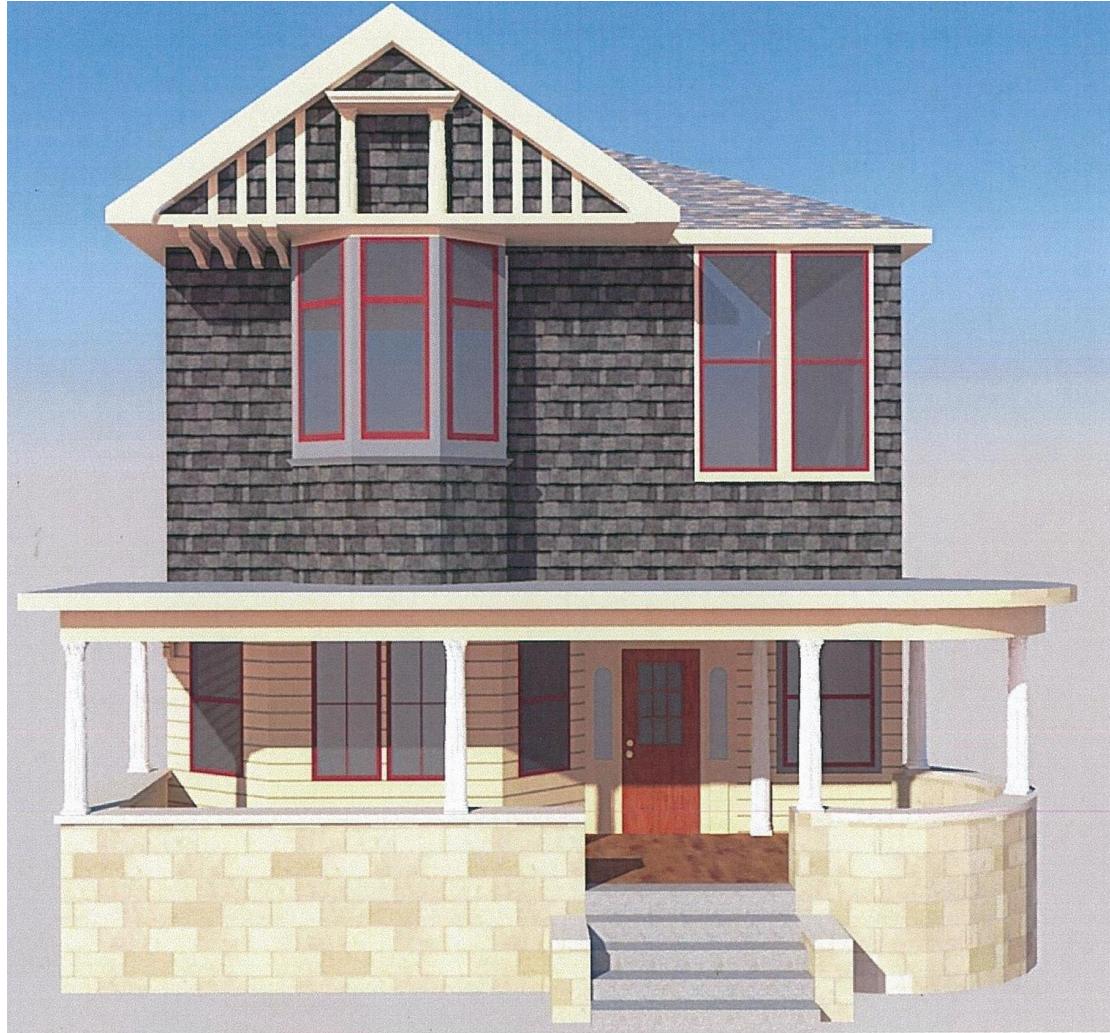
PROPOSED NEW PORCH RENOVATION

The current proposal is to extend the porch roof to cover the north end of the porch, to remove the square posts and replace with round columns and remove a second story window on the facade.

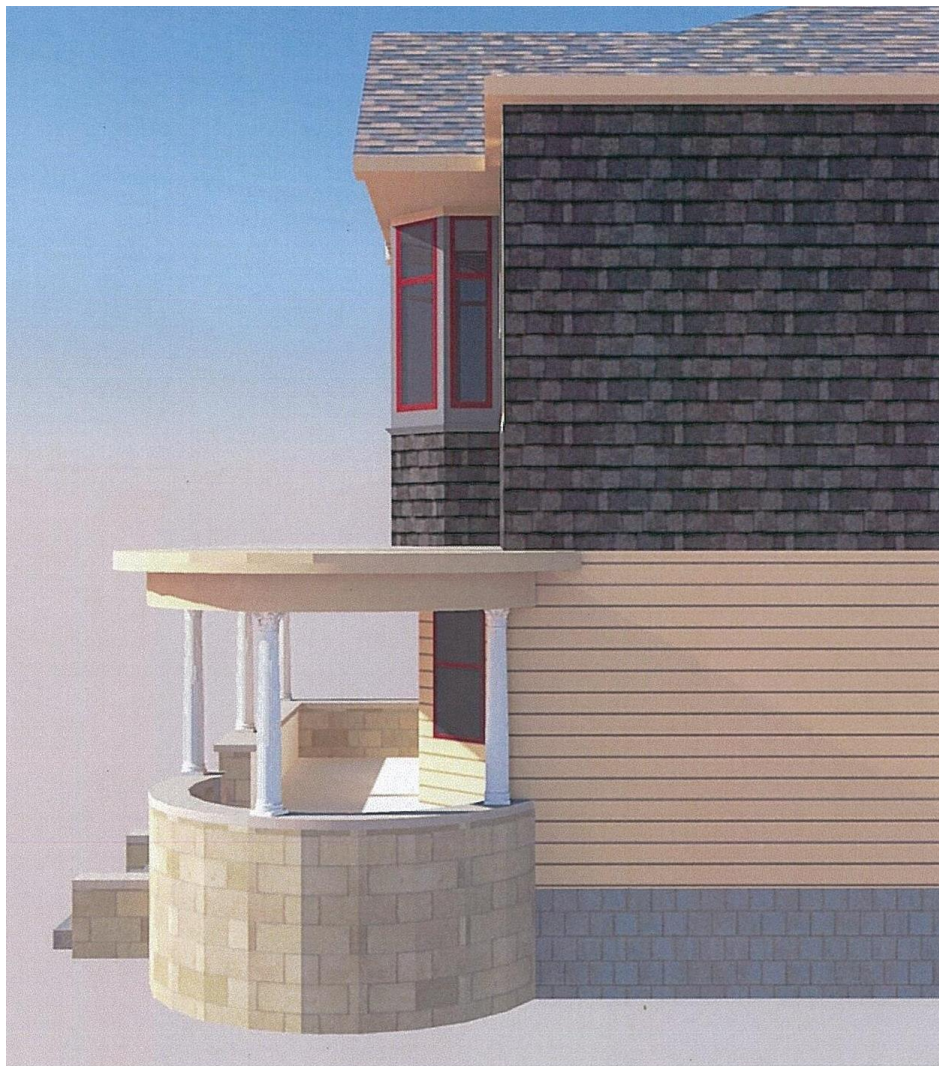
PROPOSED NEW PORCH RENOVATION

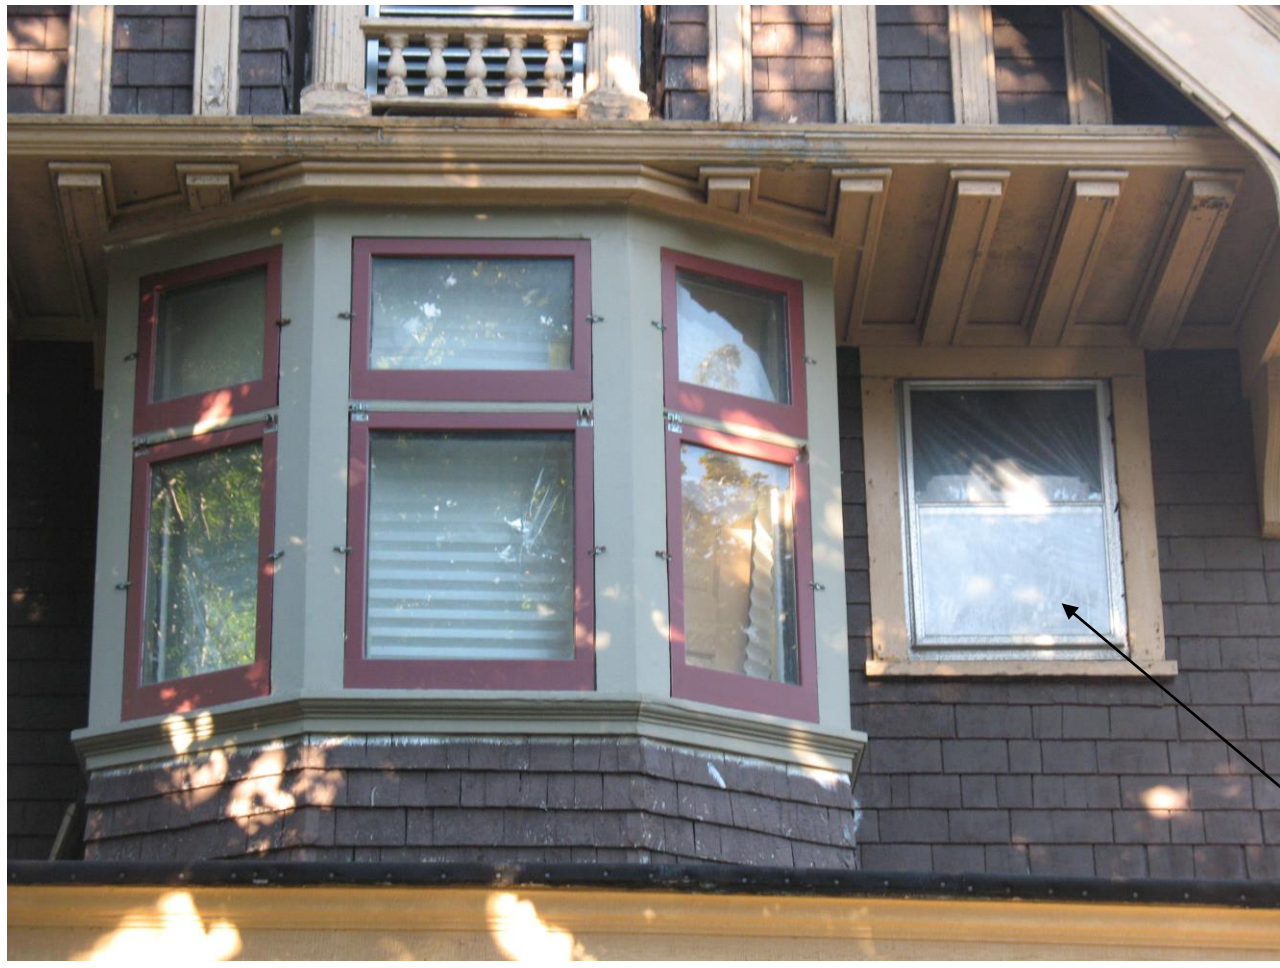
This window appears to have been added after World War II. It will be removed. The resulting opening will be sheathed over with wood shingles that match the existing and have the same exposure.

**The small window to the north of the front bay on the second story will be removed. The opening will be clad in shingles that match the size and wood species of the adjacent shingles.**

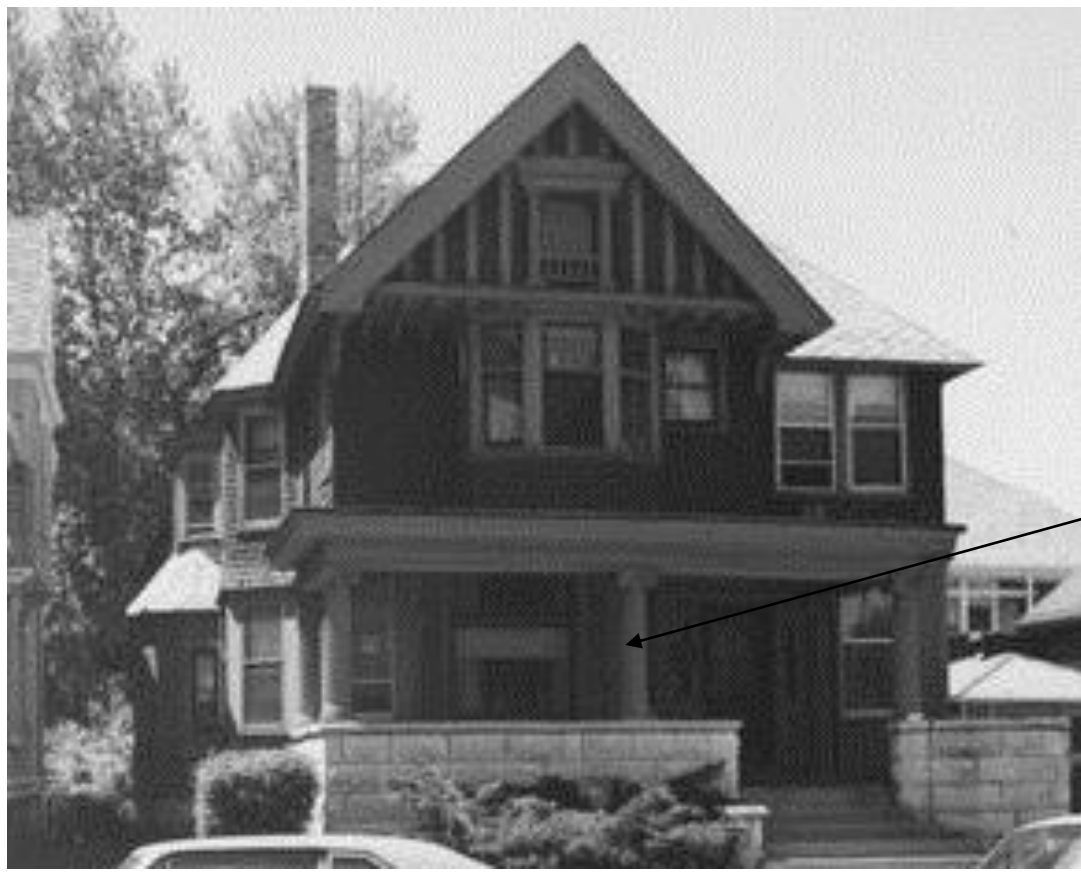
This 1980 survey photo shows the original porch columns.

**The porch posts will be removed and replaced with columns as seen in the 1980 survey photograph of the property.**
