**CARAVEL**  
**AUTISM HEALTH**

1020 WEST MITCHELL STREET, MILWAUKEE, WI 53204  
HISTORIC REVIEW PACKAGE 8/16/2021

**INTERFORM**  
ARCHITECTURE AND DESIGN

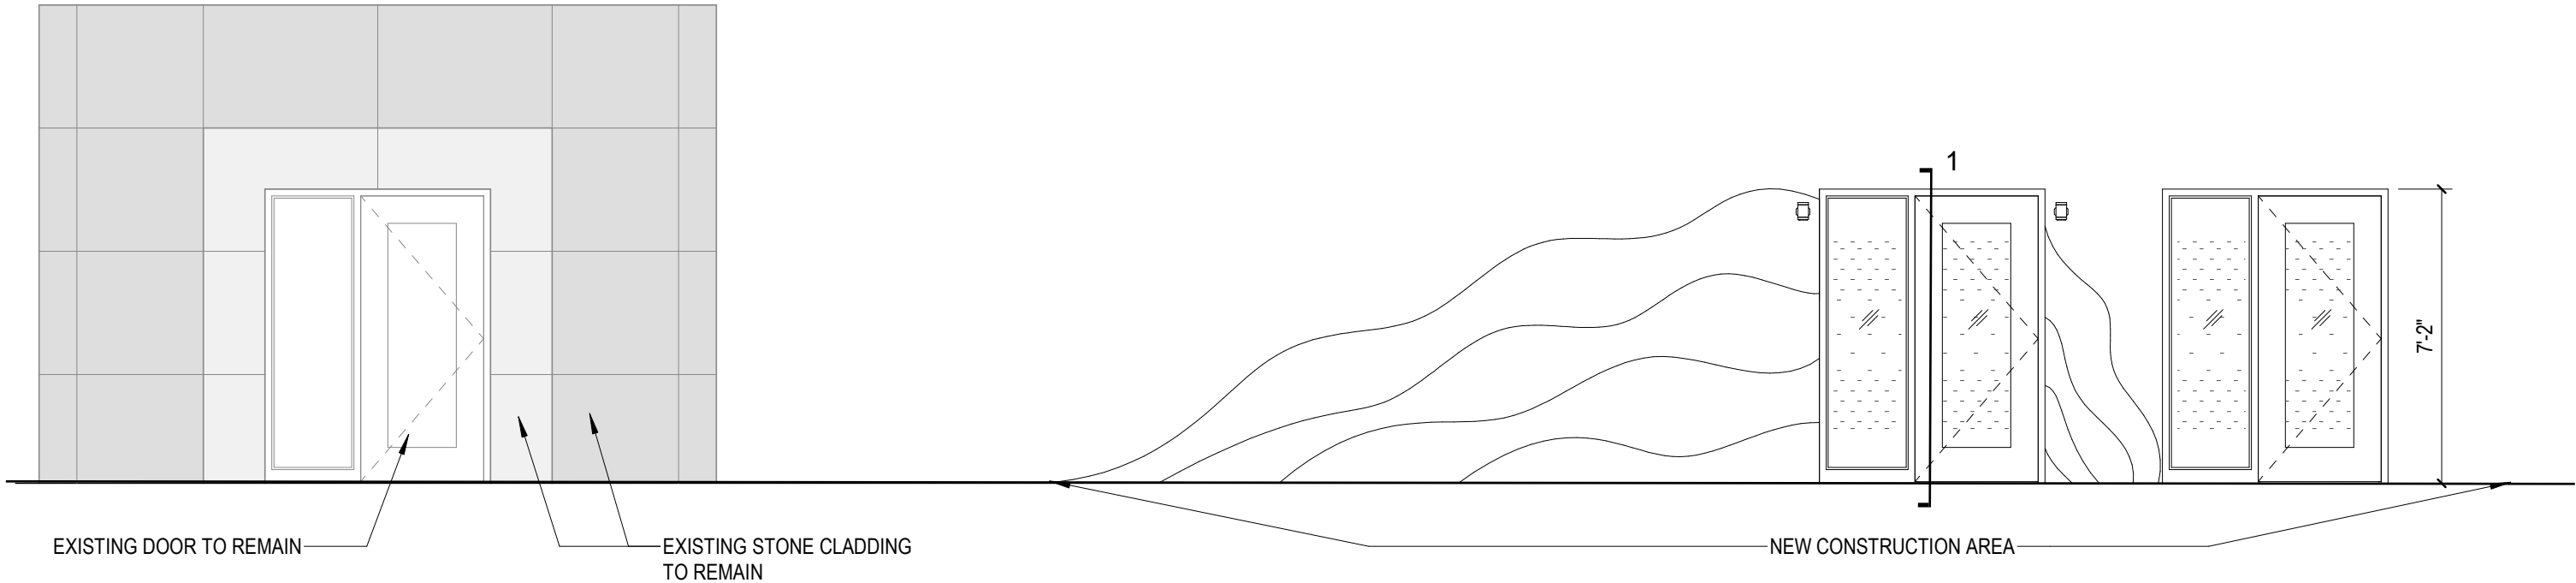
## 2 EXTERIOR ENTRY ELEVATION

**Conditions:**  
1. New entrances to be bronze or bronze-anodized finish  
2. No paint higher than current paint line on rear of property.

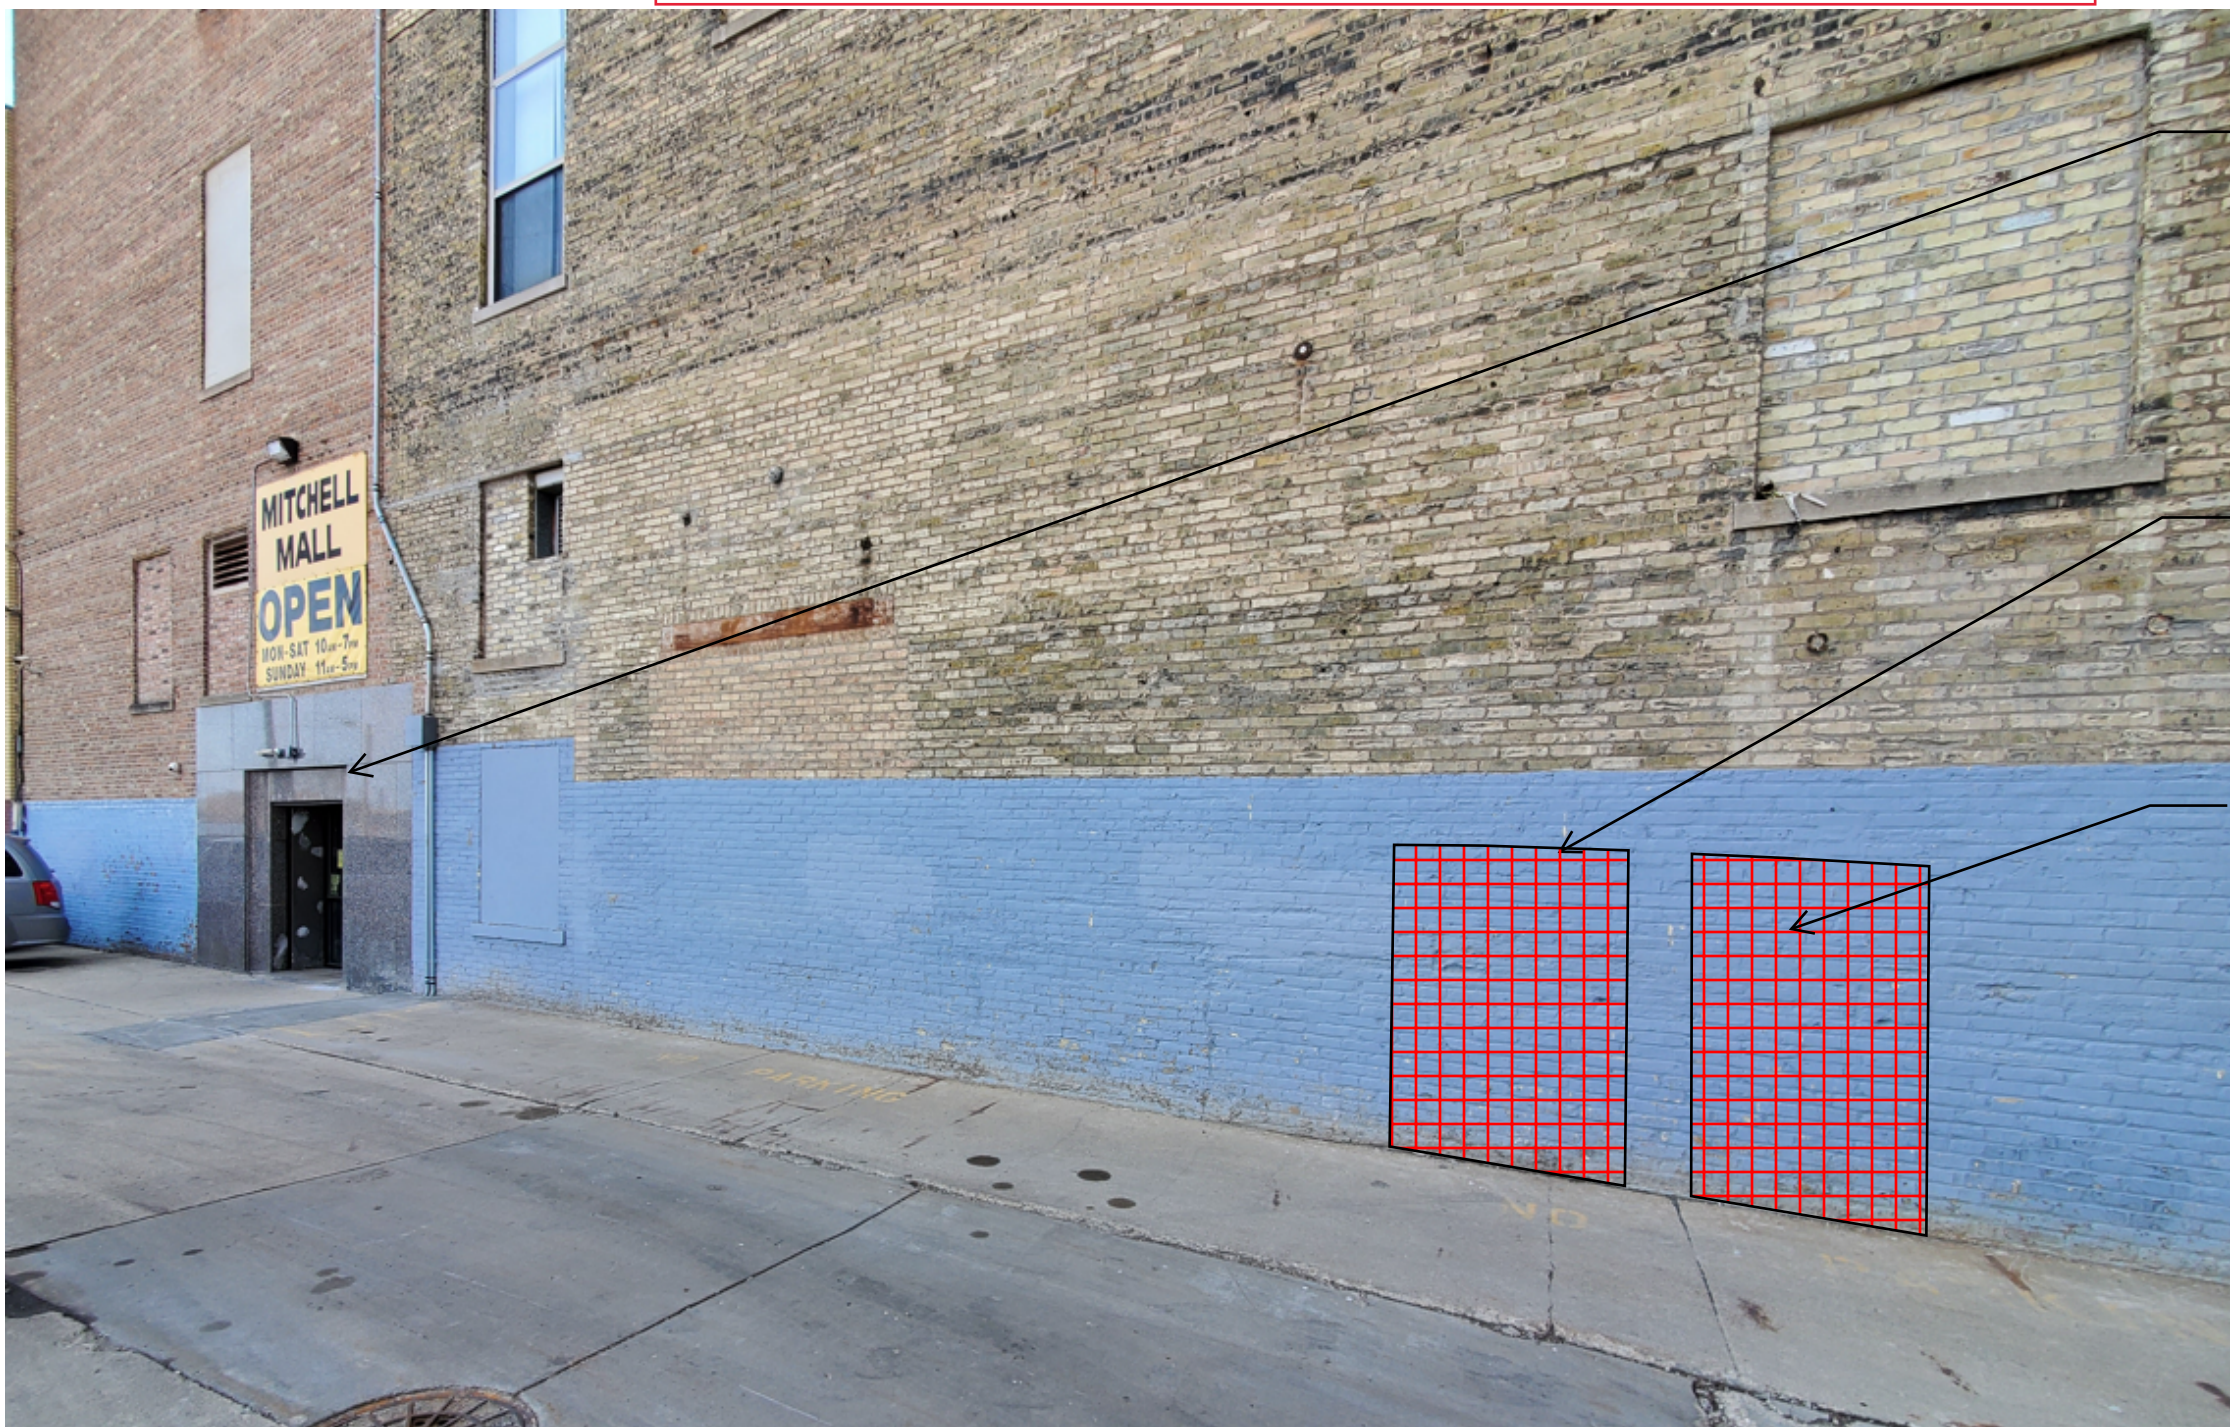
EXISTING ENTRY TO  
REMAIN FOR  
RESIDENTS  
EMERGENCY EXIT

LOCATION OF NEW  
CARAVEL ENTRY

LOCATION OF NEW  
LANDLORD ENTRY

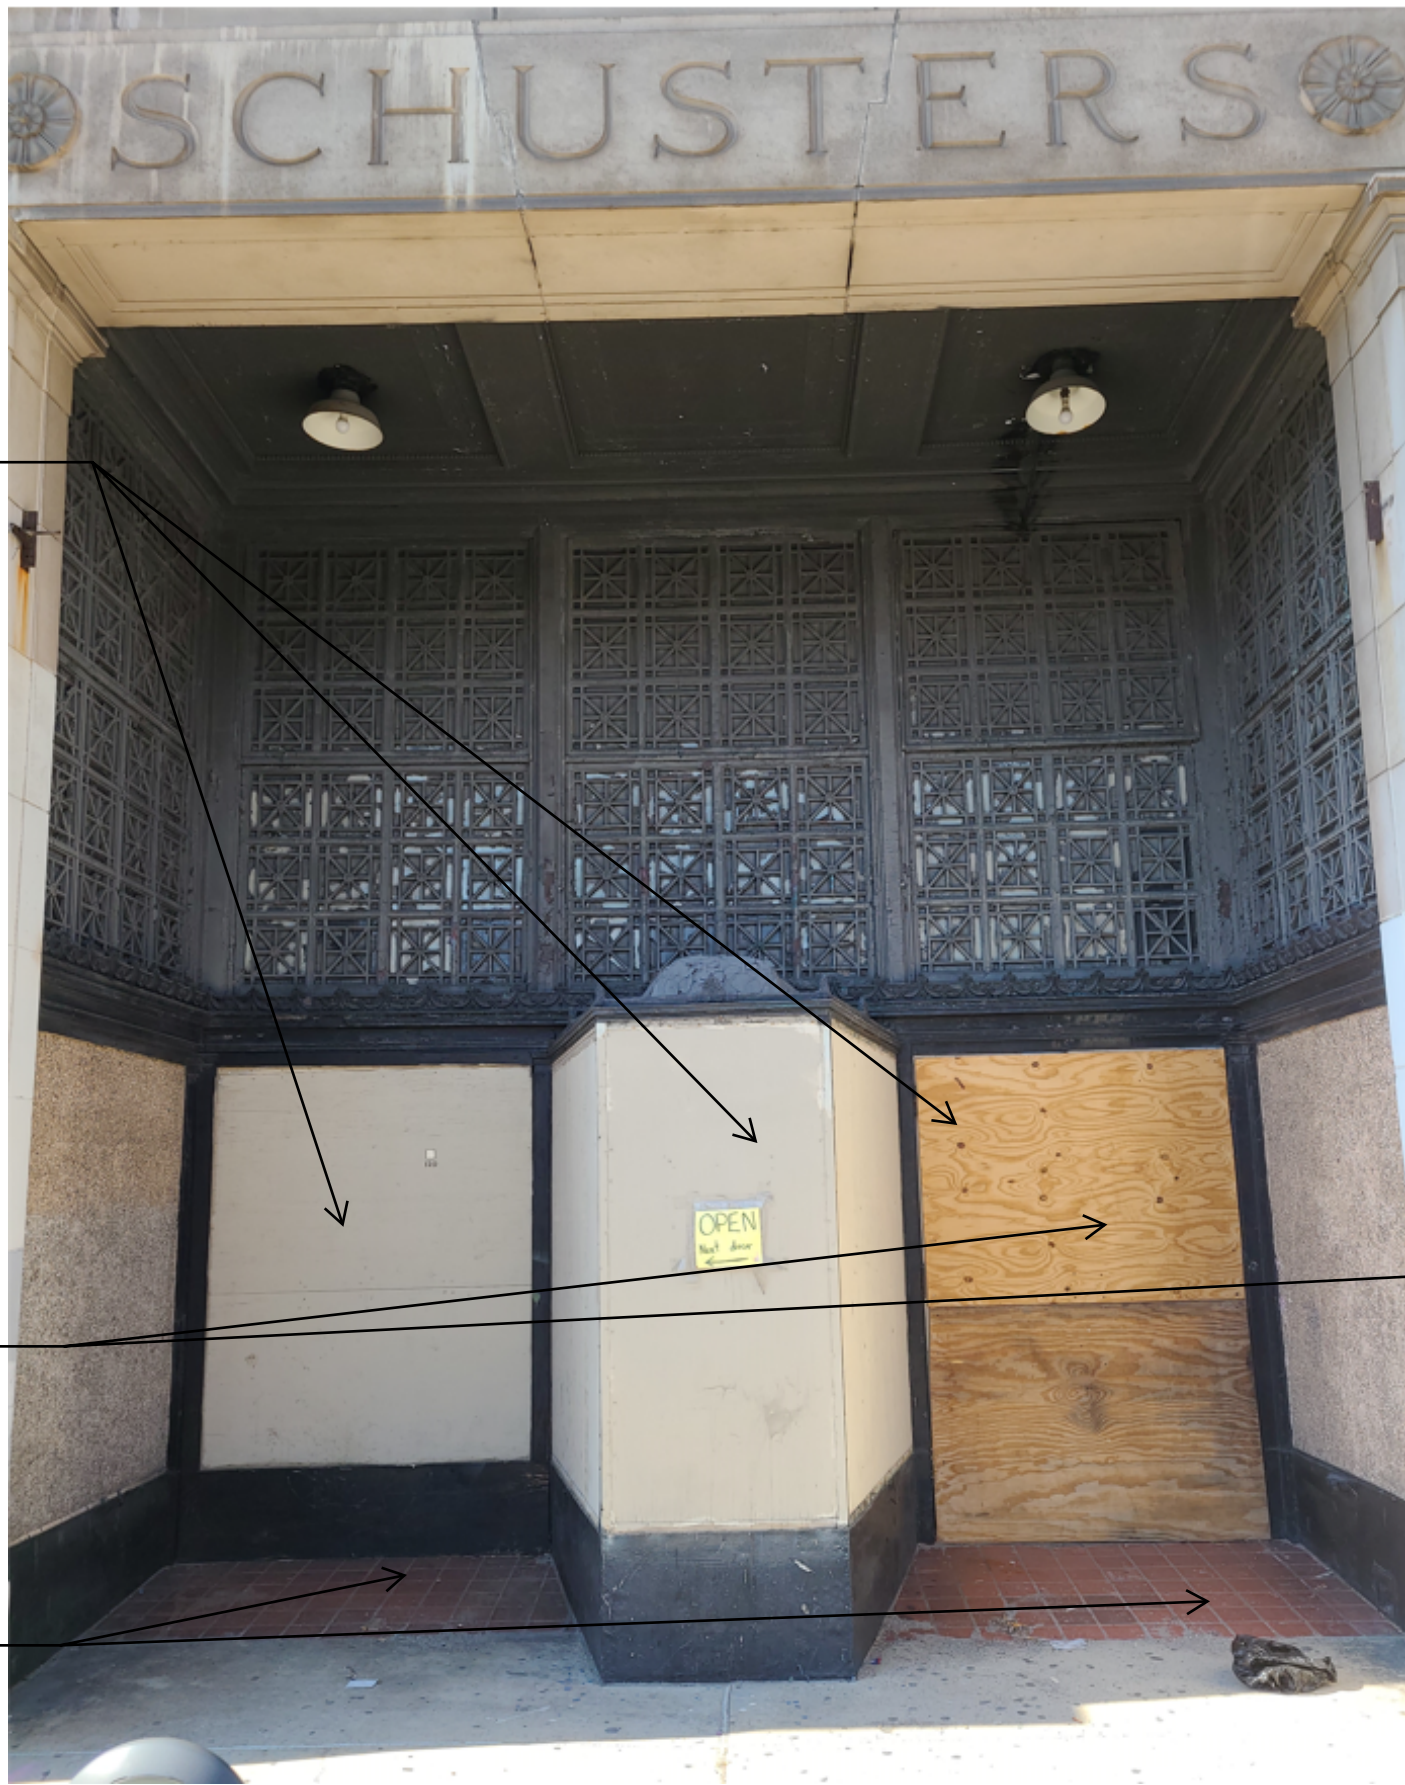
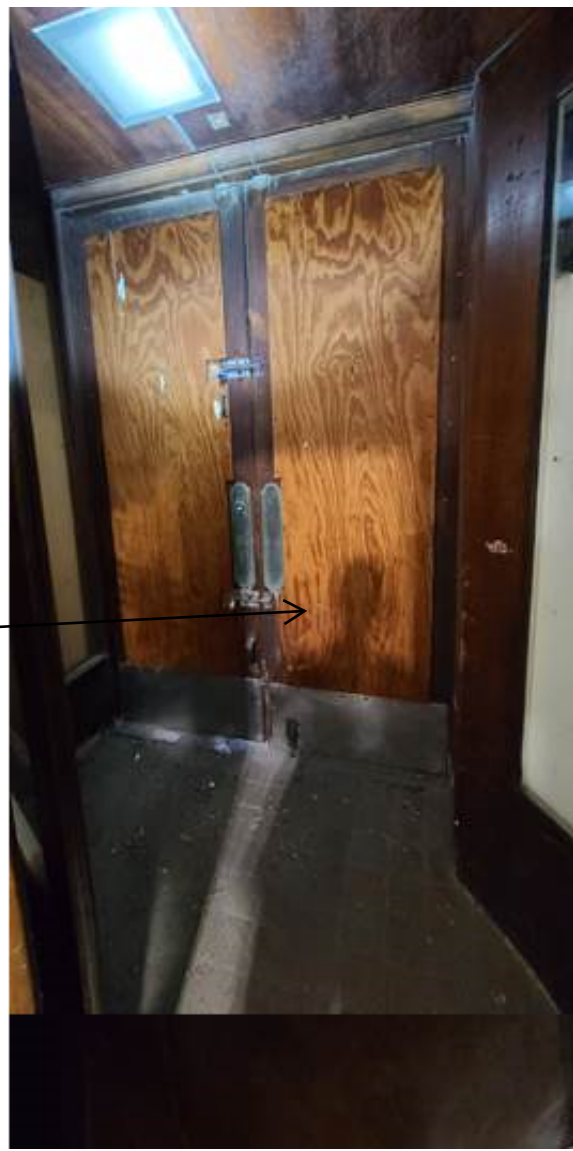
EXISTING COVER  
PLYWOOD TO BE  
REMOVED TYPICAL.

EXISTING DOORS TO  
BE RESTORED BY  
WOOD WORKER TO  
ORIGINAL CONDITION.

FLOORING TO BE  
CLEAN.
