CERTIFICATE OF APPROPRIATENESS APPLICATION FORM

The Pabst Mansion Pavilion

2000 W. Wisconsin Avenue, Milwaukee, WI 53233

PROPOSAL OVERVIEW

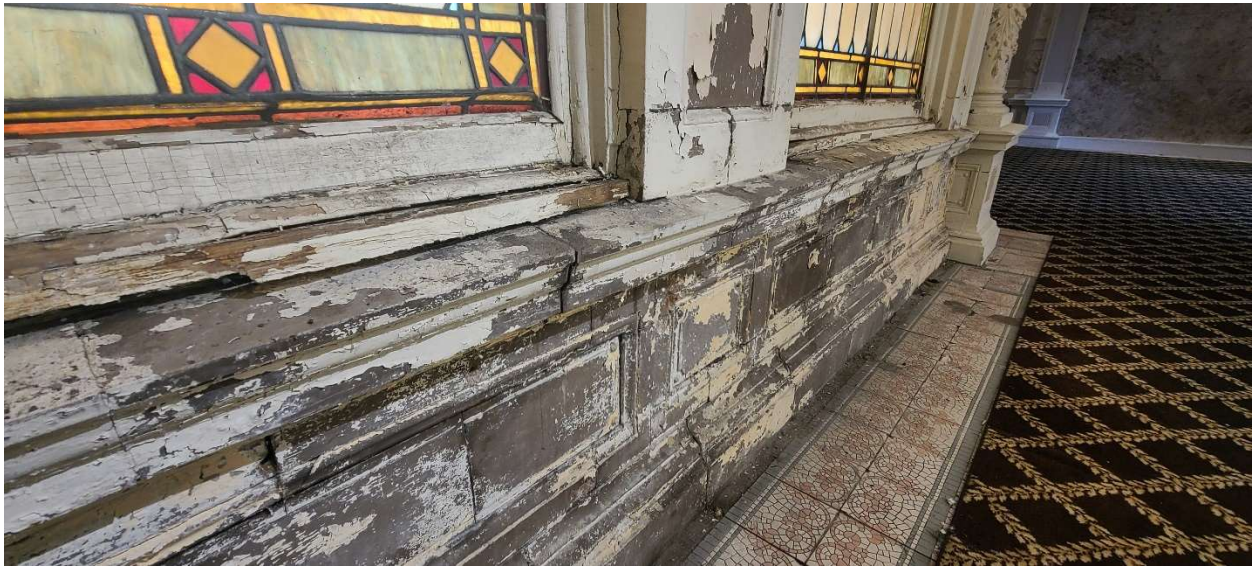
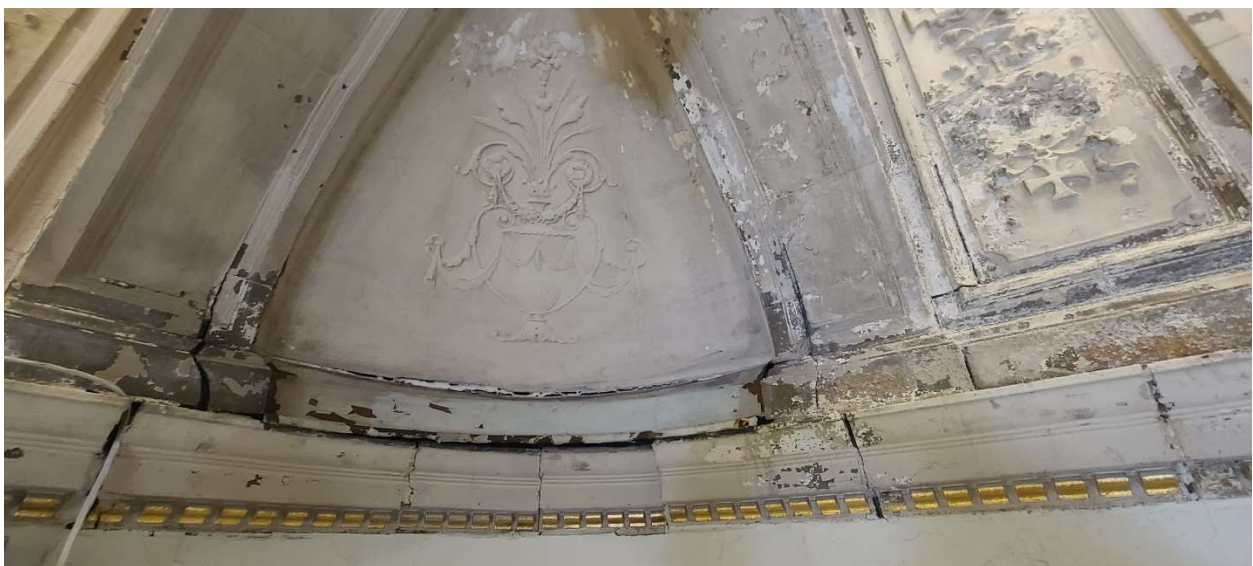
Today we can see the impact of placing a structure designed to be indoors in Wisconsin weather. Specifically, wood windowsills are rotted (*above and below*), and terra cotta is spalling and cracking due to the freeze-thaw effect of water within the walls (*below*). Most importantly, the roof (the most vulnerable location on a building) was never properly designed or installed after the building was moved to Milwaukee. Water continues to penetrate cracks and openings despite unending repair work (*below bottom*).

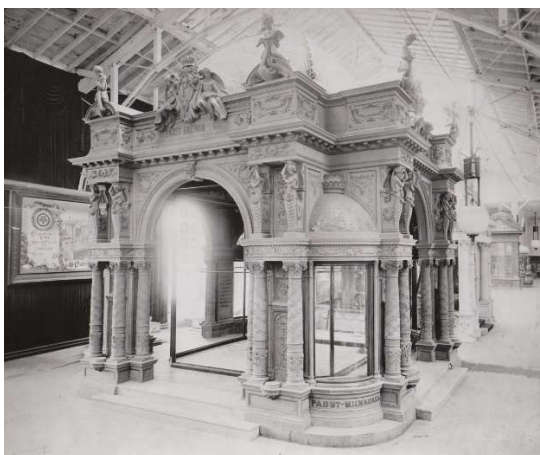
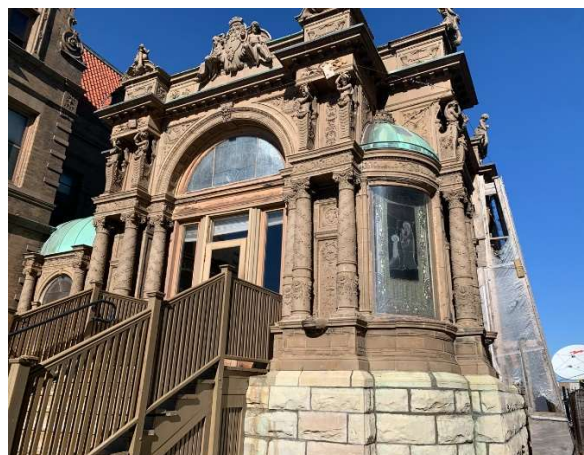
Above (*left*) is the plastered dome, and above (*right*) are the stained-glass windows all installed by the Archdiocese. The original Pabst Beer Pavilion (*below left*) at the 1893 World's Fair and a photo (*below right*) of the pavilion as it appears today. When comparing the two the compounded alterations create a different structure altogether.
