# Historic Designation Study Report

## **Bethel Evangelical Church (Bay View Assembly of God)**

2392 S. Woodward Street

City of Milwaukee  
Department of City Development  
Fall, 2001

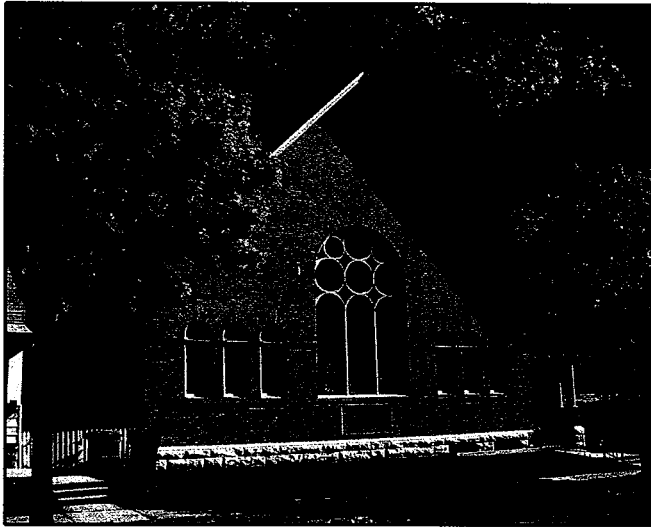
Tucked away in a quiet Bay View neighborhood, Bethel church is an eye-catching, century-old building at the northeast corner of South Woodward and East Conway Streets. The Romanesque Revival style, Cream Brick church recalls a unique period in the city's history when German building traditions were mixed with local design trends and materials.

The church's cream-colored Milwaukee brick walls are a fine reminder that the immediate Bay View neighborhood was a major center of brick-making a century ago and it is possible that Bethel's bricks were manufactured just a few blocks

away. The combination of Cream Brick walls and a raised foundation made of the Milwaukee area's special limestone give the church a unique local architectural character.

Bethel Evangelical Church is a rambling, asymmetrical, cream brick building that rests on a raised rusticated limestone foundation. In terms of its overall massing, it is composed of a one-story, front-gabled block with four major features projecting from its south elevation facing East Conway Street. The most outstanding of these attributes, a truncated, hip-roofed tower topped with a soaring finial, is roughly centered on the elevation. In front of the tower is a projecting vestibule and front-gabled porch that shelters the main entry doors. Behind the tower at the rear of the building is a one-story gabled social hall and a large, one story, flat roofed addition that was completed in 1926 by the Meredith Brothers, a local contracting firm.<sup>4</sup> The addition, made of solid masonry walls, was designed in the Neo-classical style of architecture and finished with cream-colored brick. The addition complements the architecture of the original church building and is a contributing part of the church building.

original Romanesque style of architecture. The original art glass windows that fenestrate much of the original church building are particularly impressive and they all appear to be in excellent condition.

The exterior retains nearly all of its original character although there have been a few changes over the years that do not significantly alter the historic character of the building. Some of the wooden window trim and the soffits have been covered with aluminum and windows or louvers in the tower have been boarded over. The original wooden entry doors have also been replaced with modern, double leaf, full-view metal doors.

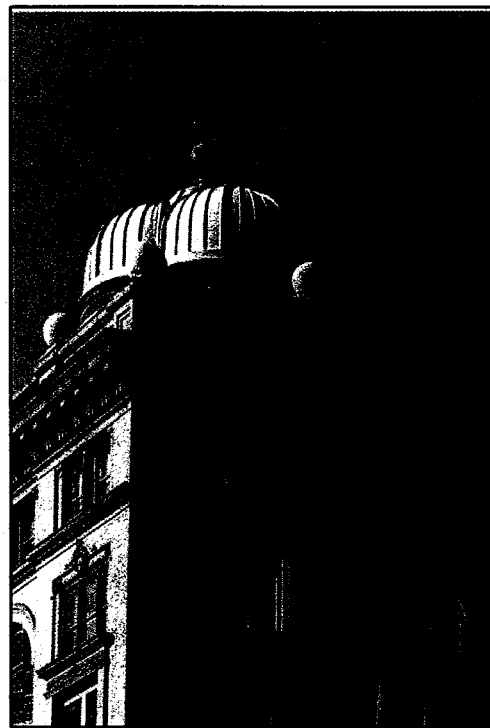
Bethel (left) is the only church in Milwaukee to feature a steeple that is topped off with a large German-style spike finial. A smaller, but equally prominent spike finial can be found atop one of Milwaukee's best-known German-style structures, the Germania Building at 135 West Wells Street, which was built in 1896 just one year before Bethel.

Bethel's most remarkable exterior feature is the soaring finial that tops off the steeple. It is the only one of its kind on a Milwaukee church and is a hallmark of German and German-American architecture of the late 19<sup>th</sup> century. One of Milwaukee's most prominent German-

style structures, the Germania Building at 135 West Wells Street (1896), features a finial of similar design.

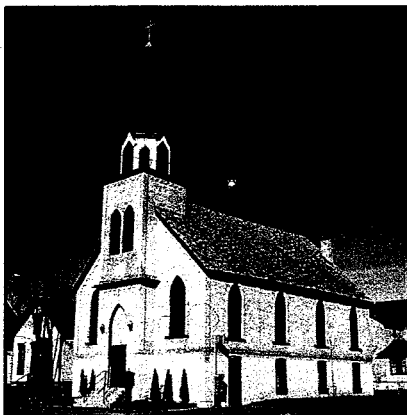
Salem Evangelical Church (1874) at 1037 S. 11<sup>th</sup> Street was the parent congregation for Bethel in Bay View.
