**TEMPORARY HISTORIC DESIGNATION STUDY REPORT
PETER AND IDA FRATTINGER HOUSE
MARCH 13, 2017**

Historic: Peter and Ida Frattinger House

807 North 23rd Street

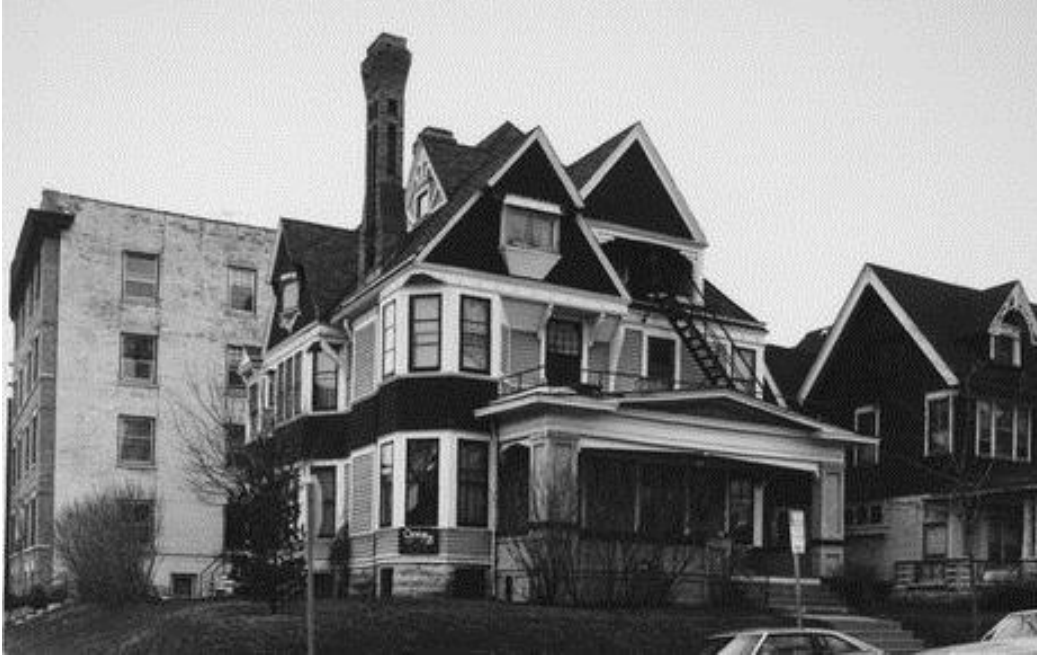
Survey Photo 1984

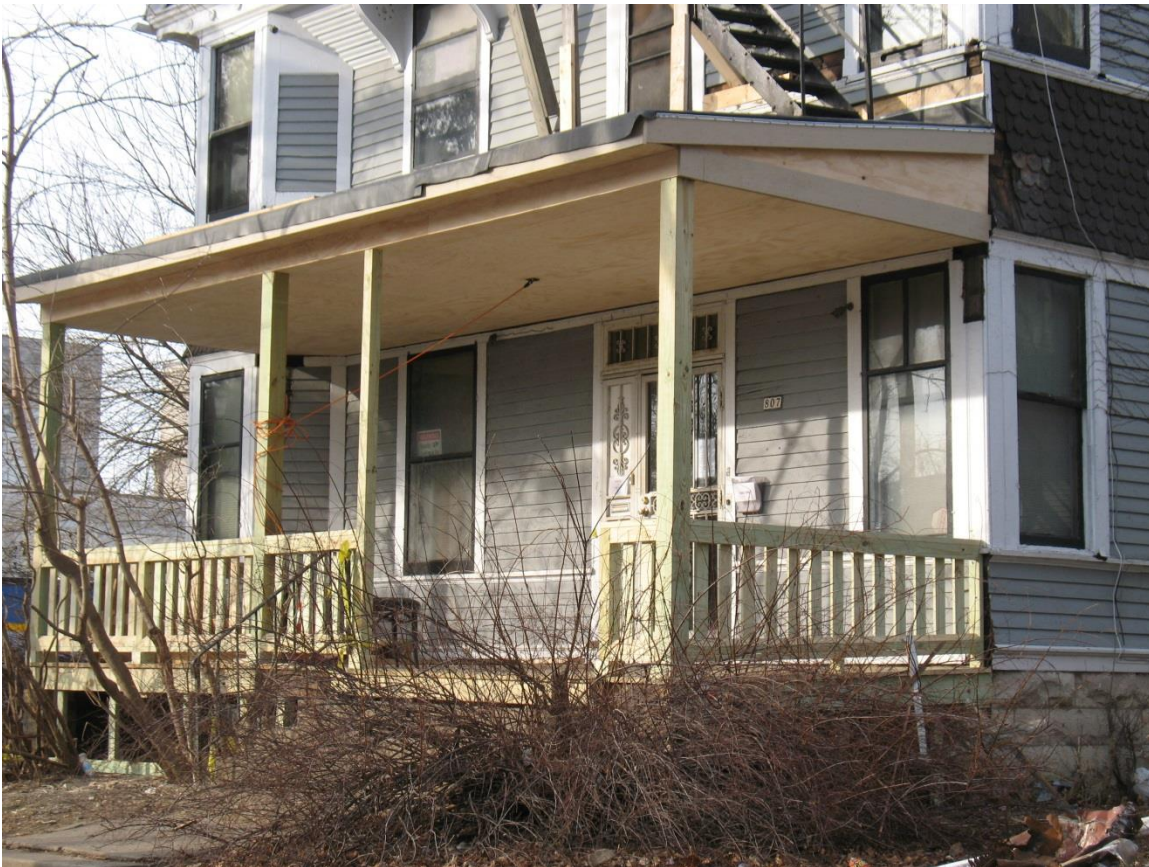
Newly constructed porch 2017

In 1916 a new full width front porch was constructed by the second owners of the house. This has recently been removed and the owners obtained permits to install a new porch. The newly constructed porch is a very crude in design, lacking all architectural detail, and built with closed soffits, simple lumber roof supports instead of finished posts or columns and a railing that is not historic. Skirting consists of wood panels as of the time of this writing. A similar inappropriate porch or open stoop was built at the southwest corner of the building along Wells Street.

The recent removal of the 1916 porch and construction of a crude, inappropriate replacement prompted this nomination for temporary designation. There was concern that other features of this house would be removed and/or substitute siding would be applied to the exterior as has happened at nearby houses.
