Roof plan with gutters and downspouts. New copper half-round gutters and corrugated copper downspouts will be installed. They will be similar to existing.

The new slate roof will match the original 1880 roof which is still on the tower. Buckingham Virginia slate will be used.

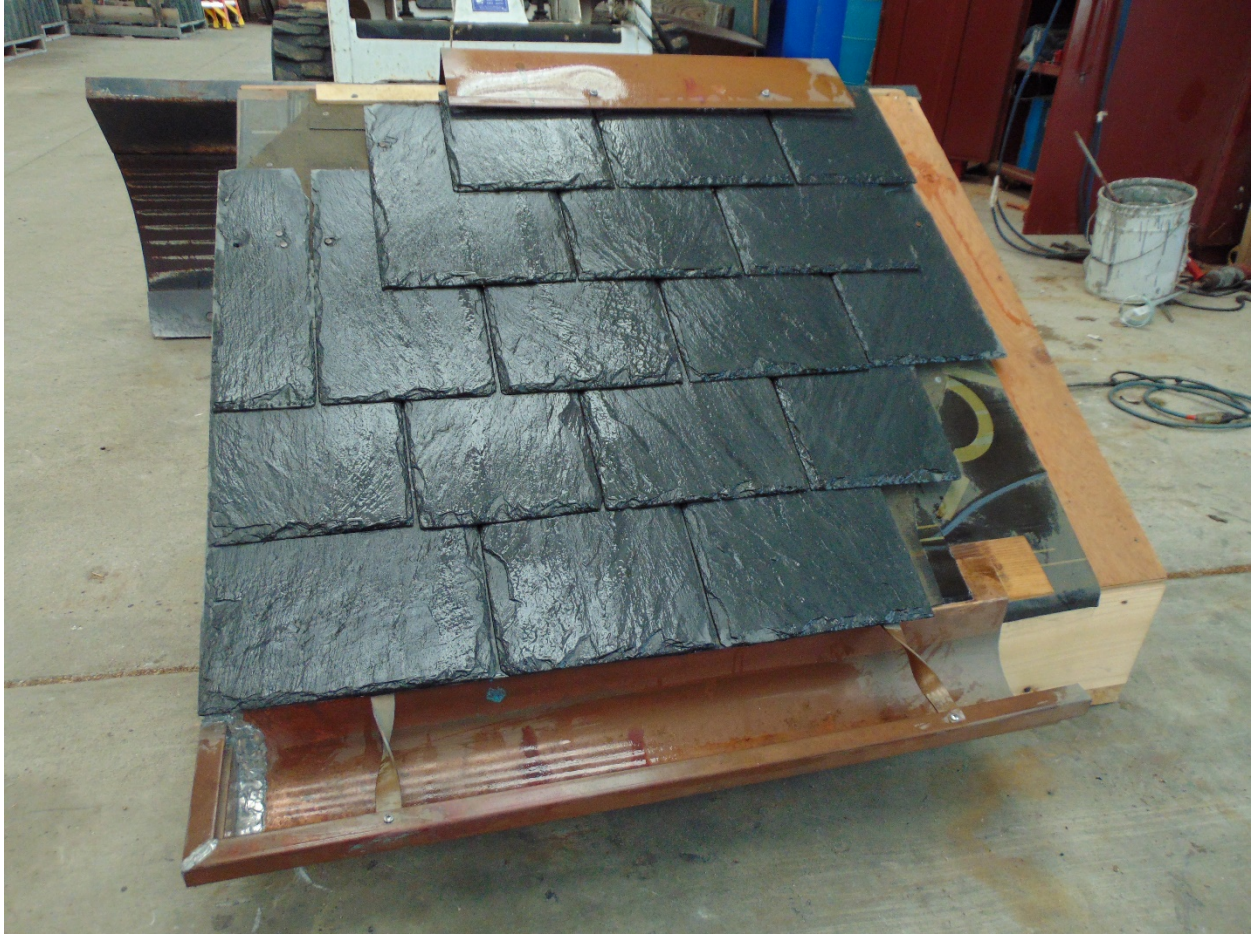
Here is a sample board for the Buckingham slate roof and copper gutter. Other examples of Milwaukee Buckingham slate roofs are: Immanuel Presbyterian, 1100 N. Astor St. Gesu Church, 1145 W. Wisconsin Ave. St. James Episcopal, 833 W. Wisconsin Ave.

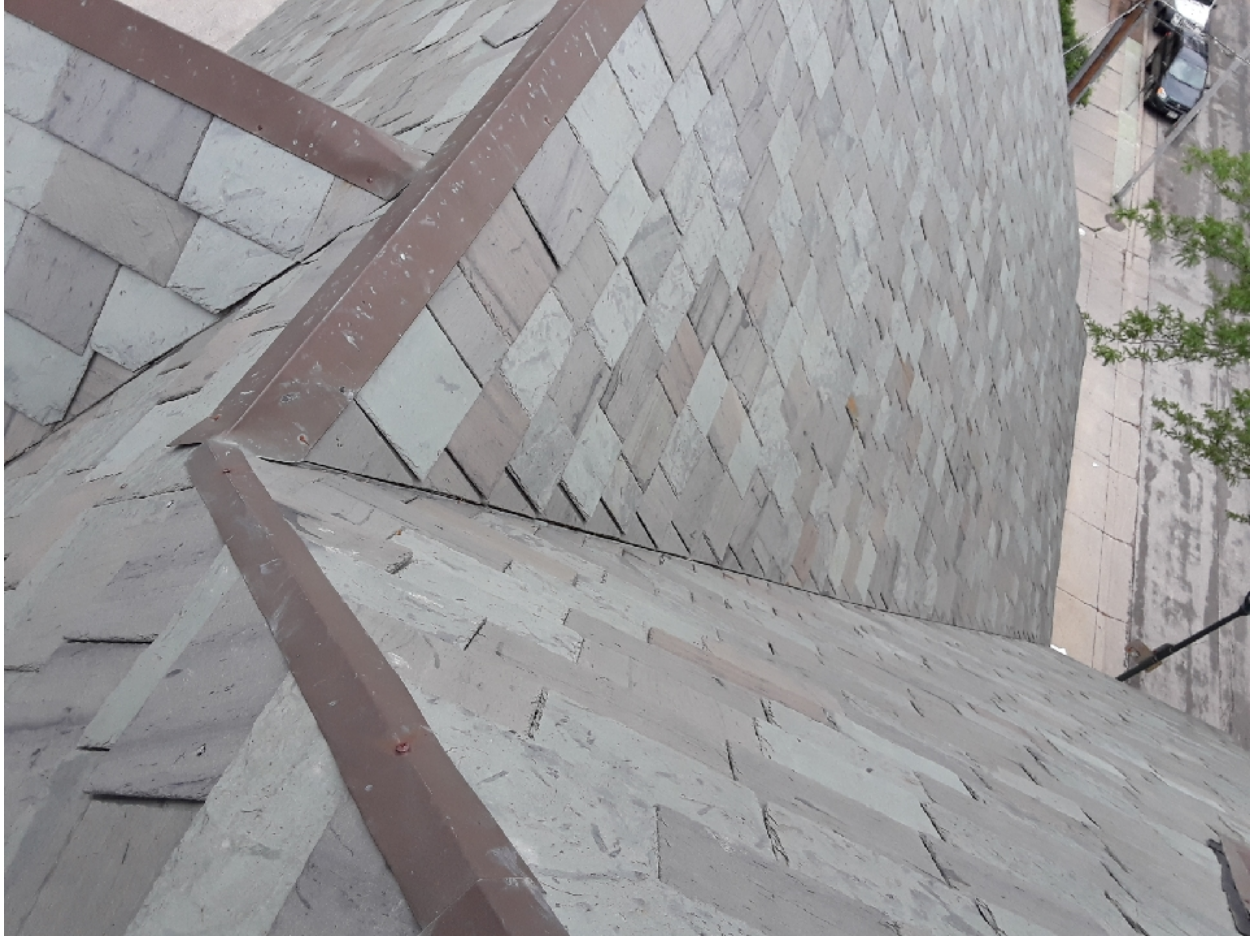
The current slate was installed about 10 years ago and the roof has failed. It is a mix of grey and green slate and not appropriate for this building.

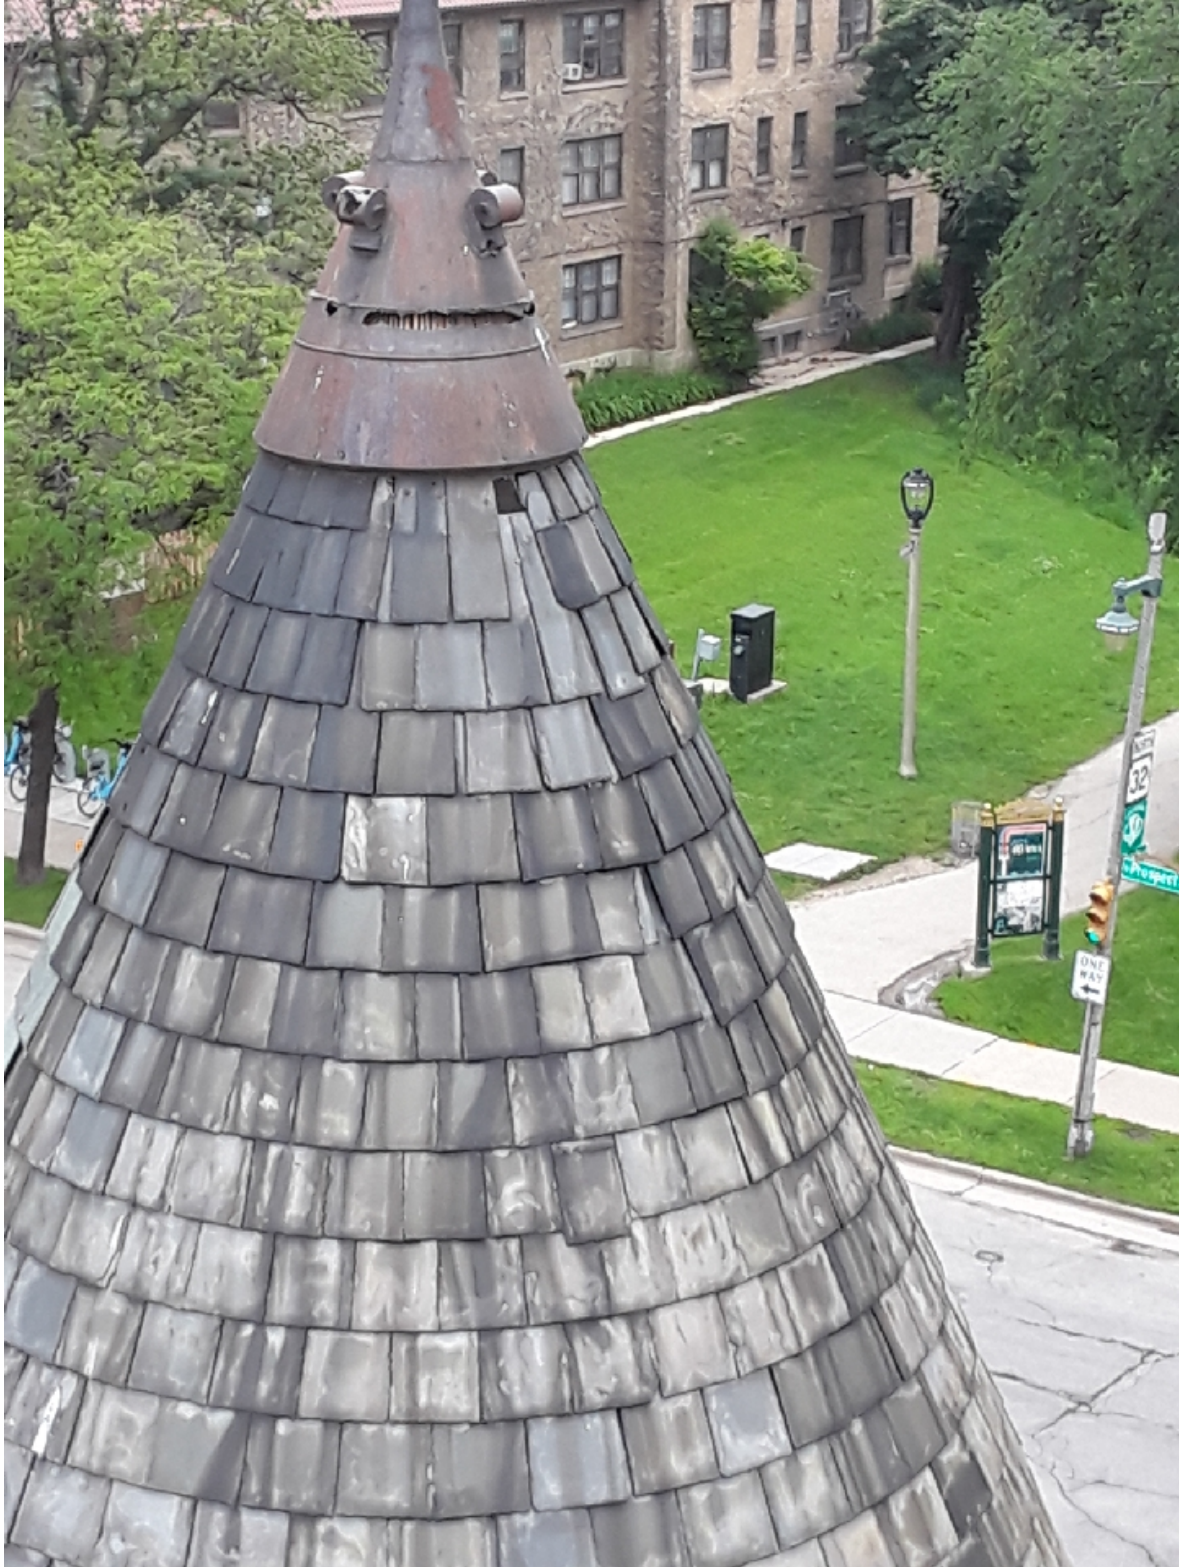
The finial on the tower is rusting away.

The tower finial will be replaced with a custom matching finial made of copper and brass.

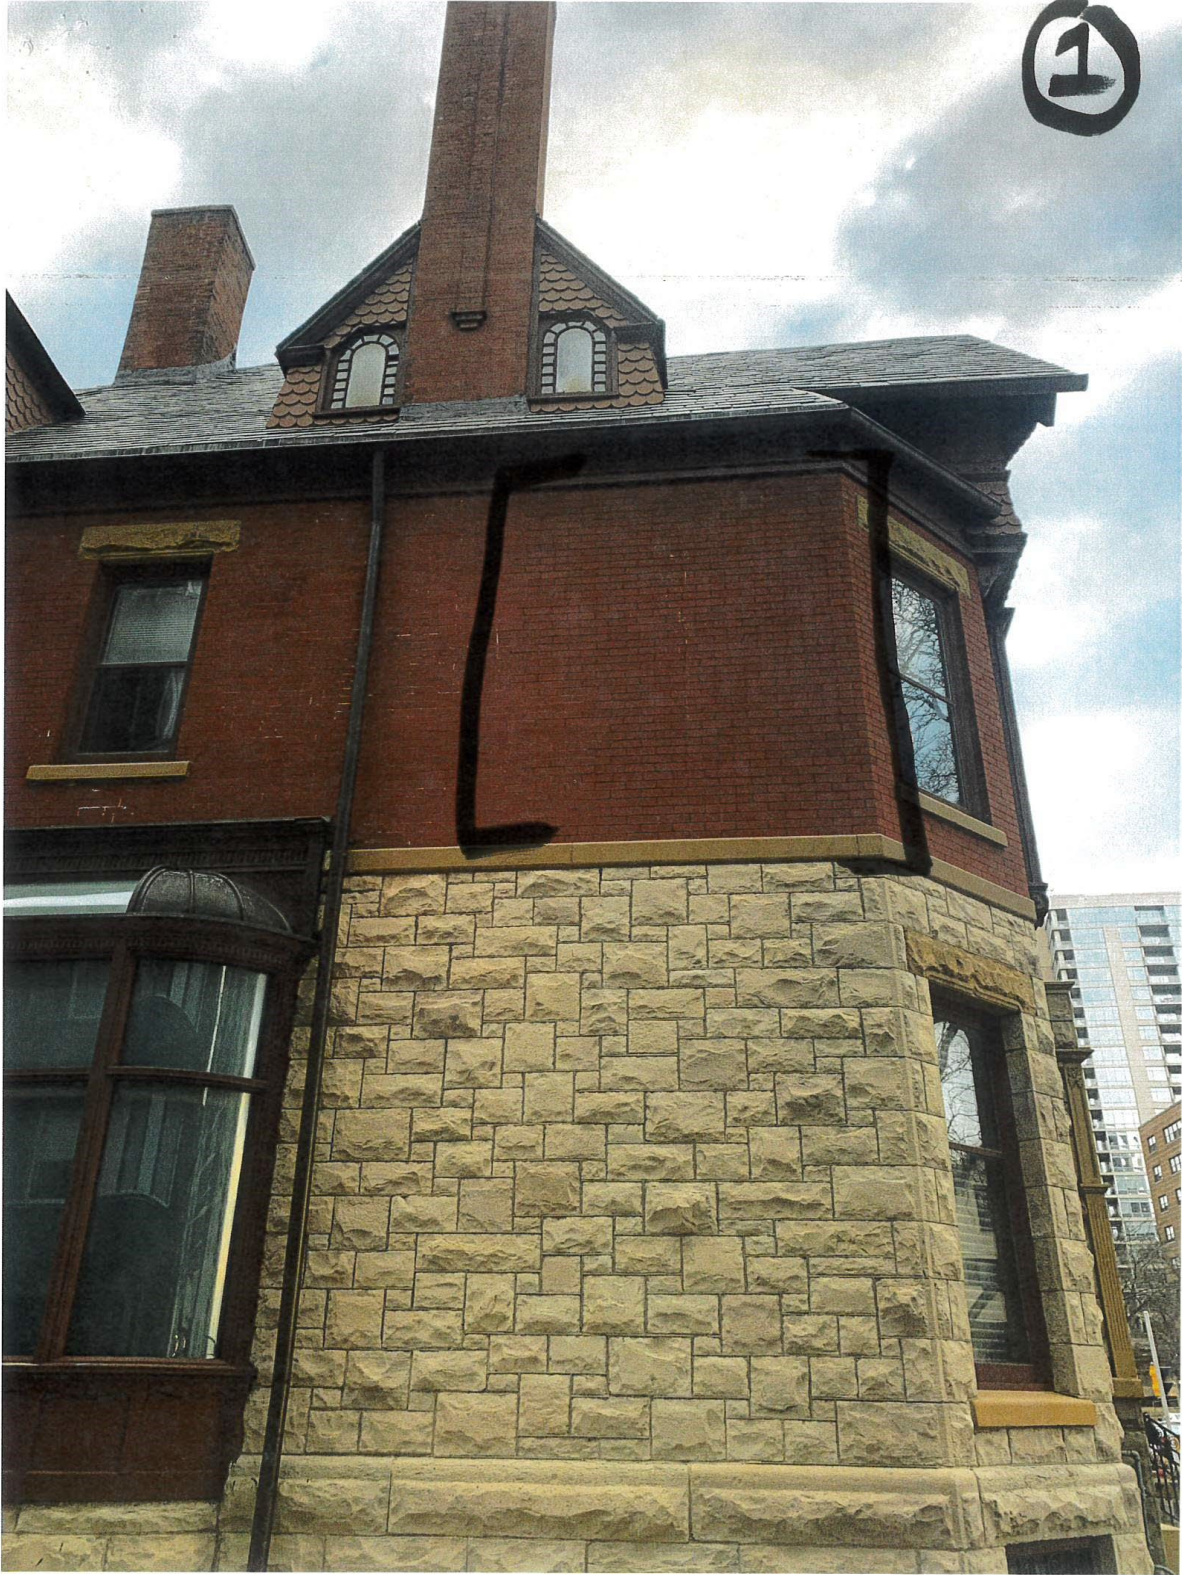
Areas to receive masonry repairs are outlined in black and include all three chimneys.

Holton Brothers is the masonry subcontractor.

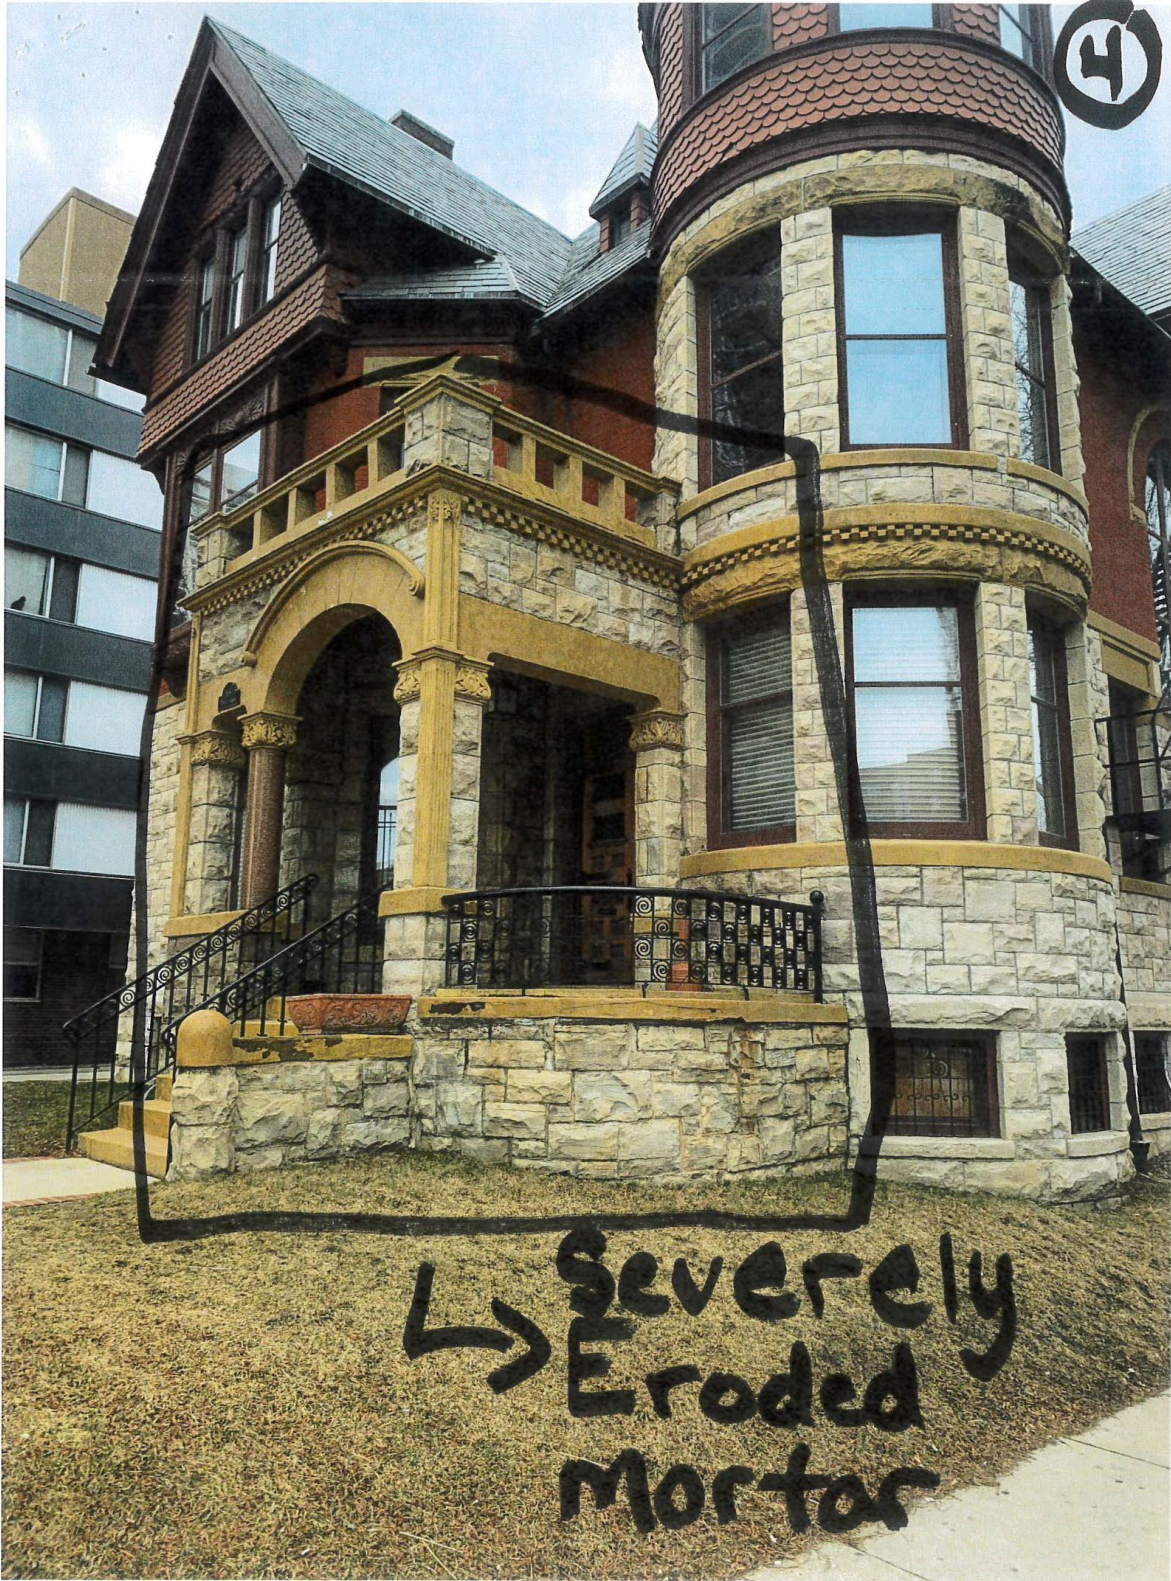
4

↳ Severely Eroded Mortar
