CERTIFICATE OF APPROPRIATENESS APPLICATION FORM

The Pabst Mansion Pavilion

2000 W. Wisconsin Avenue, Milwaukee, WI 53233

PROPOSAL OVERVIEW

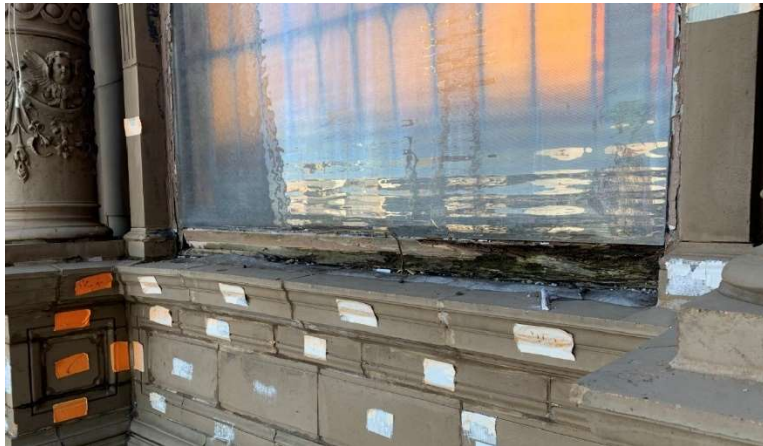
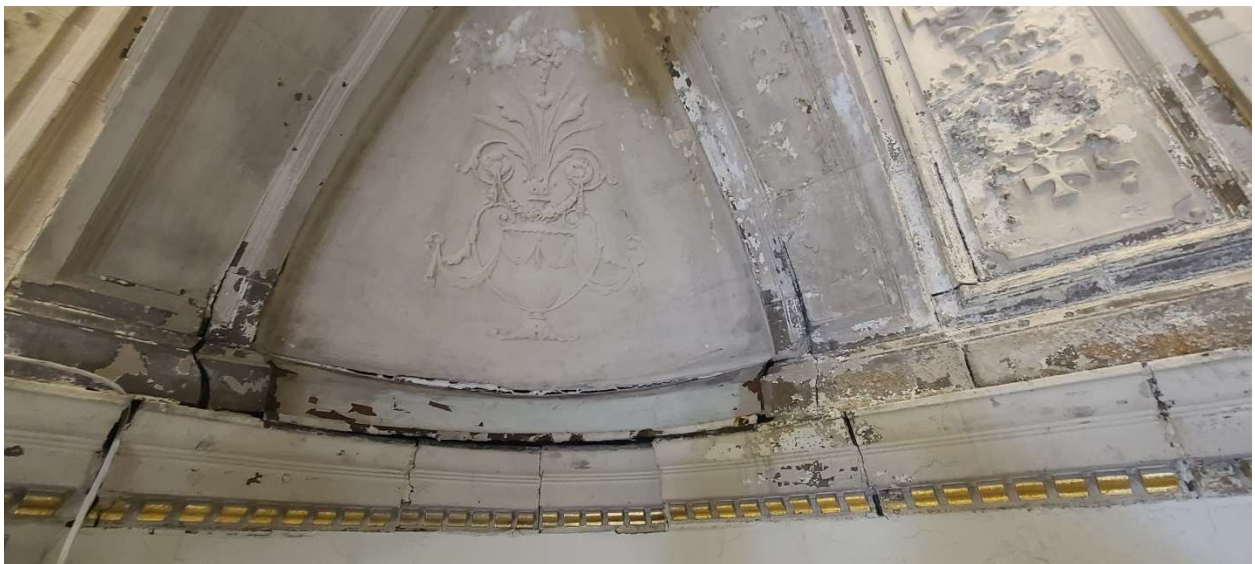
Today we can see the impact of placing a structure designed to be indoors in Wisconsin weather. Specifically, wood windowsills are rotted (*above and below*), and terra cotta is spalling and cracking due to the freeze-thaw effect of water within the walls (*below*). Most importantly, the roof (the most vulnerable location on a building) was never properly designed or installed after the building was moved to Milwaukee. Water continues to penetrate cracks and openings despite unending repair work (*below bottom*).

1. Deconstruction will commence after the entire structure is scanned, all salvageable pieces (estimated 25% of current pavilion) will be removed and carefully stored.
2. New terra cotta pieces cast.
3. Reassembly, with original pieces combined with newly cast pieces. The pavilion would be restored as an airing porch to match the original appearance.

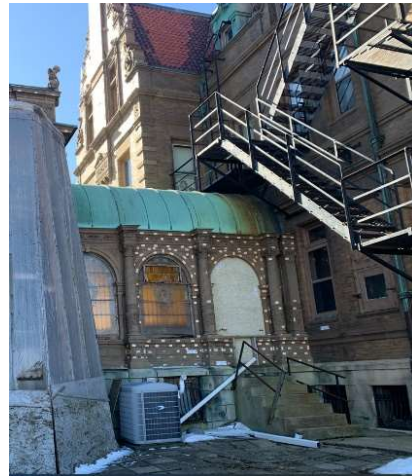
The south (*left*) and north (*right*) elevations of the non-original hyphen constructed to connect the pavilion to the mansion. Note the masonry openings retain the stained glass installed by the Archdiocese.

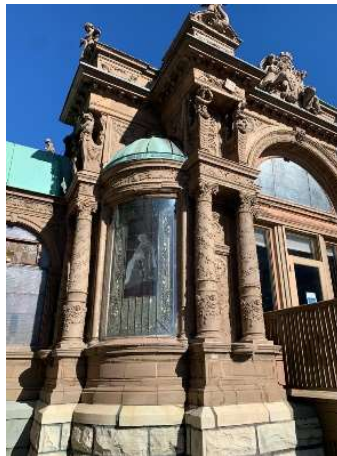
The central and corner quarter domes are copper replacing the original stained-glass domes. The south elevation also showing stained glass windows at both corners and above the non-original entrance infill. Non-original wood stair.

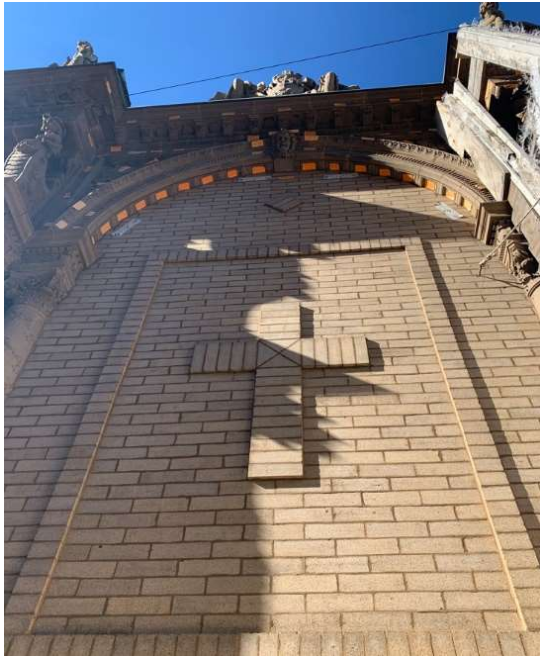
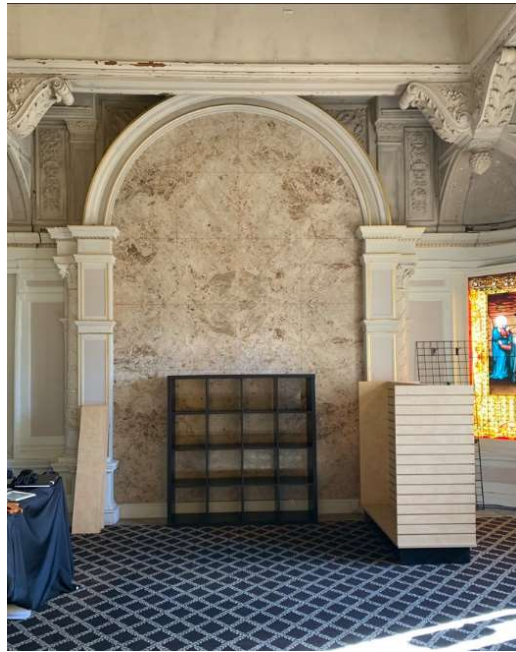
At the exterior the east elevation arch bay was infilled with brick including a cross (*left*). At the interior, marble was installed within this arched bay and the two columns were removed (*right*).

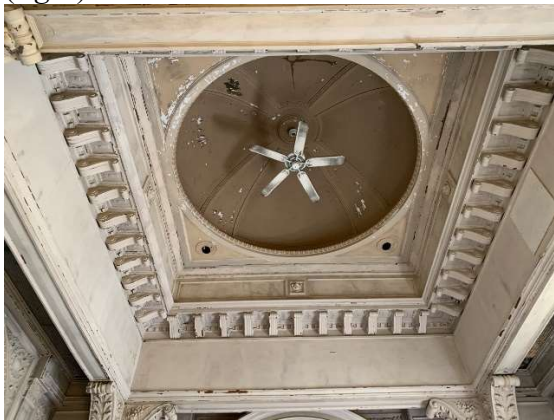
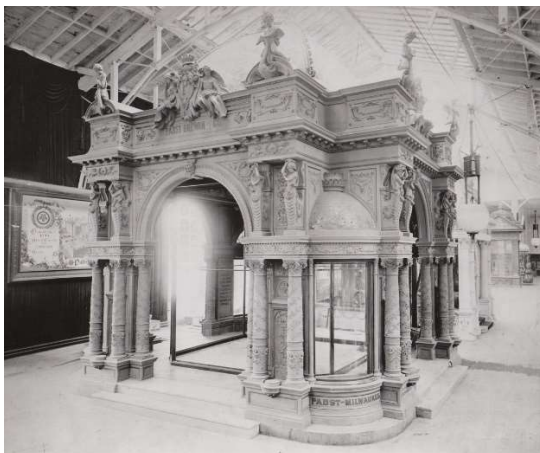
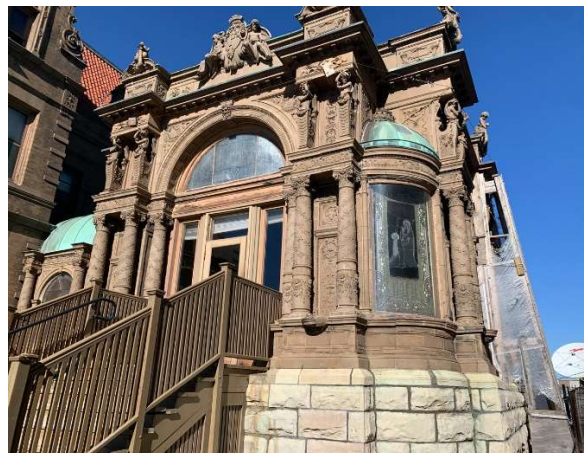
Above (*left*) is the plastered dome, and above (*right*) are the stained-glass windows all installed by the Archdiocese. The original Pabst Beer Pavilion (*below left*) at the 1893 World's Fair and a photo (*below right*) of the pavilion as it appears today. When comparing the two the compounded alterations create a different structure altogether.

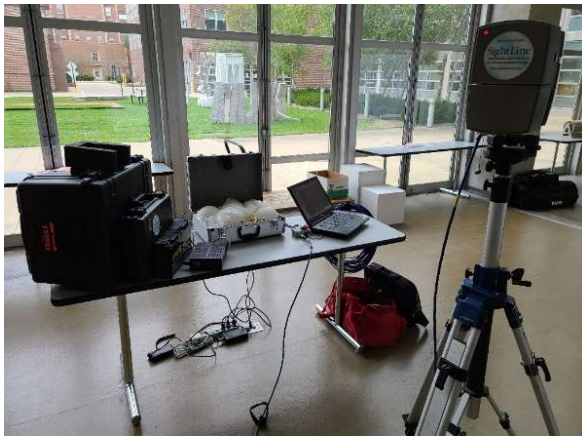
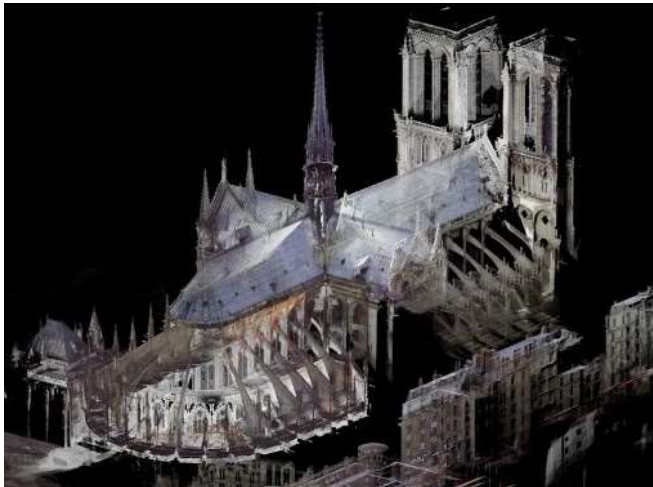
We seek approval for the first phase and will submit COAAs for the later phases. In Phase One, recording of the pavilion will be conducted using the most advanced tools available (*left*). These scans will be used in Phase Two to create new pieces with 3D printing. This eliminates guesswork and allows the construction team to have complete confidence in what ultimately is reassembled in Phase Three. Please note, it is the intention to recreate the original pavilion design as seen in 1893, the alterations the Archdiocese completed will not be part of the future reconstruction.

Laser Scanning is a recently employed technology that uses inferred laser points – similar to that of a laser pointer - to create a computerized electronic file of physical data points called a Point Cloud file. Approximately 900,000 points in space are recorded per second. The electronic data is a computer copy or twin of the original. The file is a permanent archive of the physical information about the building or object. Many owners will commit to this simple product in order to have archival information for safety purposes if anything might happen to the building. (This
