## Nomination Form

IRON BLOCK BUILDING

## **A Short History of the Iron Block Building and its Renovation**

# A LOST GEM FOUND

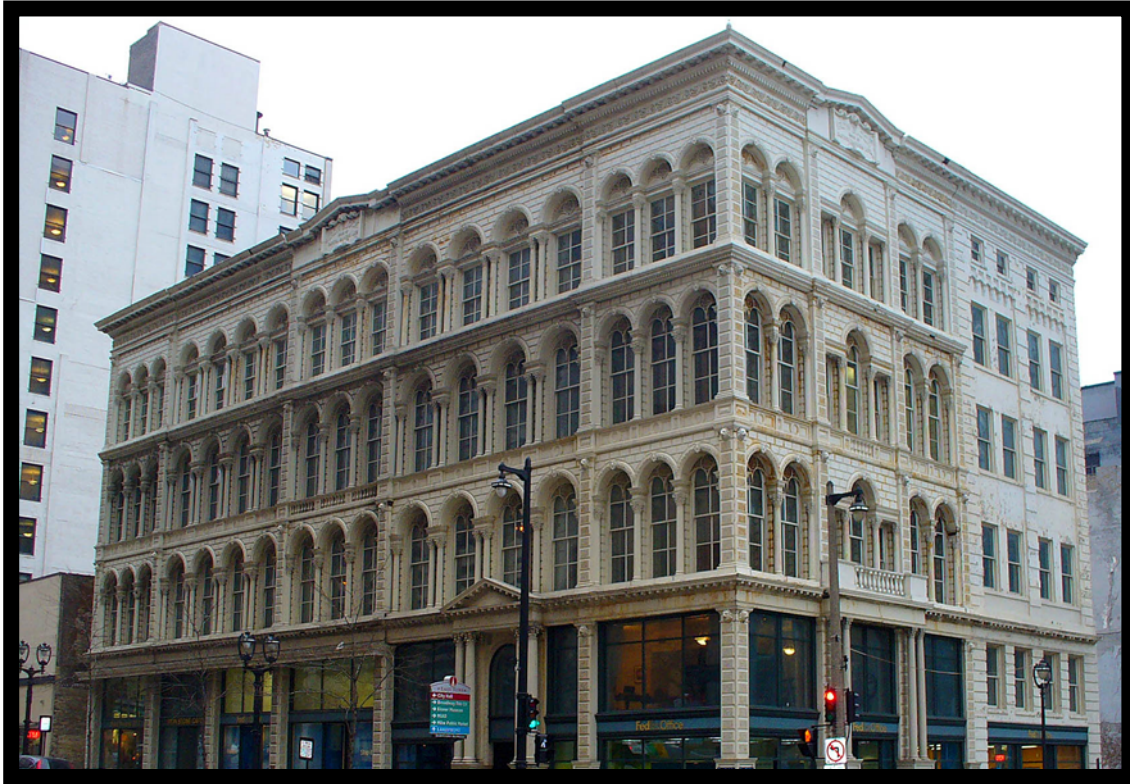
**BEFORE**

The building was again ready for attention in 2012, as the materials used in the 1983 renovation did not stand the test of time. Corrosion had attacked most of the surfaces of each façade, and it was common to see detached ornament lying on the sidewalk. A full, historically accurate renovation was planned.

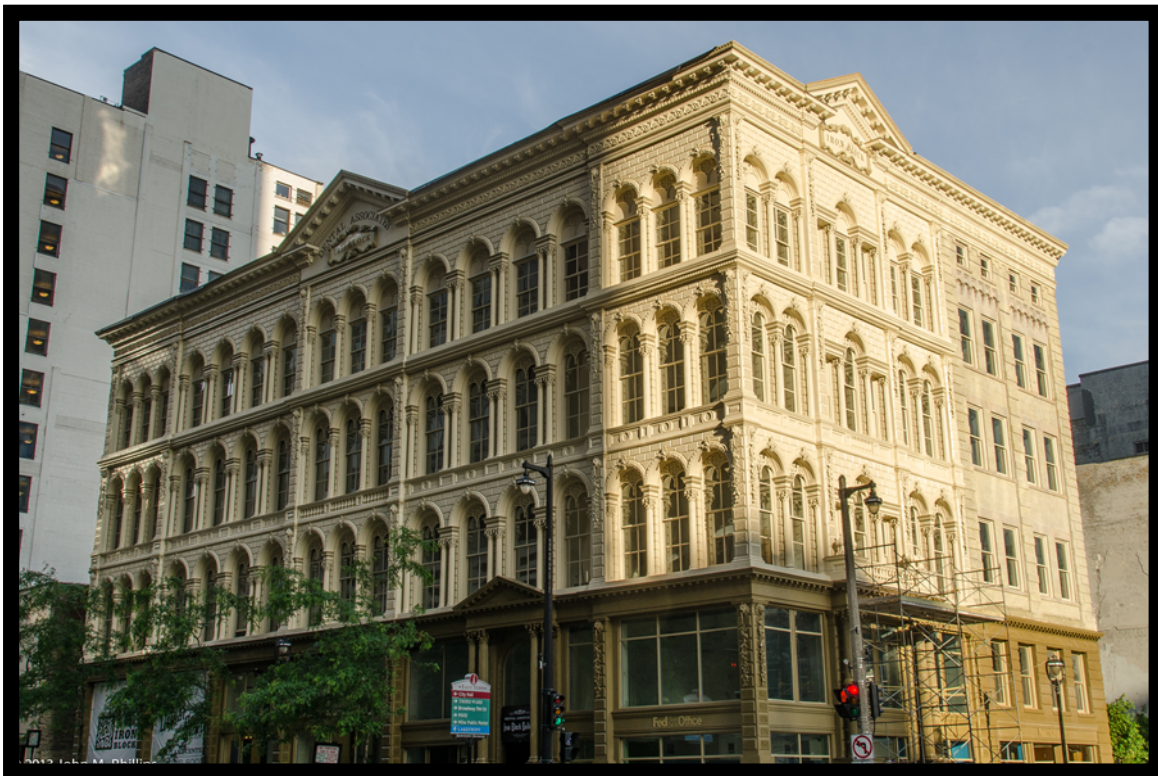
**AFTER**

In order to bring the facades back to their original magnificence, patterns and molds had to be created from photographs and pieces of the original building. Over 4,200 new pieces were cast in Wisconsin foundries to replace the missing acanthus leaves, lions' heads, columns and capitals, and even the garlands of grapevines. These pieces ranged in weight from a few ounces to over 1,200 pounds for the columns needed to restore the original entrance on Water Street. The entire iron façade was sandblasted down to raw steel, and a three-part epoxy paint system was used to chemically bond with the ferrous surfaces. New cornice and pediments were molded from FRP (fiberglass reinforced

polyester) and restored the proportions and grandeur of the original design. The addition, mistakenly painted for the better part of a century, was stripped down to the original Cream City brick.

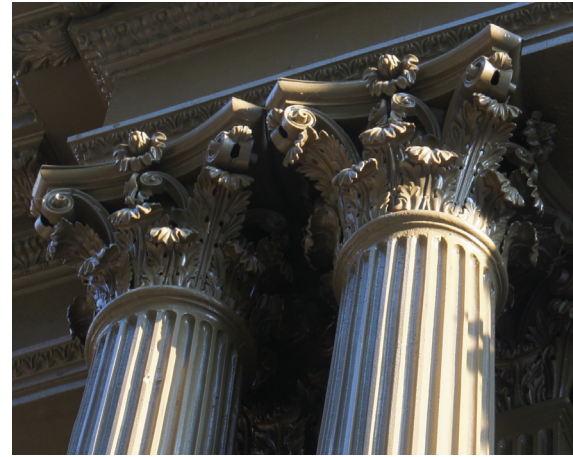
ALL OF THE COLUMN CAPITALS WERE RECAST IN 20-28 SEPARATE PIECES. IF THE COLUMN CAPITALS WERE REDONE IN JUST ONE PIECE, MUCH OF THE DETAIL WOULD HAVE BEEN LOST. BY RECASTING AND FABRICATING THE CAPITALS IN PIECES, THE TEAM WAS ABLE TO RESTORE A STUNNING LEVEL OF DETAIL IN THE BUILDING’S DRAMATIC COLUMNS.
