Certificate of Appropriateness

1923 N. 2ND ST. Brewers Hill Historic District

PTS ID 111459 COA Whole House Renovation

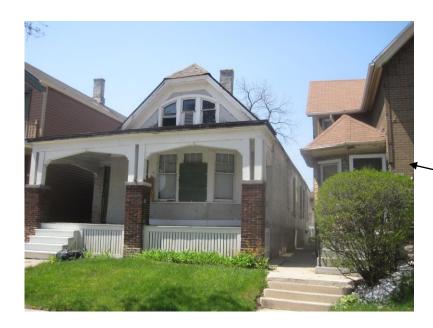
Current photo of the house, top.

1982 photo of the house, bottom.

The existing house dates from c. 1874-1875 and was the home of local police sergeant Joseph Berges.

Its current appearance as a bungalow is due to the full length porch that was added by the time of the 1910 Sanborn Fire Insurance Map. The rear frame additions were added after 1920.

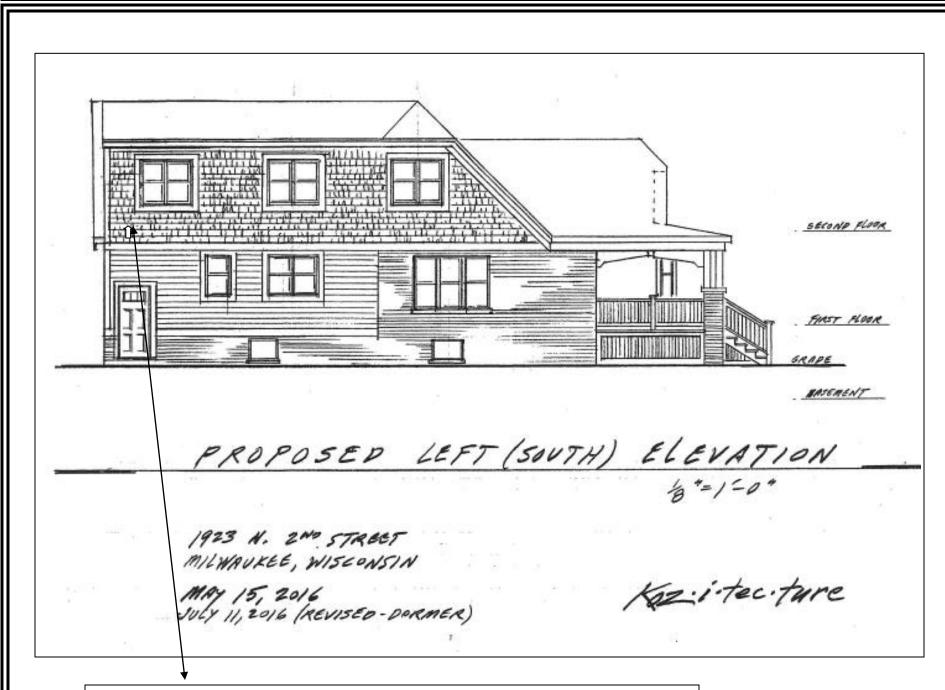
New dormer added to upper story for headroom for bedrooms.

In addition, the side gable on the south elevation will be extended to create a dormer in order to construct bedrooms in the former attic space.
