City of Milwaukee
Milwaukee County Parks

Dineen Park Master Plan

Prepared by TERRA Engineering December 2015

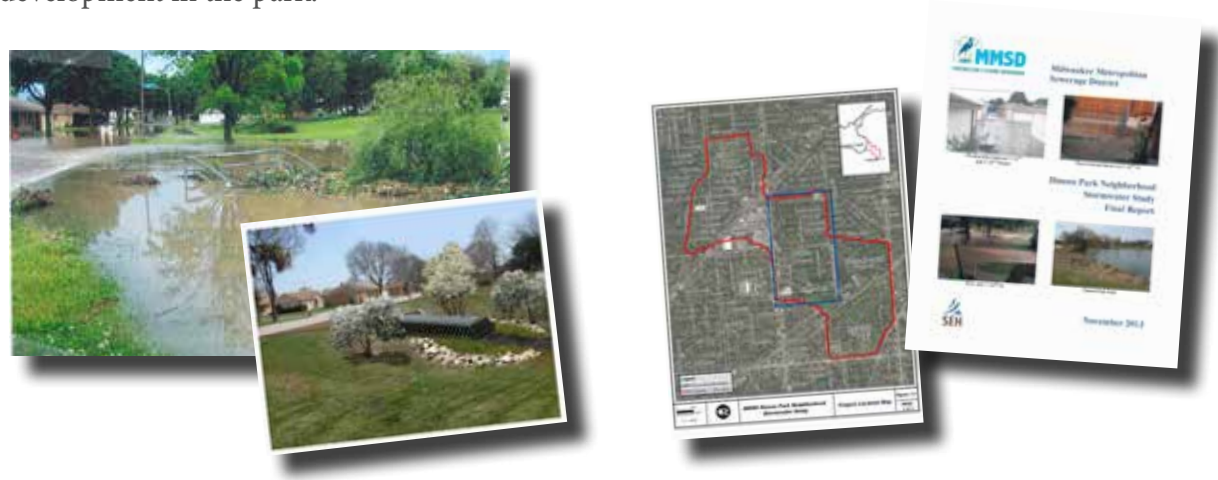
Images on Left: Existing Trash Rack at N. 63rd Street and W. Melvina Street and Trash Rack Improvements Rendering from MMSD 2013 Report. Images on Right: MMSD Report cover and Dineen Park Neighborhood Study Exhibit.

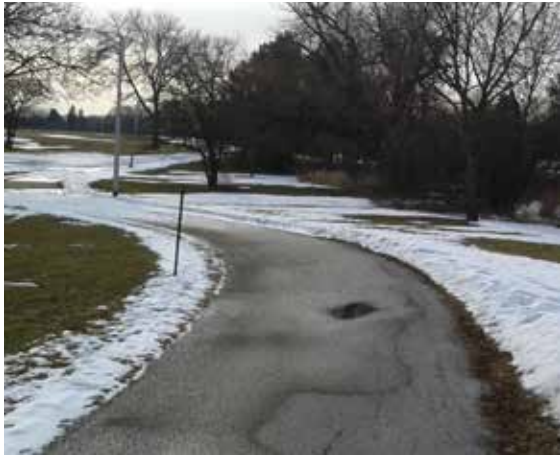
View of existing asphalt pathway looking northeast

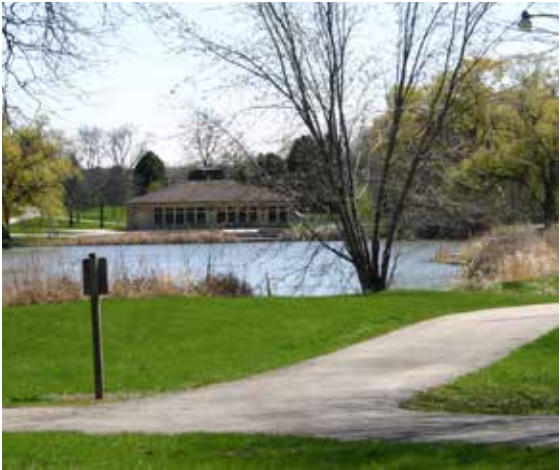
View of existing park lagoon looking southeast

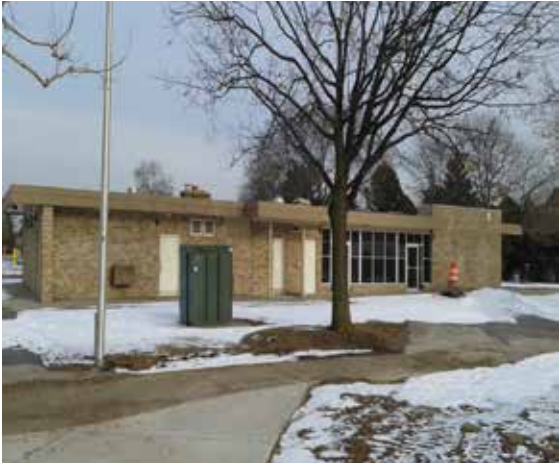
View of existing park bathhouse looking east

- The north end of building has been recently remodeled to serve as restrooms and changing rooms for users of the splash pad.
- New mechanical equipment supporting the splash pad has been fitted into the former lifeguard offices south of the north restrooms.
- The original community room remains largely unchanged but is a little worse for wear.
- The south end of the building has been shuttered. These spaces include a former pool shower room, restroom, and changing/dressing room. Also some concession space and a service area appear unused.

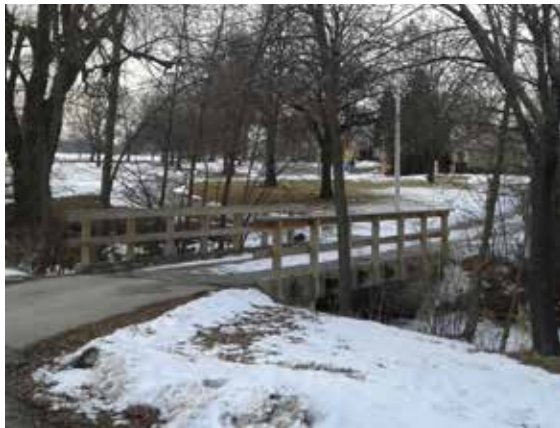
View of existing pedestrian bridge crossing looking northeast

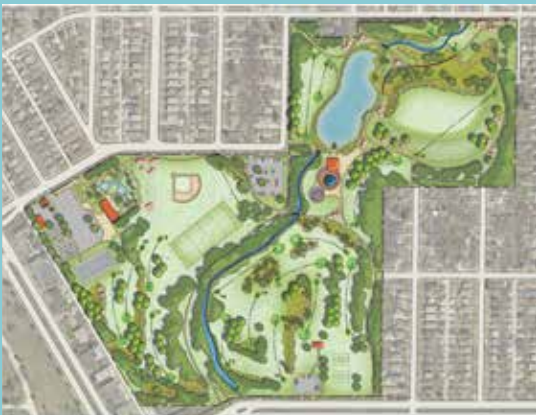
Championship Disc Golf Course Concept

This concept builds upon the current park’s 18-hole disc golf course by lengthening the hole lengths for championship level playing. The course’s playing experience is further enhanced with more challenging shots created by tree lined fairways, native plantings throughout course, and shots over the park’s creek.

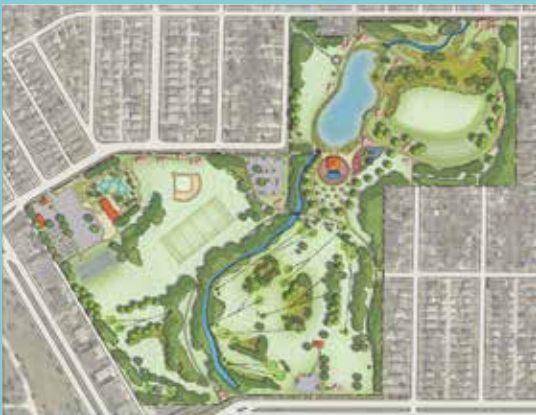
Festival Plaza Concept

This concept utilizes the currently unused wading pool location to create a centrally located festival plaza. The plaza offers the desired community gathering space for farmers markets and outdoor performances.

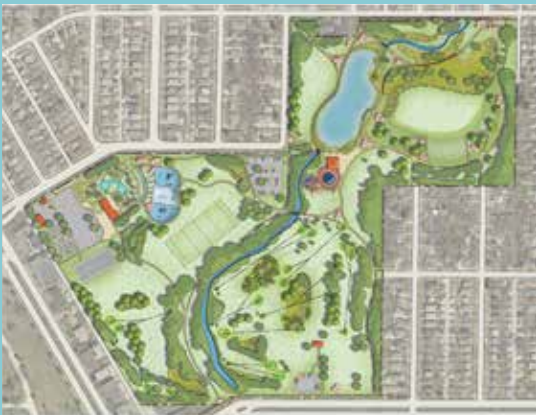
Regional Playground Concept

This concept enhances the splash pad playing area with the proposed regional playground. The playground utilizes the existing topography by creating slides that take the user from splash pad play area to the proposed playground space.

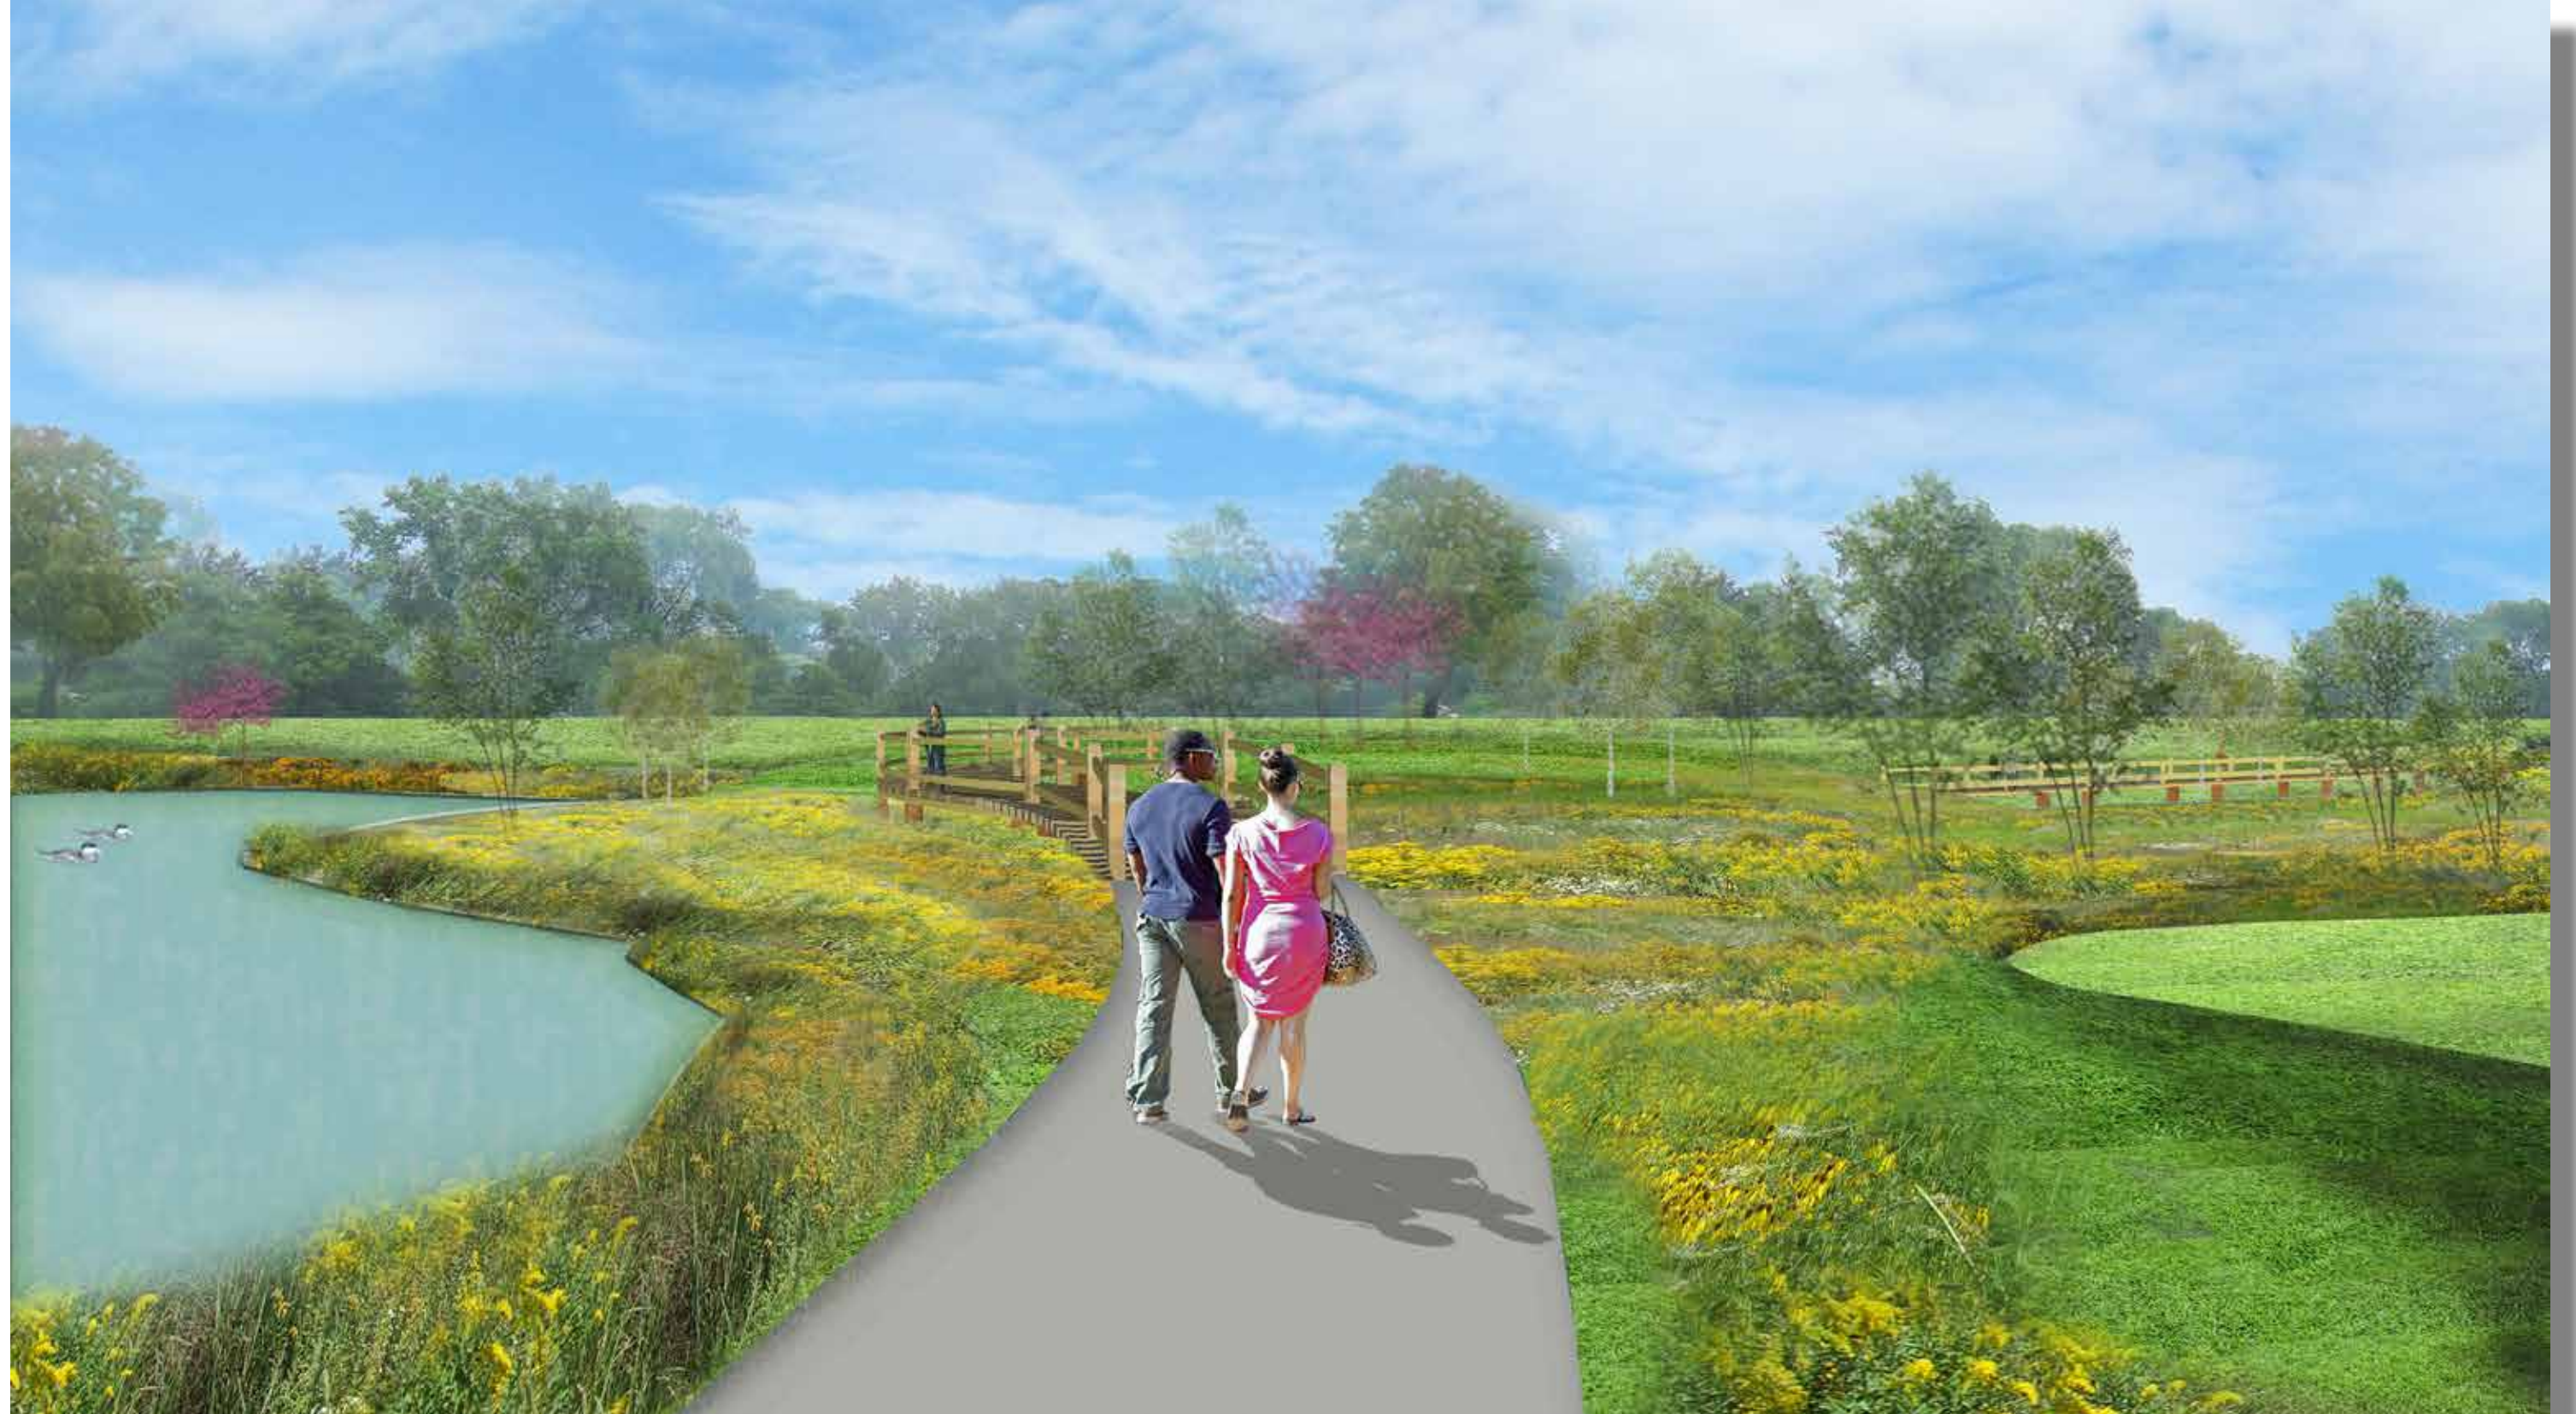
Section Through Stormwater Mitigation Area

*Estimated drain down time for the stormwater management facilities is 24 to 48 hours.

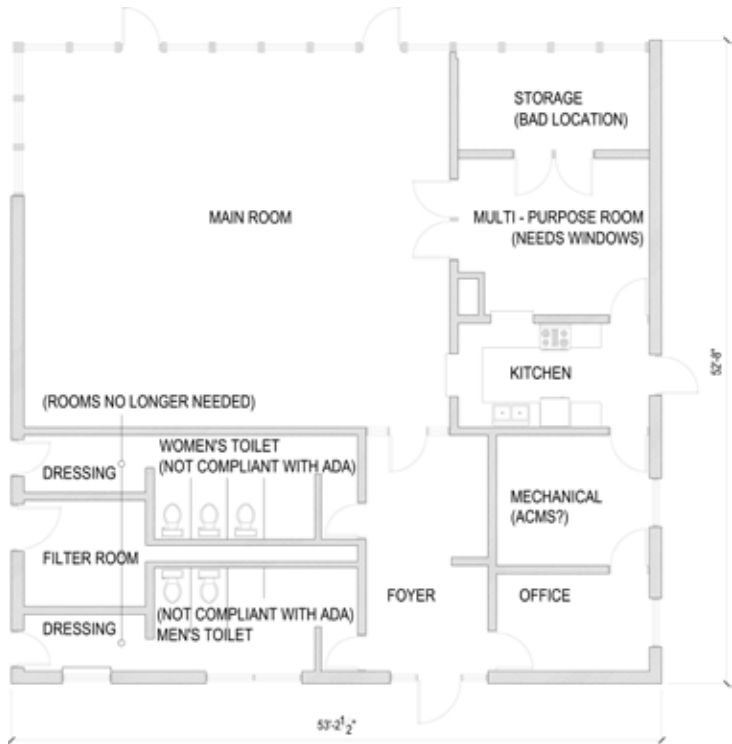
Lagoon Pavilion Existing Floor Plan

- Mechanical systems appear to be original and we suspect inefficient. Duct wraps should be tested for ACMs. System replacement should be considered.
- Restroom configurations do not comply with accessibility (ADA) standards.
- At some point the smaller public room in the northwest corner was divided and the view of the lagoon blocked by space repurposed as storage.
- Three small spaces in the southwest corner became functionally obsolete when the wading pool adjacent to the south of the building was decommissioned.
- The kitchen appears to be functional, but like most of the building, needs remodeling to refresh finishes and update equipment.

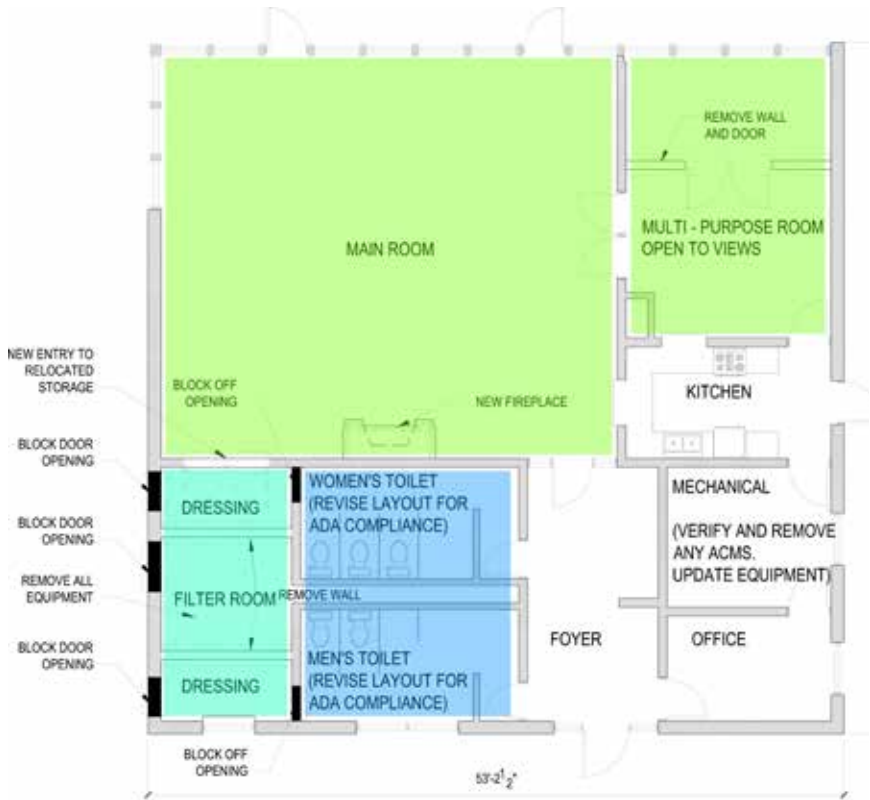
Lagoon Pavilion Floor Plan Recommendations

- Recapture unused southwest pool dressing and filter room as a furniture storage room for flexible use of the main public rooms.
- Remove existing storage room south wall to reopen multipurpose room to views of the lagoon.
- Reconfigure restrooms to provide for ADA access requirements.
- Replace aged mechanical equipment with high efficiency units and remove any ACMs.
- Remodel interiors to refresh finish materials, replace lighting, and add a fireplace feature to the main public room.
- Restore the exterior of the building.

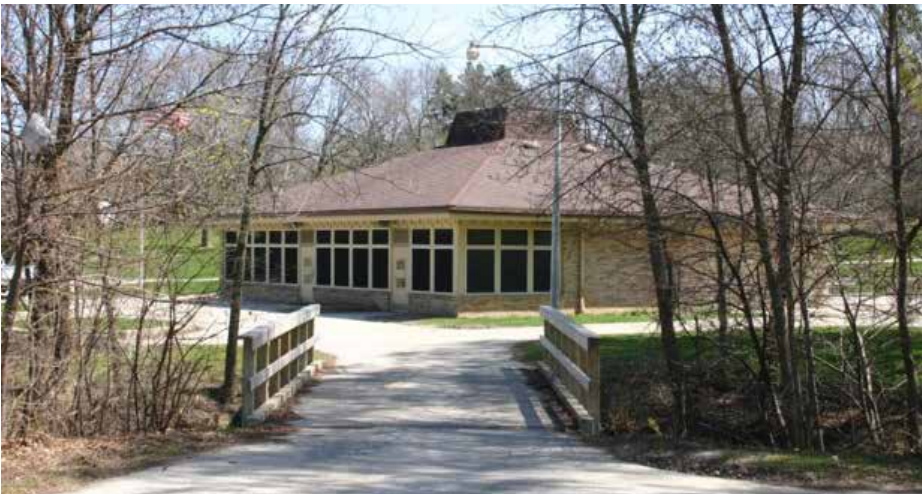
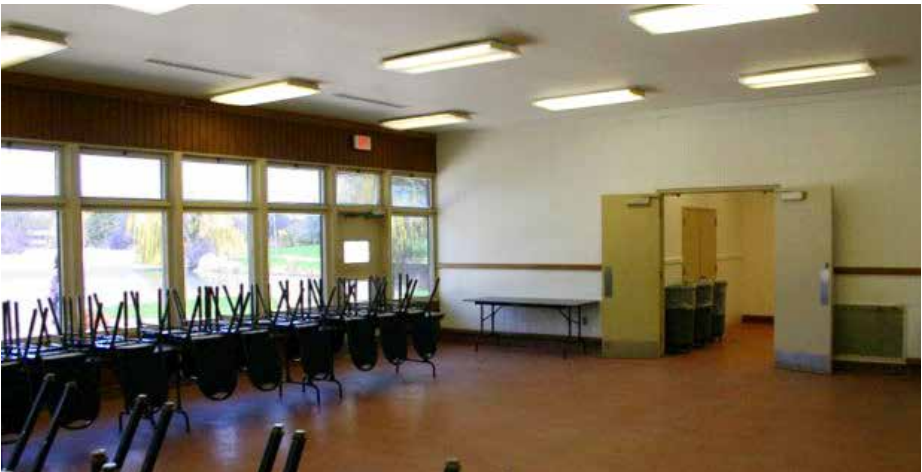
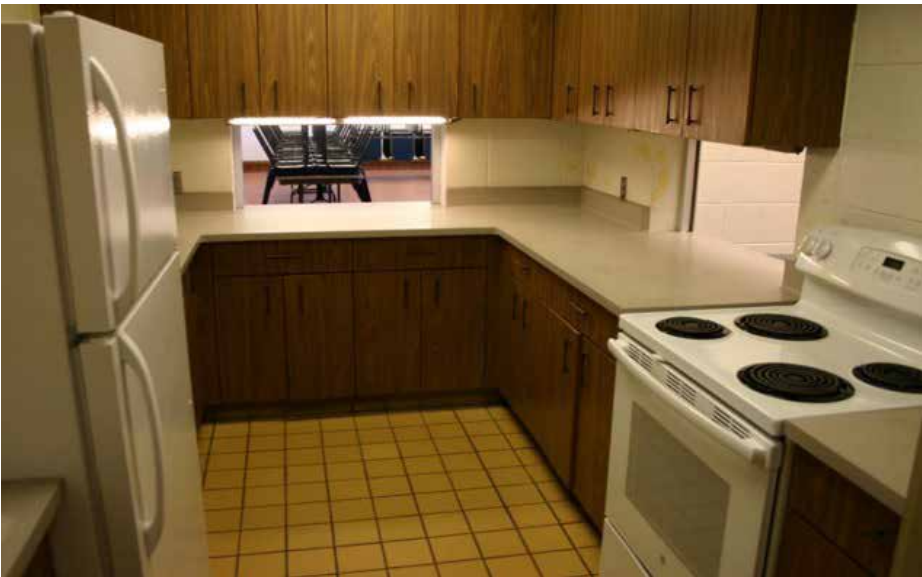
Existing Lagoon Pavilion Photos

The Pavilion was constructed in 1969. Some minor maintenance and building security renovation work was done in 1999. The building is structurally sound, functional, and serviceable for community residents as a venue for voting, neighborhood meetings, and is available to rent for family gatherings, anniversaries, birthday parties, graduations and other celebrations.

Observations:

The pavilion is an important park landmark that meets the needs of the community as an indoor public gathering space. After 45 years of service it has become worn and could be said to be in its “gray life”. Renovation to recapture and reuse existing spaces more effectively and generally refresh the facility is proposed.

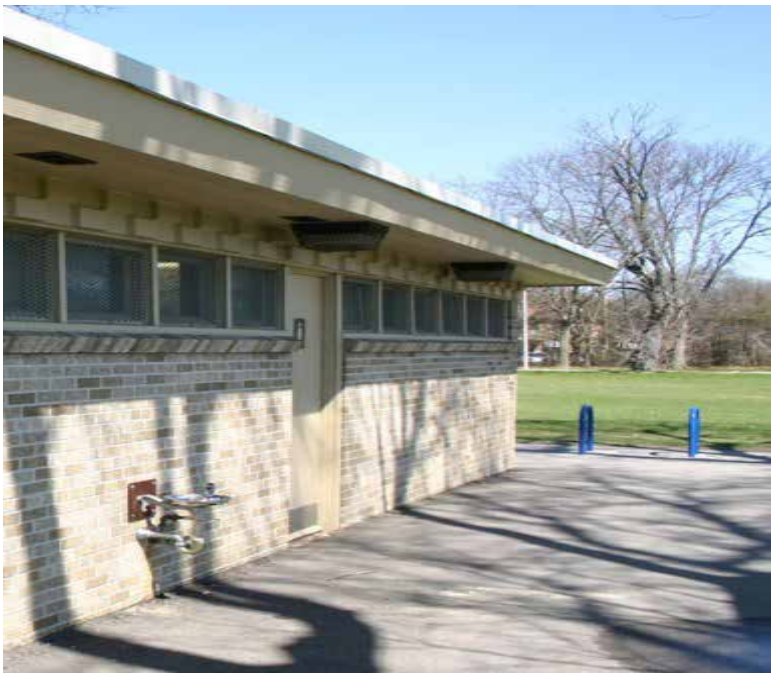
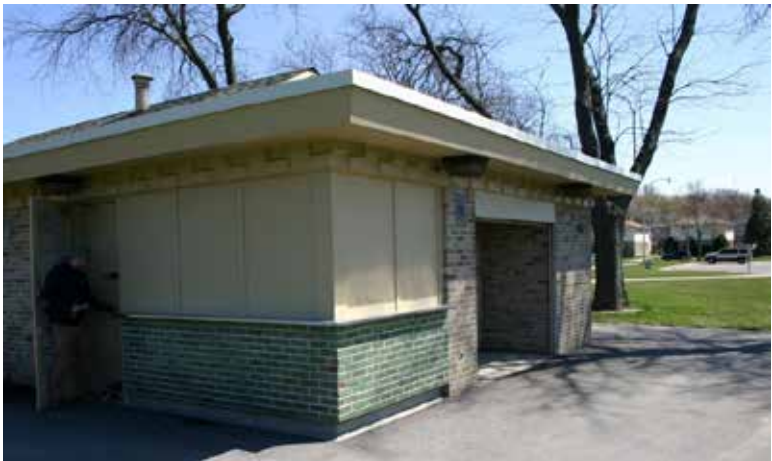
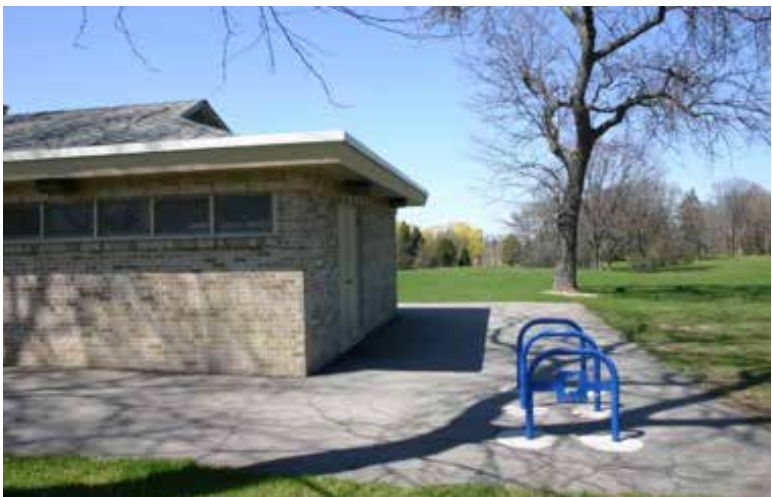
Existing Comfort Station Photos

This is a very small building at the southeast corner of the park. None the less, it has utilities and once supported the lawn bowling and golf programs that have now been replaced by disc golf and volleyball as identified in the Master Plan. The building should continue to play a part in supporting these activities and perhaps more.

Observations:

- Repurposing floor plan is limited by small spaces with interior masonry walls.
- Restrooms are not ADA compliant.
- Building finishes are dated.
- Exterior masonry bearing walls with generally long slot-like wall openings limits interior light.
- Overhangs extend a couple feet out.
- Boarded windows on NW corner block a nice view to the north.

Converting the current Comfort Building may be easier to justify if it can be seen as an investment in a revenue generator. The south half of the building can be viewed as support space and be upgraded for park users' convenience. The north half could be repurposed for summer rental.

- Renovate the restrooms to current ADA standards.
- Retain a small storage area in the southeast corner of the building.
- Create a rental facility by opening the north wall to views to the north and connecting the north half of the building directly to a small north terrace for picnicking. Add a countertop and a sink to provide potable water for convenience.
- Install garage doors to close the north wall in winter providing storage space for seasonal supplies and equipment.

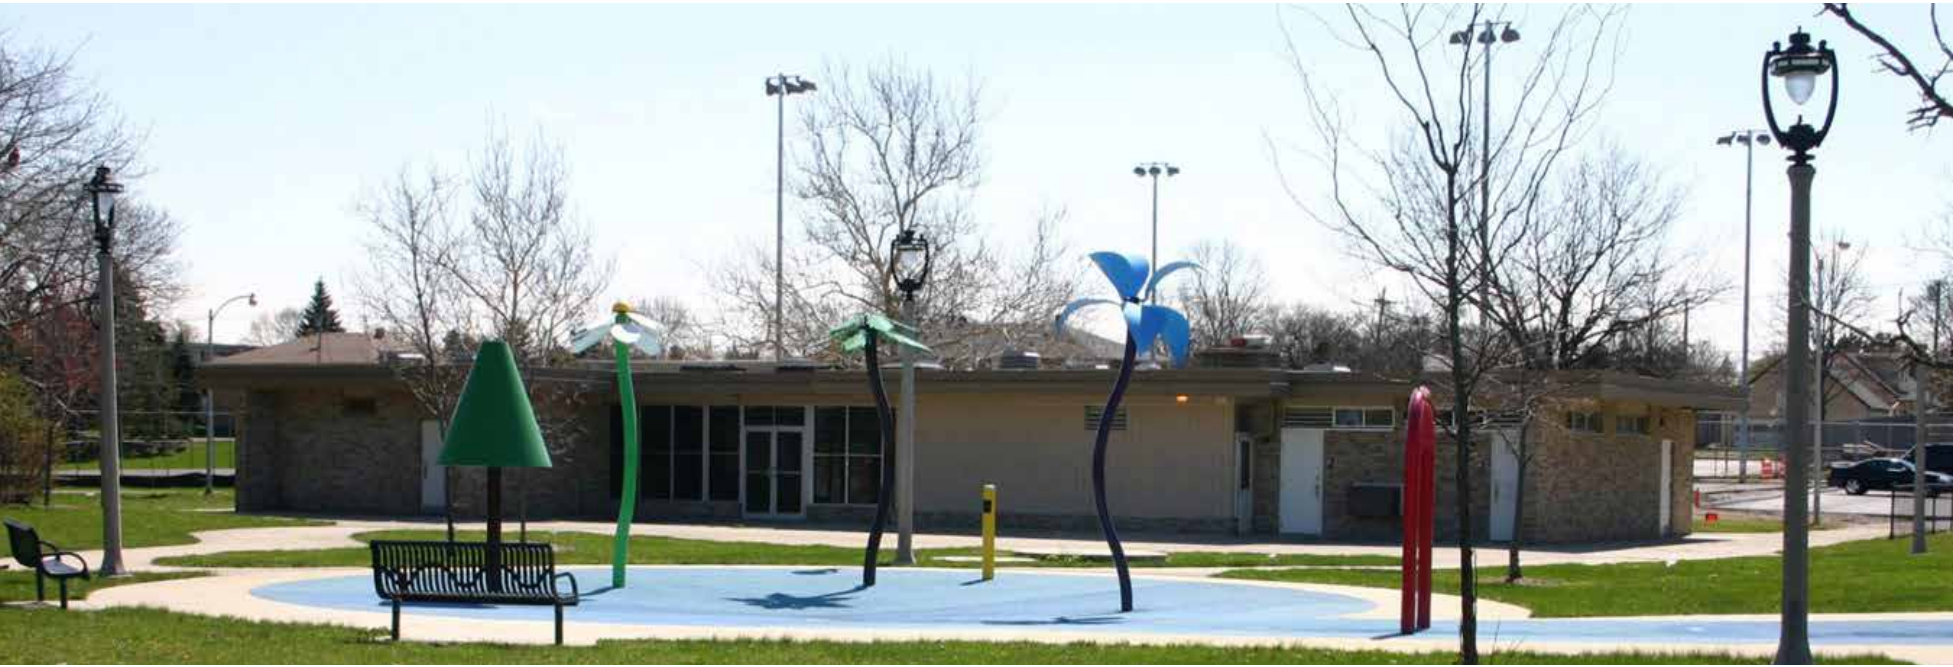
Existing Bath house Photos

The Bath House was constructed in 1965. Some restroom/changing room renovation work was done recently to the north end of the building to support the new splash pad. The building is structurally sound, functional, and serviceable for community residents using the splash pad. At the middle of the building a community room is available for rental as a venue for birthday parties and other celebrations.

Observations:

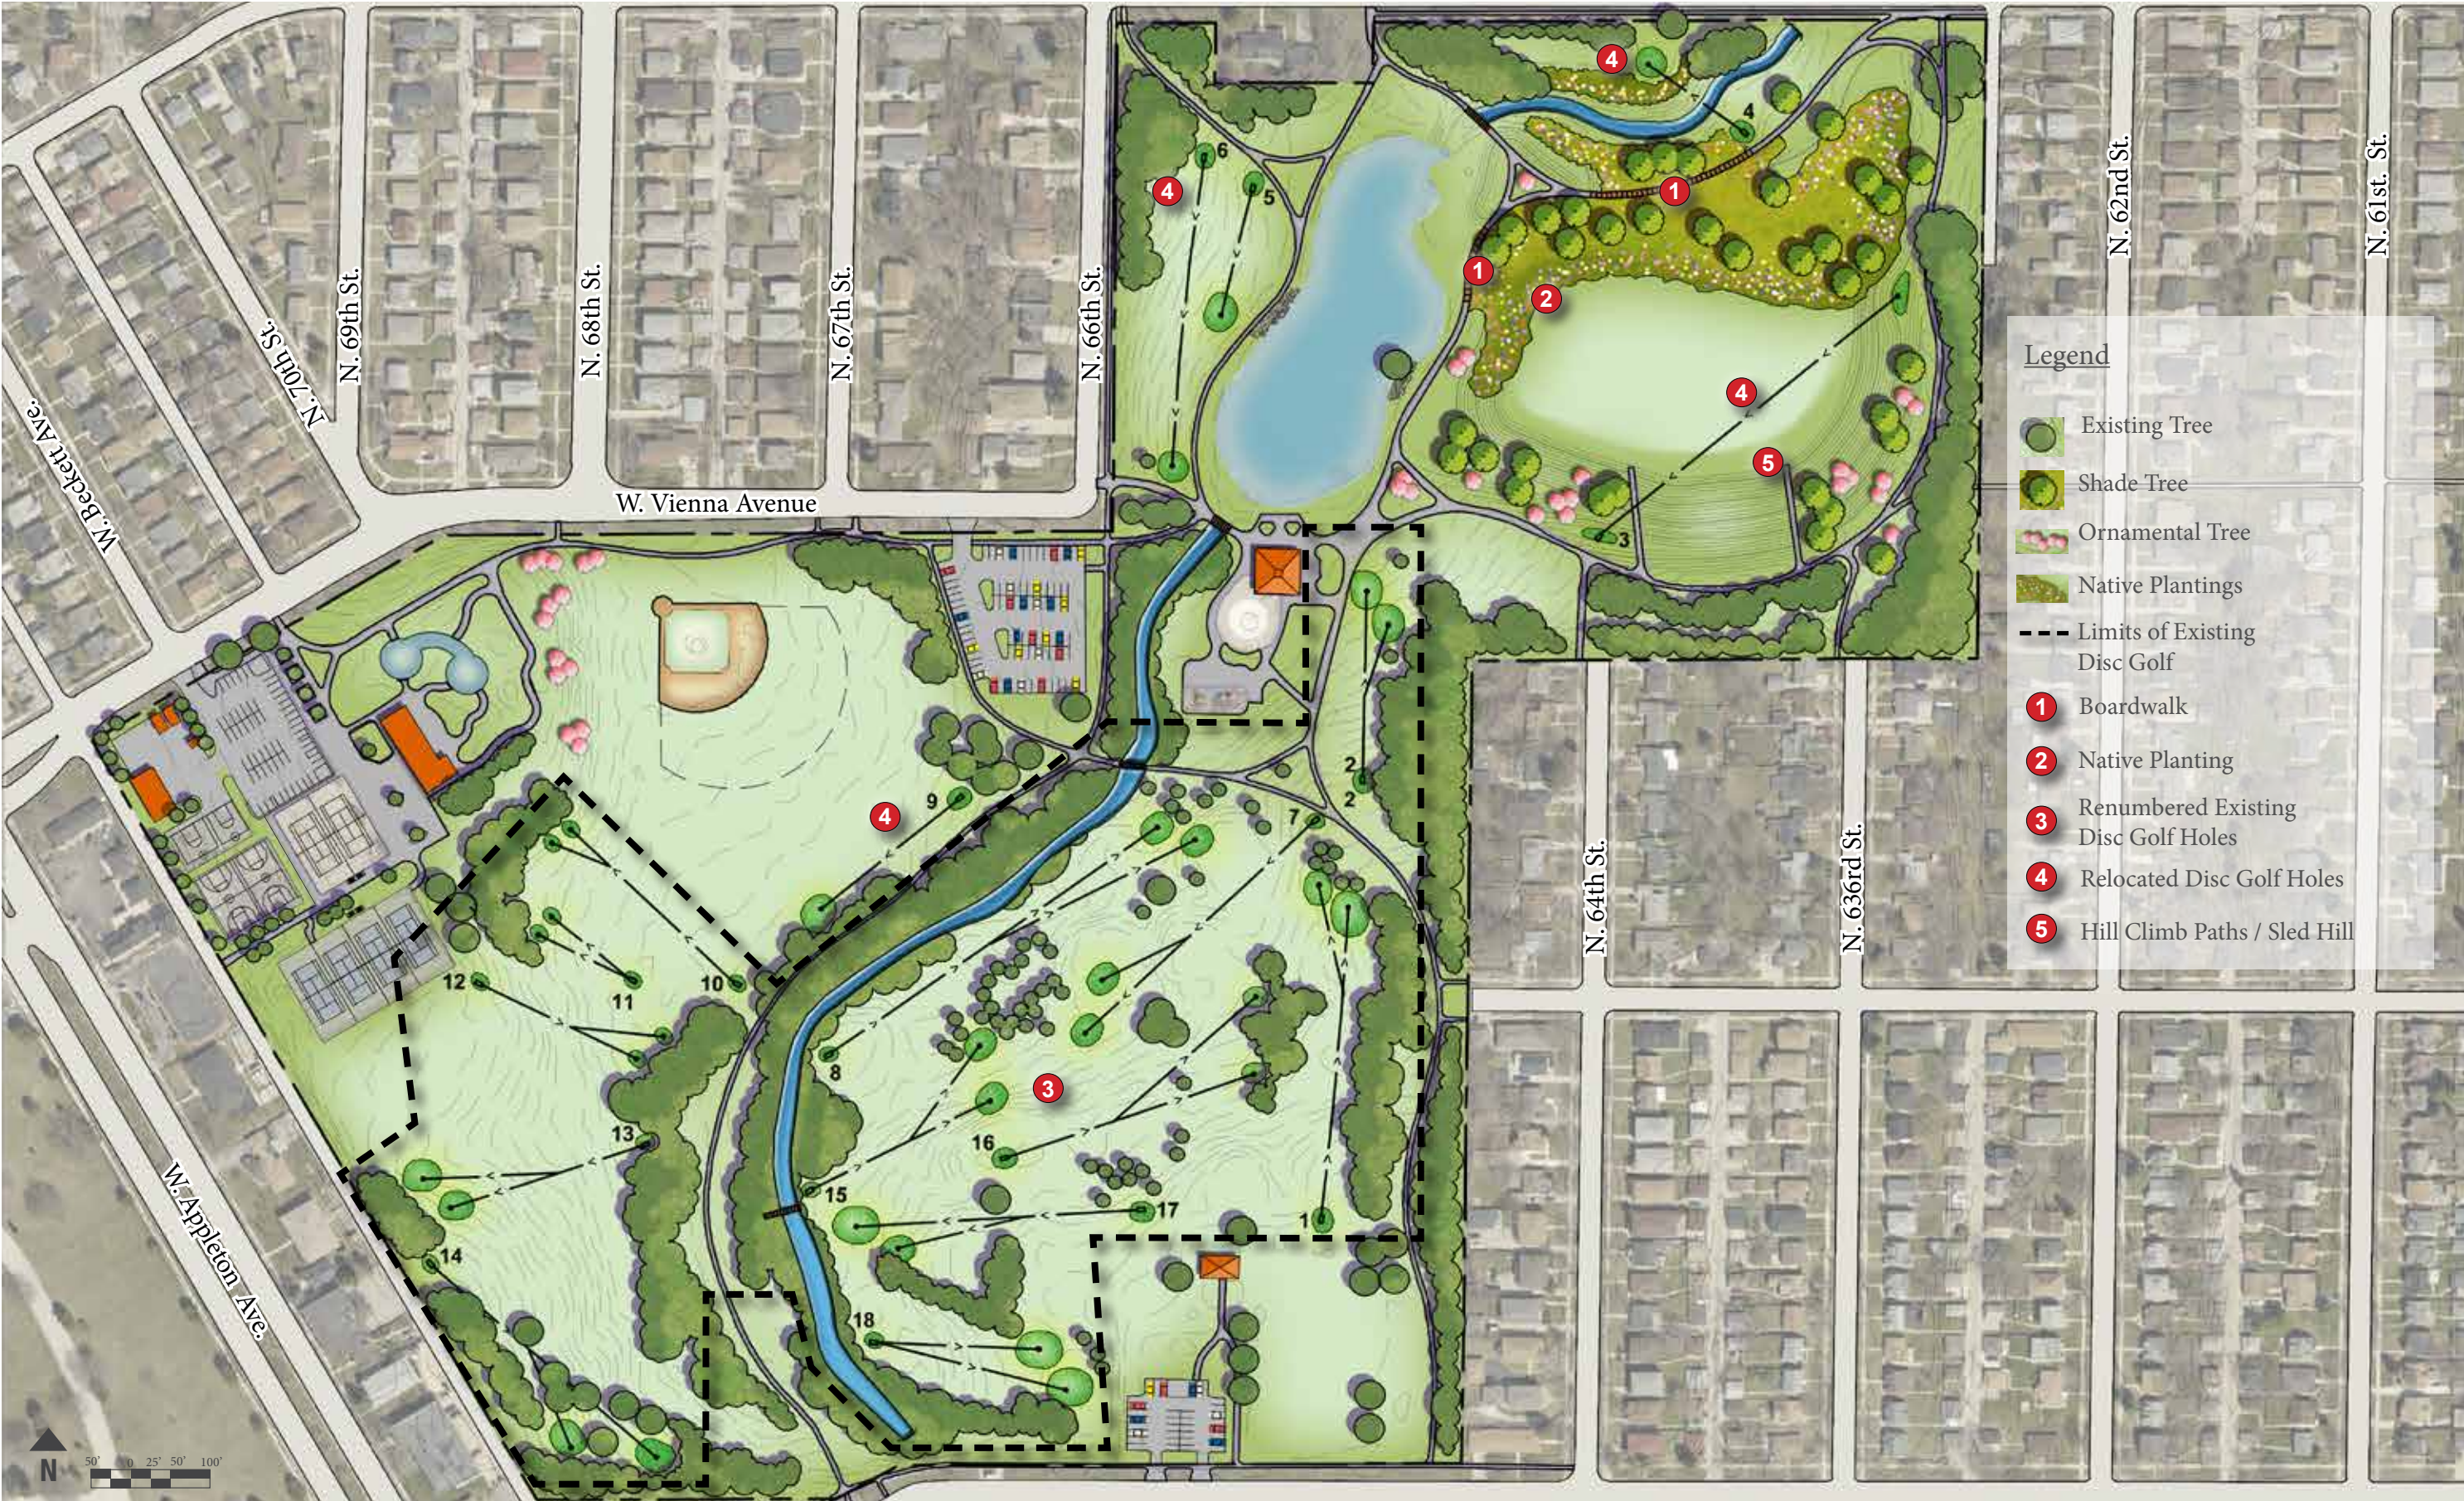
PROPOSED STORMWATER MITIGATION AREA

The Master Plan improves the natural environment with proposed shade trees and native plantings throughout the entire park site. In addition, the recommended plan proposes pathways to connect W. Keefe Parkway and W. Vienna Avenue to improve pedestrian circulation through the park and provide direct access to the regional playground from the southern boundary of the park. The boardwalks and reconfigured pathways around the stormwater mitigation facility provide full access even in flood events.
