Certificate of Appropriateness

North Point North Historic District 2691 N LAKE DR

Description of work 1. Repair/replace flat roof areas with rubber membrane roof and new flashing per attached

5/10/2017 PTS ID 114274 COA: porch and roof repairs

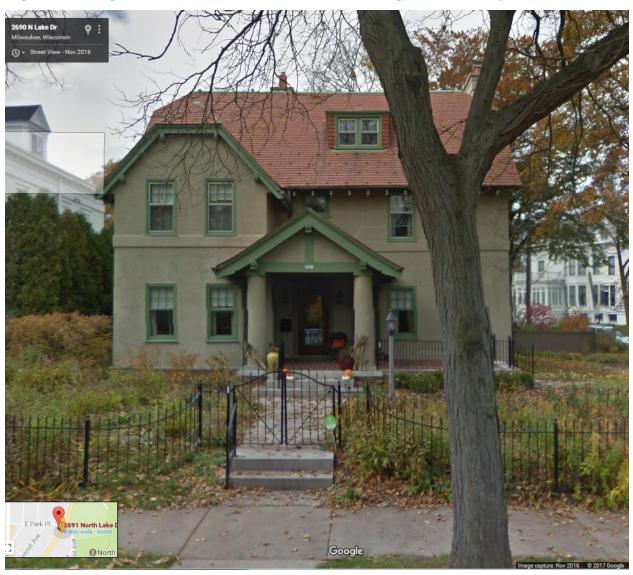
Current conditions at front of house.

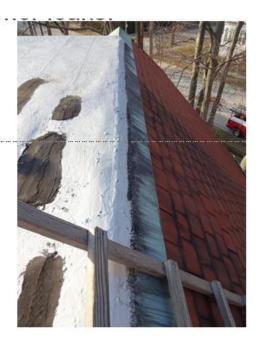
Typical conditions on flat roof areas.

Upper West (2) Flat Roofs:

The proper scaffolding will have to be set up on the West side of the house to allow us access to both flat roofs. The scaffolding will be taken down when the job is completed. We will have to remove the existing tiles along all of the flat roof intersections with the roof so that the new flat roofs can be flashed properly. The existing two valleys that intersect with the flat roofs will be removed at this time. The existing roofing material will then be removed down to the original decking on both flat roofs. \$55.00/hr plus materials for any wood repairs that may be needed after the tear-off is completed. The current scuddle box on the North flat roof will be eliminated since they are only problematic and is no longer being used. 1/2 ISO board will then be applied over both flat roof surfaces. The ISO board will be secured down using 2 1/4 inch screws that will be applied through three inch discs. Commercial glue will then be applied over both flat roof surfaces. 60mm Edpm rubber roof systems will then be applied over both flat roof surfaces. The rubber will be run up onto the pitched roof section to eliminate the flat roof intersection with the tile roof. The rubber will be run up onto the existing chimney on the South flat roof. At this time we will use 16oz copper and custom make and install a new counter flashing around the entire chimney. The proper sealant will be used to seal the intersection of the chimney and new copper flashing. At this time we will custom make and install a new copper apron along all of the roof edges. All seams to be soldered. Six inch bar tape will then be used to seal the intersection of the rubber roof with the copper apron. At this time we will install new copper "W" style valleys in both valleys. The existing tiles will then be re-installed being secured down properly.
