## Certificate of Appropriateness

2518 N. TERRACE AV.

PTS ID 114491 COA: replace roofing

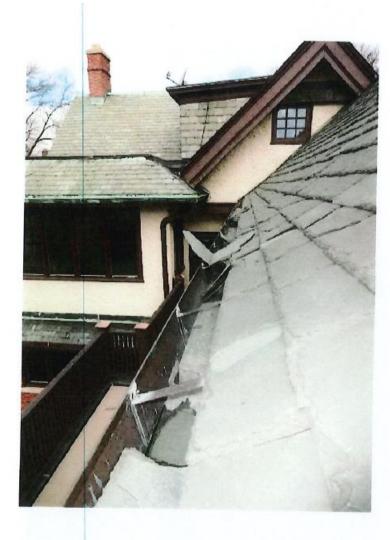
Roof to be replaced

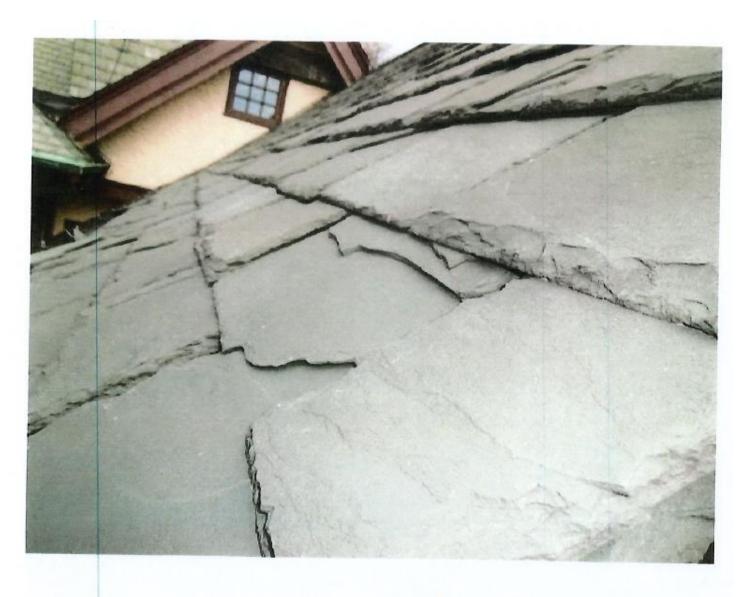
Roof tile to be replaced
