Scope of Work for 3005 West Kilbourn Avenue

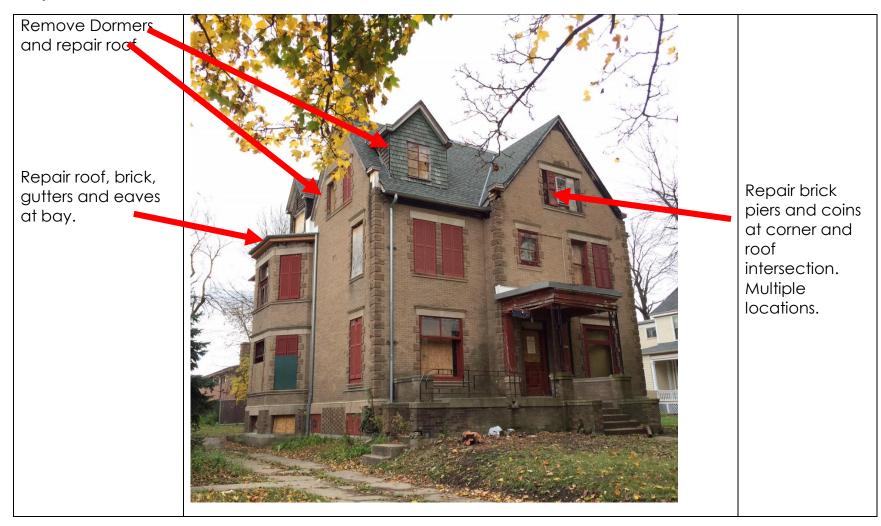
Multiple locations at roofline.

Repair brick piers and coins at corner and roof intersection. Multiple locations. Bebuild and tuckpoint brick piers and coins. Corners must be trimmed to match original details of wooden cap, crown, fascia boards etc. areas to be properly flashed to divert water to gutters.

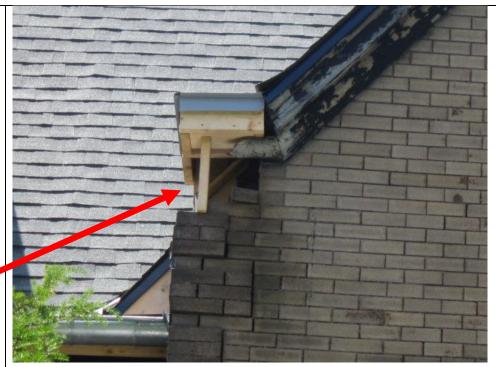
Example of original brick corner and wood trim with crown at corners. Rebuilt areas to match this original details.

This detail can be found at southwest corner of house.
