# **ARCHITECT'S FIELD REPORT**

Charles Allis Art Museum
Exterior Improvements
Milwaukee County – Department of Administrative Services
Milwaukee County Project No. 0527-17438
James G. Otto Architect, LLC Project No. 15005.00

Visit Number: Five

Date: July 25, 2018
Time: 10:30 am
Weather: Sunny
Temperature Range: High 70's
Present At Site: Jim Otto

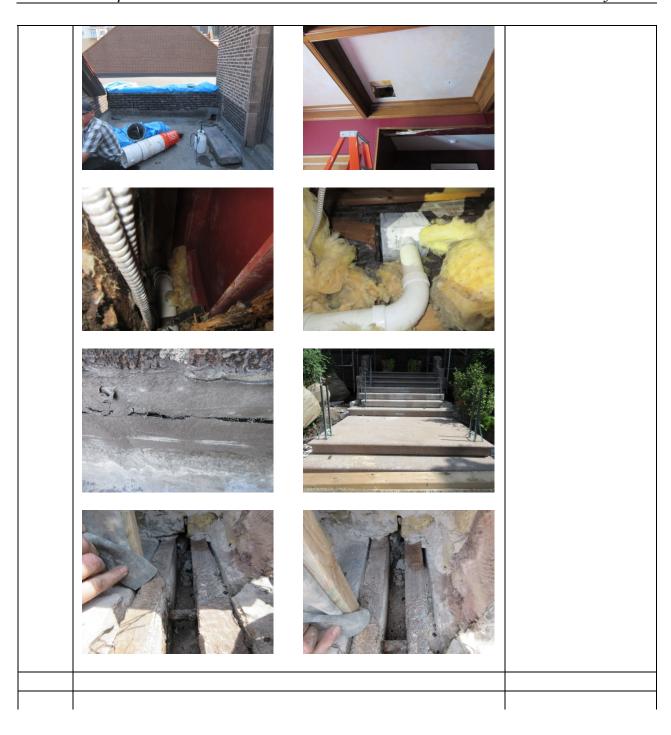
Item	Description	Action By
5.01	Reviewed current work in progress as follows:	
	Balcony; the steel members embedded in the masonry are in very	
	good condition.	
	South Stair; the granite steps and landing are installed.	
	Fire Escape; fire escape has been removed for repairs.	
	<ul> <li>Foyer Roof Area; the masonry has been pointed.</li> </ul>	
	Foyer Roof Area Drain; the drain connection has been opened for	
	review. The new drain and piping can be installed as designed. The	
	leak damage appears to be due to failed roof base flashing which will be	
	resolved by the new work.	
	Garage North Wall; not mobilized, no progress.
