2803 E. Bradford Avenue – Slower South Elevation Window.

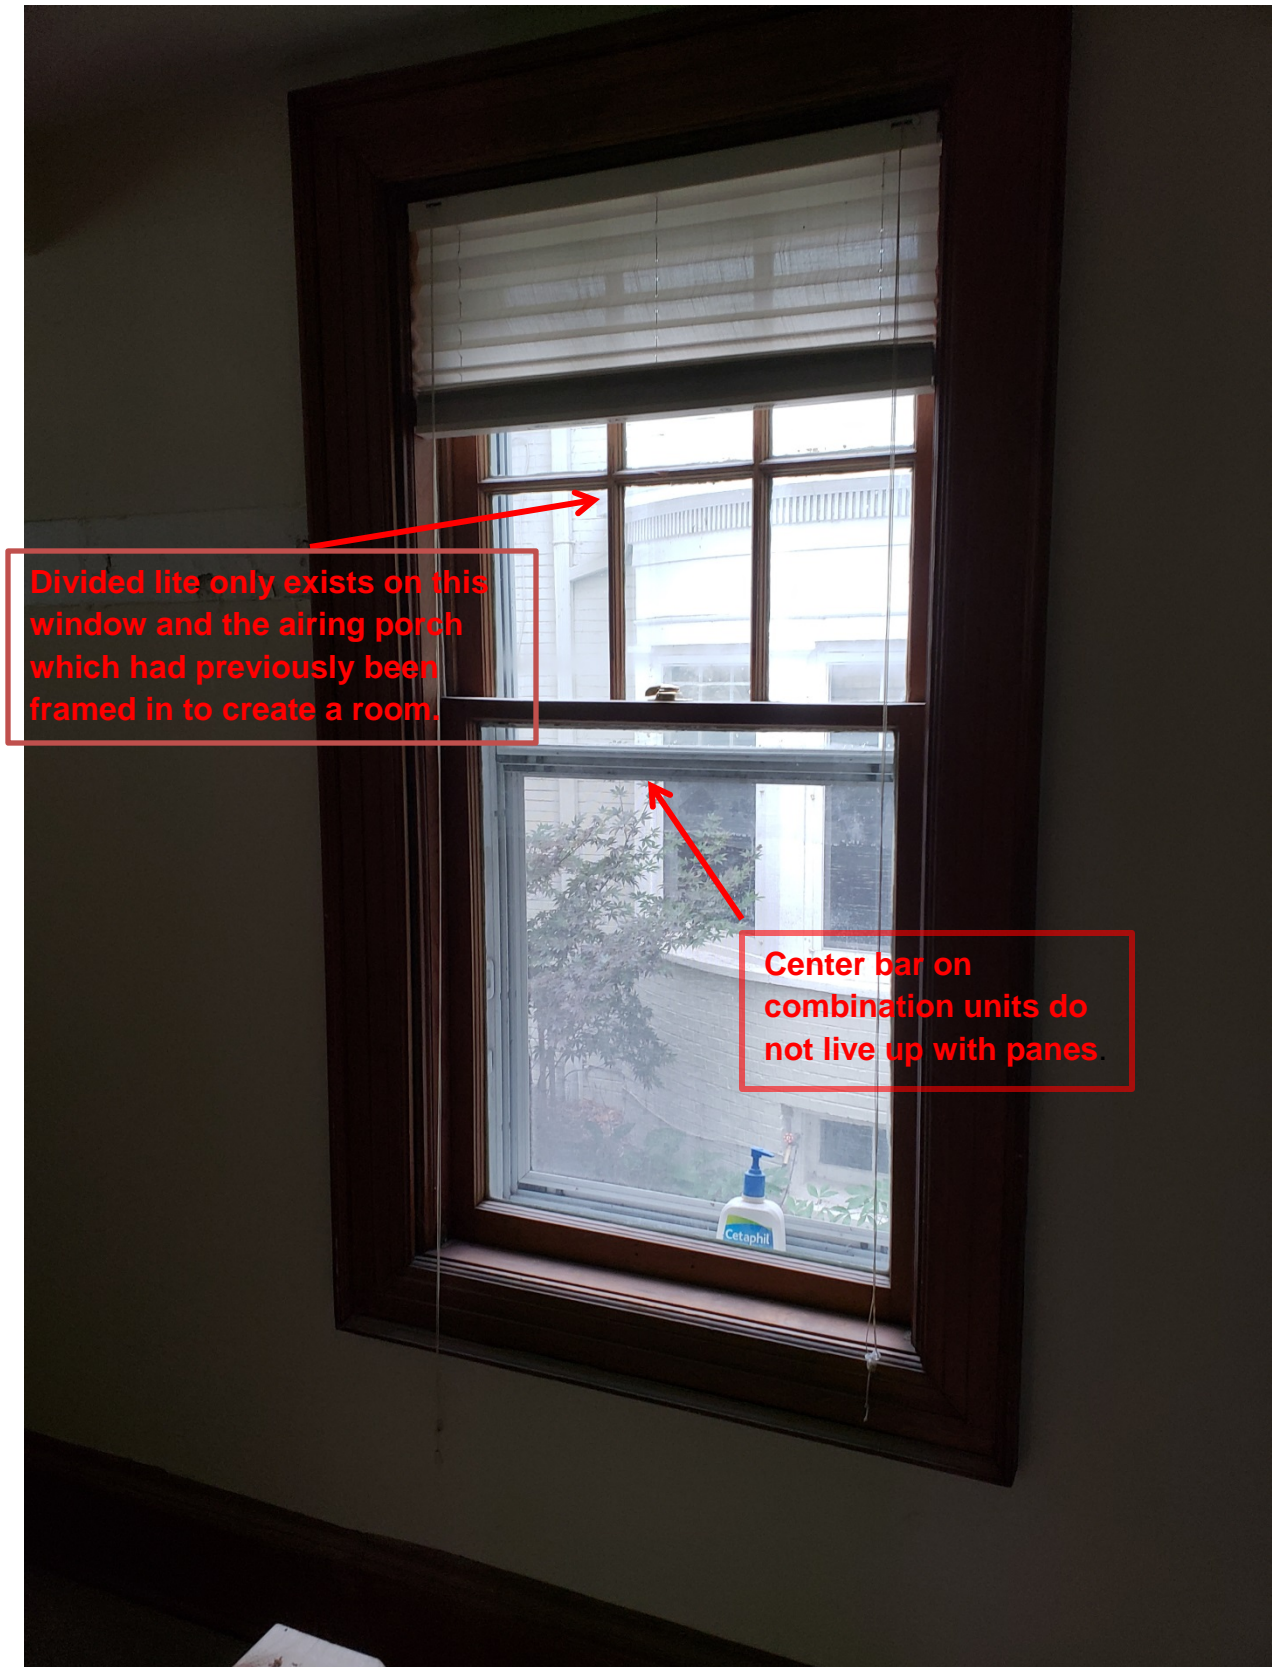
Divided lite only exists on this window and the airing porch which had previously been framed in to create a room.

Center bar on combination units do not live up with panes.
