Certificate of Appropriateness

Property	2251 N. LAKE DR.	North Point South HD
Description of work	Porch repairs per attached description and photo	
Date issued	11/12/2018	PTS ID 114654 COA: porch repairs

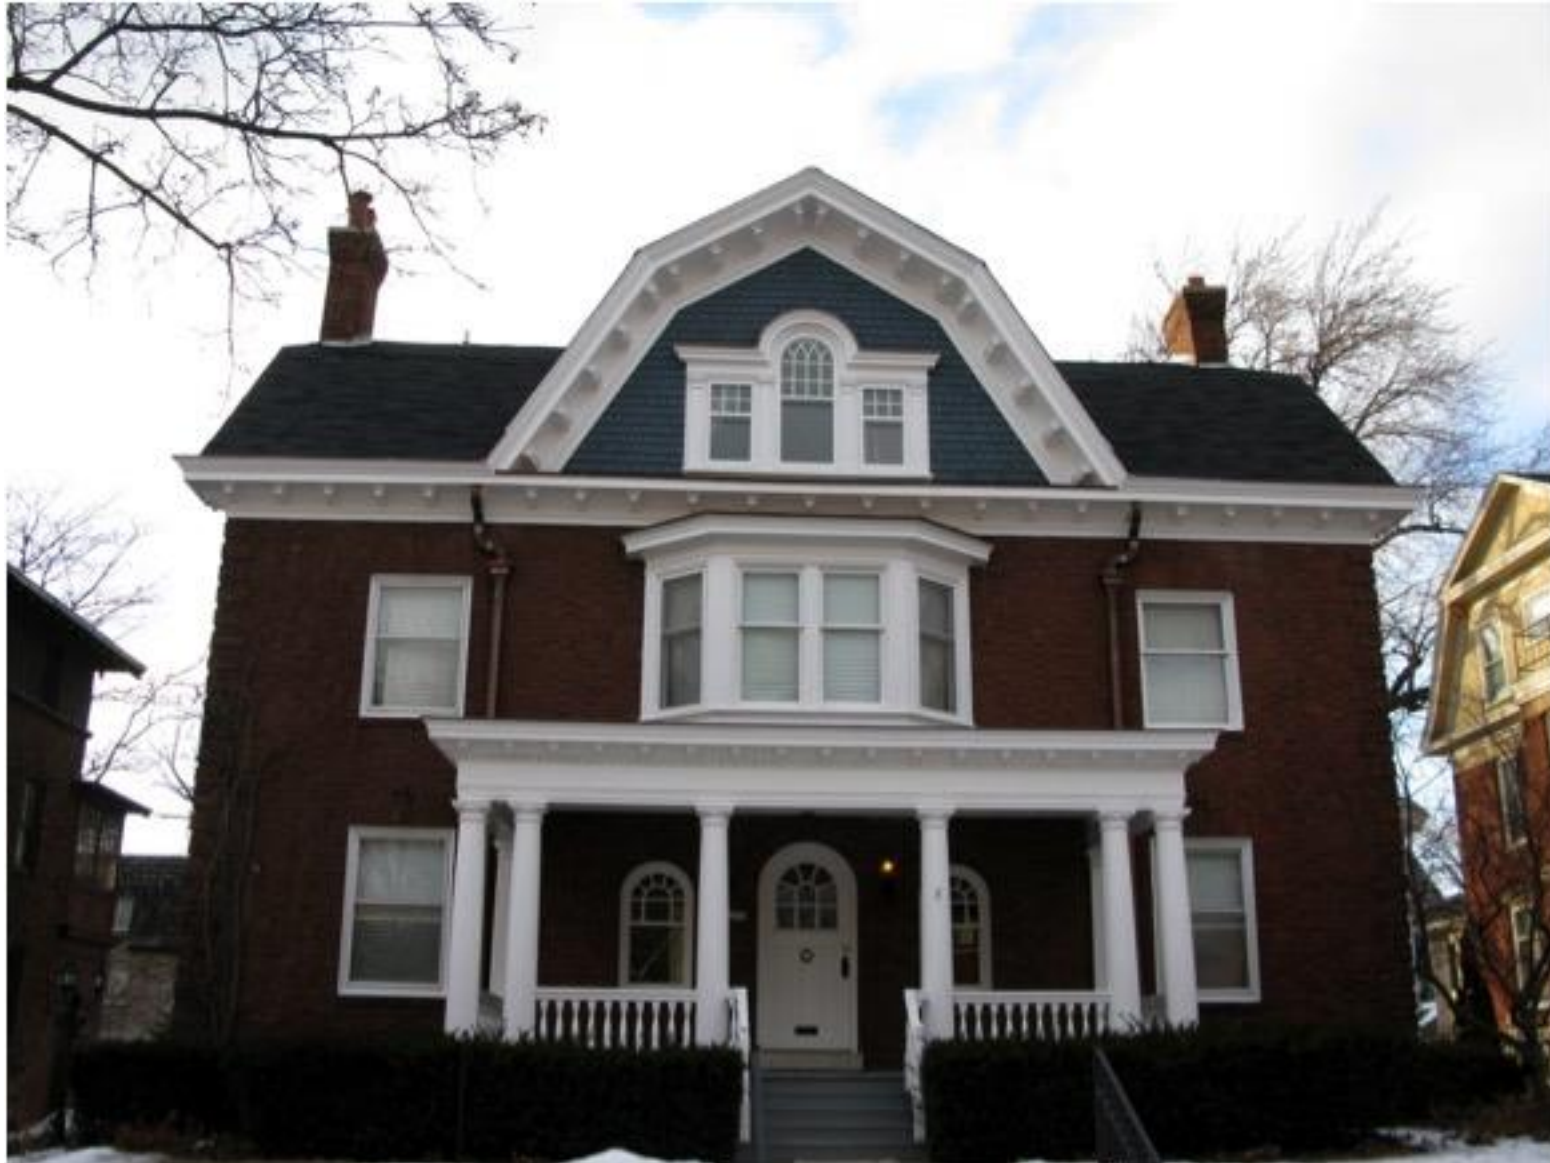
“Before” photo

The wooden front porch columns are rotted. They will be removed and set aside for epoxy repair and repainting in white.

The existing tongue and groove wood front porch flooring is partially rotted. While the columns are removed the floor will be removed and disposed of. New ipe tongue and groove flooring will be installed and oiled.

The wooden front porch railing will be removed and set aside for reinstallation and repainting in white.

Any structural damage found under the porch deck will be repaired at this time.

The front stairway railing will be removed and set aside for reinstallation and repainting in white.

The existing stair treads will be removed and disposed of. New ipe stair treads will be installed and oiled.

The existing risers will be saved for reinstallation and repainted.
