LIVING WITH HISTORY

Certificate of Appropriateness

953 N. 33RD ST. Concordia Historic District

PTS ID 114618 COA: porch and related 2019

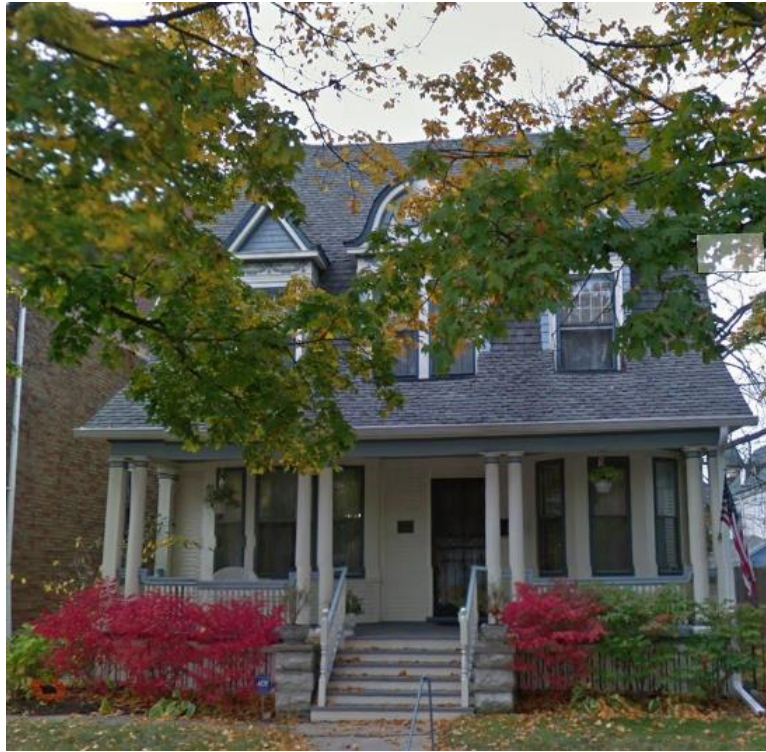
Porch roof will remain since it is integrated into the roof of the house.

All sections of the porch below the roof are to be removed including columns, balusters, steps, handrails and skirting.

New footings will be poured and the porch deck and skirting are to be rebuilt.

This photo shows work underway.

A COA for the railings, balusters, columns and handrails will be approved in a separate COA.

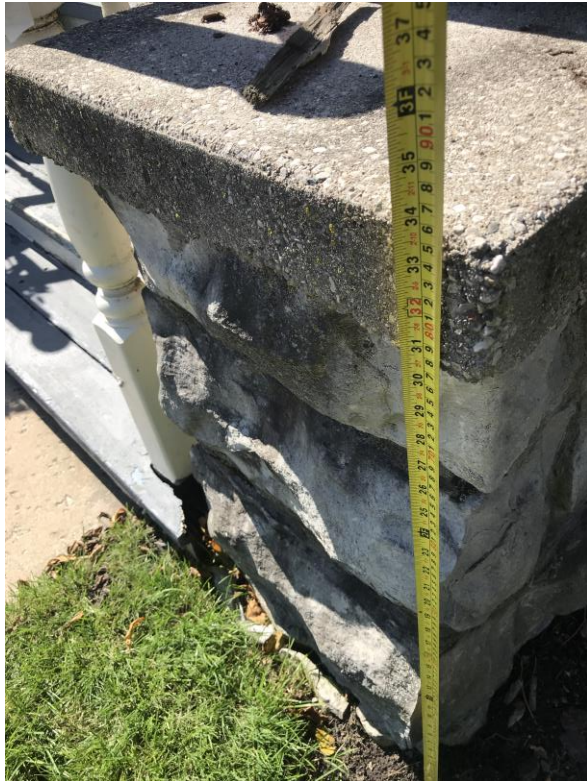
Wing walls measure 32 inches tall by 22 inches wide by 52 inches deep (front to back)
They will remain.

The masonry wing walls will remain.
