Safeco Insurance Company of America

Claim Number: 465410366002
Insured Name: Joel Benway Katherine Benway
Date of Loss: July 15, 2017
Policy Number: OZ4593144
Underwriting Company: Safeco Insurance Company of America

Claim Number: 465410366002 **Policy Number:** OZ04593144 **Type of Loss:** Wind

Price List: WIMW8X_SEP17
Restoration/Service/Remodel
Estimate: JOEL BENWAY__
KATHERI

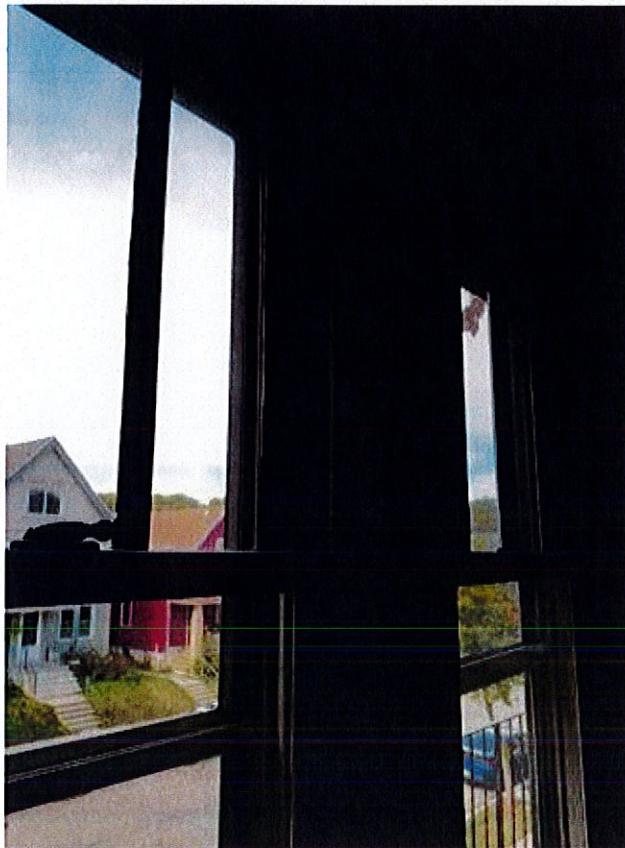
73-Wood window

Windows had a pulley system with a weight installed to raise and lower the window
