# Facilities Condition Assessment Program

## Port of Milwaukee Analysis Update

August 2012

## BRADFORD AND COIL BUILDINGS

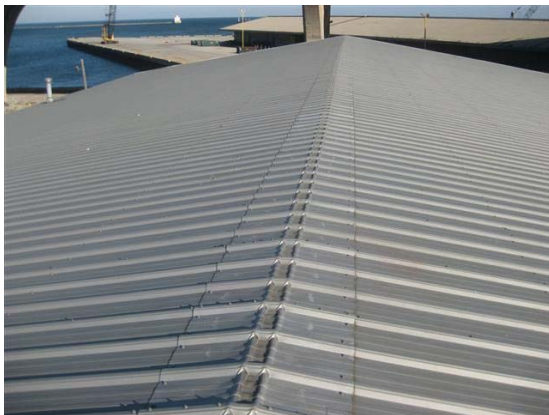
Bradford 1 includes a 160 square metal roof. The roofs are inspected and maintained by a third party. The last inspection occurred in 2012 where the roofs are indicated to be in fair condition. The inspection revealed the onset of rust at the roof edges and flashing. Additionally, the southwest corner was reported as damaged.

Roof overview

The useful life of metal roofs is up to 35 years. Its replacement is anticipated by 2030. Near term maintenance should be funded from the operating budget.

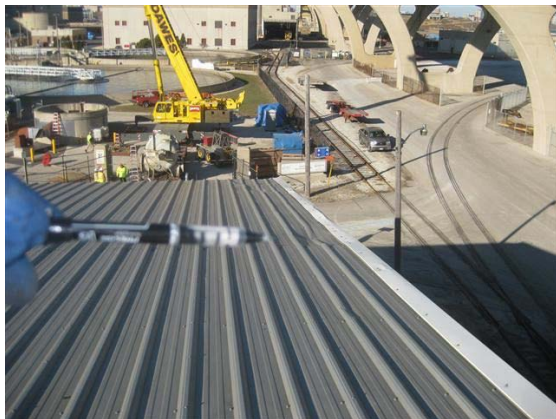
Damaged roof section

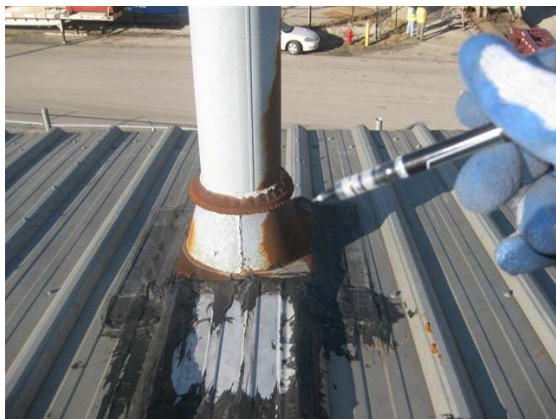
Rusted flashing

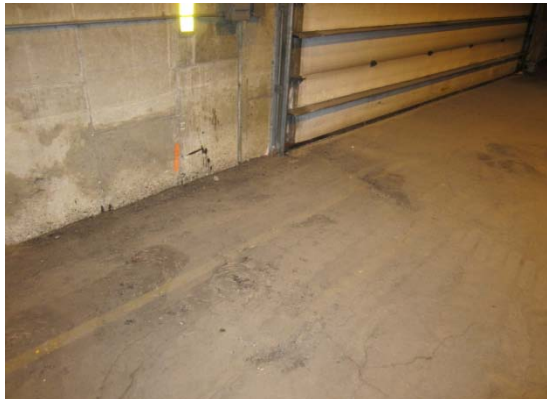
Asphalt pavement

The useful life of interior asphalt pavement is up to 40 years. Port of Milwaukee should conduct interim repairs from the O+M budget as needed. Large replacements are considered capital expenditures. Therefore, the condition of the pavement should be monitored annually to prepare for capital repairs.

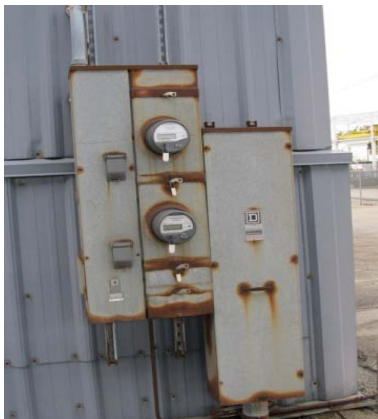
Bradford 1 electrical components include a revenue meter and a service panel. These components are at an age of 18 years and are reported in good condition. Port of Milwaukee should anticipate replacement of these components by 2032.

Revenue meters

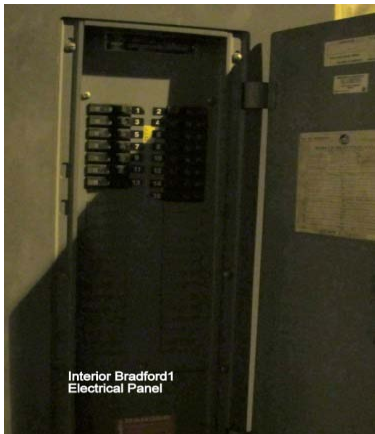
Service panel

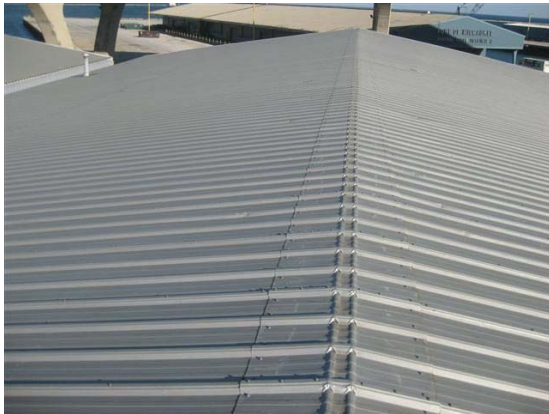
Bradford 2 includes a 160 square metal roof. The roofs are inspected and maintained by a third party. The last inspection occurred in 2012 where the roofs are indicated to be in fair condition. The inspection revealed the onset of rust at the roof edges and flashing. Additionally, the northeast corner was reported as damaged.

Roof overview

The useful life of metal roofs is up to 35 years. Its replacement is anticipated by 2030.

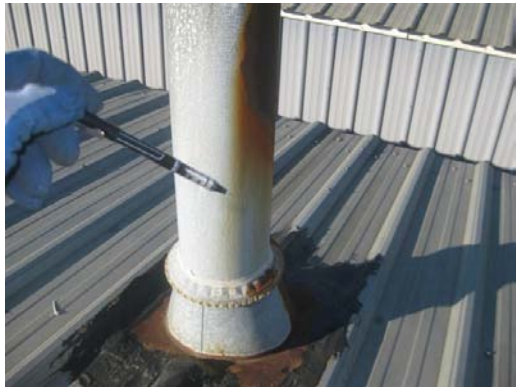
Rusted flashing

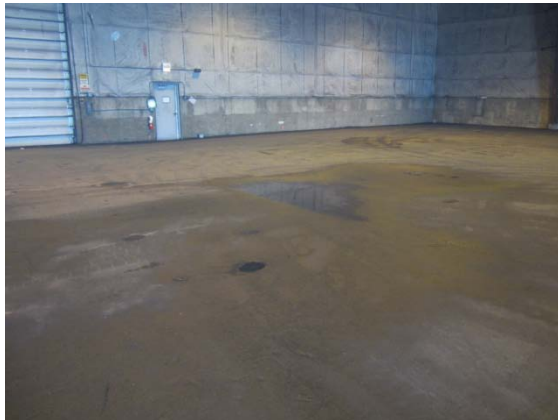
Asphalt pavement

The useful life of interior asphalt pavement is up to 40 years. Port of Milwaukee should conduct interim repairs from the O+M budget as needed. Large replacements are considered capital expenditures. Therefore, the condition of the pavement should be monitored annually to prepare for capital repairs.

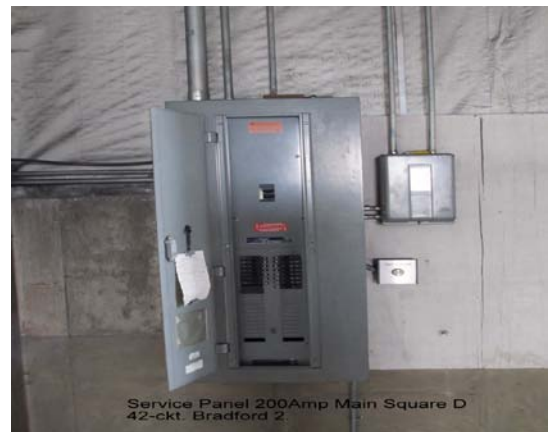
Bradford 2 electrical components include service conduit from Bradford 1 and a 200 amp service panel. These components are at an age of 18 years and are reported in good condition. Port of Milwaukee should anticipate replacement of these components by 2032

Bradford 2 200 amp service panel

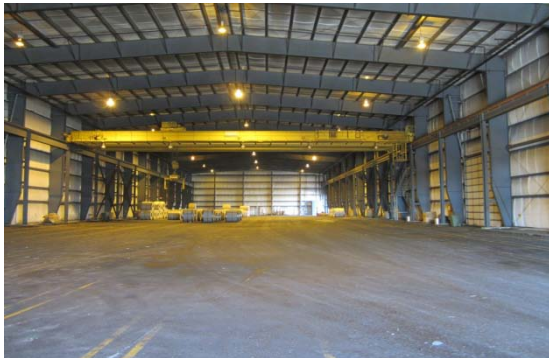
Asphalt pavement

The useful life of interior asphalt pavement is up to 40 years. Port of Milwaukee should conduct interim repairs from the O+M budget as needed. Large replacements are considered capital expenditures. Therefore, the condition of the pavement should be monitored annually to prepare for capital repairs.

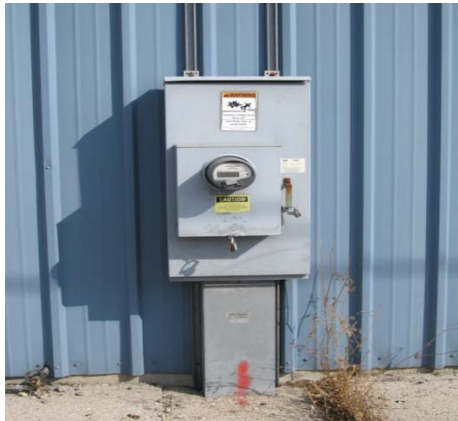
Revenue meter

The Coil Warehouse electrical components include a feeder for the overhead crane, revenue meter and various service panels. These components are at an age of 14 years and are reported in good condition. Port of Milwaukee should anticipate replacement of these components by 2032.

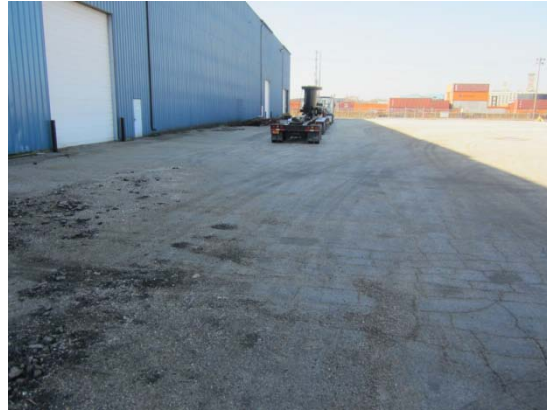
Bradford and Coil Buildings contains 25,800 SY of asphalt pavement surrounding the three buildings. The pavement is in satisfactory condition. The inspection revealed locations of failed pavement in the form of alligator cracking and transverse cracking throughout the property. In the main lot, pothole erosion, large water pooling, and alligator cracking were observed. Near the north and west entrance, a high concentration of failed pavement was observed.

Failed pavement

The overall condition of the pavement is in satisfactory condition. Phased asphalt pavement replacement is of up to 8,600 square yards is anticipated every five years beginning by 2014. Asphalt pavement maintenance, including crack filling and partial replacements, at the remaining pavement should be conducted in conjunction with pavement replacement.

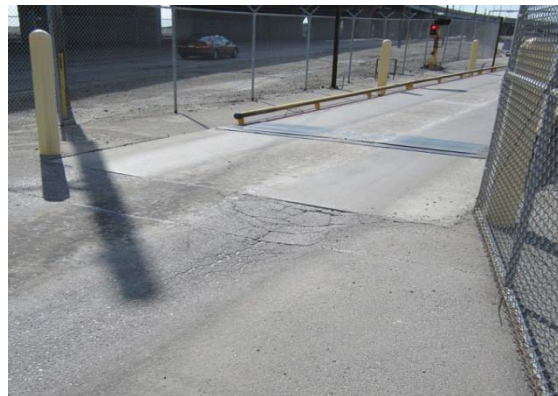
IMC Salt Office Building property contains 3,050 square yards of finished asphalt pavement. The inspection revealed small concentrations of alligator cracks. Interim asphalt pavement maintenance, including crack filling and partial replacements, should be funded from O + M in 2012. The overall condition of the pavement is good.

Cracked pavement

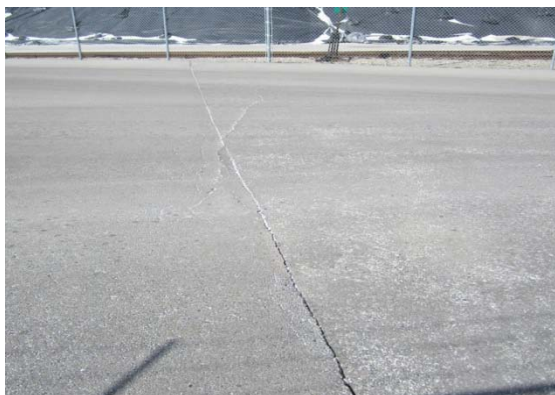
Traverse cracking

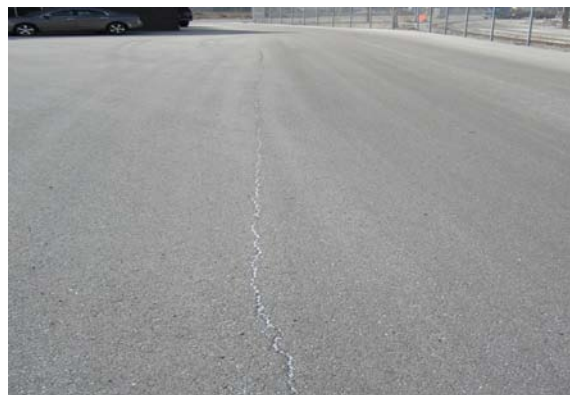
Longitudinal cracking

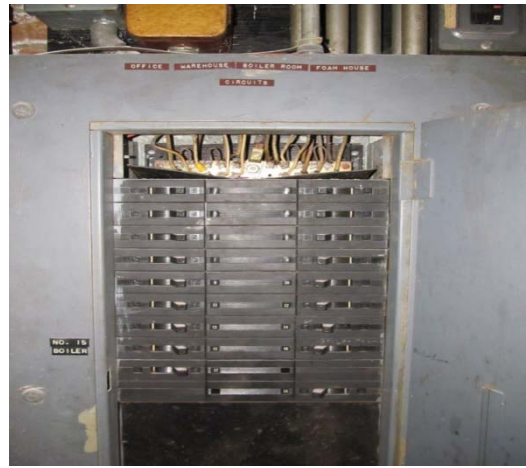
Breaker panel

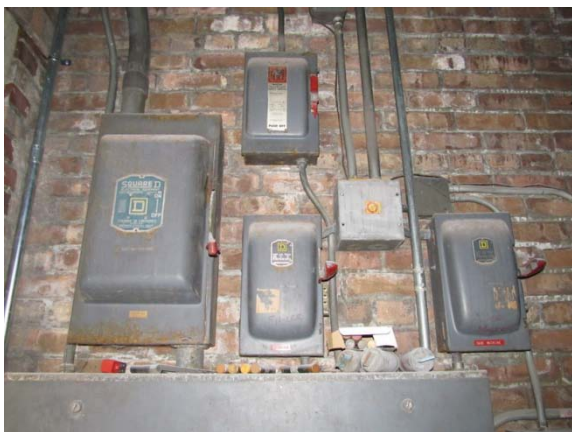
Miscellaneous disconnects

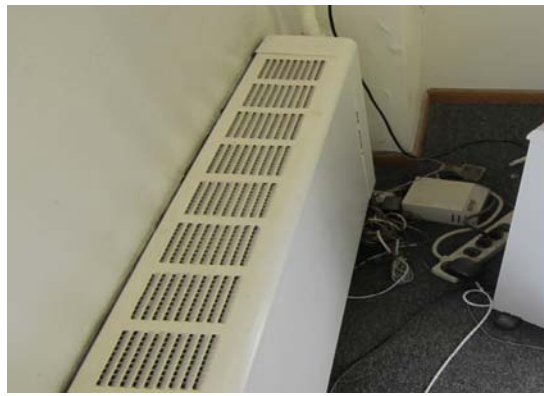
Baseboard radiation

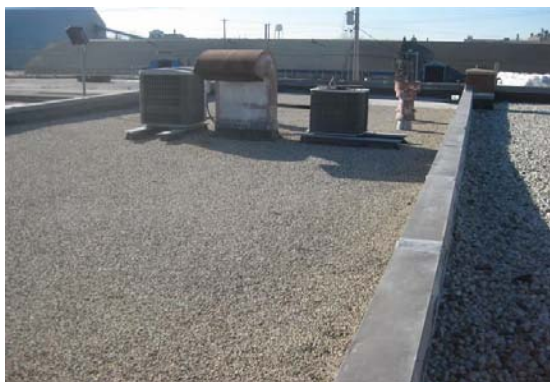
Condenser units

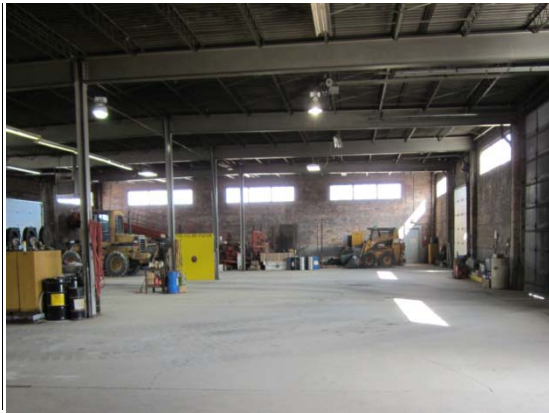
Steel components

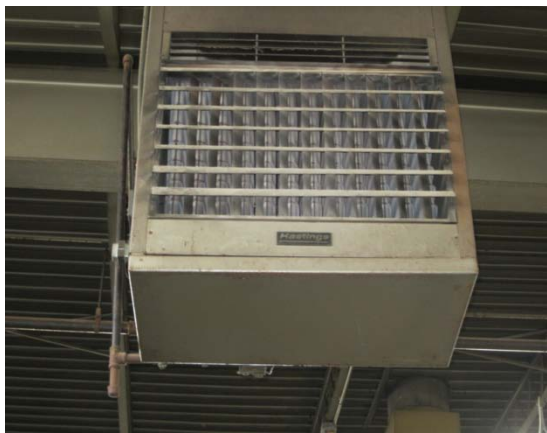
Unit heaters

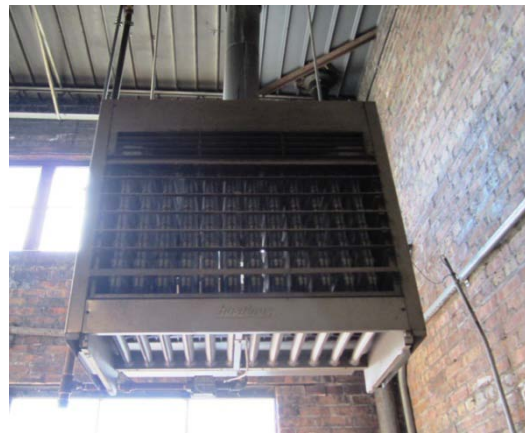
Unit heater

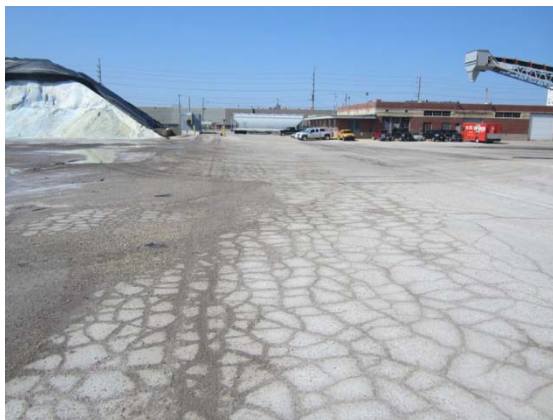
Milwaukee Bulk Terminal Warehouse property contains 13,400 square yards of finished asphalt pavement throughout the property. The overall condition of the pavement is fair. The inspection revealed failed pavement in the form of alligator cracks. The Port of Milwaukee should anticipate phased replacement of up to 6,700 square yards of asphalt pavement beginning by 20XX.

Alligator cracks

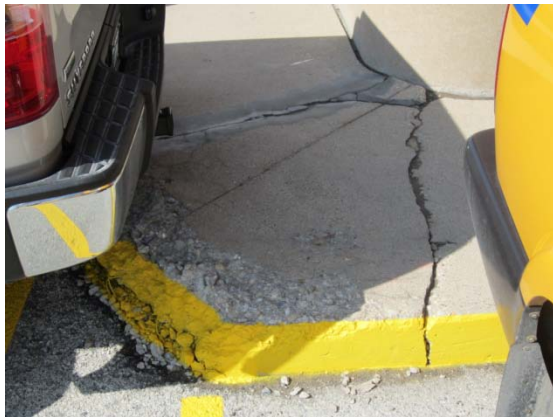
Milwaukee Bulk Terminal Warehouse property contains 5,150 square feet of concrete flatwork throughout the property. The concrete appeared in good overall condition with only isolated locations of concrete deterioration. Port of Milwaukee should plan partial concrete replacement of up to 1,000 square feet (or 20%) in conjunction with phased asphalt pavement replacement. Interim concrete pavement maintenance, including isolated repairs should be funded from O + M in 2012.

Cracked concrete

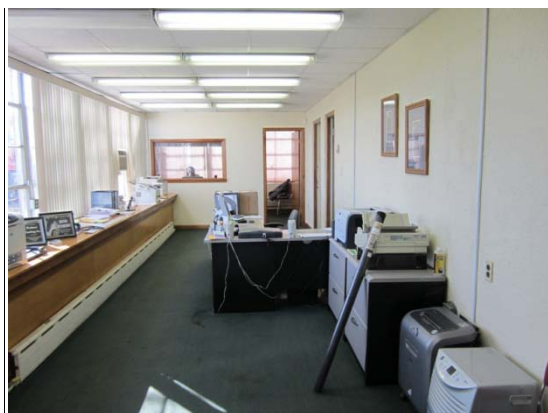
Front office area

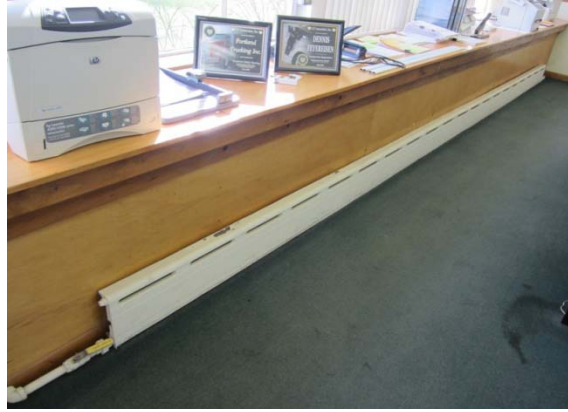
Floor carpet with stains

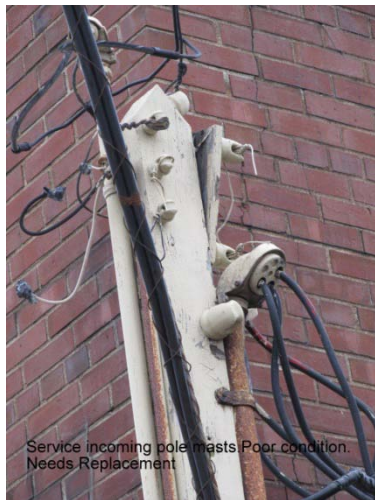
Service incoming pole masts Poor condition. Needs Replacement

Incoming pole mast reported in poor condition

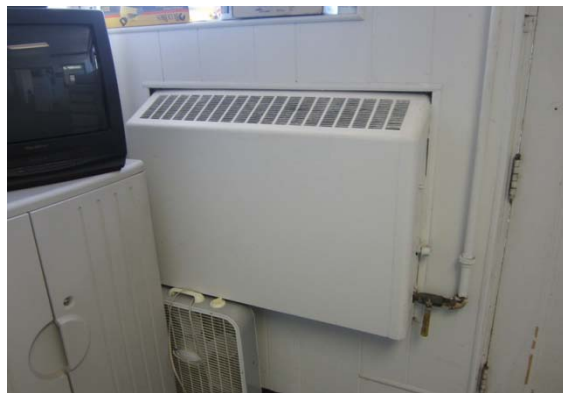
Building radiator

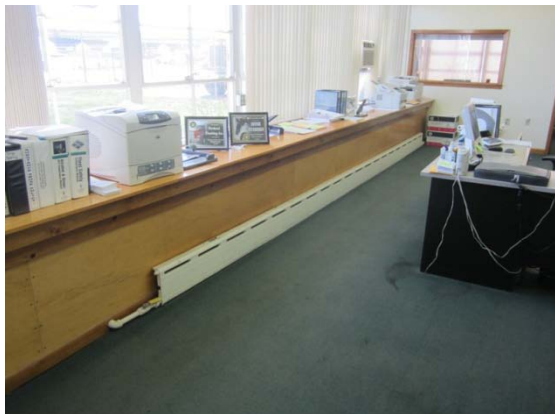
Baseboard radiation

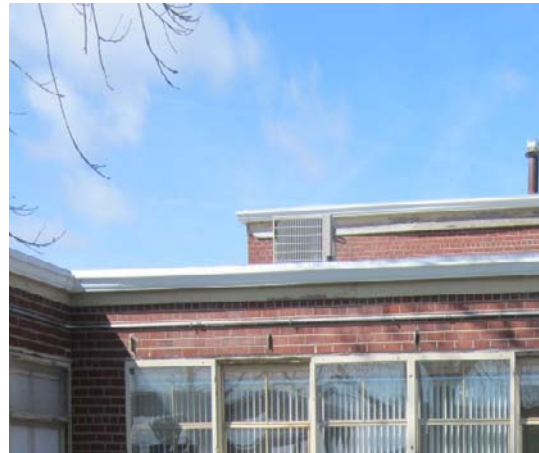
Condenser unit

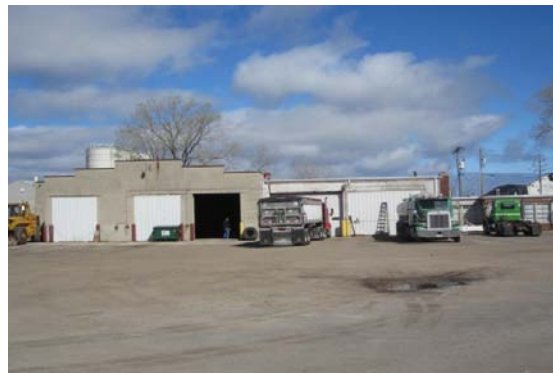
South elevation pot hole

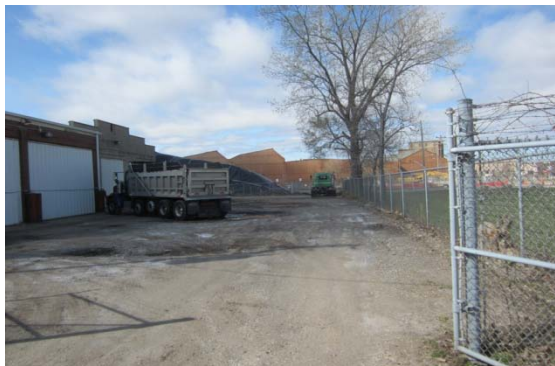
North elevation

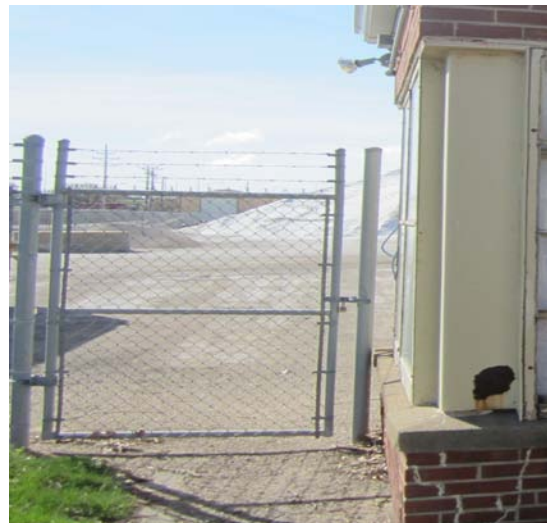
Fence gate

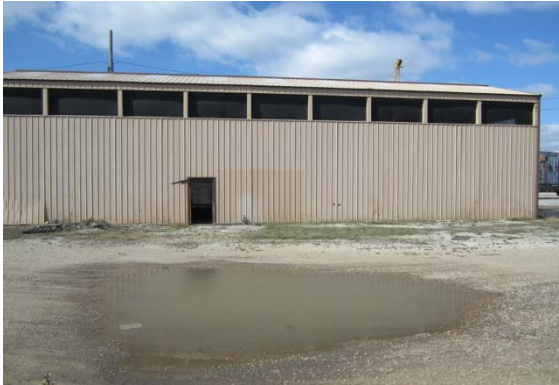
Sandblast Shed comprises 640 square feet of windows and screen. Typical useful life expectancy for windows is up to 35 years. Currently there are no windows in place but only screens. The City of Milwaukee anticipates wooden frame window replacement by 2018.

Typical wooden frame windows

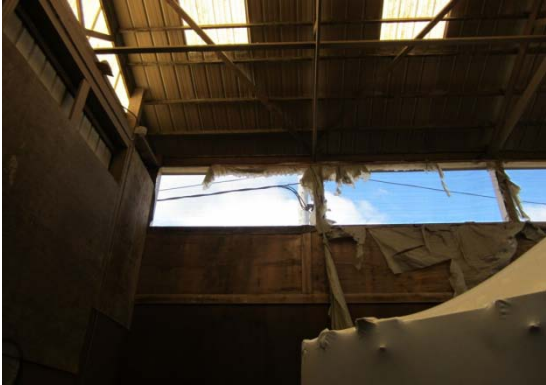
Inside window and screen

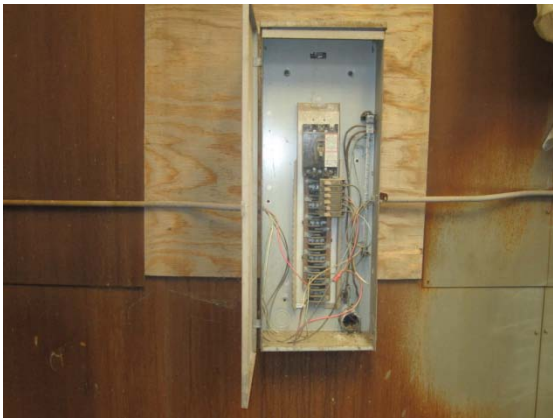
Service panel

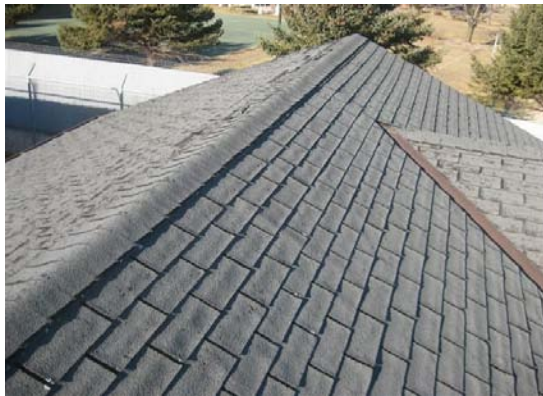
Roof overview

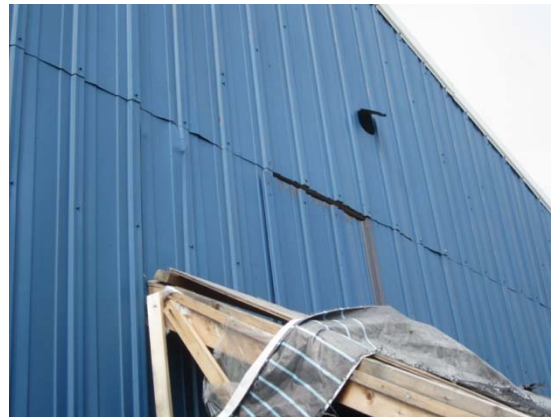
Loose siding panel at west elevation

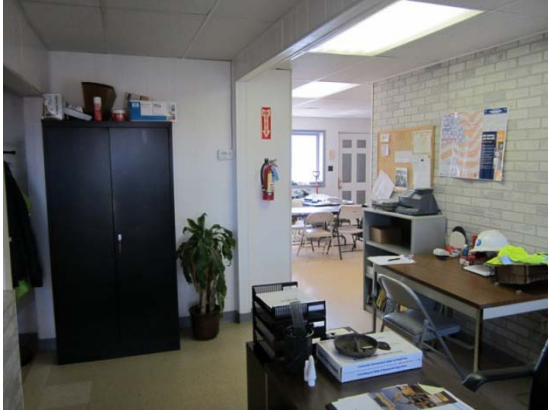
Office area

The inspection revealed that the interior spaces were in satisfactory condition. Port representatives reported that the previous occupant conducted a recent interior renovation. The inspection reveals normal wear at the interior finishes.

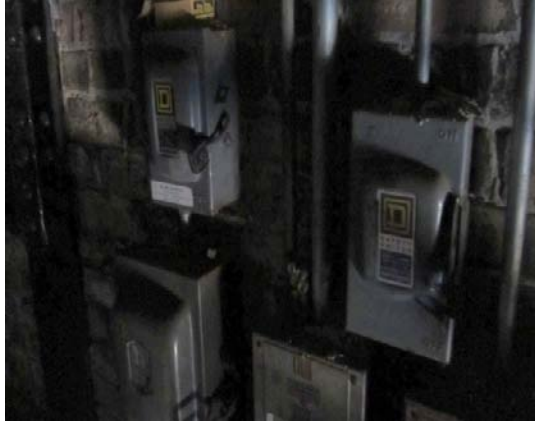
North American Salt Company electrical components include secondary and branch circuit distribution. The components are at varied ages and conditions. Based on condition, the Port of Milwaukee should anticipate phased service upgrades/replacement of electrical components.

Abandoned disconnects

Phase 1 upgrades are scheduled for electrical components that are in condition 4 and below (shaded red). Phase 2 upgrades are scheduled for electrical components that are in condition 5-6 (shaded blue). The remaining components, rated 7 and above (shaded green) are long-lived. The following table summarizes the initial phases and conditions. Actual scope of work may vary at time of electrical upgrades.
