# Facilities Condition Assessment Program

## Port of Milwaukee Analysis Update

August 2012

## BRADFORD AND COIL BUILDINGS

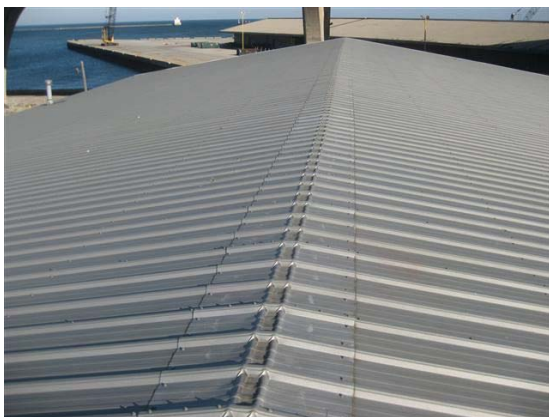
Bradford 1 includes a 160 square metal roof. The roofs are inspected and maintained by a third party. The last inspection occurred in 2012 where the roofs are indicated to be in fair condition. The inspection revealed the onset of rust at the roof edges and flashing. Additionally, the southwest corner was reported as damaged.

Roof overview

The useful life of metal roofs is up to 35 years. Its replacement is anticipated by 2030. Near term maintenance should be funded from the operating budget.

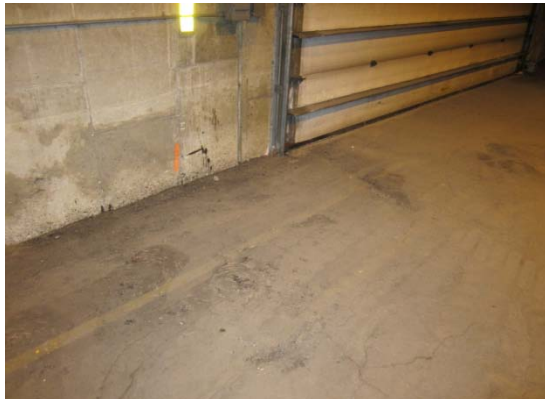
Asphalt pavement

The useful life of interior asphalt pavement is up to 40 years. Port of Milwaukee should conduct interim repairs from the O+M budget as needed. Large replacements are considered capital expenditures. Therefore, the condition of the pavement should be monitored annually to prepare for capital repairs.

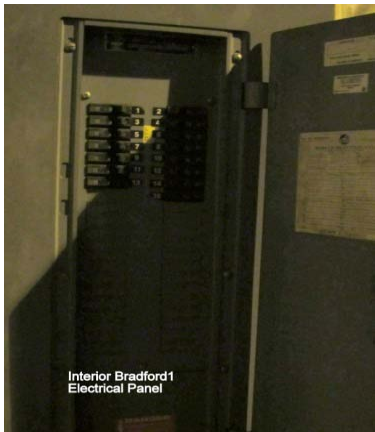
Bradford 1 electrical components include a revenue meter and a service panel. These components are at an age of 18 years and are reported in good condition. Port of Milwaukee should anticipate replacement of these components by 2032.

Service panel

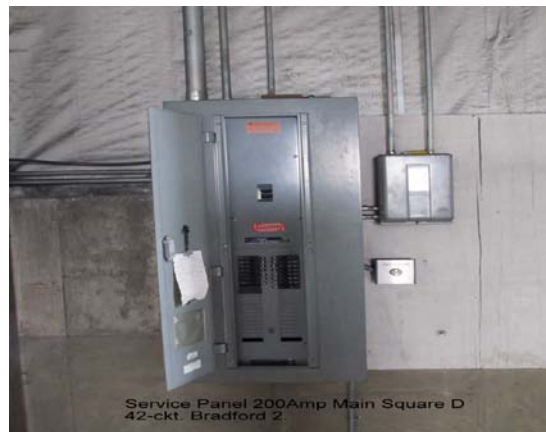
Bradford 2 electrical components include service conduit from Bradford 1 and a 200 amp service panel. These components are at an age of 18 years and are reported in good condition. Port of Milwaukee should anticipate replacement of these components by 2032

Bradford 2 200 amp service panel

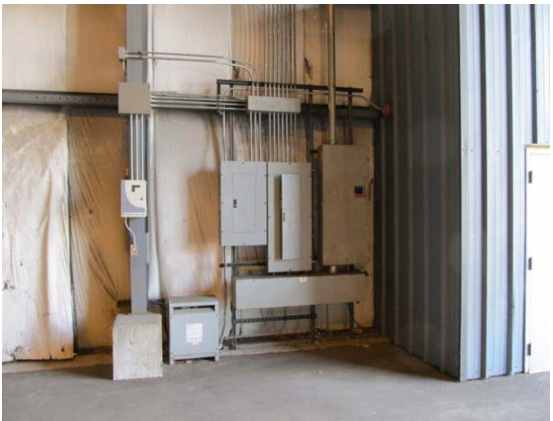
The Coil Warehouse electrical components include a feeder for the overhead crane, revenue meter and various service panels. These components are at an age of 14 years and are reported in good condition. Port of Milwaukee should anticipate replacement of these components by 2032.

Service panels

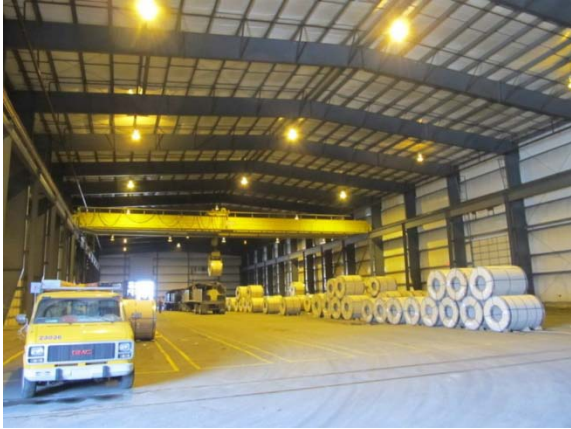
Overhead crane service

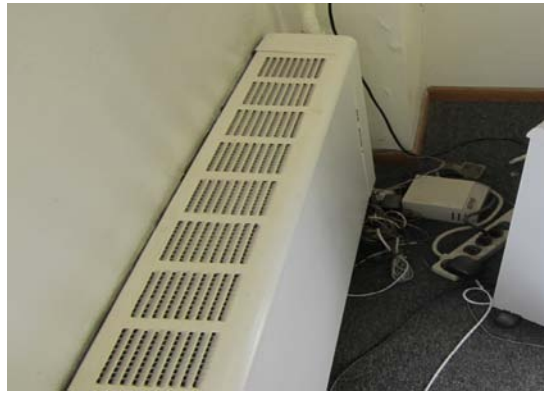
Baseboard radiation

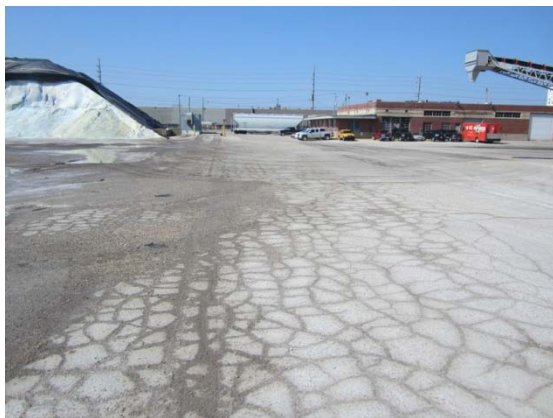
Milwaukee Bulk Terminal Warehouse property contains 13,400 square yards of finished asphalt pavement throughout the property. The overall condition of the pavement is fair. The inspection revealed failed pavement in the form of alligator cracks. The Port of Milwaukee should anticipate phased replacement of up to 6,700 square yards of asphalt pavement beginning by 20XX.

Alligator cracks

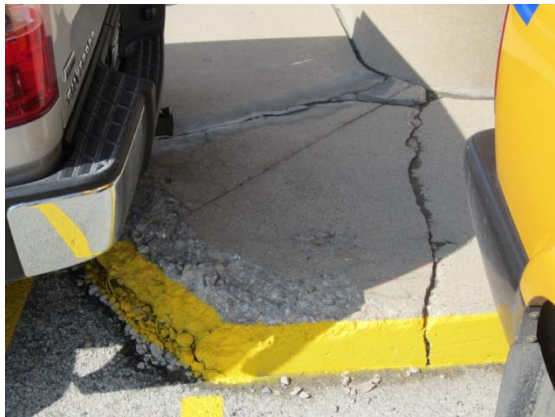
Milwaukee Bulk Terminal Warehouse property contains 5,150 square feet of concrete flatwork throughout the property. The concrete appeared in good overall condition with only isolated locations of concrete deterioration. Port of Milwaukee should plan partial concrete replacement of up to 1,000 square feet (or 20%) in conjunction with phased asphalt pavement replacement. Interim concrete pavement maintenance, including isolated repairs should be funded from O + M in 2012.

Cracked concrete

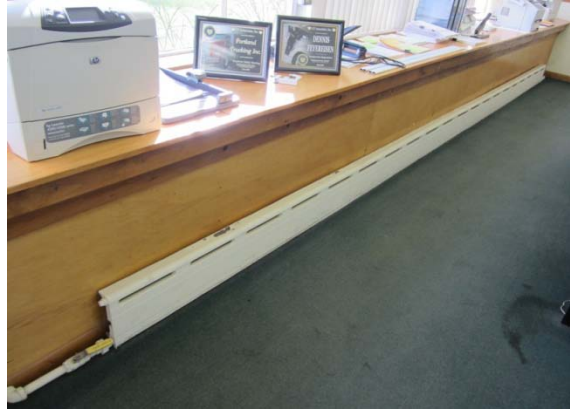
Floor carpet with stains

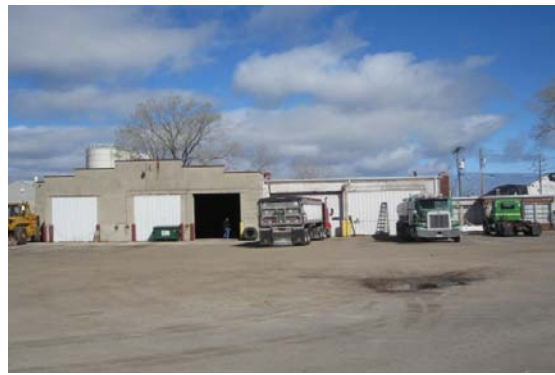
South elevation pot hole

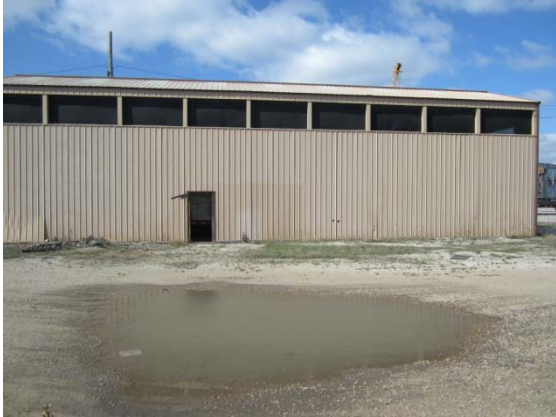
East elevation

Sandblast Shed includes approximately 3,710 square feet of corrugated metal siding and 190 square feet of fiberglass siding. The siding is likely original to the facility. The inspection revealed isolated occurrences of damaged/bent siding. The useful life of exterior siding is up to 35 years. Port of Milwaukee should anticipate its replacement by 2018, unless the Sandblast Shed is removed prior to these capital repairs.

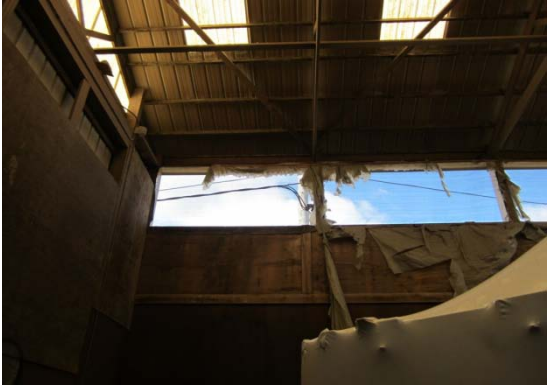
Inside window and screen

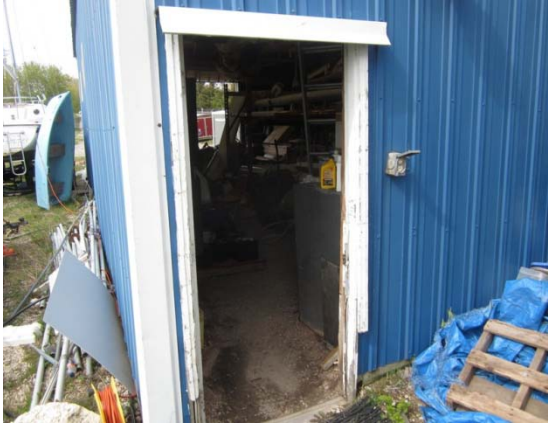
Service door

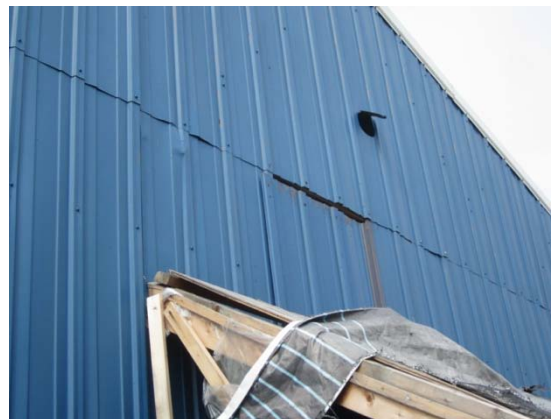
Loose siding panel at west elevation
