**The Grand Department Store**  
HISTORIC PRESERVATION CERTIFICATION APPLICATION  
PART 1 - EVALUATION OF SIGNIFICANCE & PART 2 - DESCRIPTION OF REHABILITATION

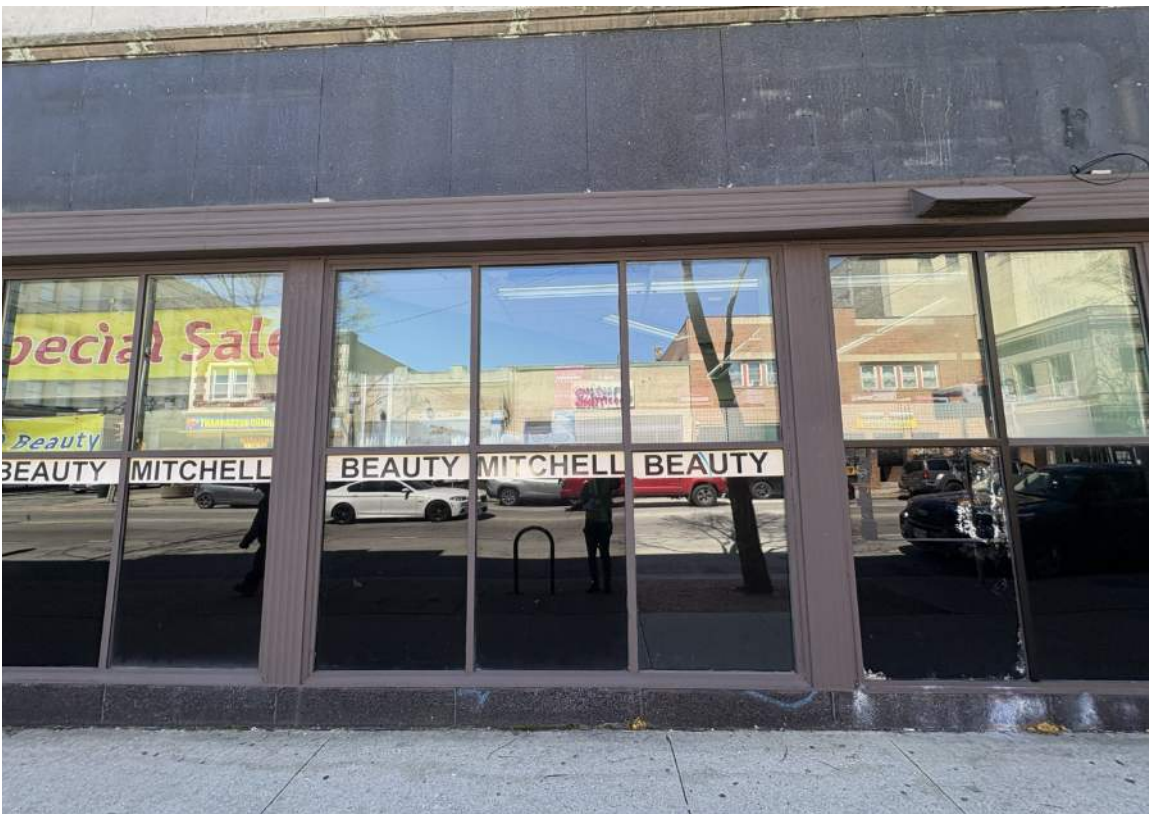
IMAGE 7: Exterior - looking south at existing storefront system and fluted bronze header and mullions

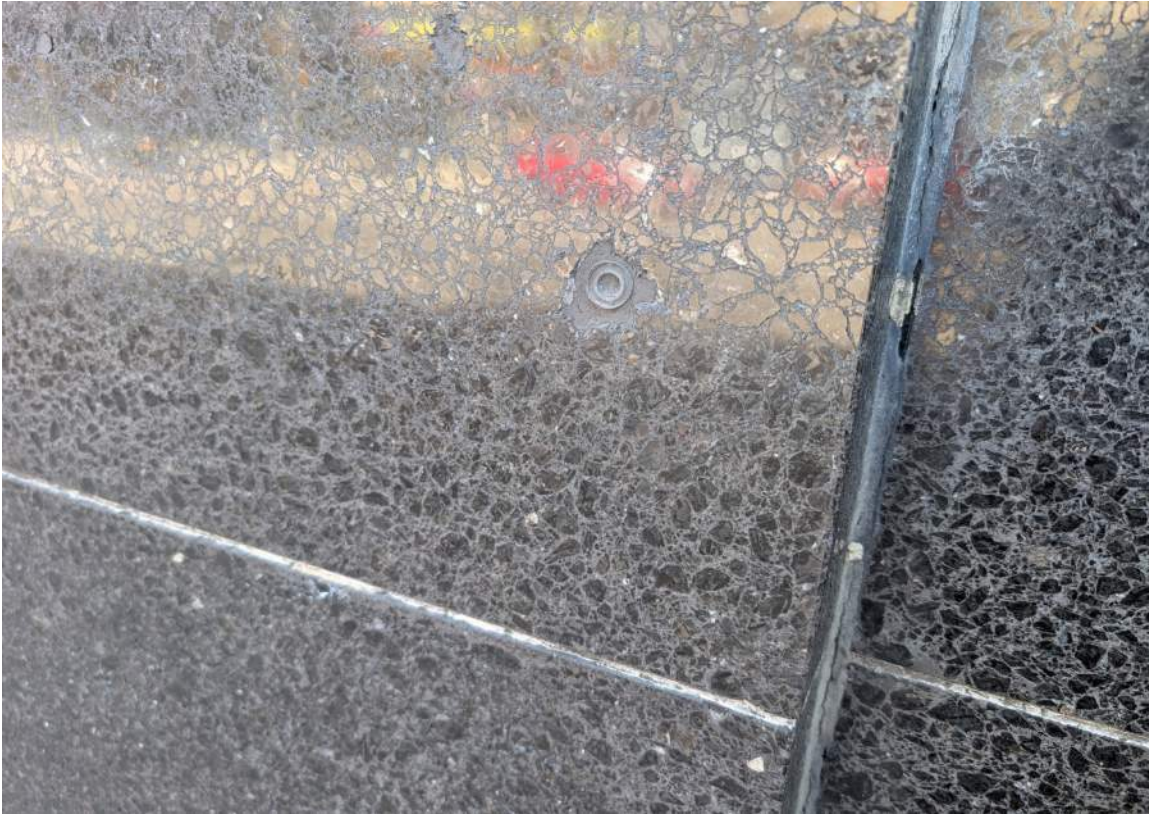
IMAGE 14: Exterior - cast granite panels with existing penetration and signage anchor

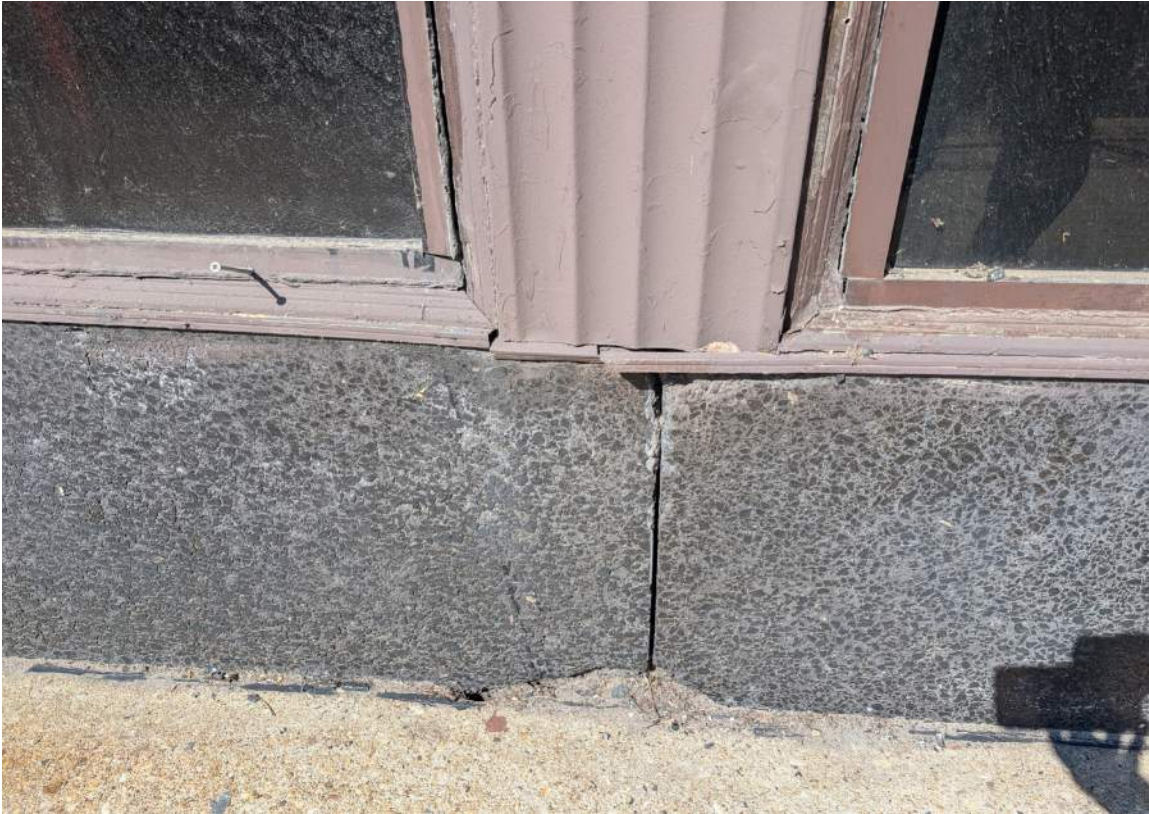
IMAGE 16: Exterior - looking down at existing cast granite at grade, painted, bronze fluted mullion, and existing storefront system with perimeter trims

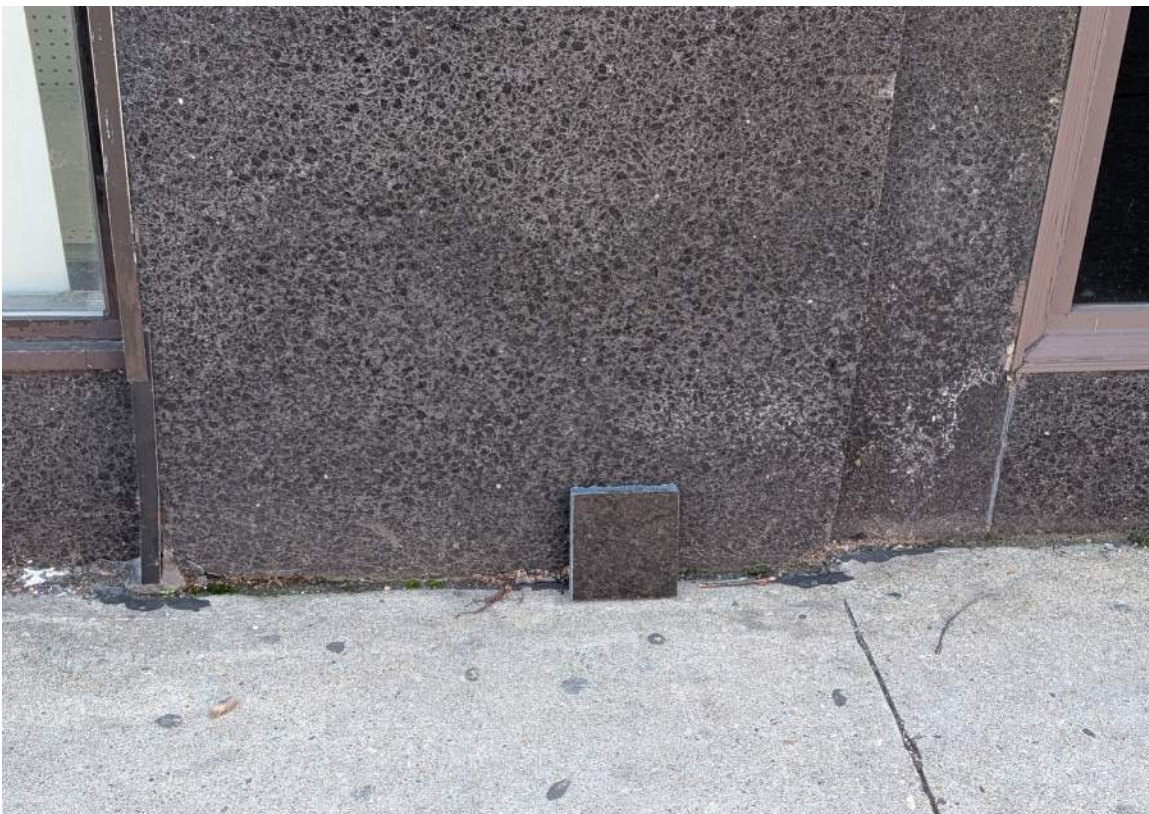
IMAGE 17: Exterior - looking down at existing cast granite panels at grade with sample of proposed replacement granite material in foreground (see attachments for additional info)

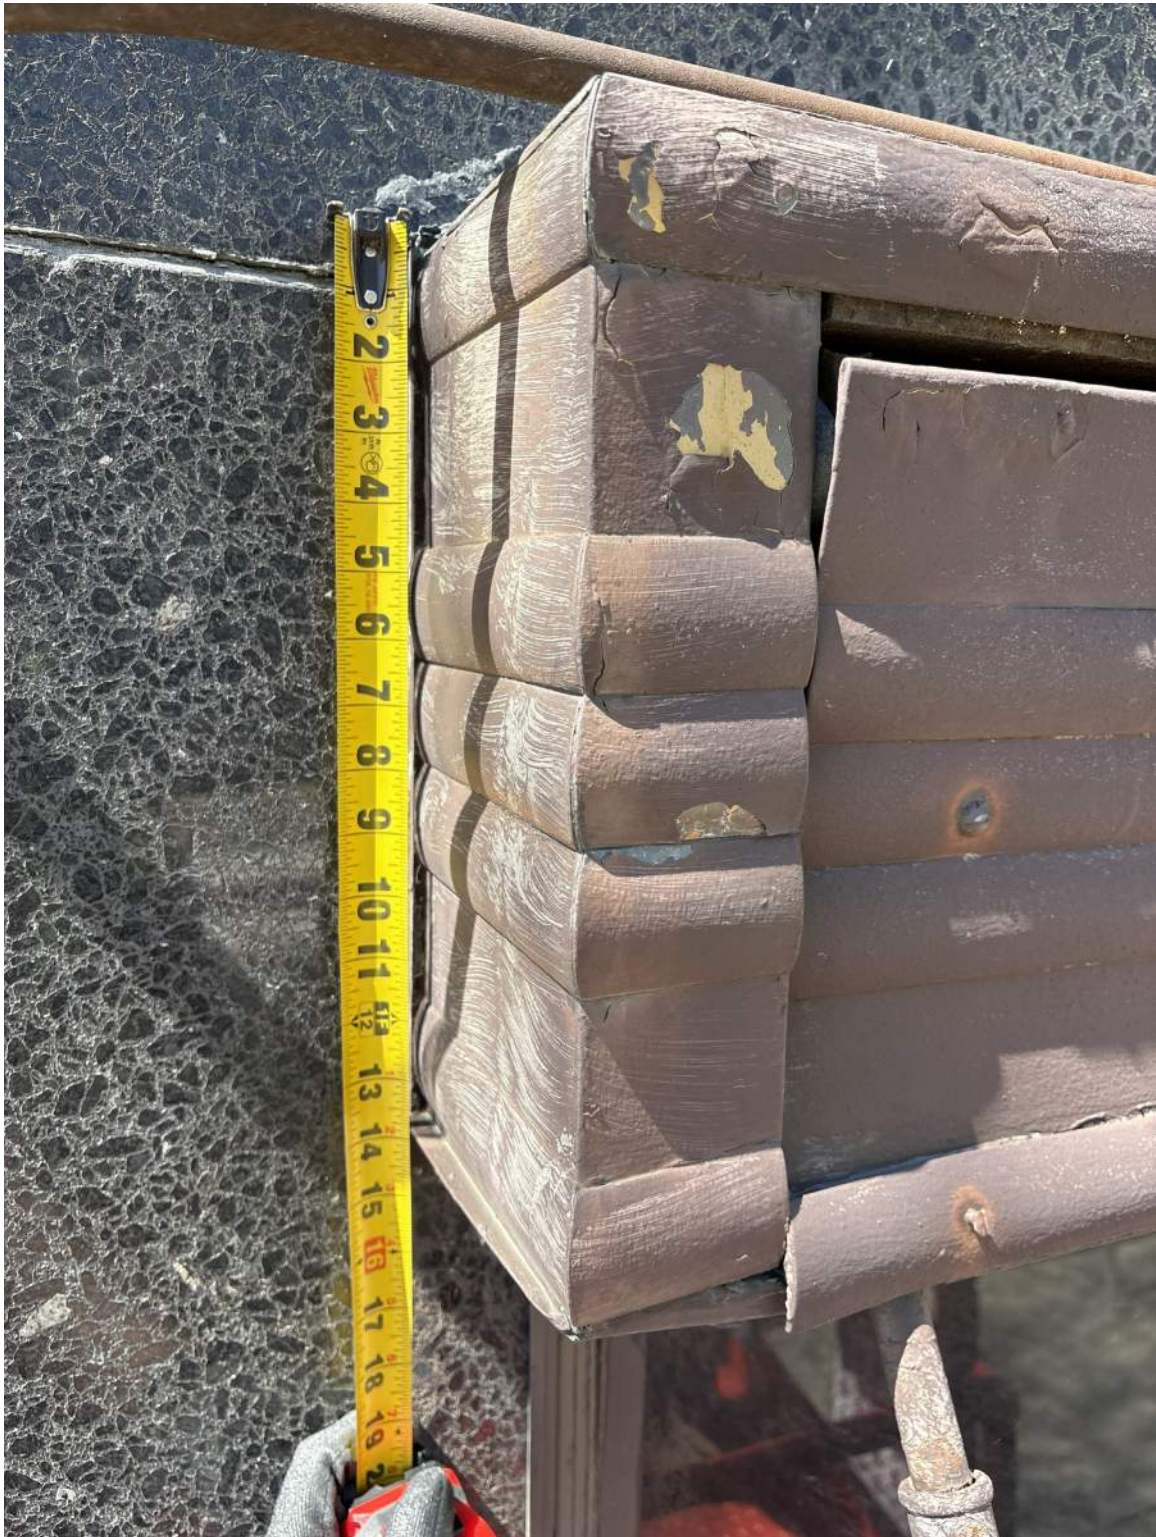
IMAGE 29: Exterior - close up photo of end cap on existing fluted bronze storefront headed (photo from boom lift)

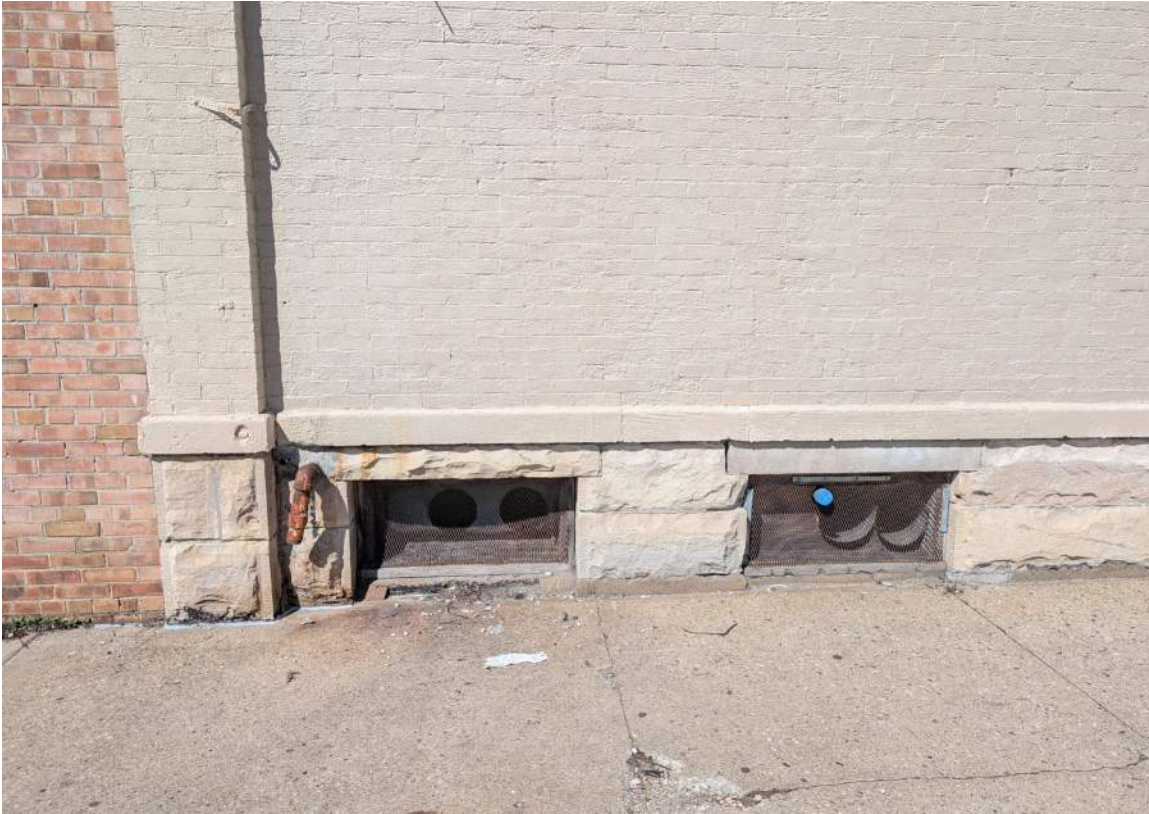
IMAGE 32: Exterior - looking west at brick and rusticated stone wall with existing openings to basement; right hand existing lintel has already been replaced

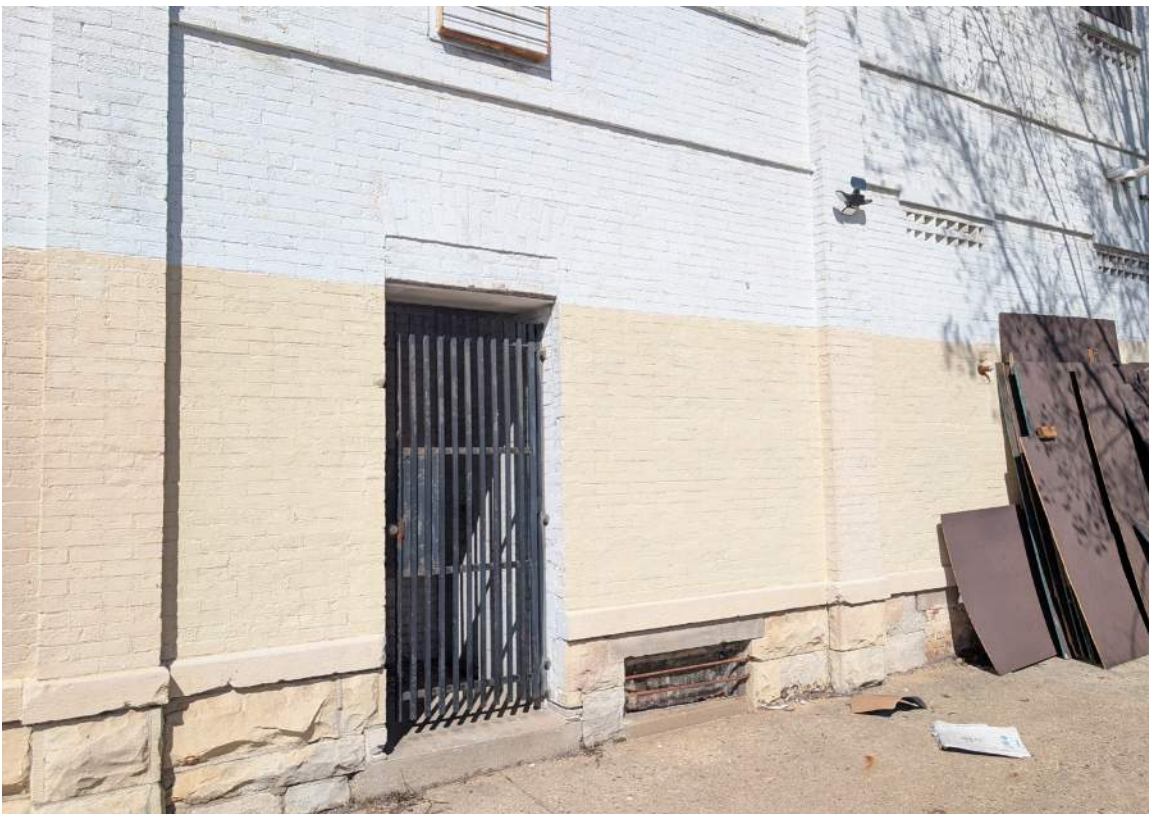
IMAGE 33: Exterior - looking northwest at existing opening which has been partially infilled at the head

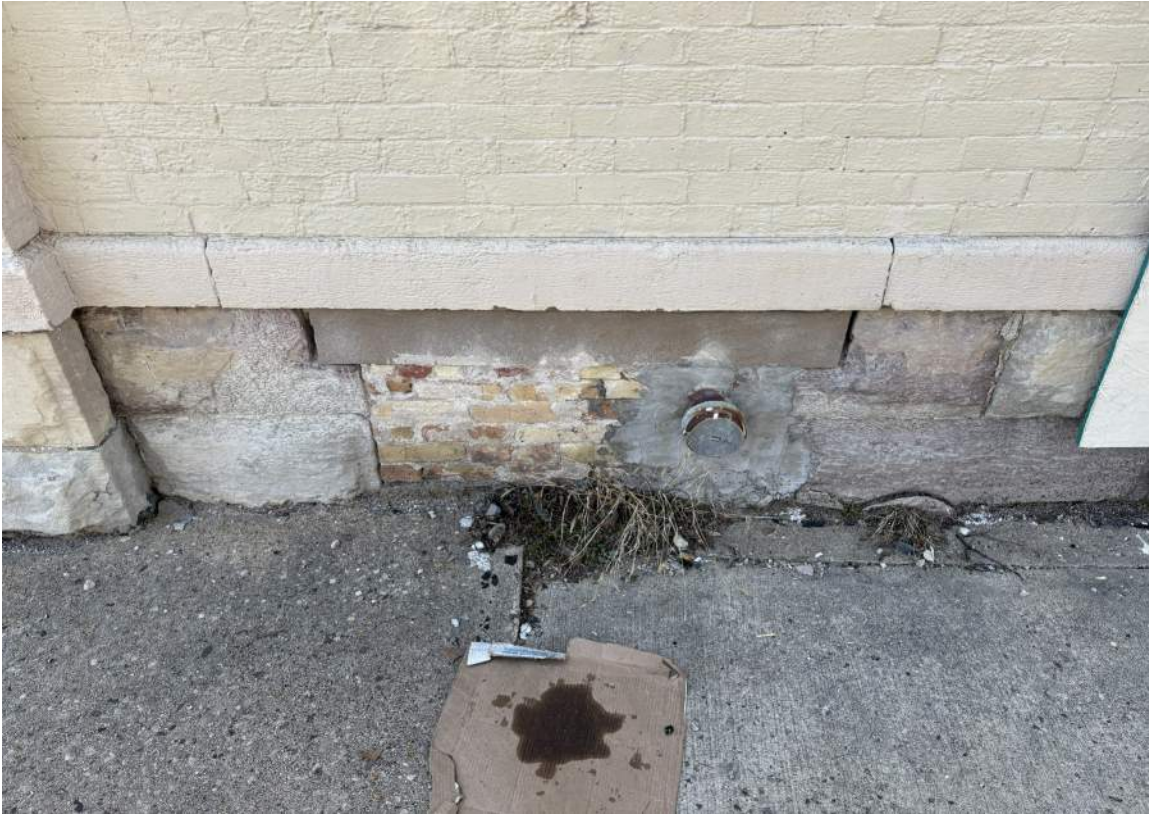
IMAGE 34: Exterior - looking down at existing brick infill at basement opening and existing replacement lintel

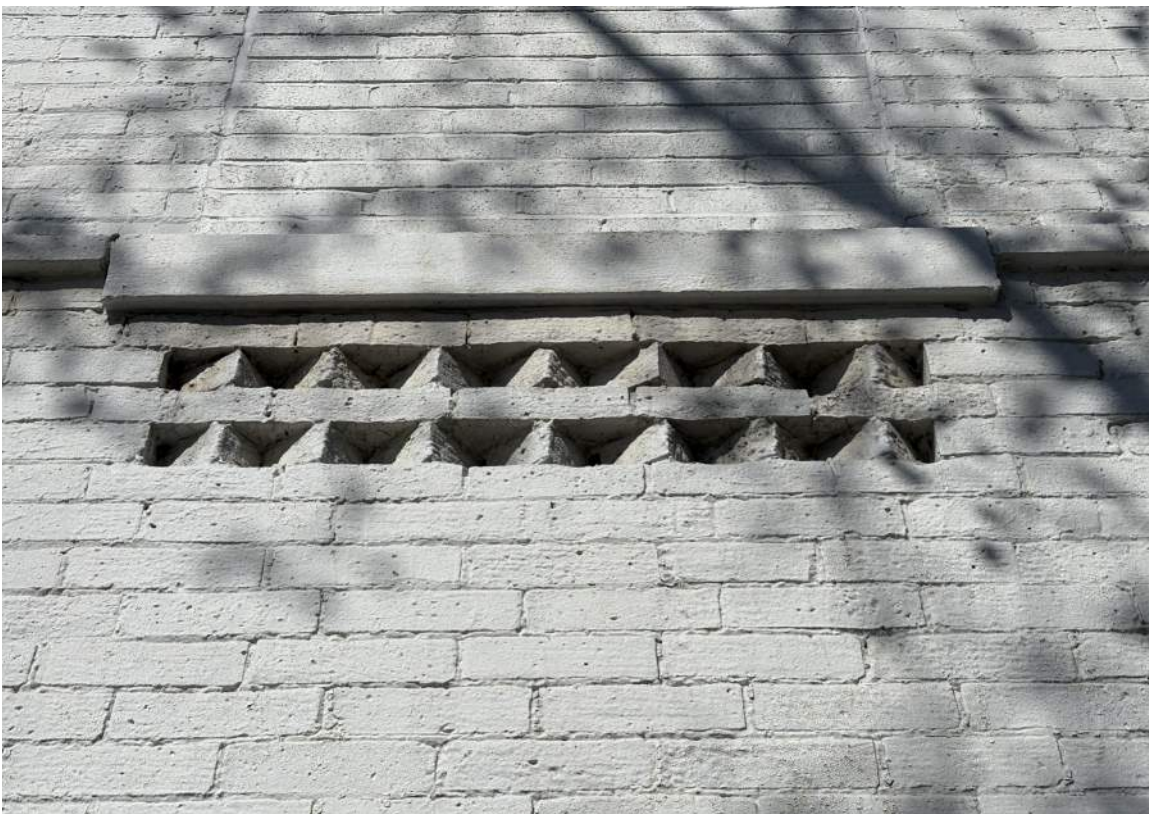
IMAGE 35: Exterior - looking up at existing brick infilled opening with remaining limestone sill and original rotated brick vents below

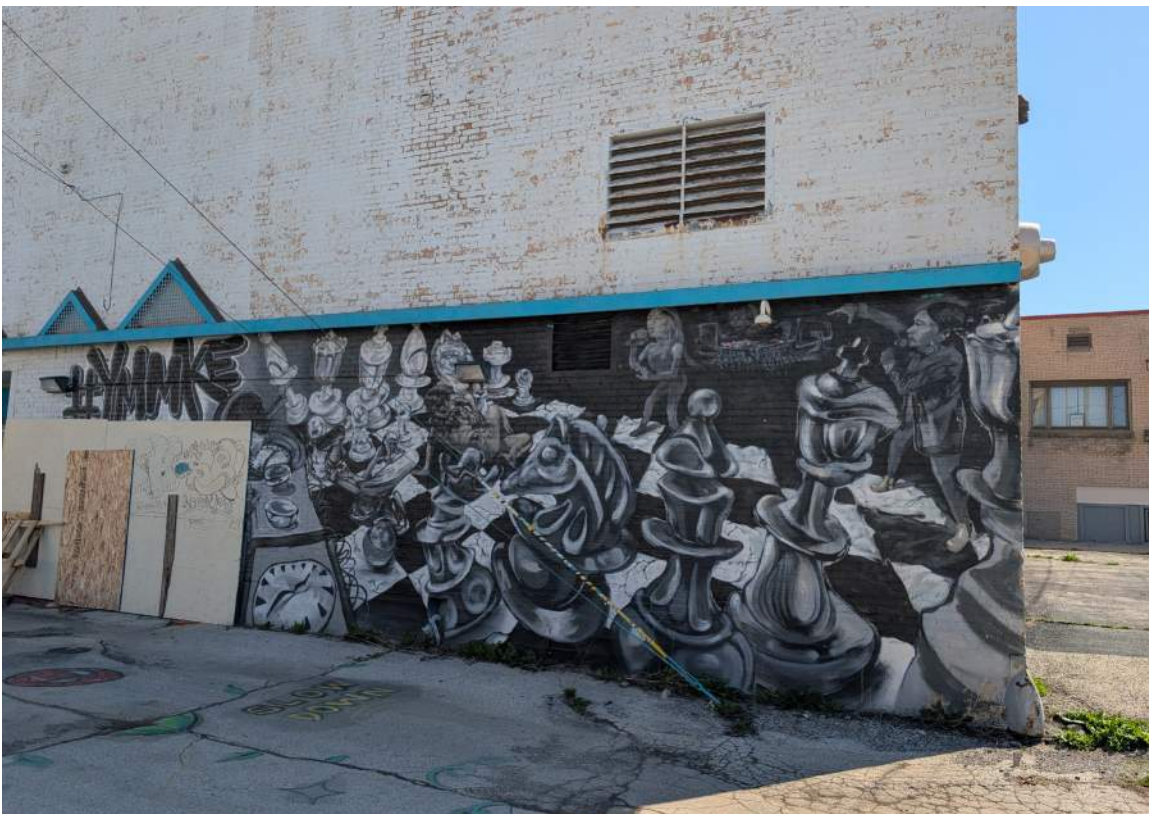
IMAGE 47: Exterior - looking northeast at existing graffiti and wall-mounted signage

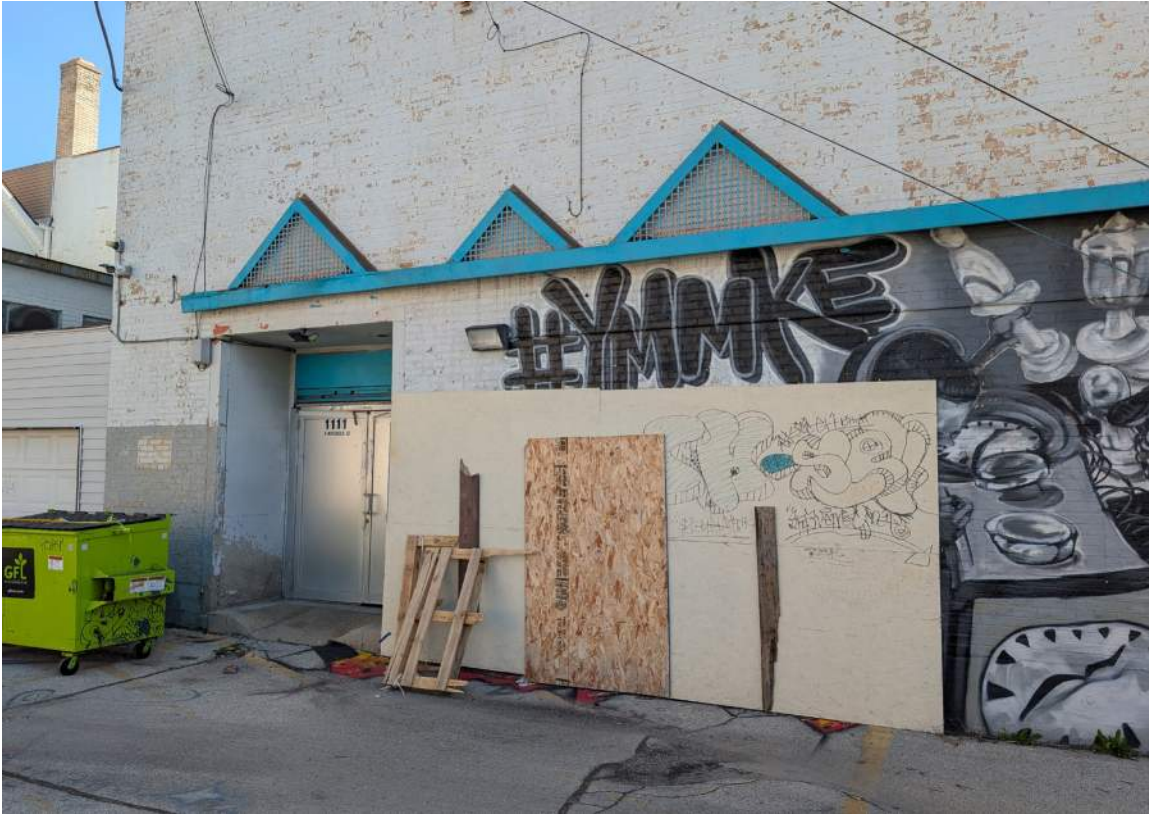
IMAGE 48: Exterior - looking northeast at existing graffiti and wall-mounted signage on west facade of 1949 Structure

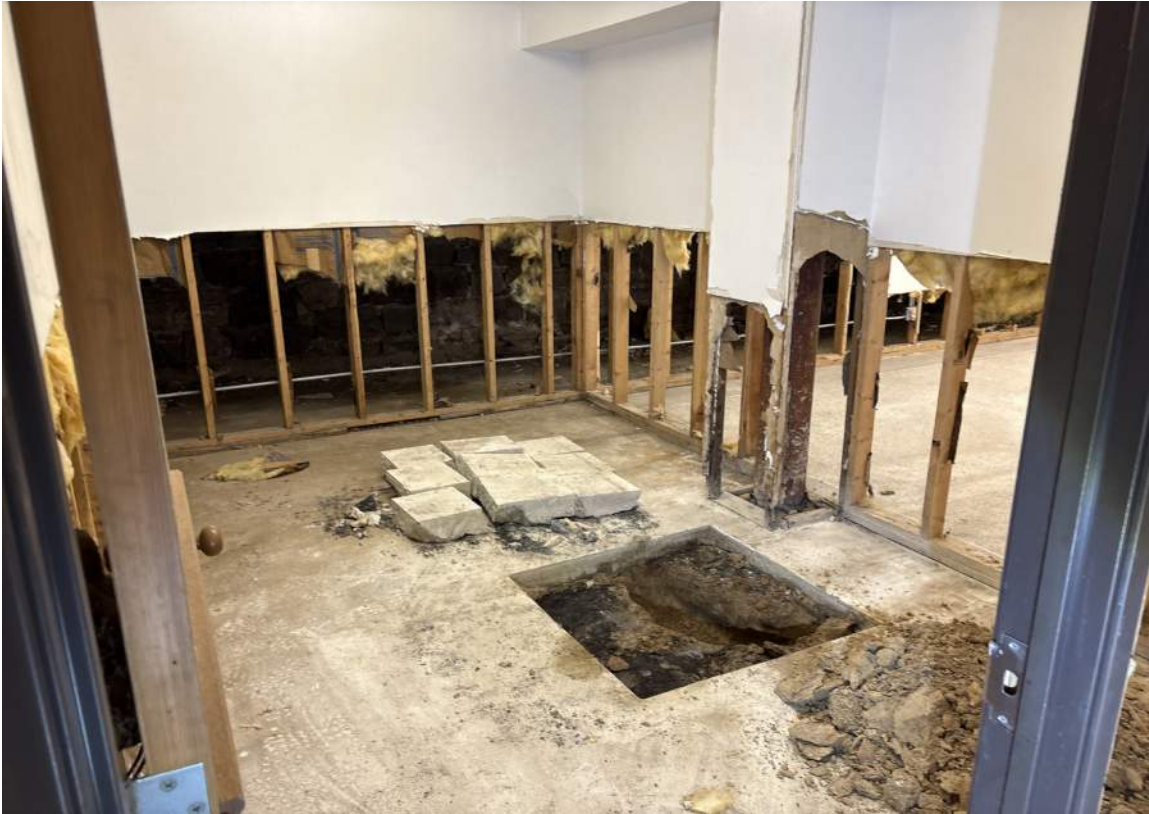
IMAGE 62: Basement - pre-1888 Structure - looking northeast at existing hole in slab-on-grade concrete floor

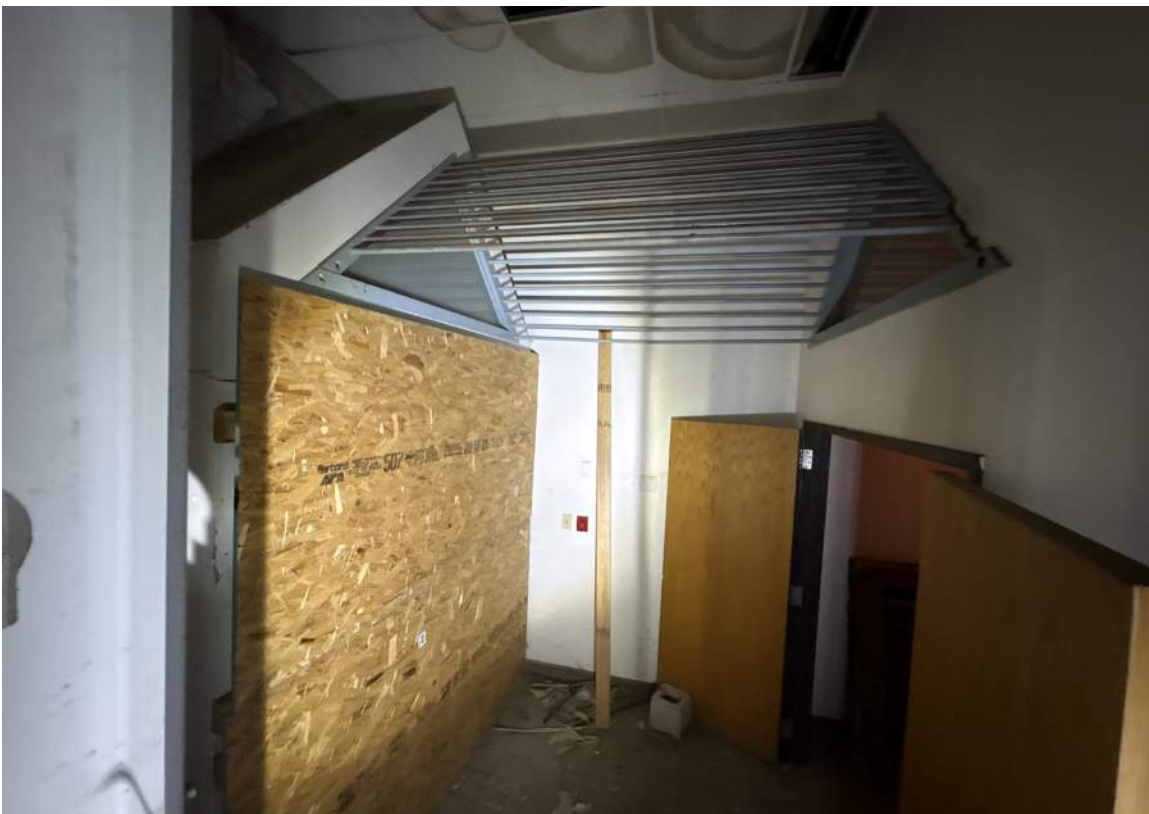
IMAGE 85: Level 01 - 1949 Structure - looking north at existing boarded exit to alley

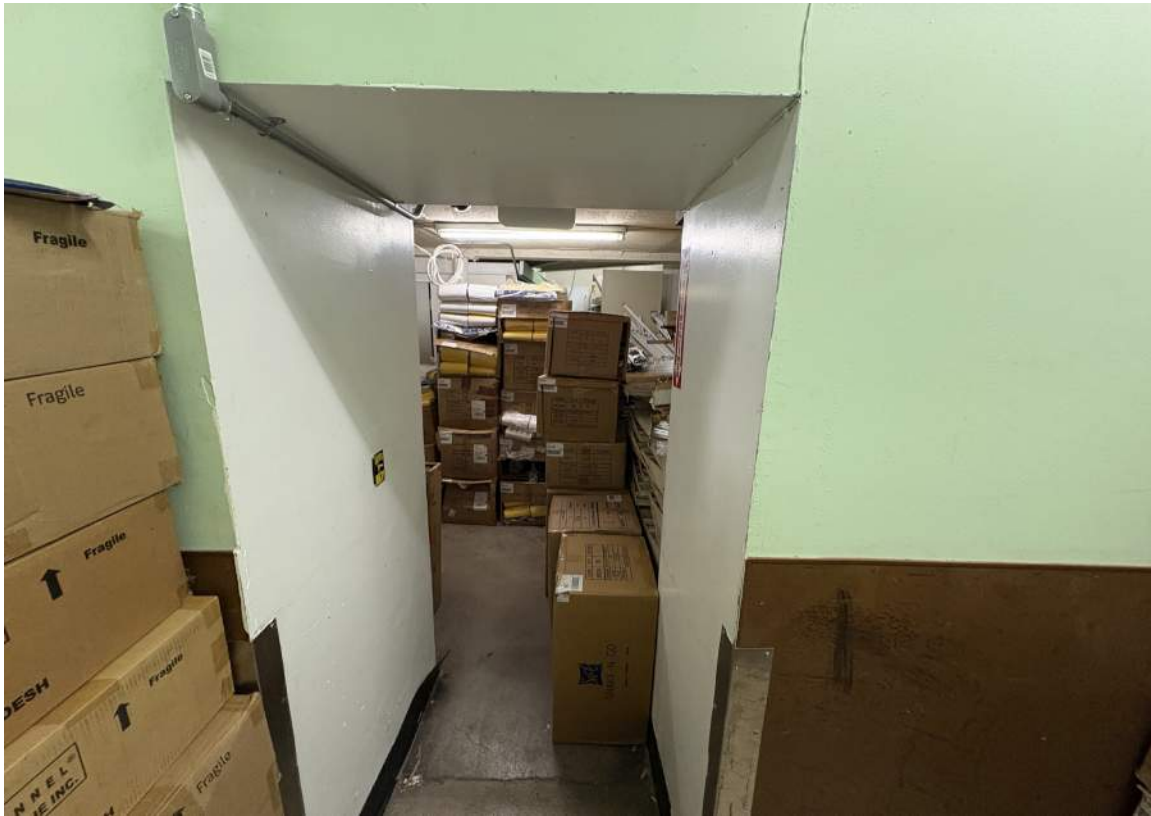
IMAGE 88: Level 01 - 1911 Structure - looking south into space beneath existing mezzanine

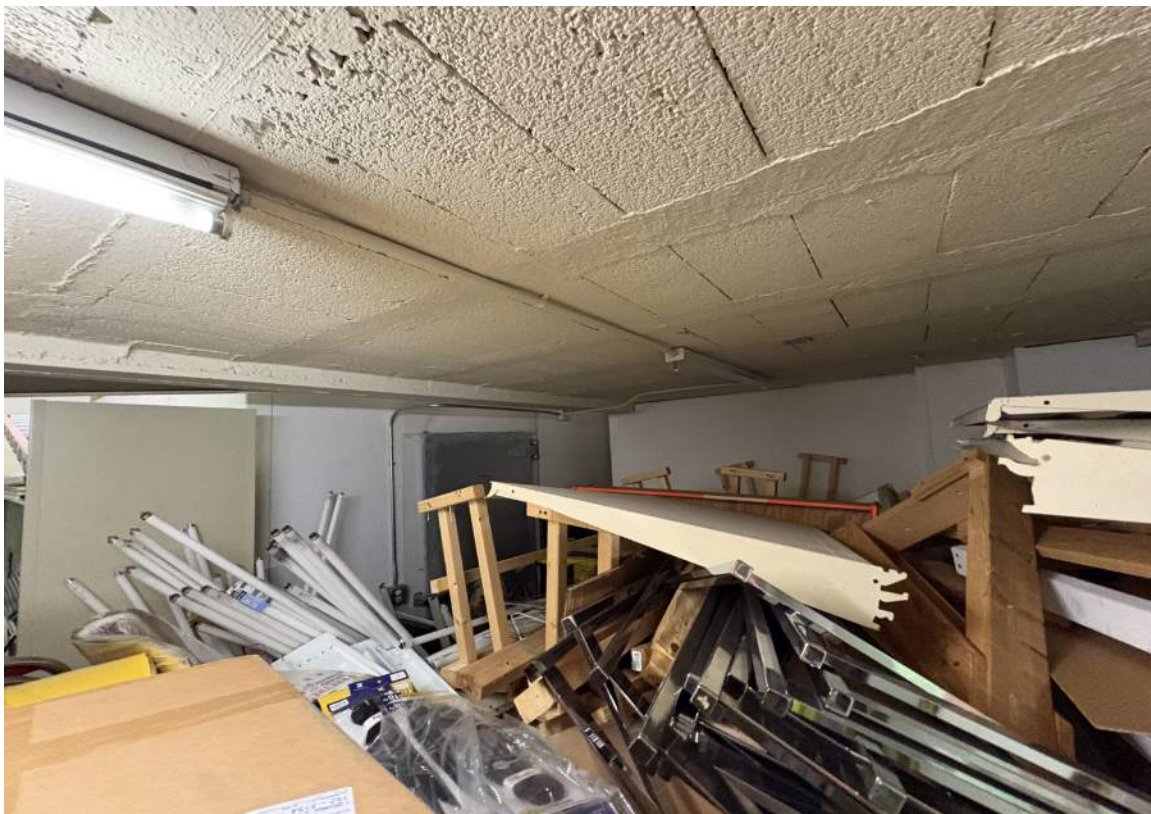
IMAGE 89: Level 01 - 1949 Structure - looking southwest - mezzanine structure overhead

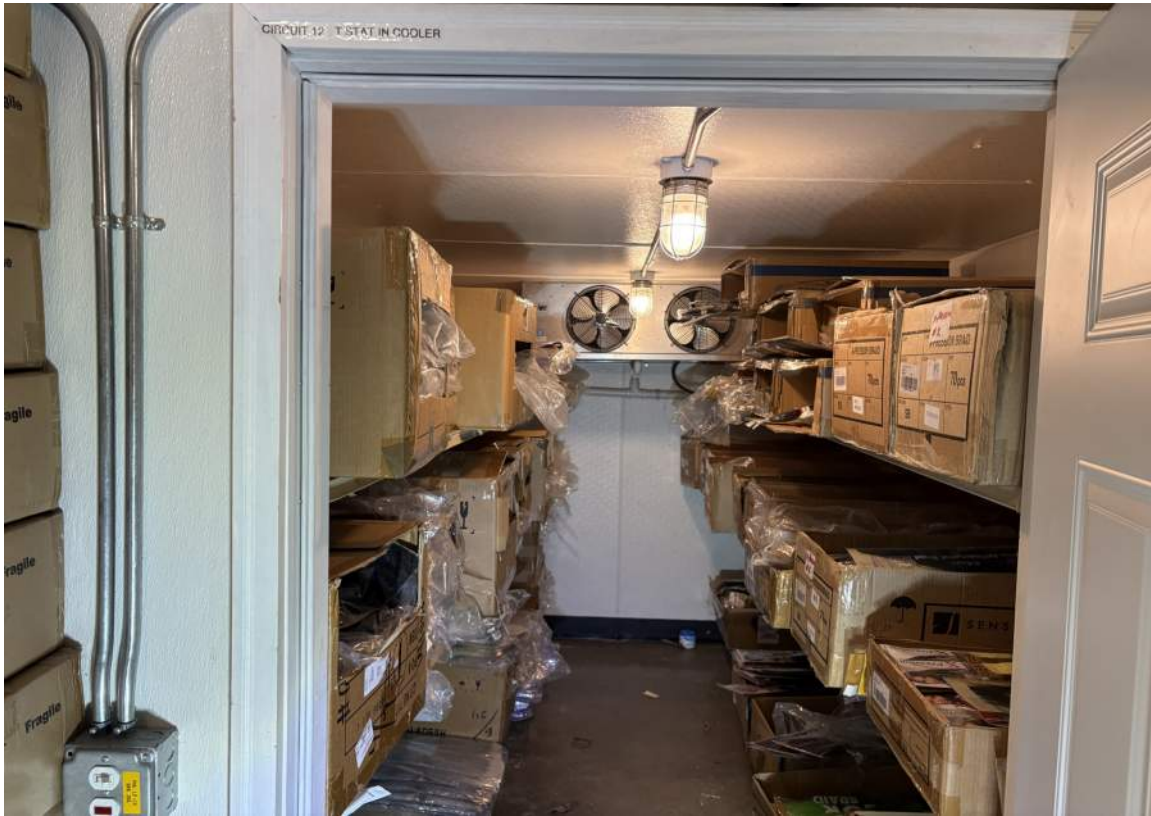
IMAGE 90: Level 01 - 1949 Structure - looking south into existing walk in cooler

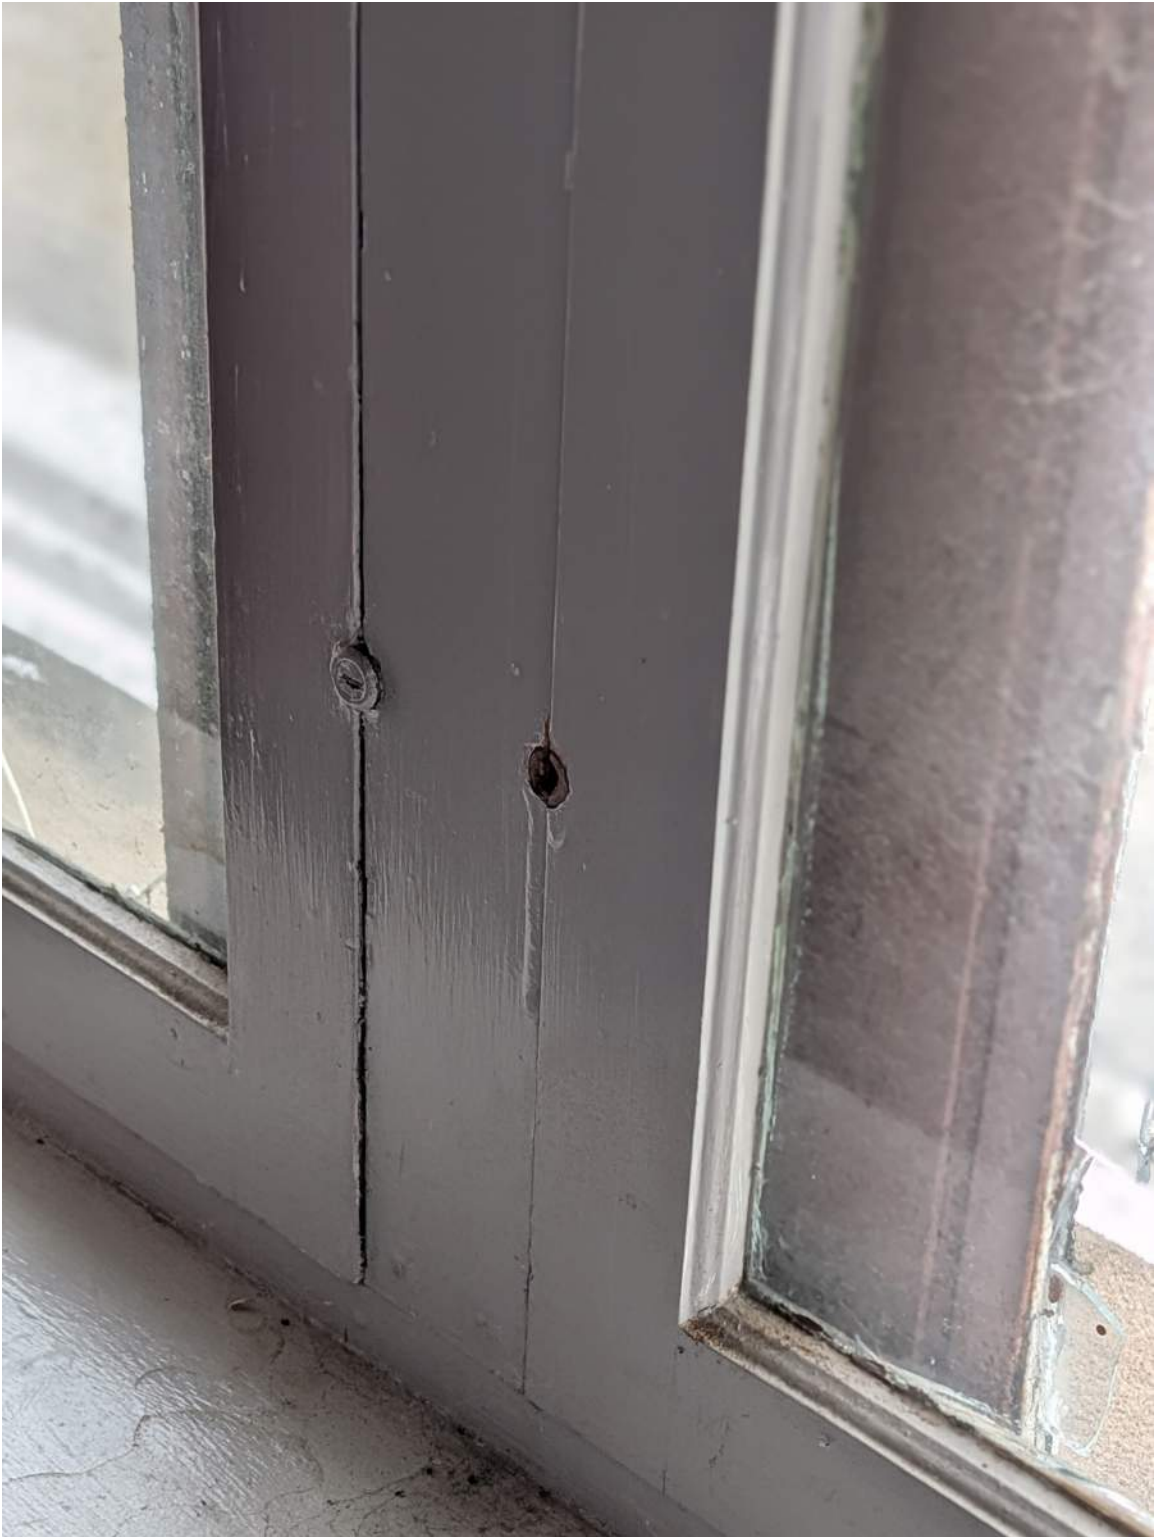
IMAGE 100: Mezzanine - 1949 Structure - looking down at existing interior wood storm windows and sill

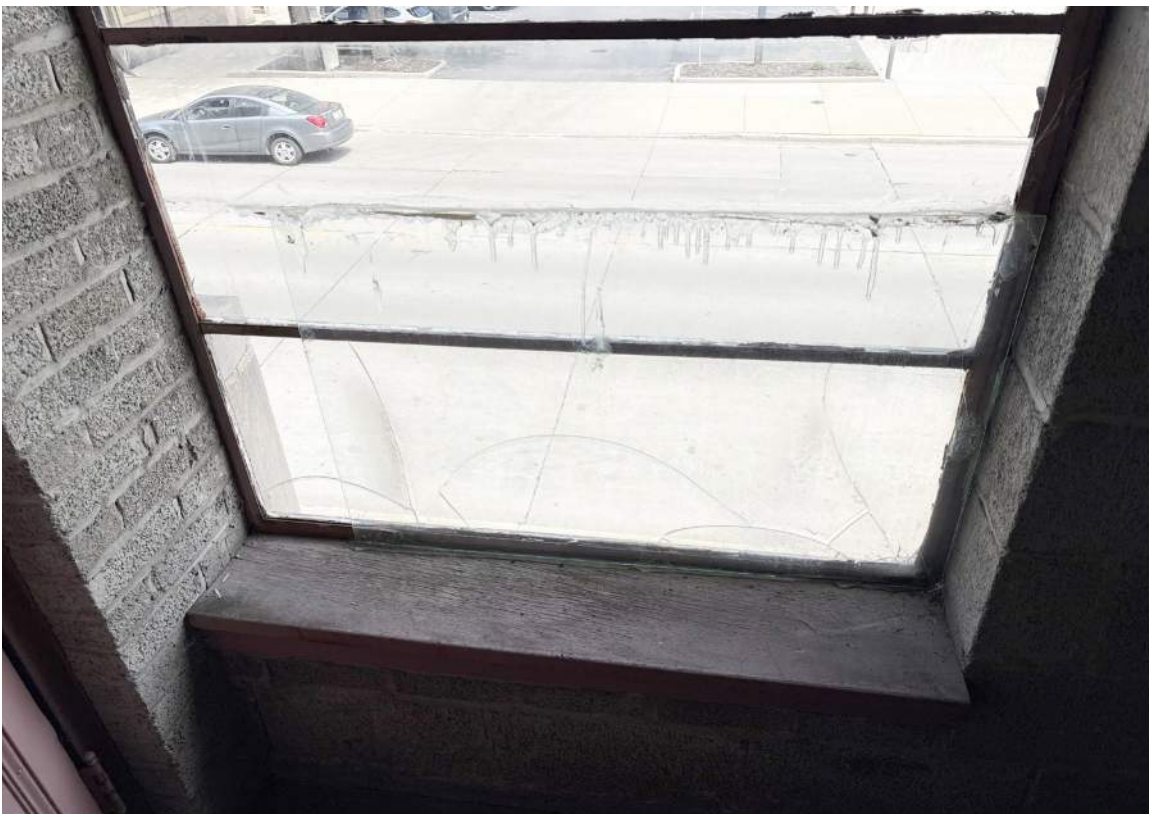
IMAGE 102: Mezzanine - 1949 Structure - inside staircase looking east at original steel sash window without interior storm window

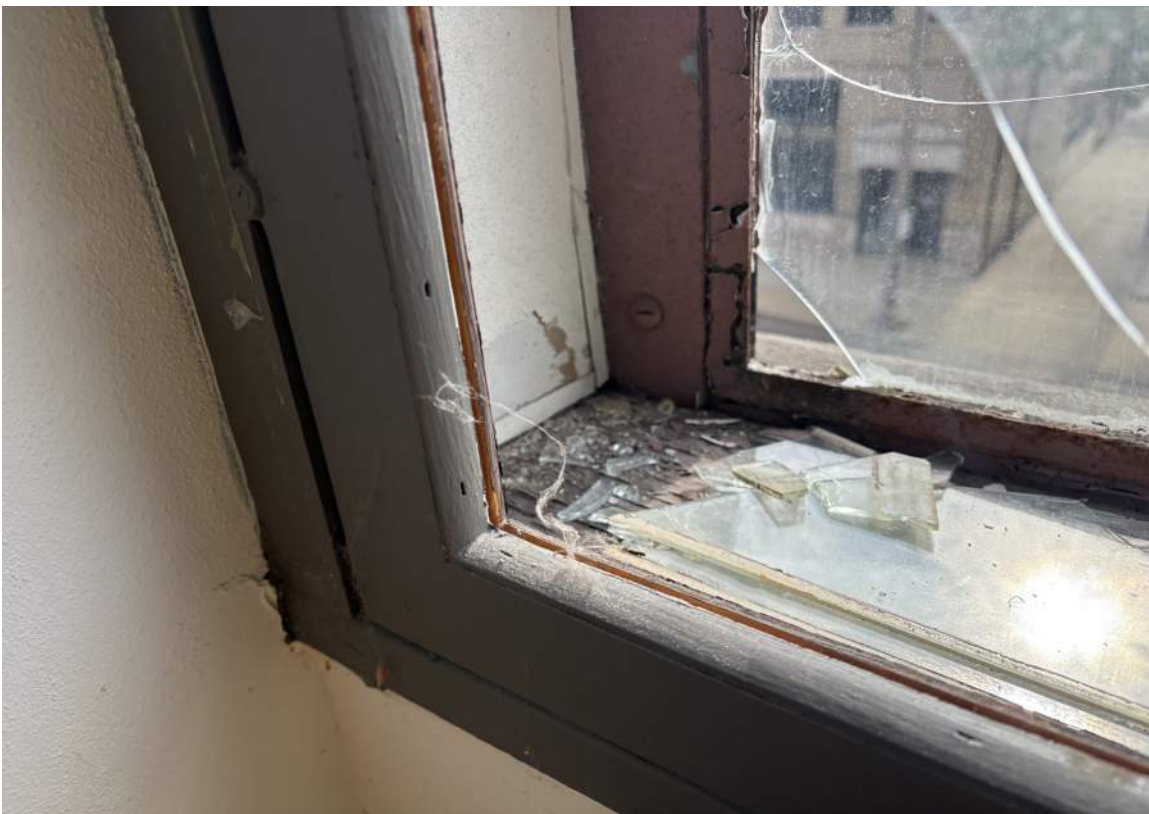
IMAGE 107: Level 02 - 1949 Structure - looking northeast at existing interior wood storm window in foreground and original steel sash window beyond

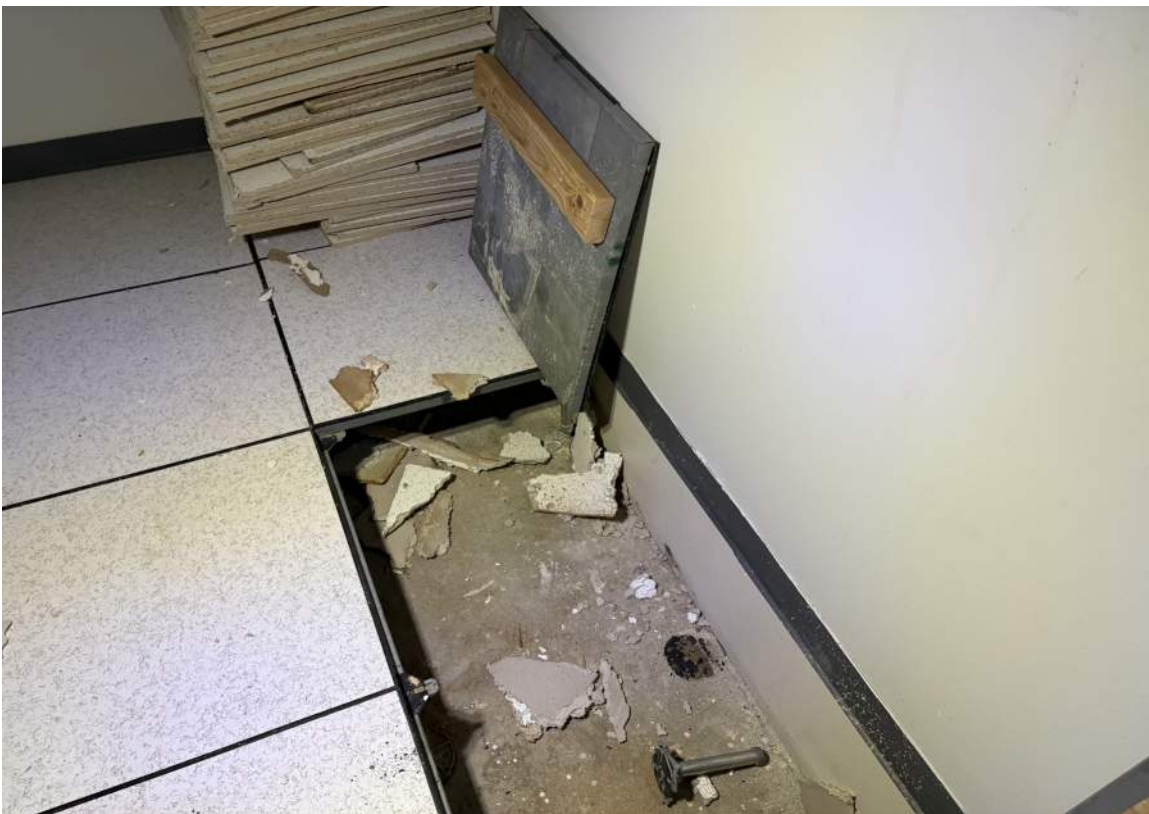
IMAGE 111: Level 02 - 1949 Structure - looking down at removed portions of raised floor system over concrete floor

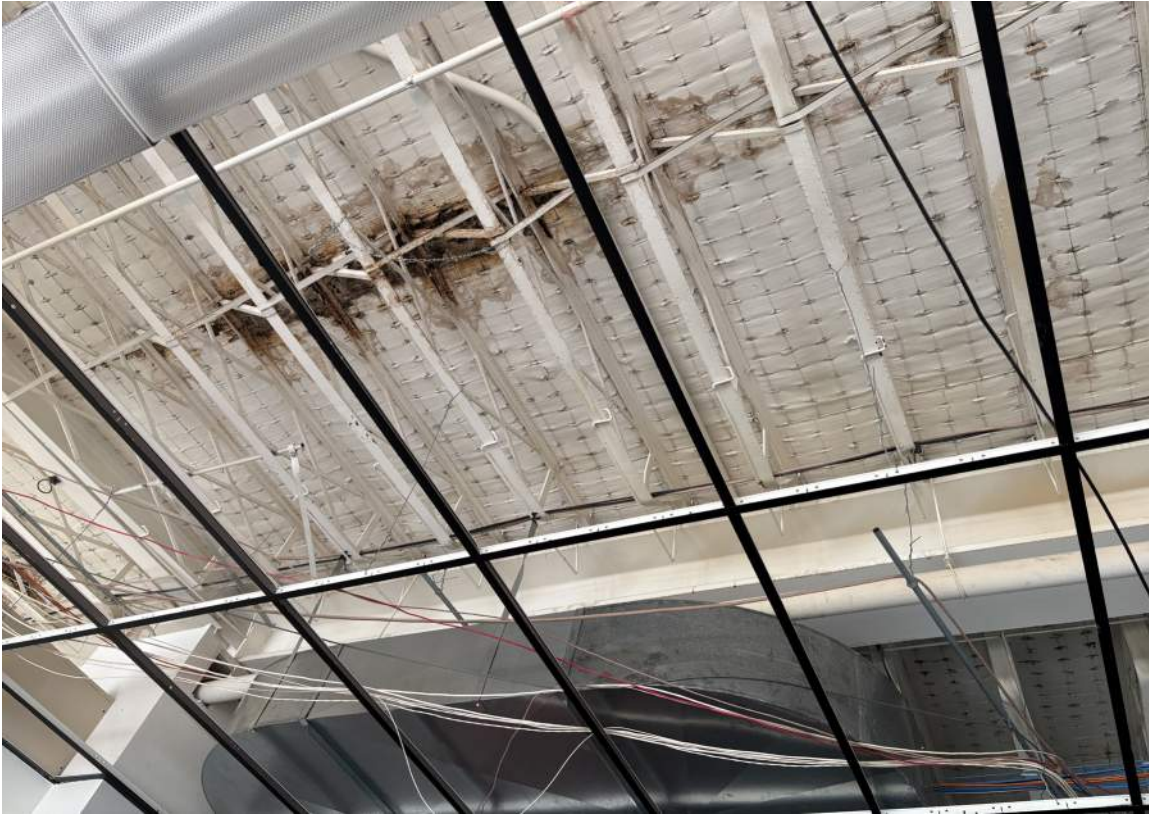
IMAGE 112: Level 02 - 1949 Structure - looking up at water infiltration and rust at existing steel roof joists

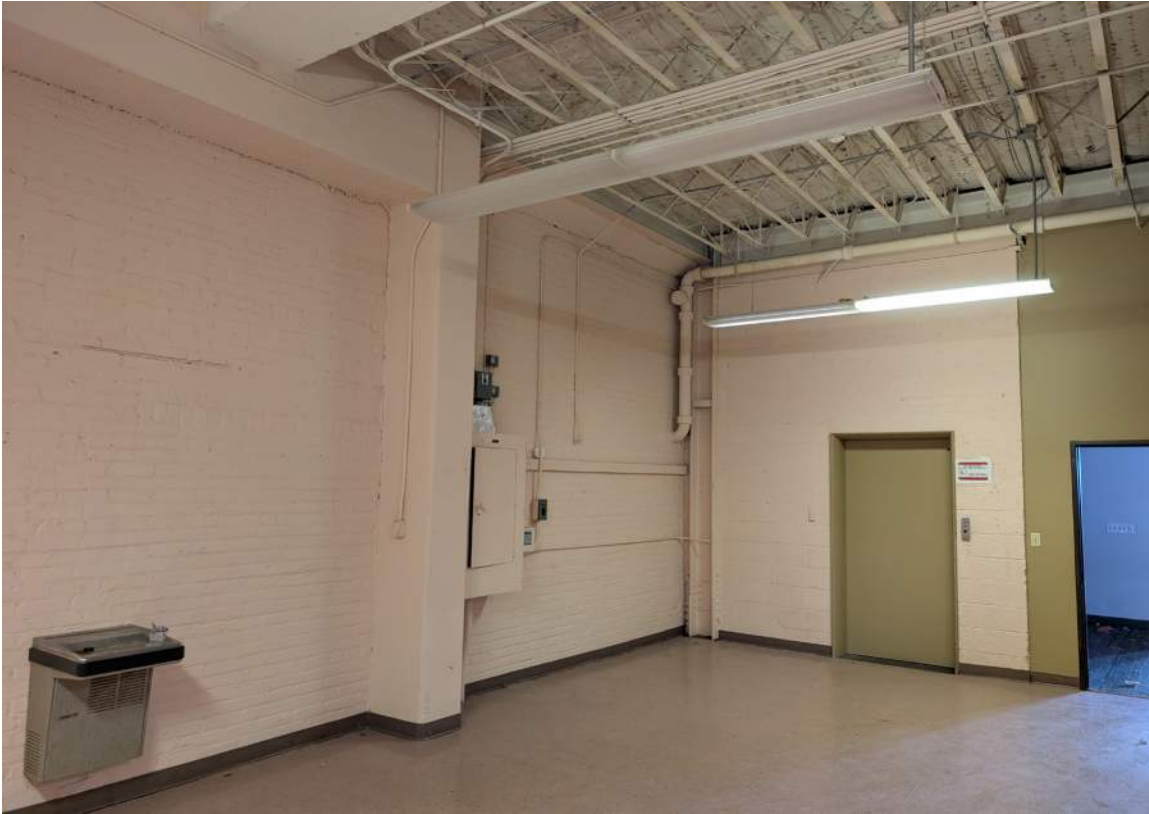
IMAGE 114: Level 02 - 1949 Structure - looking northeast at existing decommissioned passenger elevator
