**The Grand Department Store**  
HISTORIC PRESERVATION CERTIFICATION APPLICATION  
PART 1 - EVALUATION OF SIGNIFICANCE & PART 2 - DESCRIPTION OF REHABILITATION

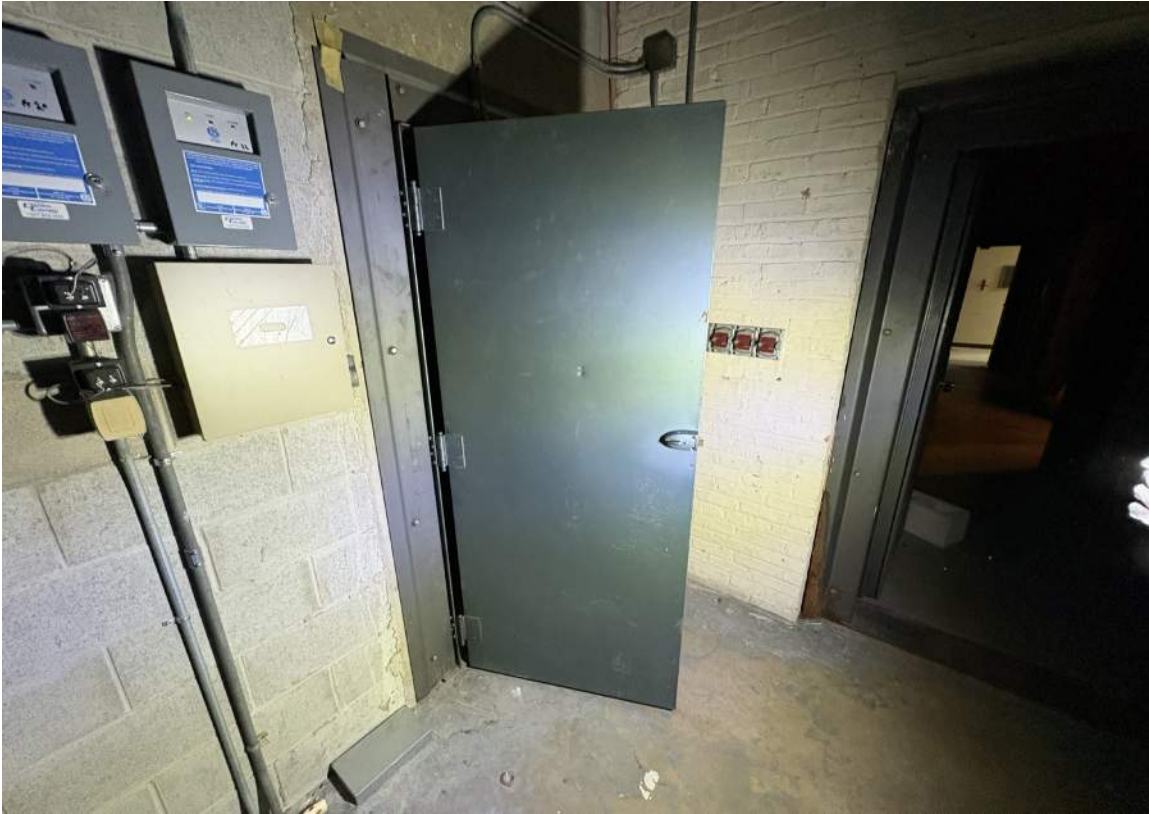
IMAGE 129: Level 02 - 1949 Structure - looking northeast at existing door into stairwell in steel vault frame

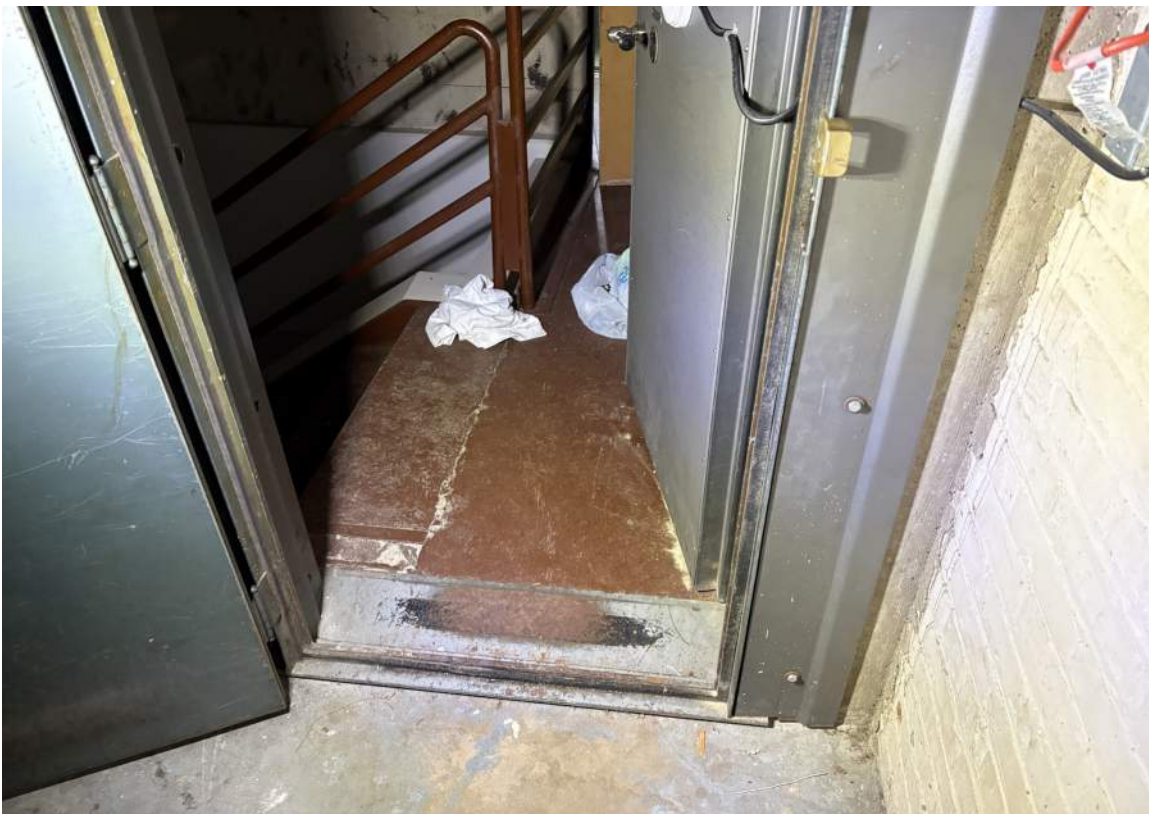
IMAGE 130: Level 02 - 1949 Structure - looking north at floor transition into stairwell

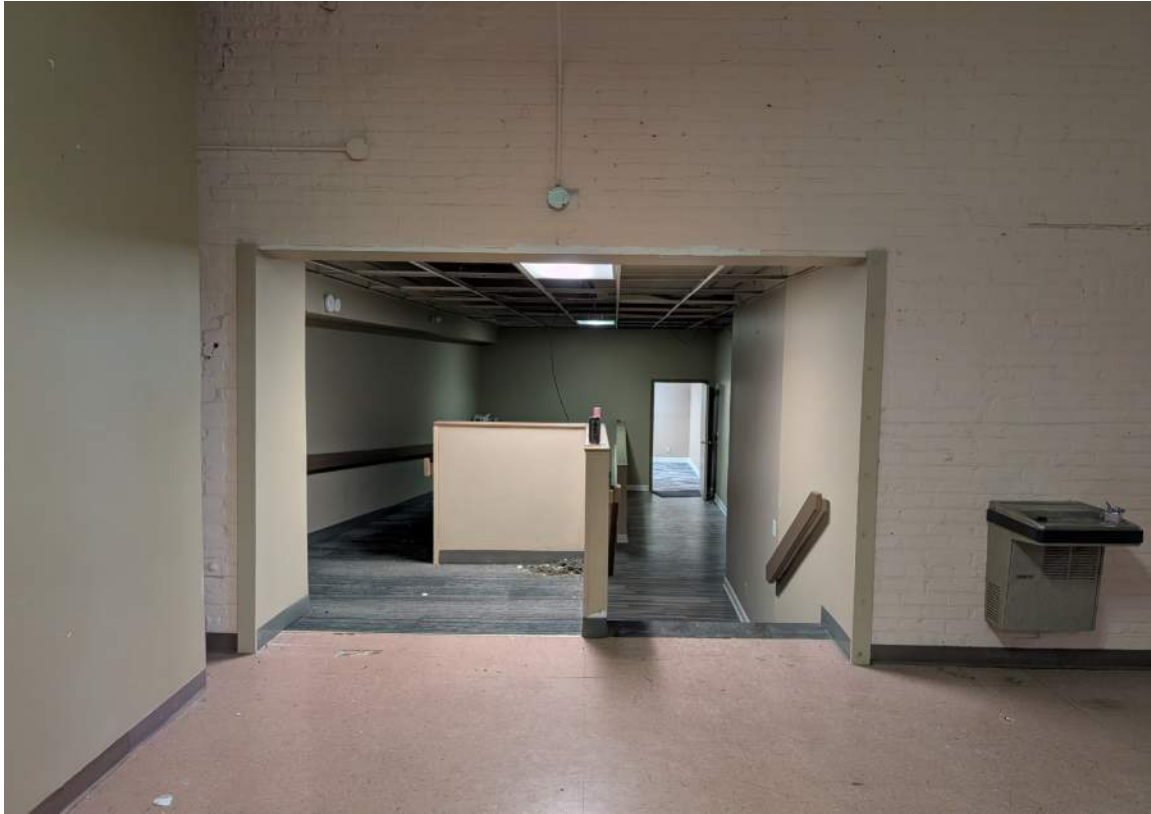
IMAGE 131: Level 02 - 1949 Structure - looking north at existing overframed stair and ramp leading down to 1911 Structure

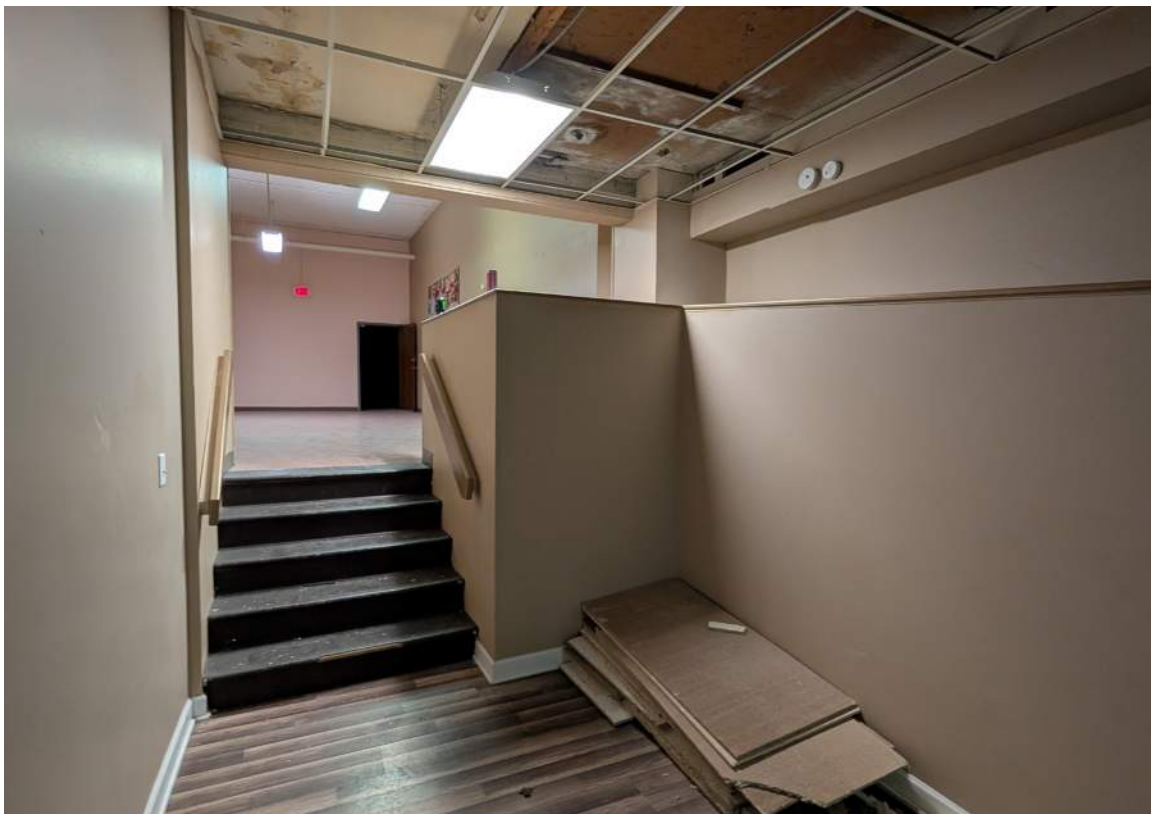
IMAGE 132: Level 02 - 1911 Structure - looking south at stair up to 1949 Structure

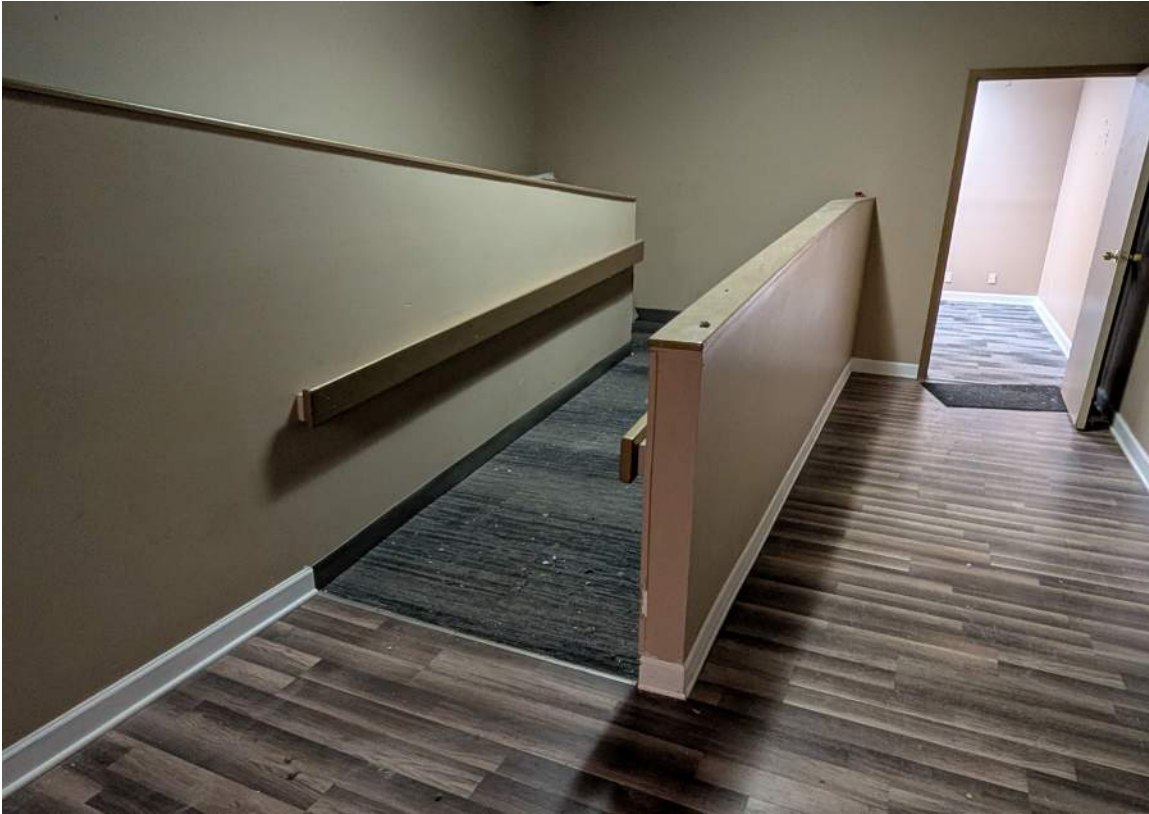
IMAGE 133: Level 02 - 1911 Structure - looking northwest at existing overframed ramp

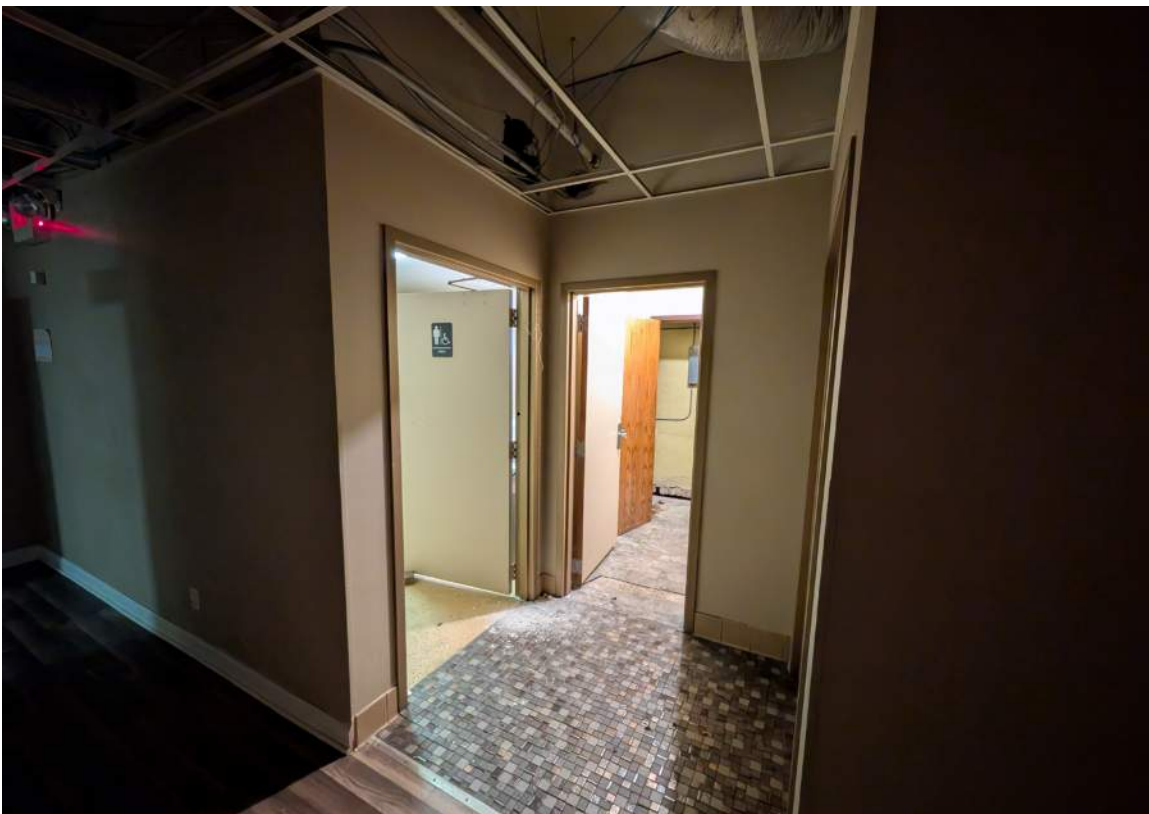
IMAGE 134: Level 02 - 1911 Structure - looking southeast at existing bathrooms and janitor's closet

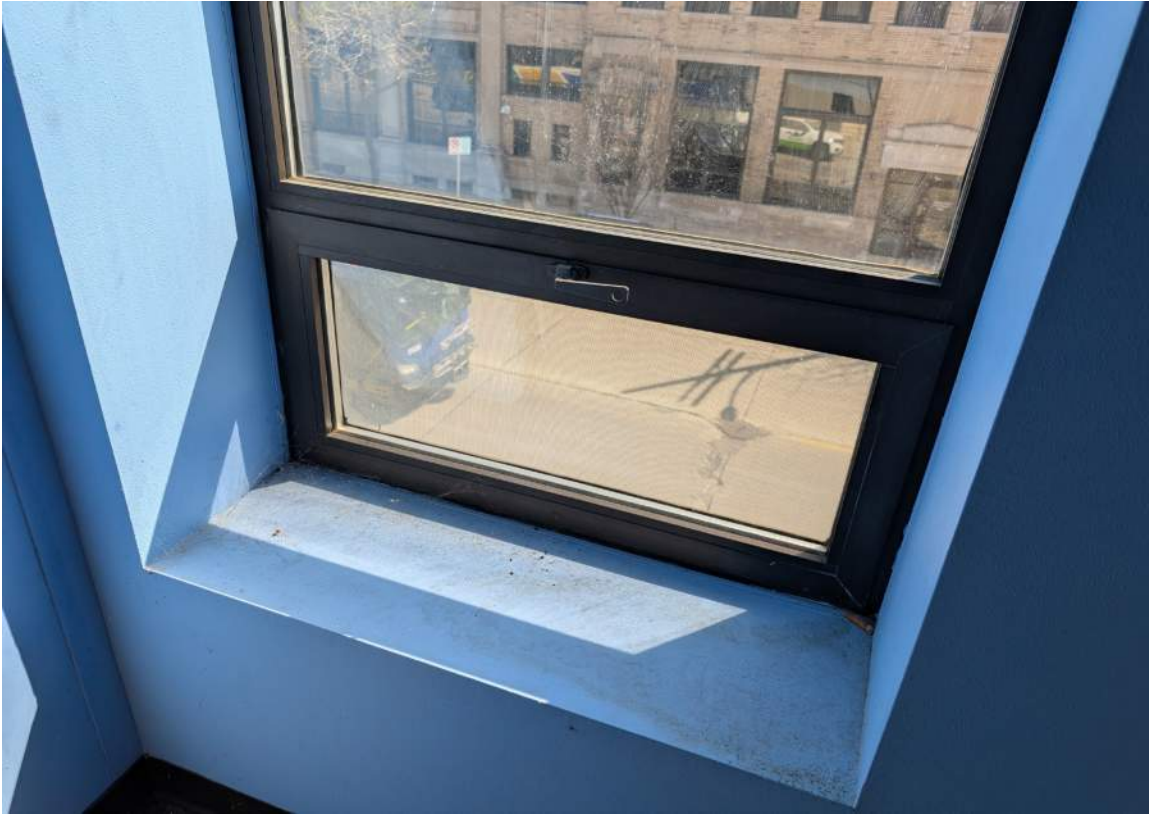
IMAGE 140: Level 02 - 1911 Structure - looking east at existing storefront window with lower operable hopper

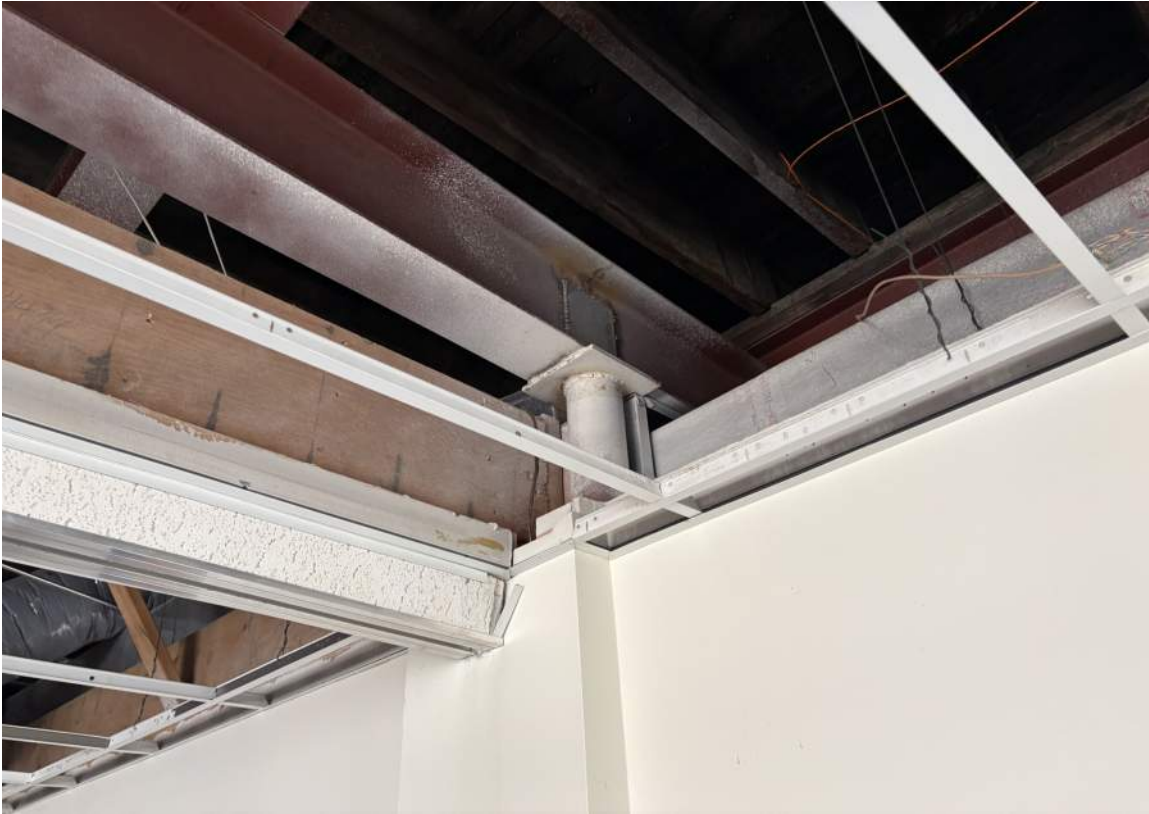
IMAGE 142: Level 02 - 1891 Structure - looking southwest and up at existing tube steel column and steel beam overhead below wood roof framing

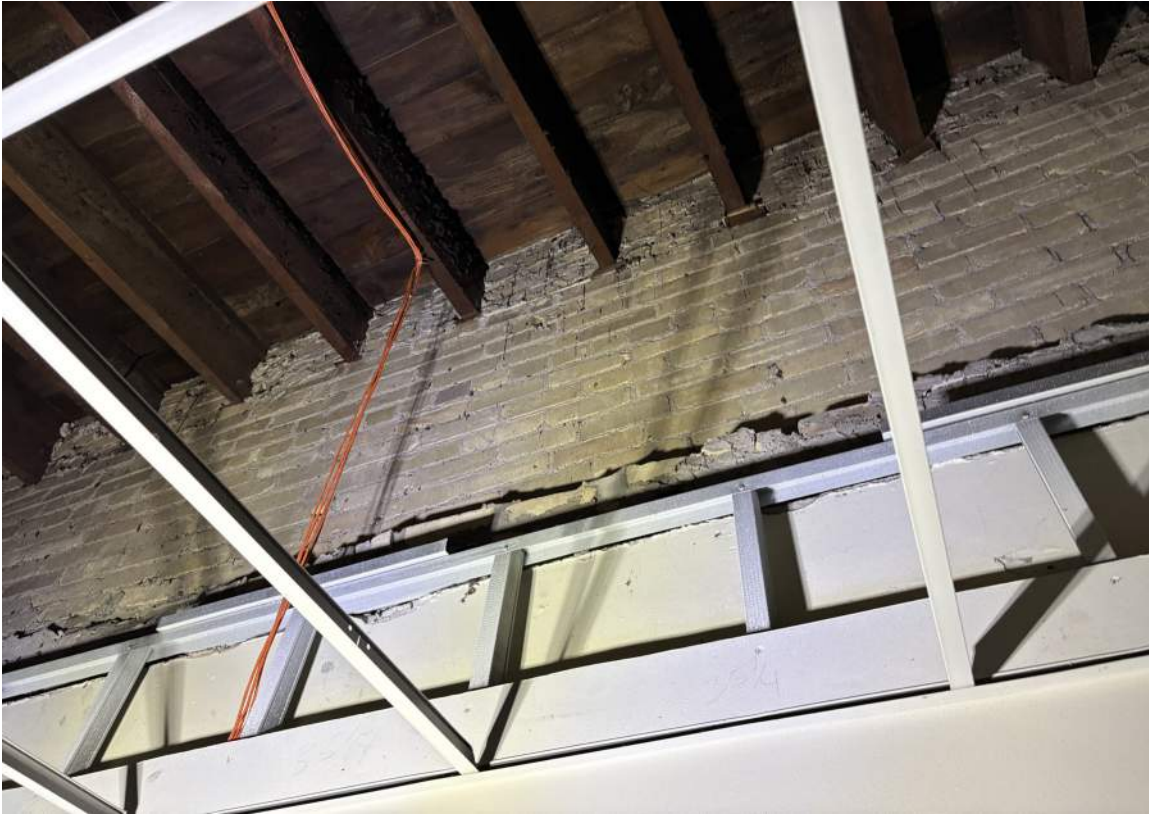
IMAGE 144: Level 02 - 1891 Structure looking up and west at masonry wall separating pre-1888 Structure

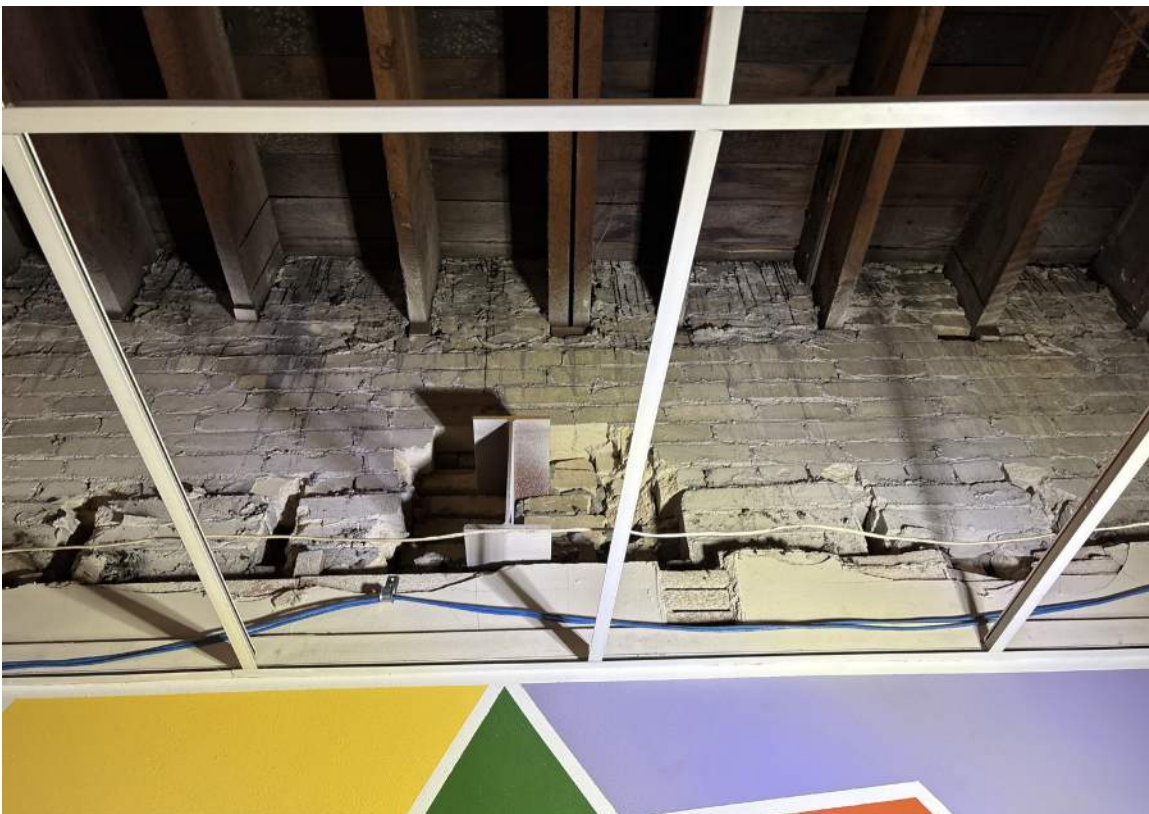
IMAGE 145: Level 02 - pre-1888 Structure - looking up and east at masonry walls separating in 1891 Structure with penetrating steel beam

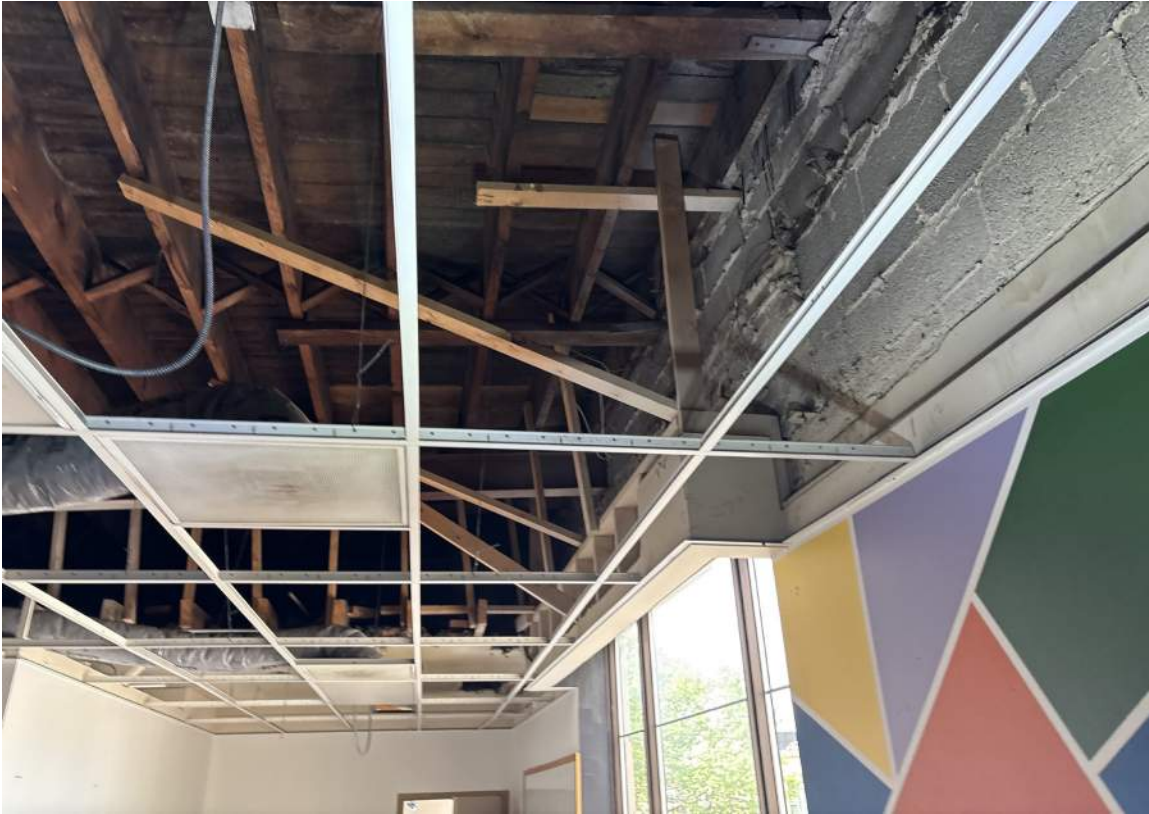
IMAGE 148: Level 02 - pre-1888 Structure - looking west at exterior wall and wood roof framing

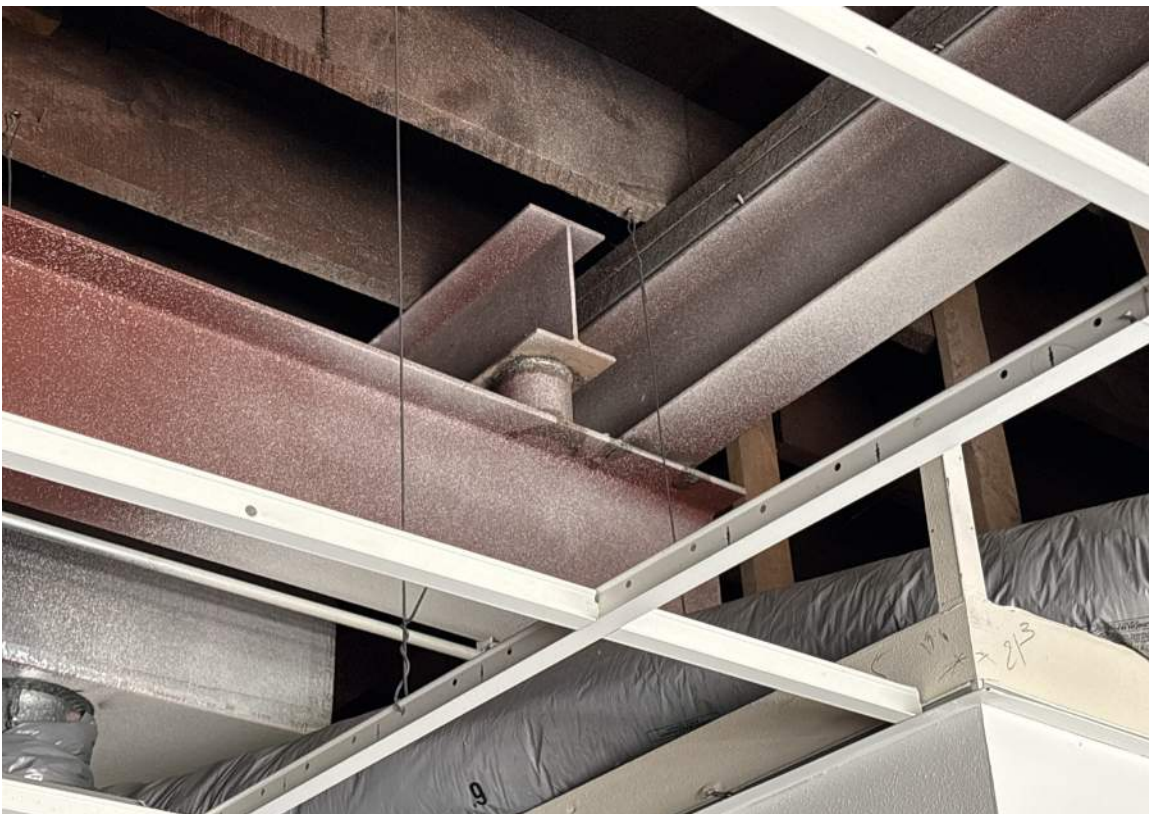
IMAGE 149: Level 02 - pre-1888 Structure - looking up at existing steel beams below wood roof structure

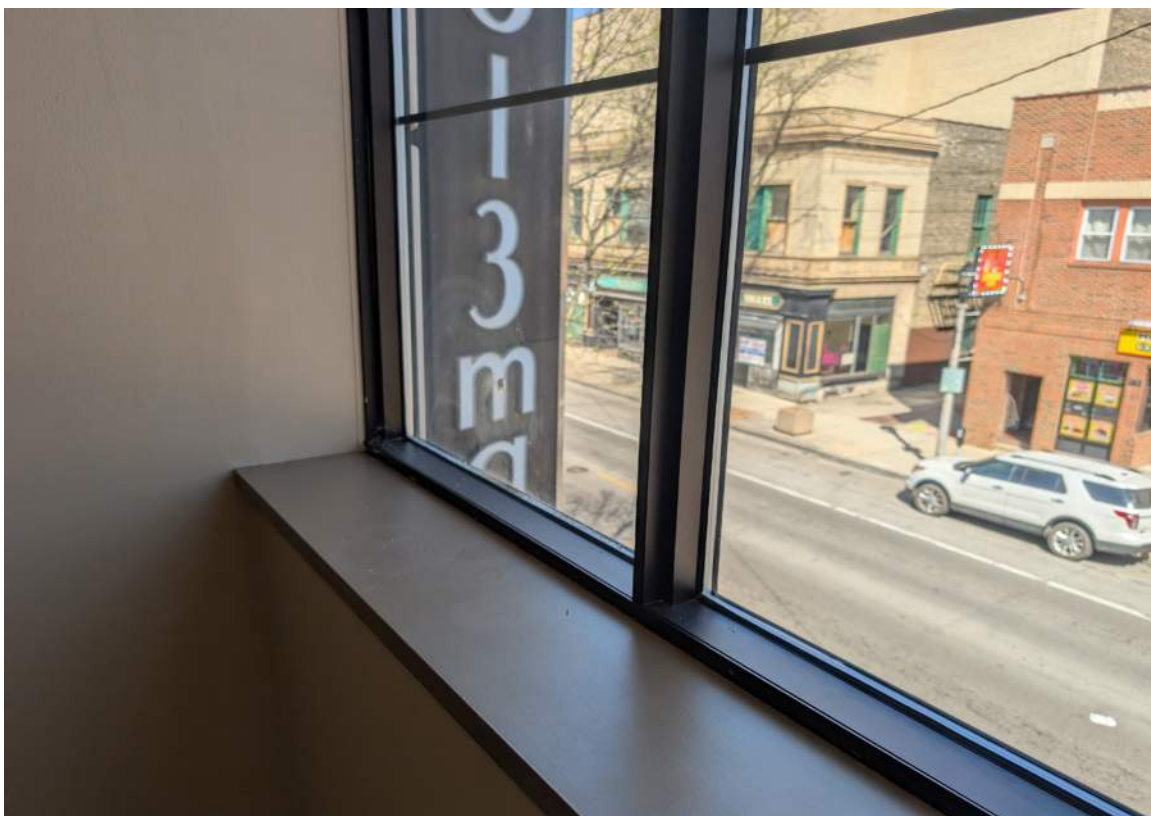
IMAGE 151: Level 02 - pre-1888 Structure - looking northwest at existing storefront window

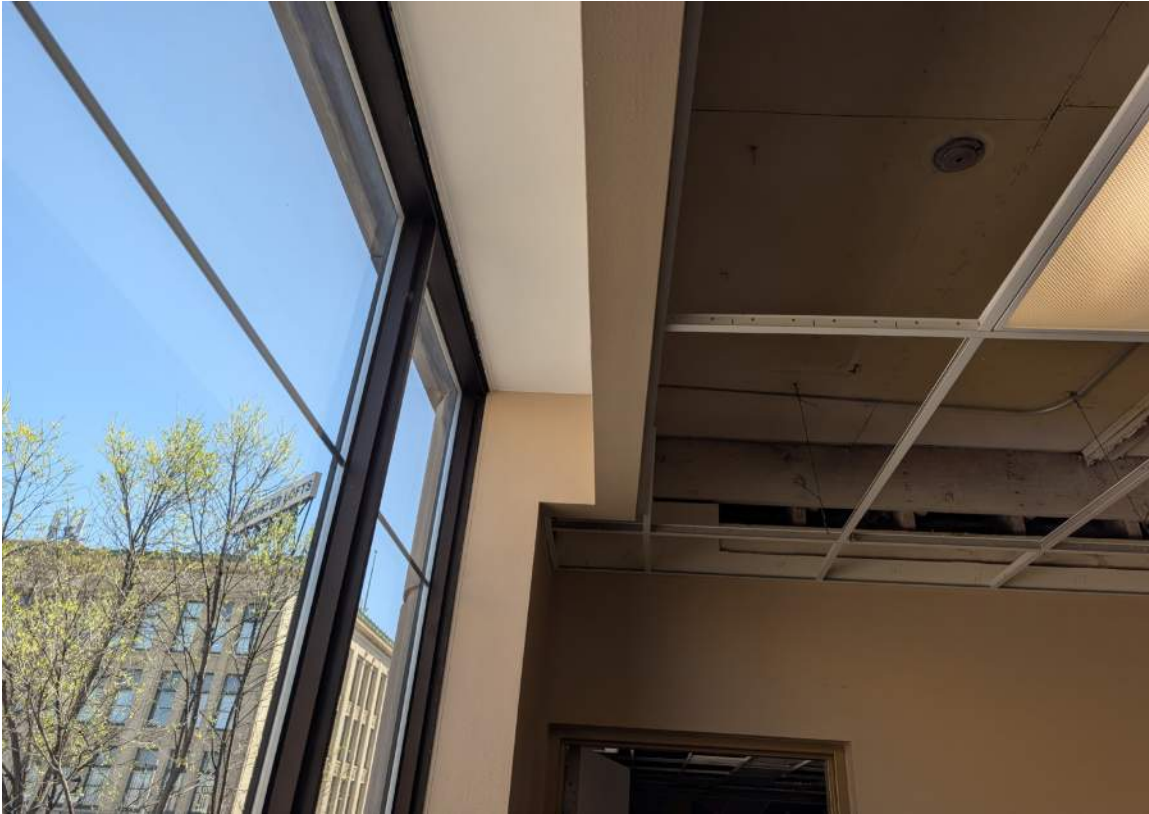
IMAGE 152: Level 02 - pre-1888 Structure - looking up and east at head of existing storefront window

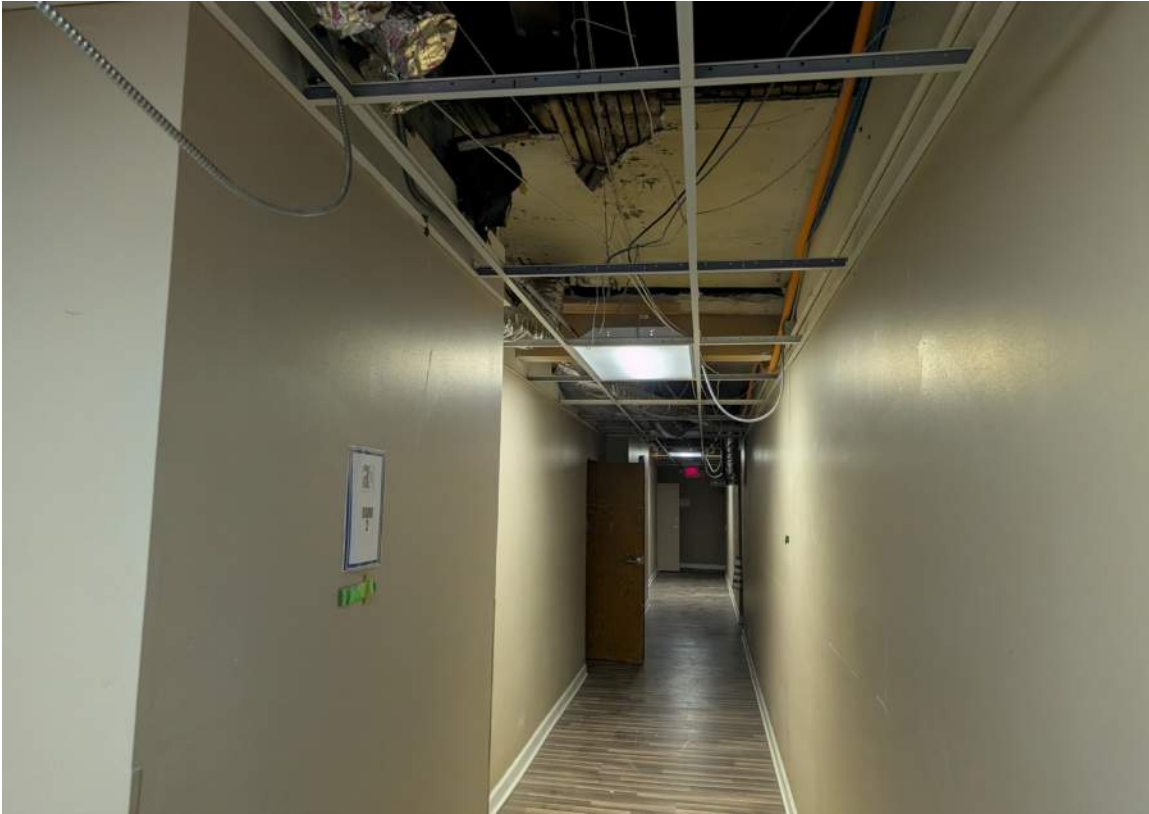
IMAGE 156: Level 02 - pre-1888 Structure - looking west down existing corridor - small remnant of plaster ceiling on wood lath overhead

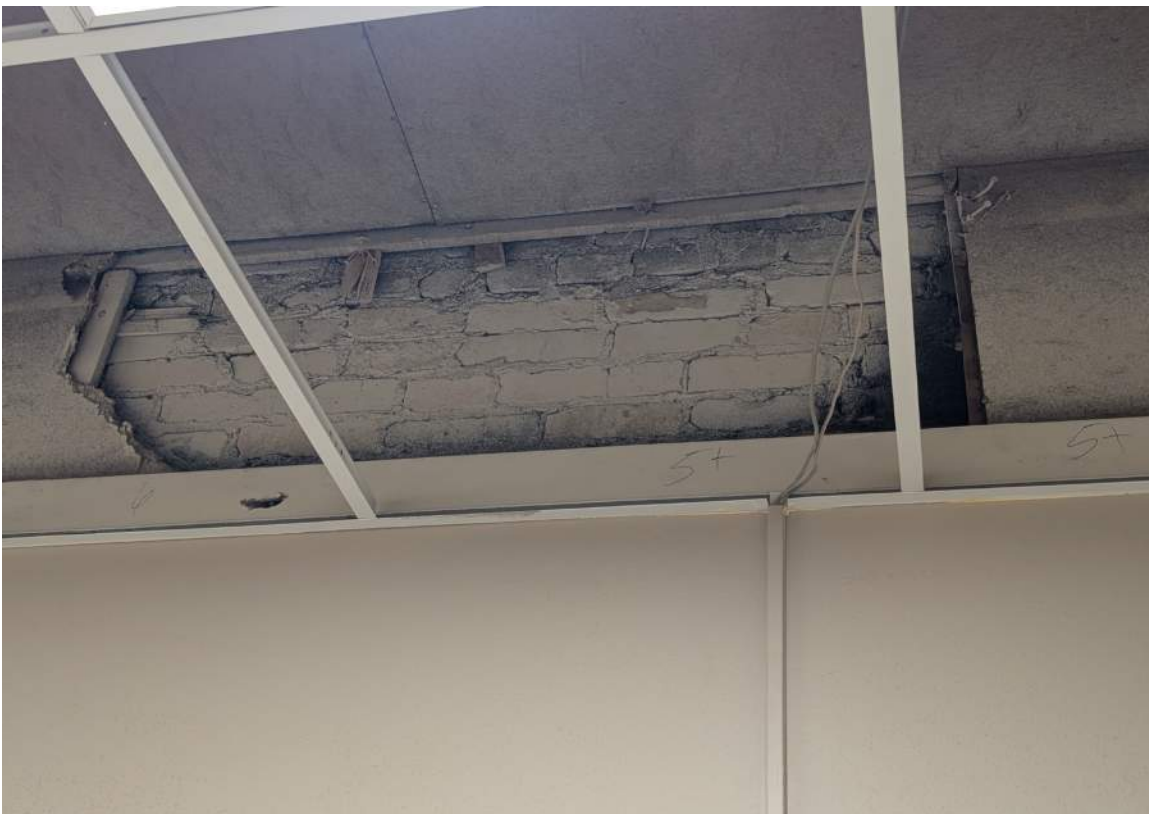
IMAGE 159: Level 02 - pre-1888 Structure - looking west and up at small portion of brick masonry wall exposed above existing wall furring

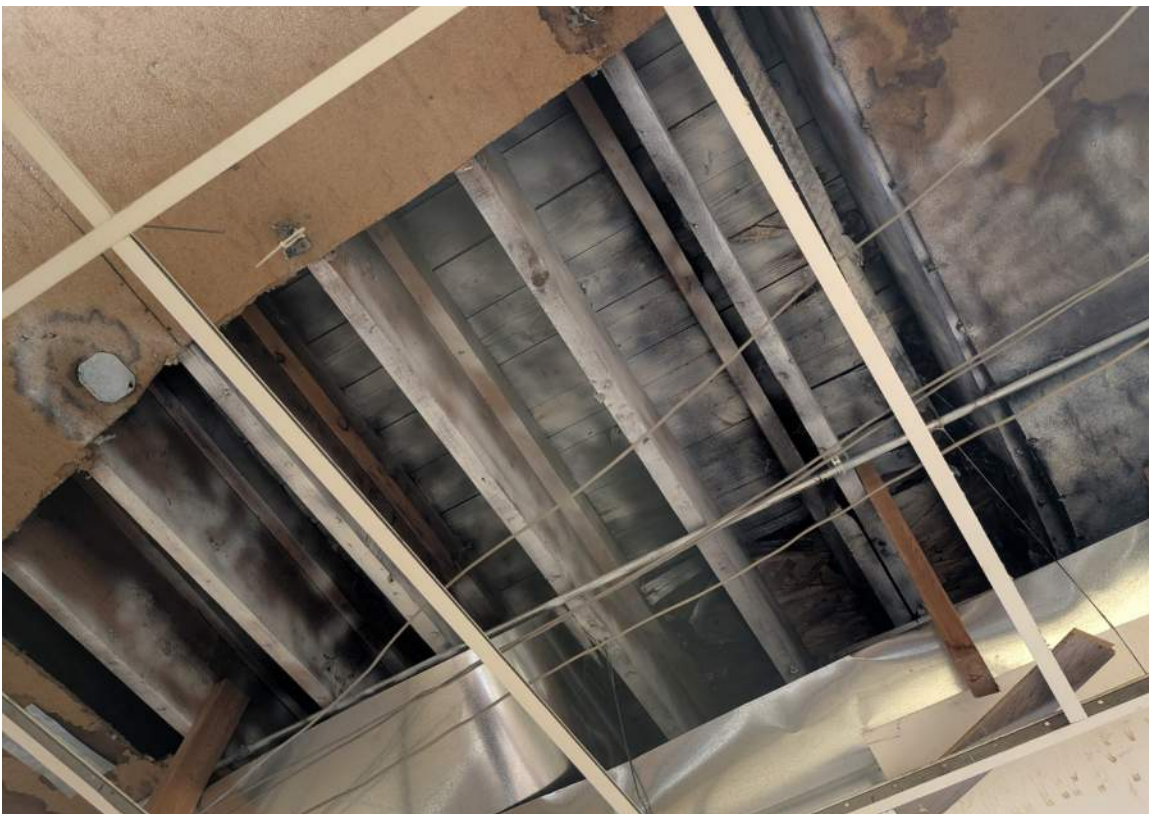
IMAGE 161: Level 02 - pre-1888 Structure - looking up and southwest at existing wood roof framing

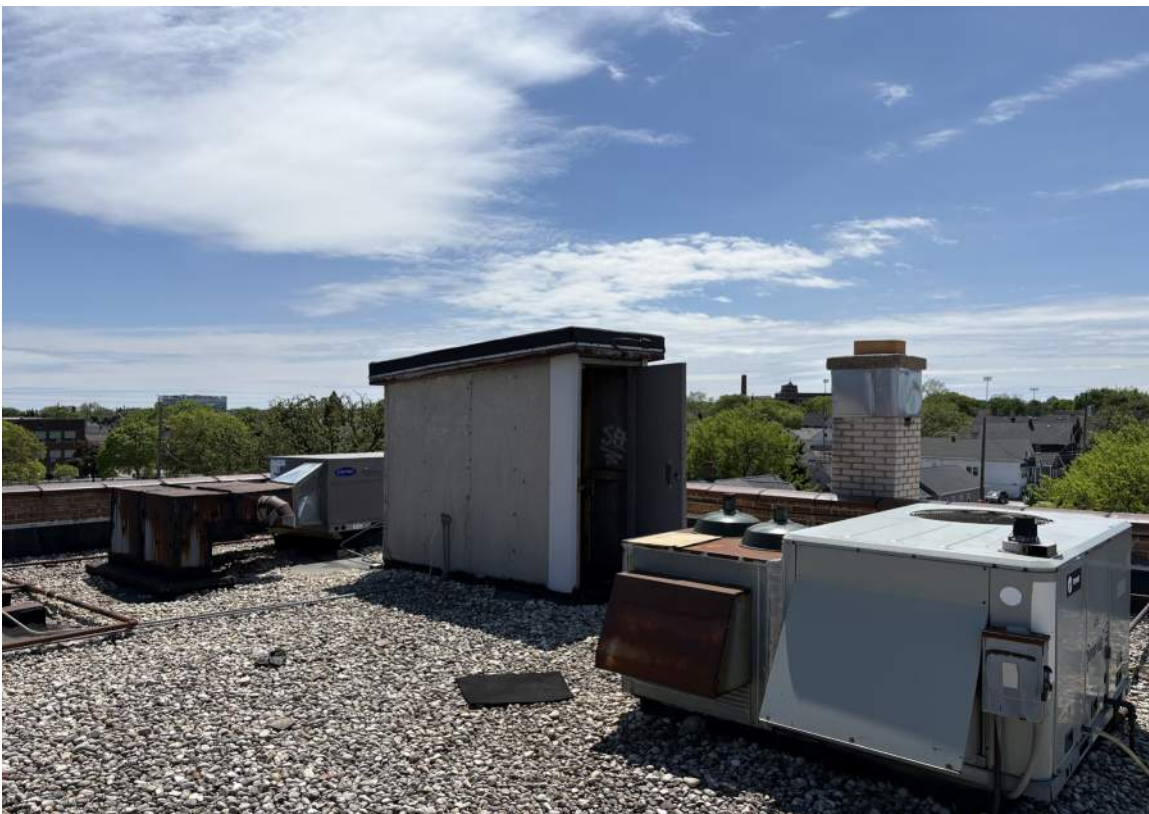
IMAGE 163: Rooftop - 1949 Structure - looking southeast at existing stair doghouse and mechanical equipment

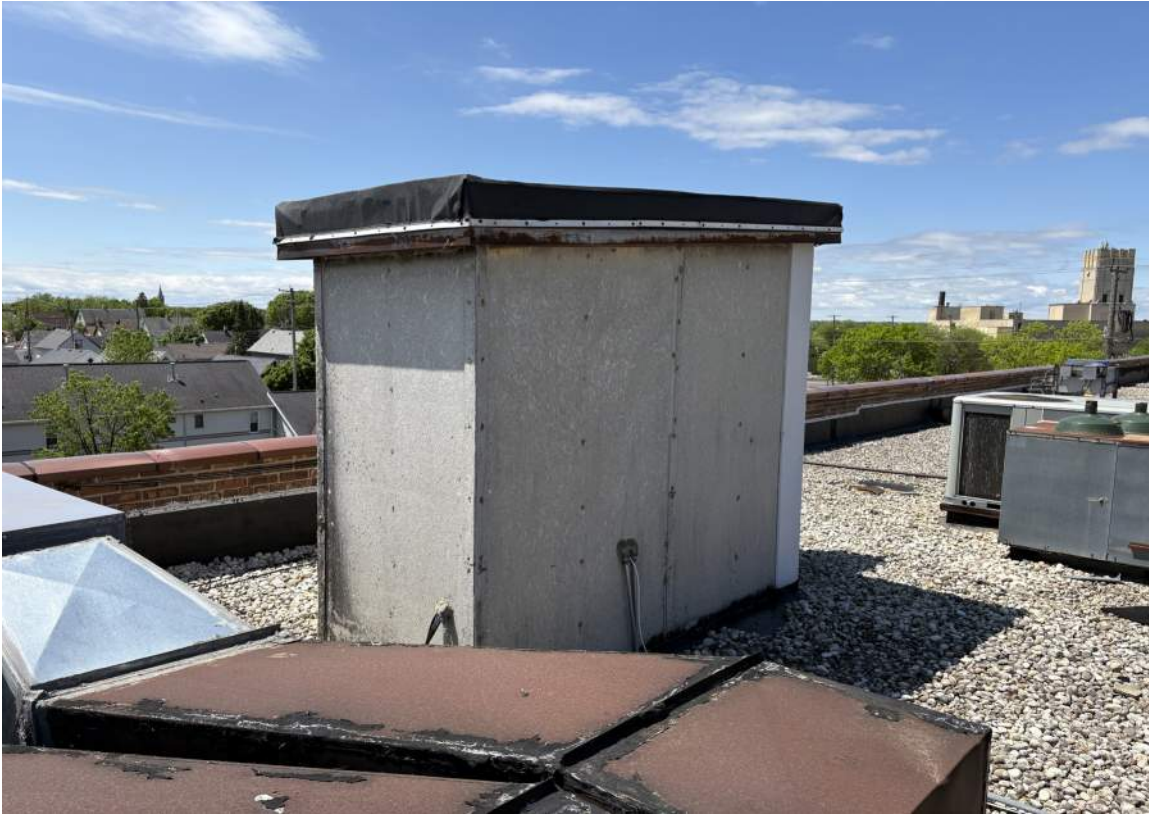
IMAGE 164: Rooftop - 1949 Addition - looking southwest at existing stair doghouse

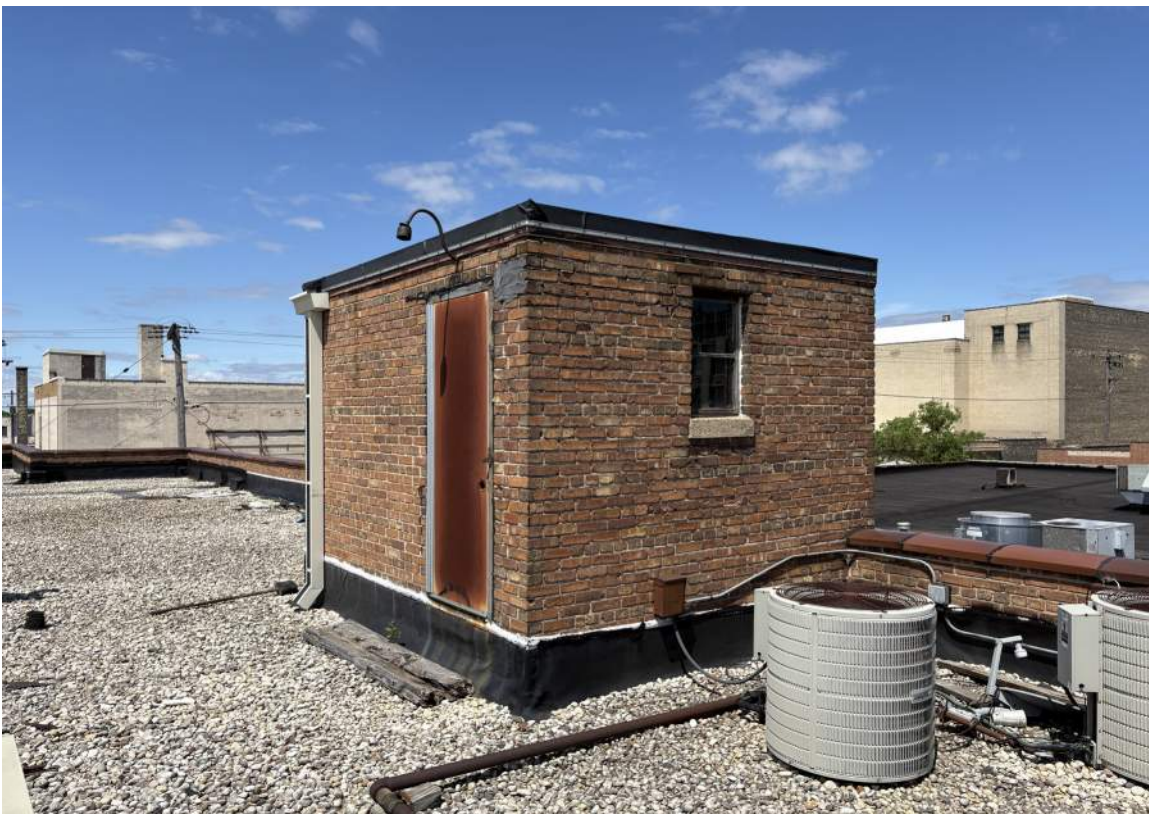
IMAGE 165: Rooftop - 1949 Structure - looking northwest at existing passenger elevator overrun

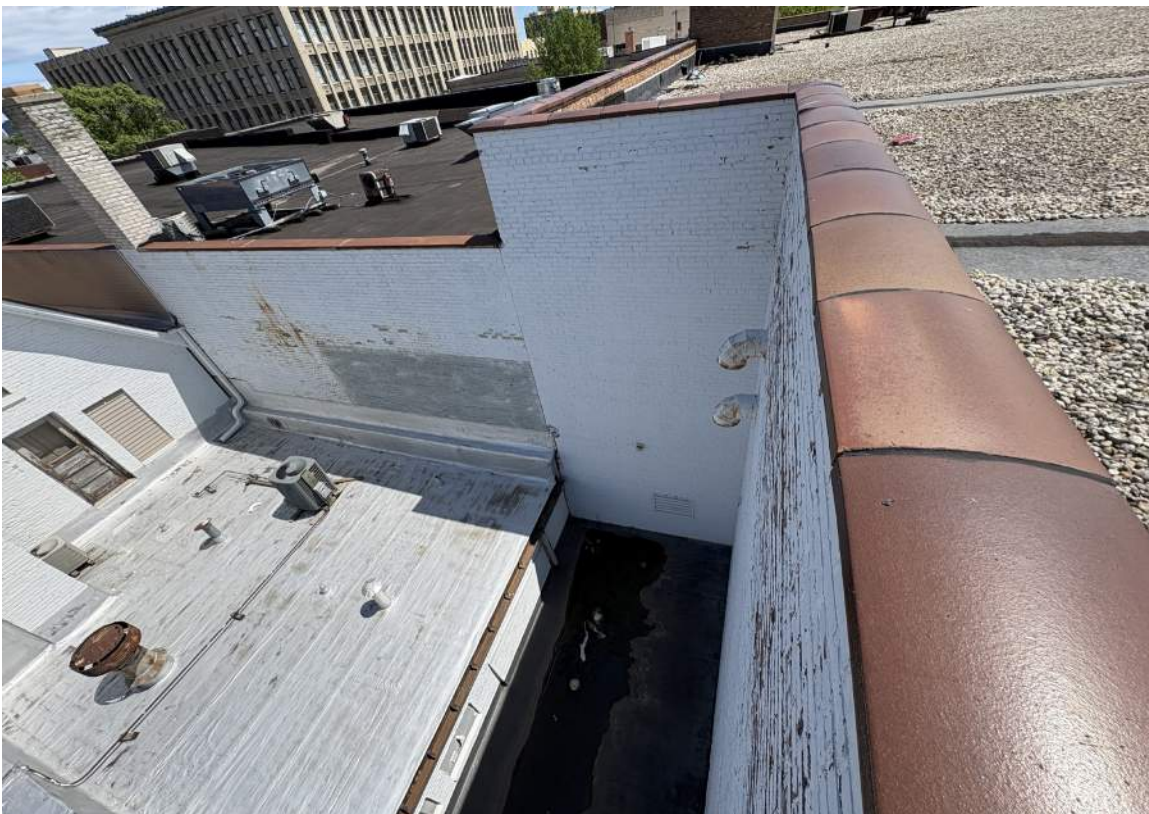
IMAGE 167: Rooftop - 1949 Structure - looking northeast at clay tile parapet caps and abutting neighboring building below

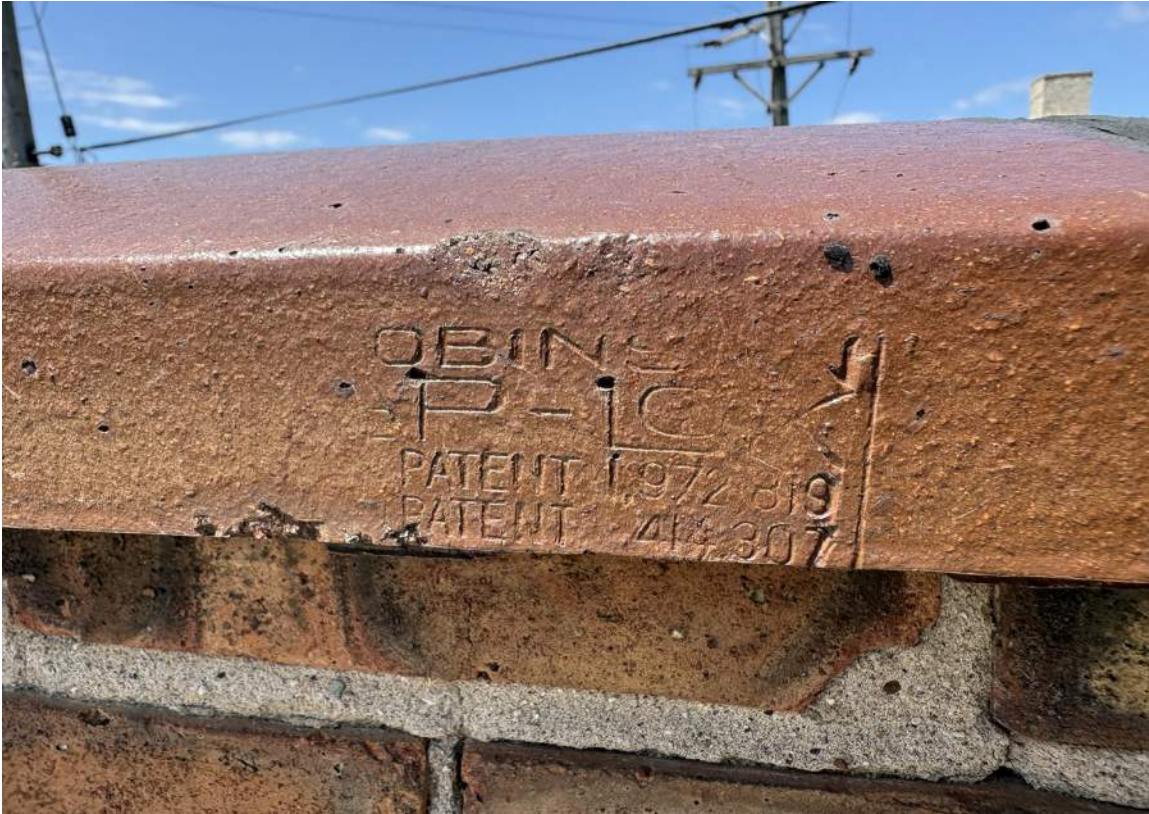
IMAGE 168: Rooftop - 1949 Structure - close up of existing clay tile parapet caps

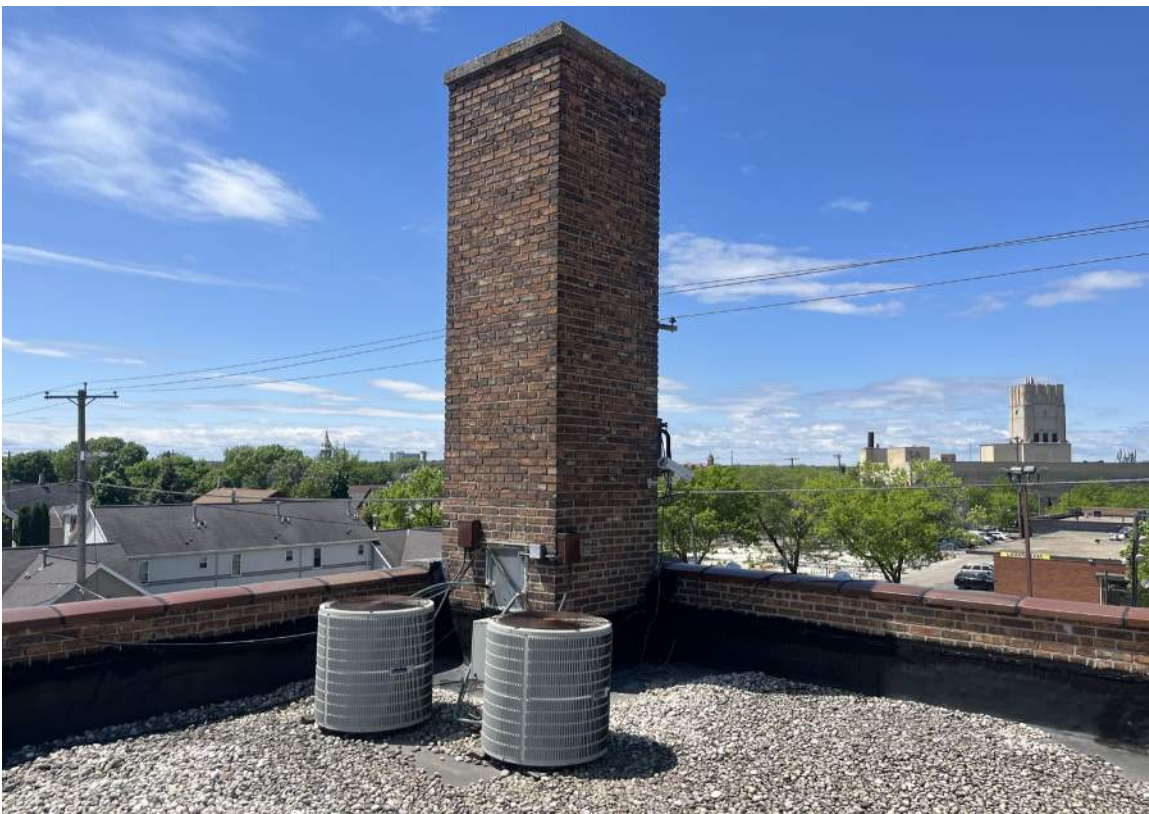
IMAGE 169: Rooftop - 1949 Structure - looking southwest at brick chimney

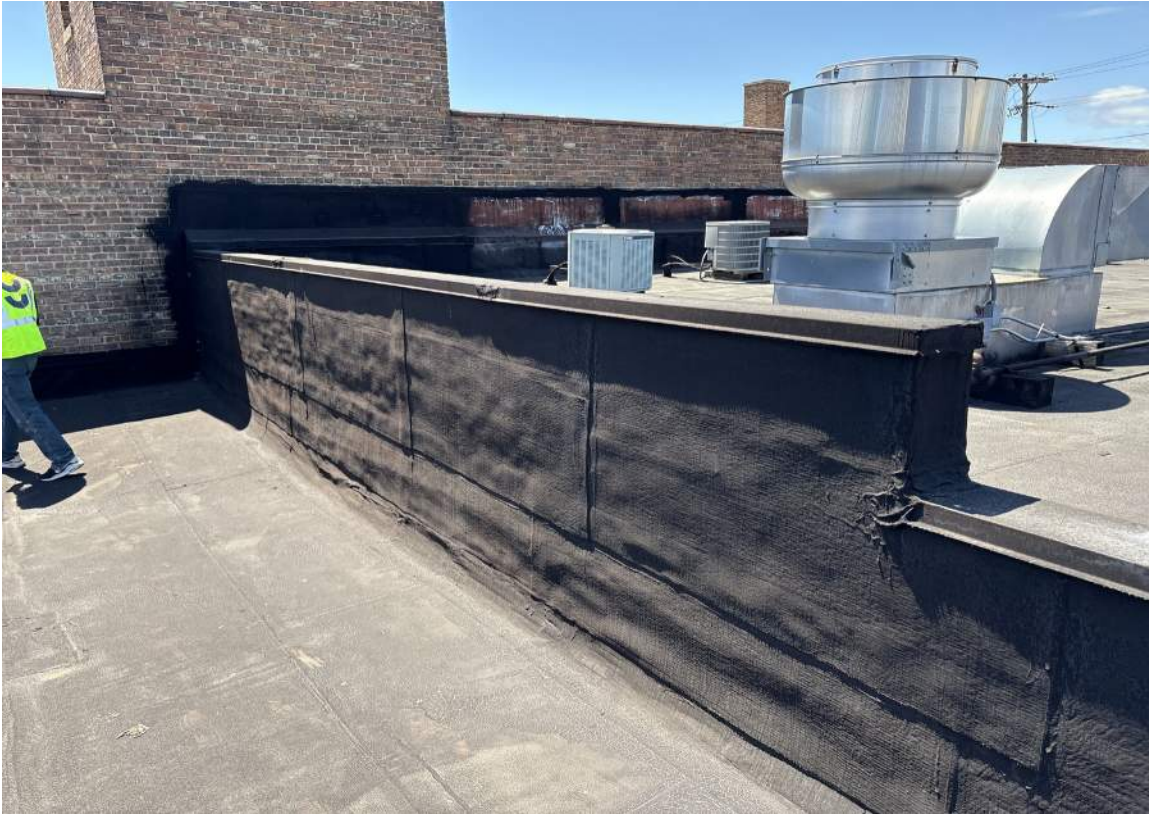
IMAGE 170: Rooftop - 1911 Structure - looking southwest
